| REPORT DOCUMENTATION PAGE | | | | Form Approved<br>OMB No. 0704-0188 | |
|---|---|---|---|---|---|
| 4. TITLE AND SUBTITLE<br><br>AFRL Solid Propellant Laboratory Explosive Siting and Renovation Lessons Learned | | | | 5a. CONTRACT NUMBER | |
| 7. PERFORMING ORGANIZATION NAME(S) AND ADDRESS(ES)<br><br>Air Force Research Laboratory (AFMC)<br>AFRL/RZSP<br>10 E. Saturn Blvd.<br>Edwards AFB CA 93524-7680 | | | | 8. PERFORMING ORGANIZATION<br>REPORT NUMBER<br><br>AFRL-RZ-ED-TP-2010-258 | |

# **AFRL Solid Propellant Laboratory Explosive Siting and Renovation Lessons Learned**

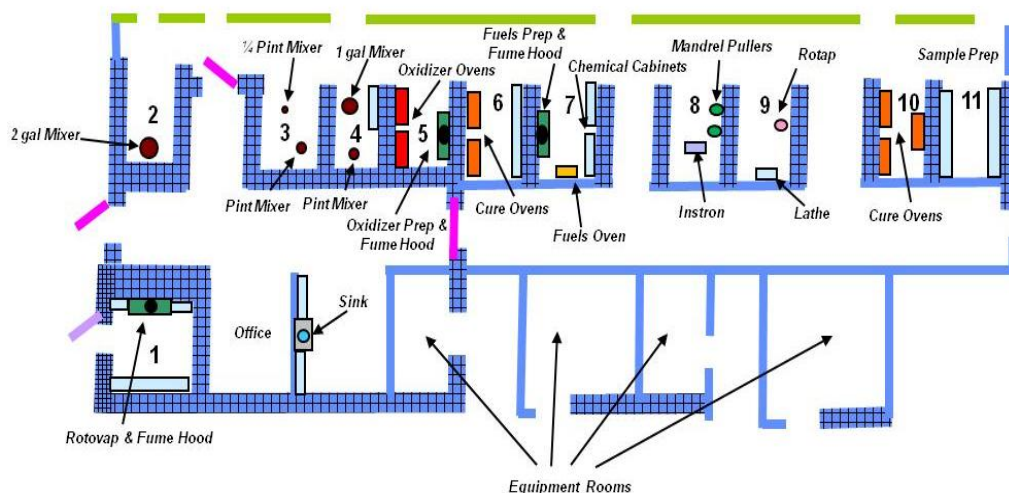
**Figure 1. Bldg 8473 Pre-Renovation Layout**

Before the renovation, Bldg 8473 consisted of eleven reinforced concrete cells with blow-out rear walls, explosion resistant windows and remote manipulators (Cells: 1-4, 8, 9 and 11). The basic operations consisted of: mixing, casting and curing of high energy solid propellants. Remote operations were performed behind blast walls in the hallways while looking through explosion resistant glass windows. The basic layout is shown in Figure 1.

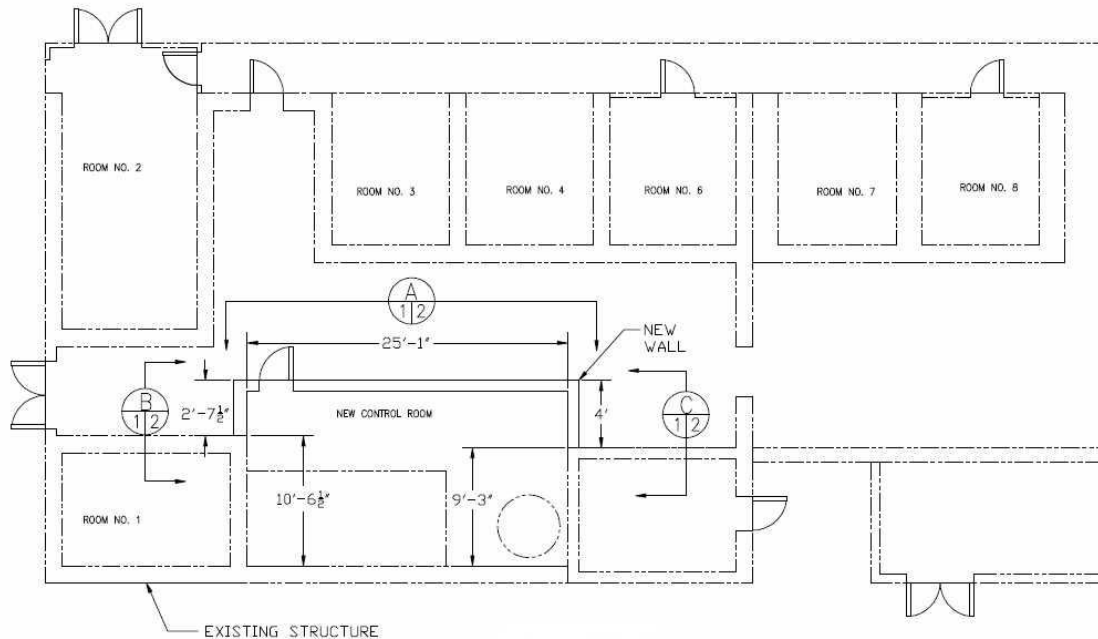
**Figure 1. Proposed layout of the new hardened control room**

The NAVFAC ESC engineering analysis determined that all of the issues AES identified for Cells 1-11 would be mitigated by requiring personnel to conduct remote operations from inside the hardened control room with the blast door closed and all other building occupants to maintain minimum standoff distance from explosive operations.

The scope of the NAVFAC ESC contract was expanded to include a preliminary design of a hardened control room to protect personnel from blast and fragment hazards. The NAVFAC ESC design was for an 8-inch reinforced concrete wall composed of 4 ksi concrete with #4 bars spaced at 12 inches on center each way for each face, anchored into the existing reinforced concrete walls and a 3 psi rated blast door. The general layout of the control room proposed by NAVFAC ESC is shown in Figure 1. AES was tasked to provide a detailed design with inputs from NAVFAC ESC.

The final AES design of the hardened control room and blast door were reviewed and endorsed by NAVFAC ESC “The hardened control room walls and blast door are designed to sufficiently resist any fragments and residual leakage blast pressure generated by an accidental explosion from one of the test cells. The blast door is the DB-200 Model from Protective Door Industries, has a minimum ultimate unit resistance of 3 psi and large ductility capabilities to attain large deflections, would be loaded in the seated direction, and has a custom door frame and anchors designed specifically to resist the blast loads and develop the full resistance of the door.”
