ERBIL MATERNITY AND PEDIATRIC
HOSPITAL
ERBIL, IRAQ

SUSTAINMENT ASSESSMENT

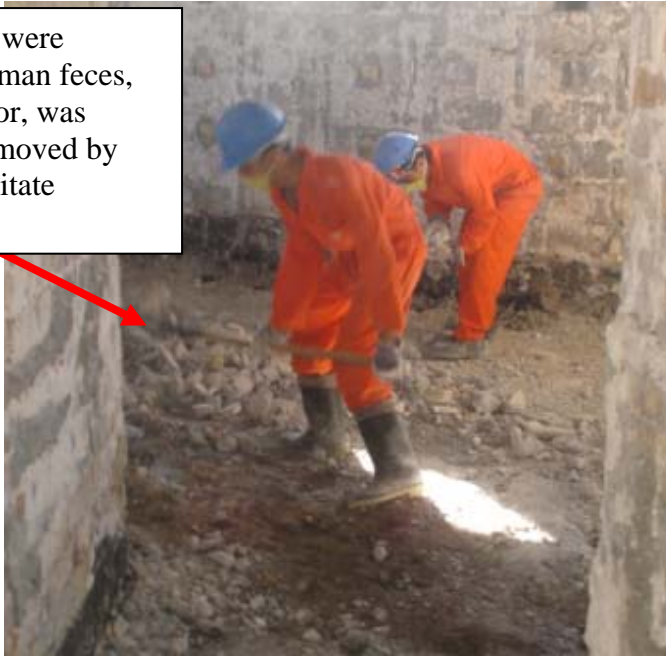
Site Photo 1. External toilet prior to renovation. (USACE photo taken 18 June 2006)

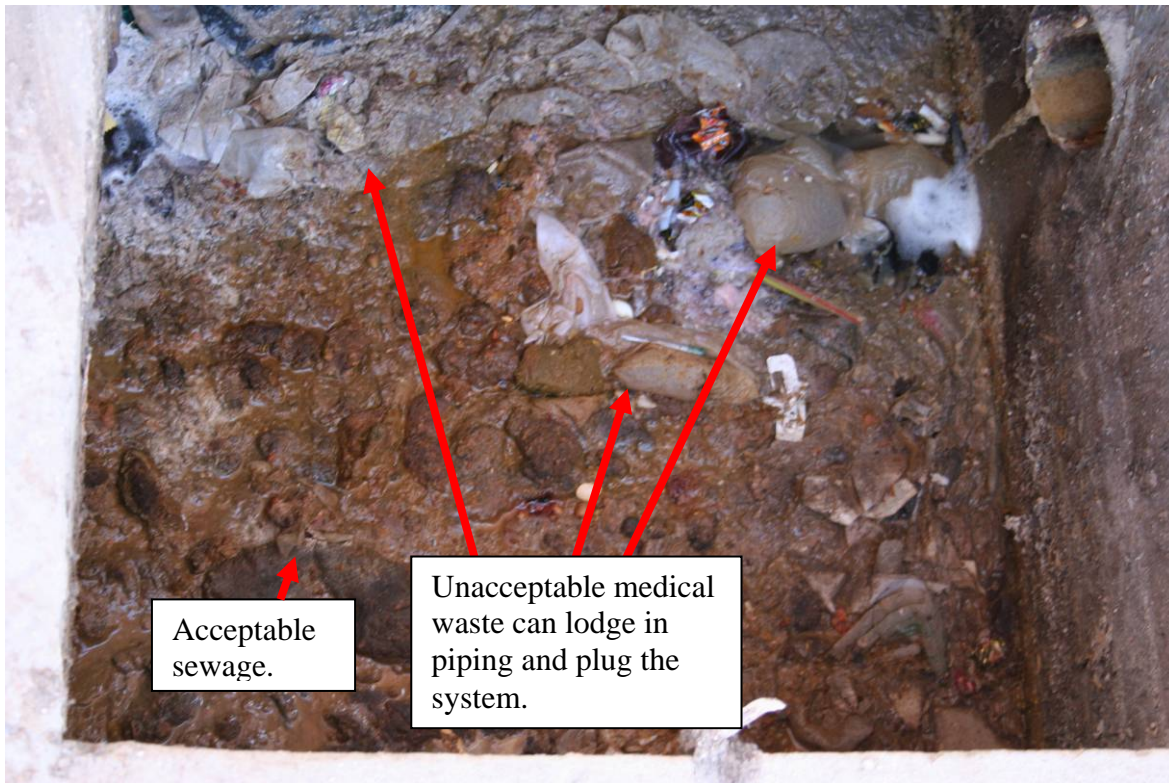
Site Photo 8. Medical waste material found in manholes and traps

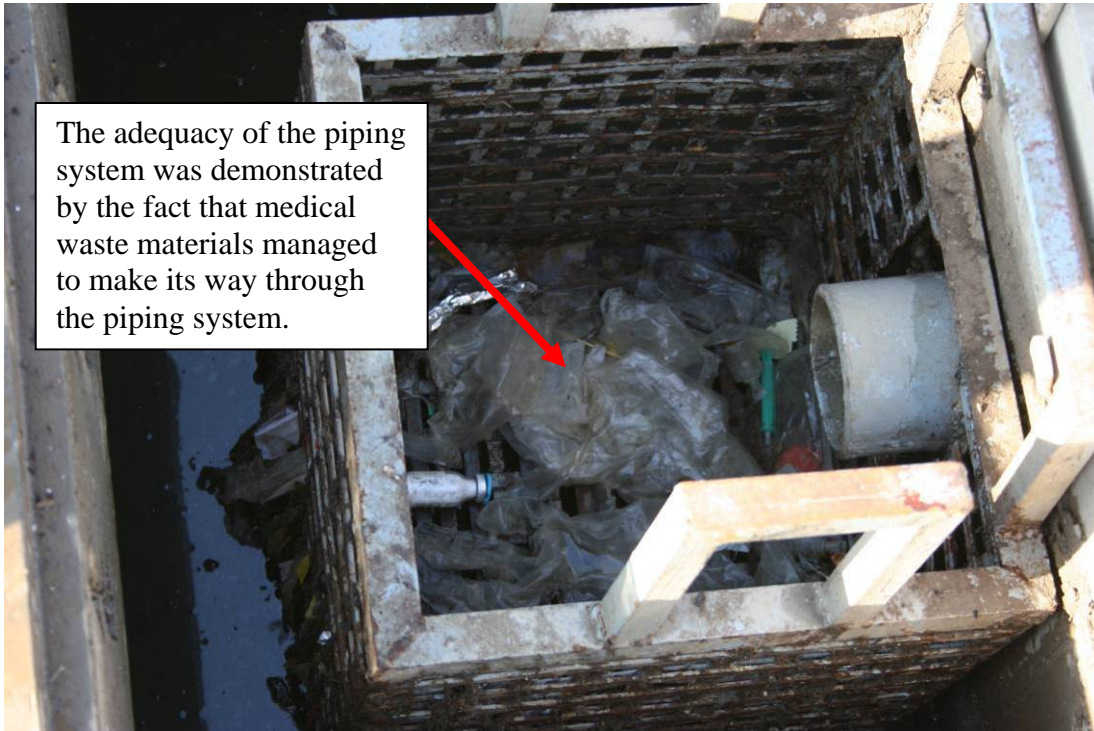
The adequacy of the piping system was demonstrated by the fact that medical waste materials managed to make its way through the piping system.

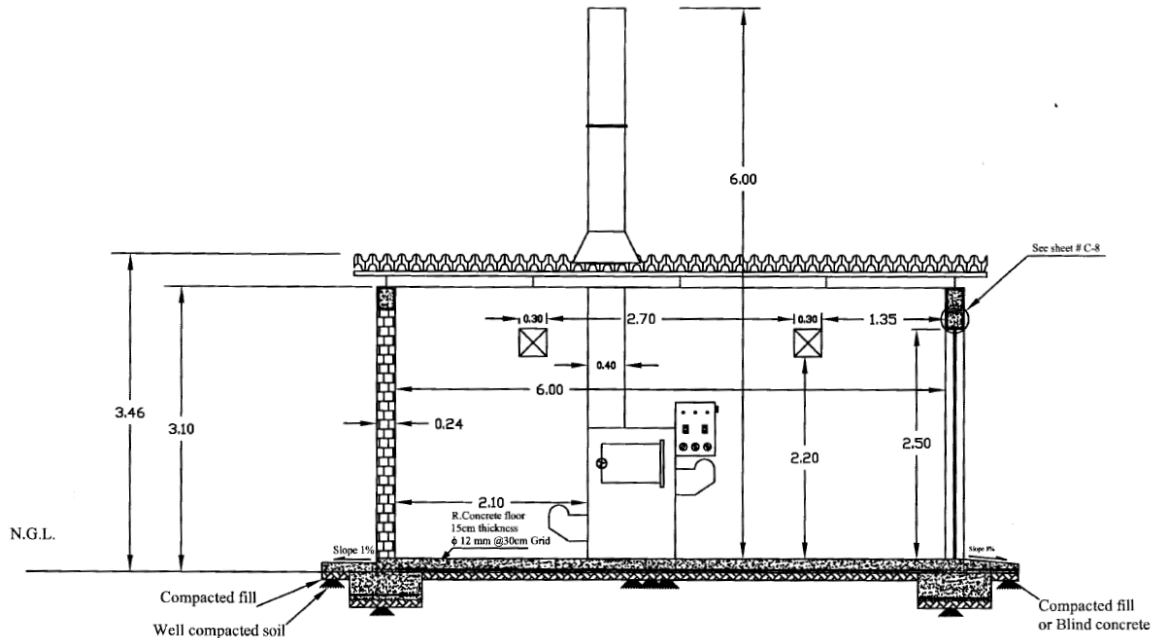
Site Exhibit 1. Incinerator building drawing copied from contractor submittal.

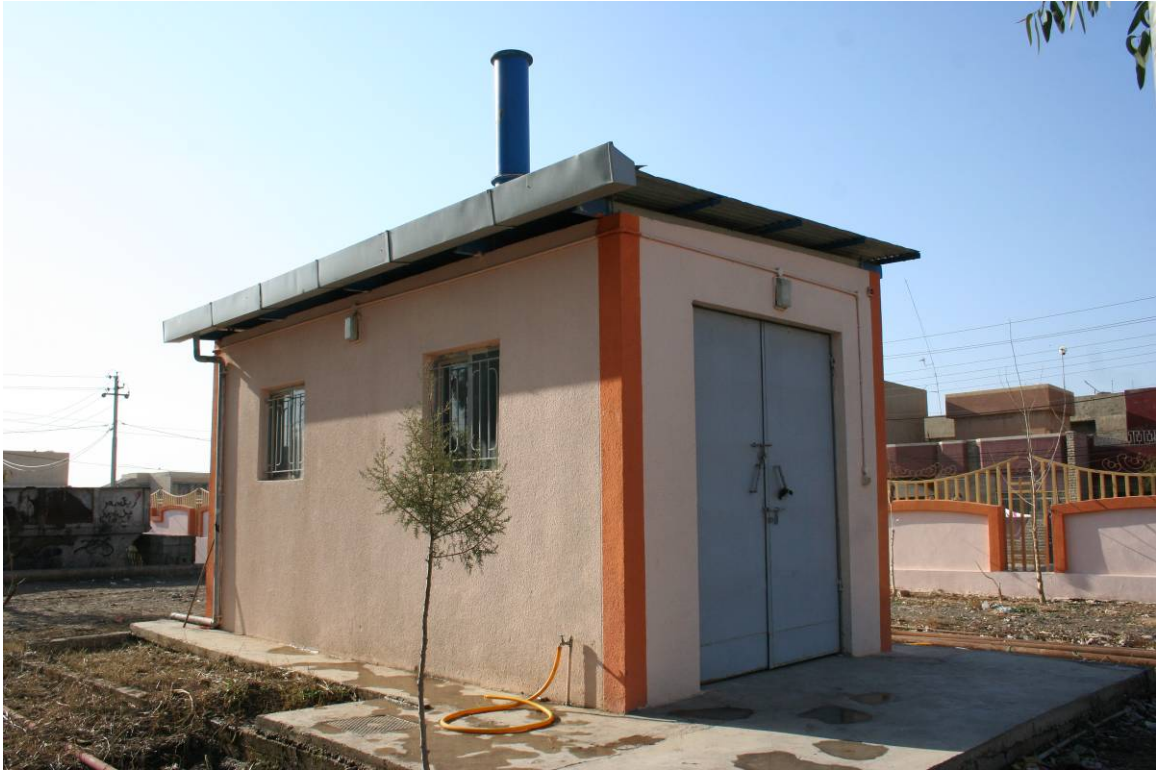
Site Photo 11. Incinerator building

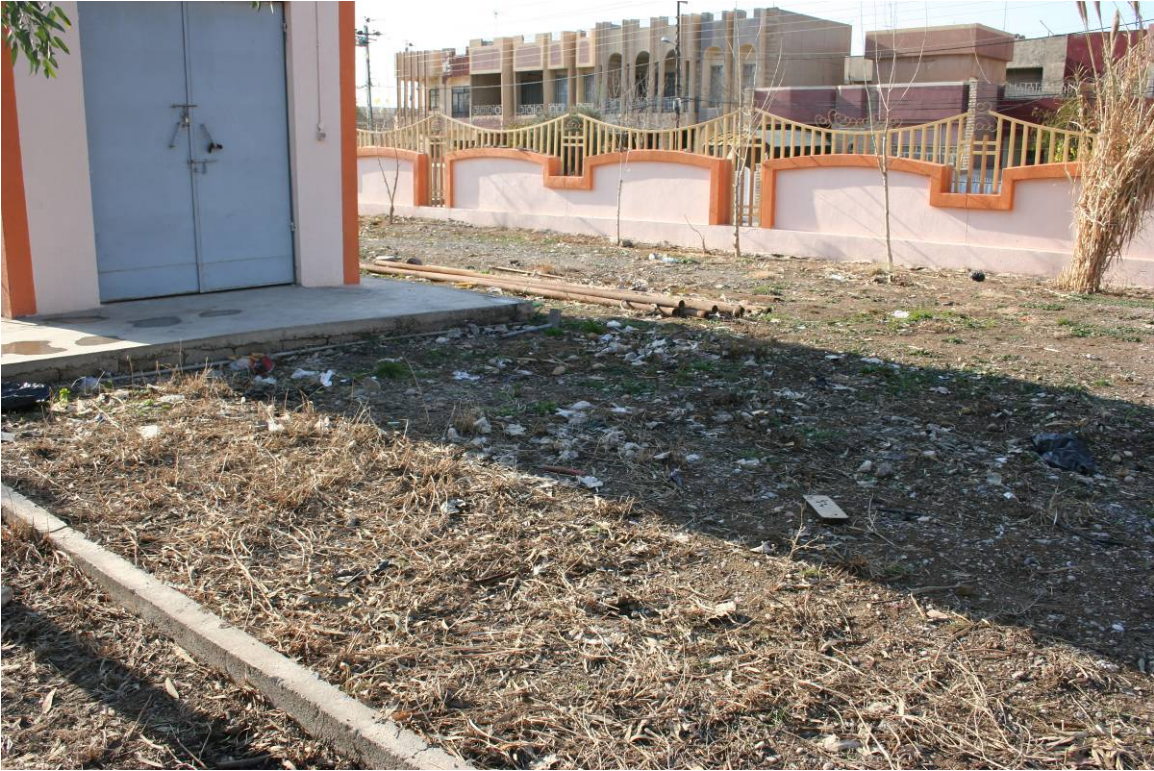
Site Photo 12. Medical waste materials scattered on the ground area in front of the new incinerator.

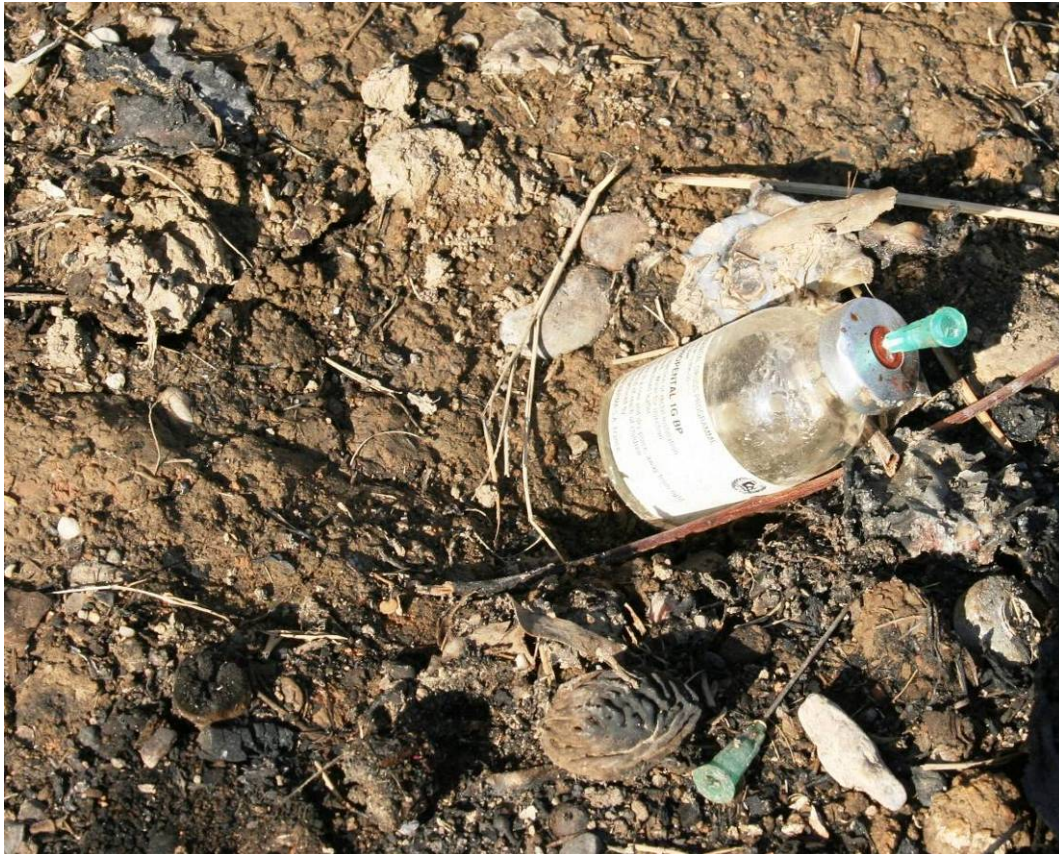
Comparison of Area Before and After Turnover

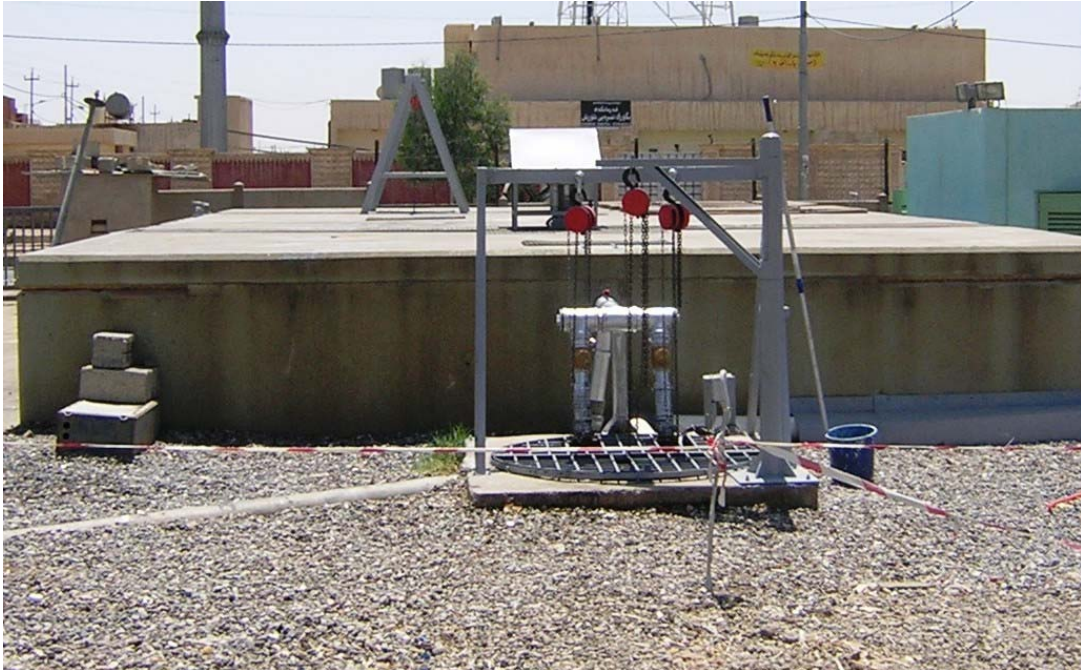
Site Photo 16. Immediately following renovation, area behind the incinerator was clean. (USACE photo)

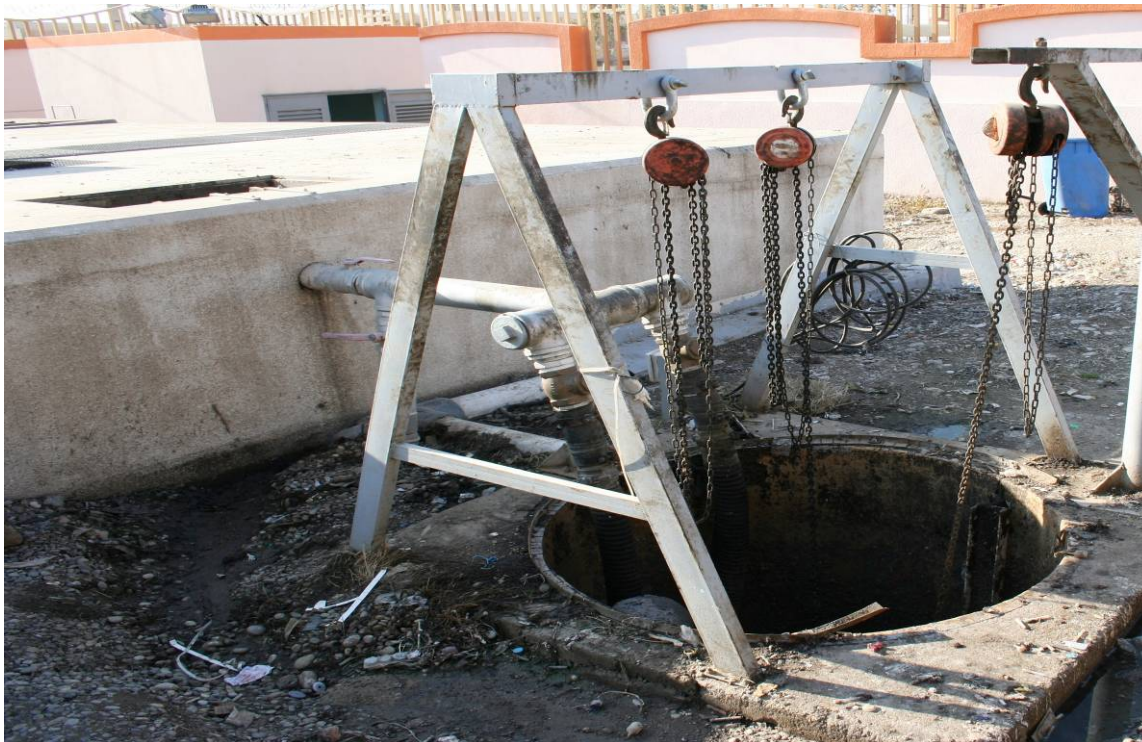
Site Photo 18. During the inspection, the area between the cesspool and septic tank was littered with ineffectively burned medical waste materials.

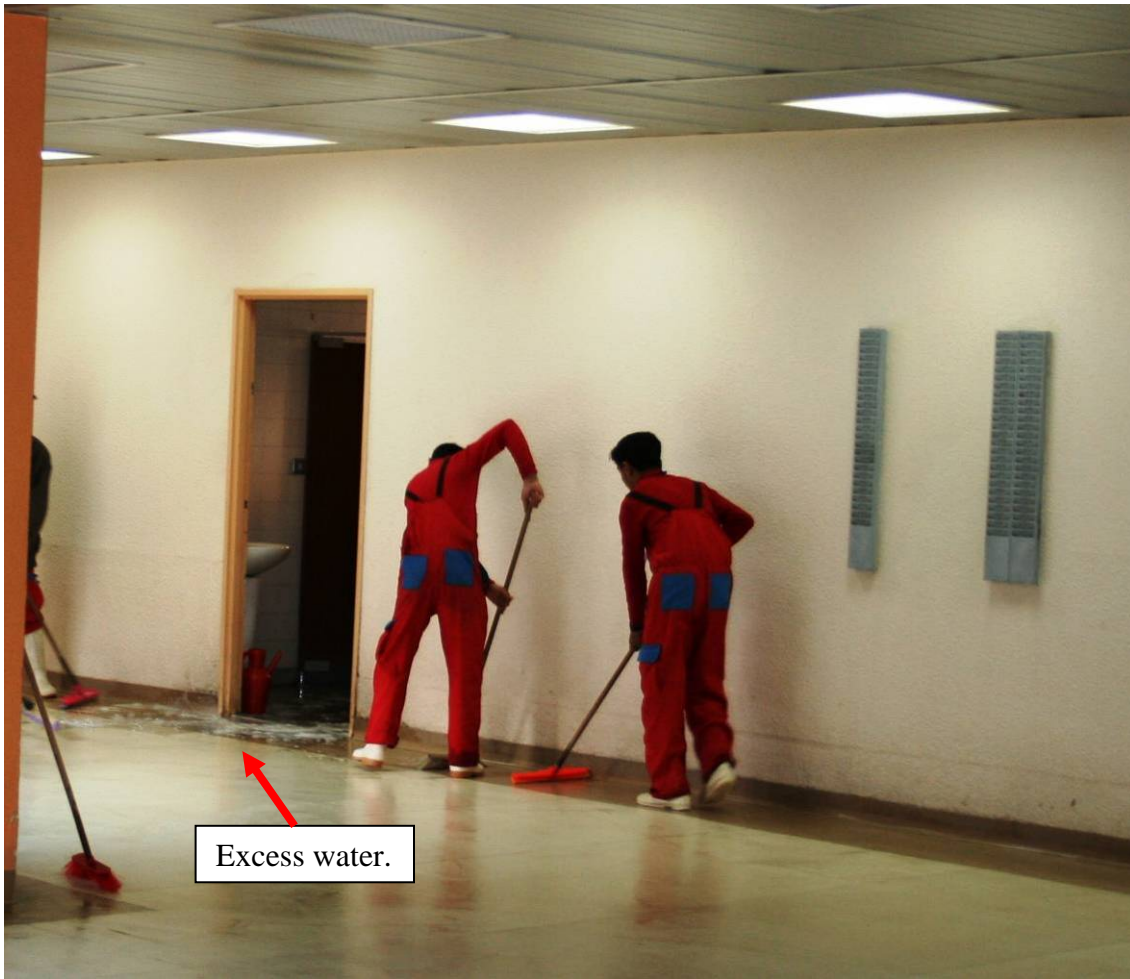
Site Photo 19. Cleaning crew workers used too much water to clean floors.

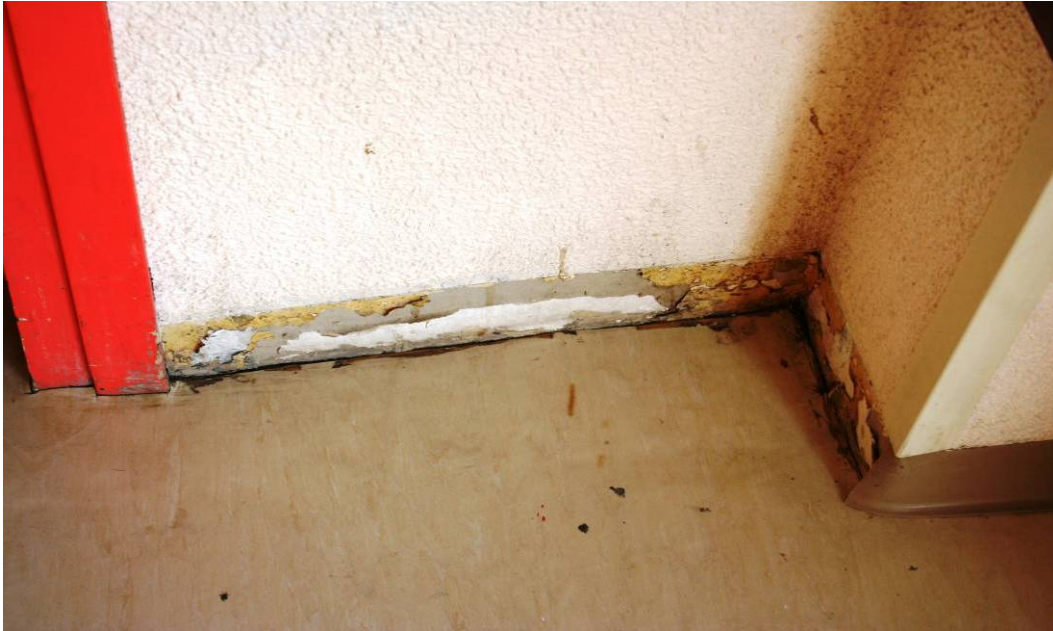
Site Photo 20. Water saturated and damaged wall.

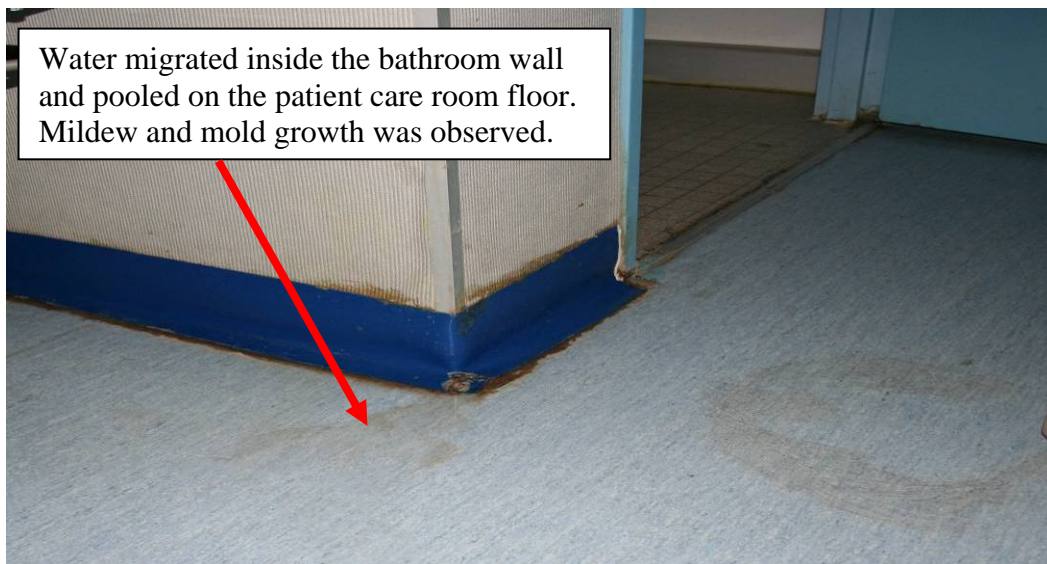
Water migrated inside the bathroom wall and pooled on the patient care room floor. Mildew and mold growth was observed.

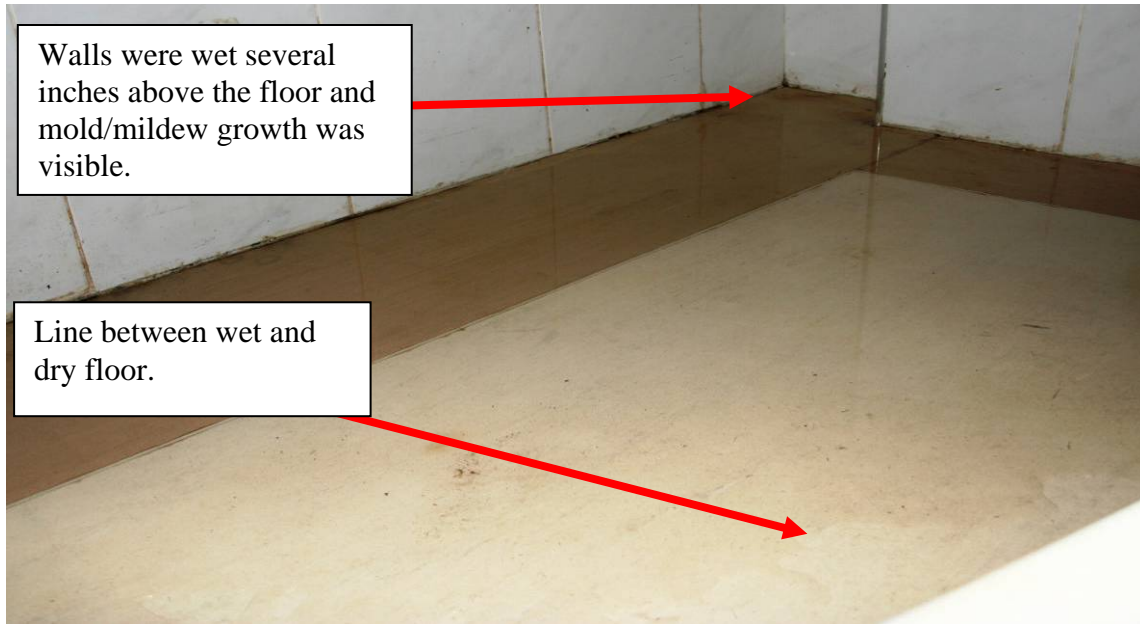
Site Photo 22. Unusable room after water migrated through the walls.

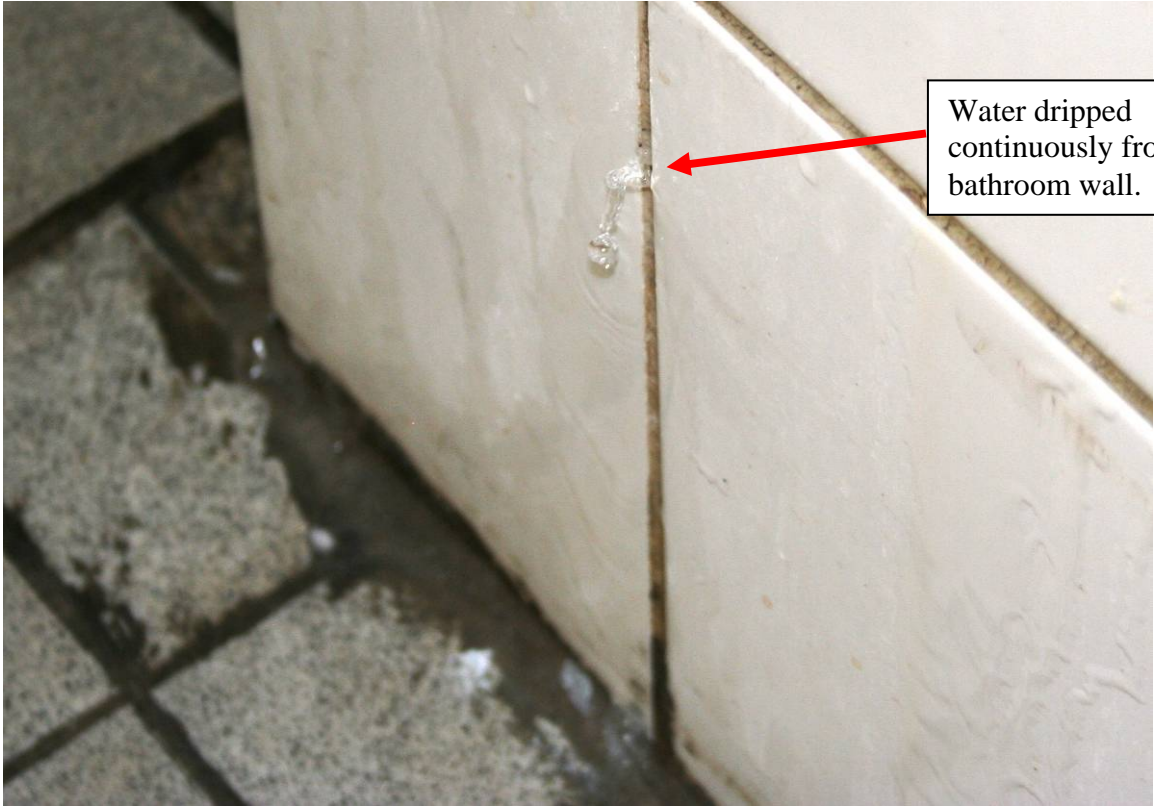
Site Photo 23. Steady dripping of water from a bathroom wall.

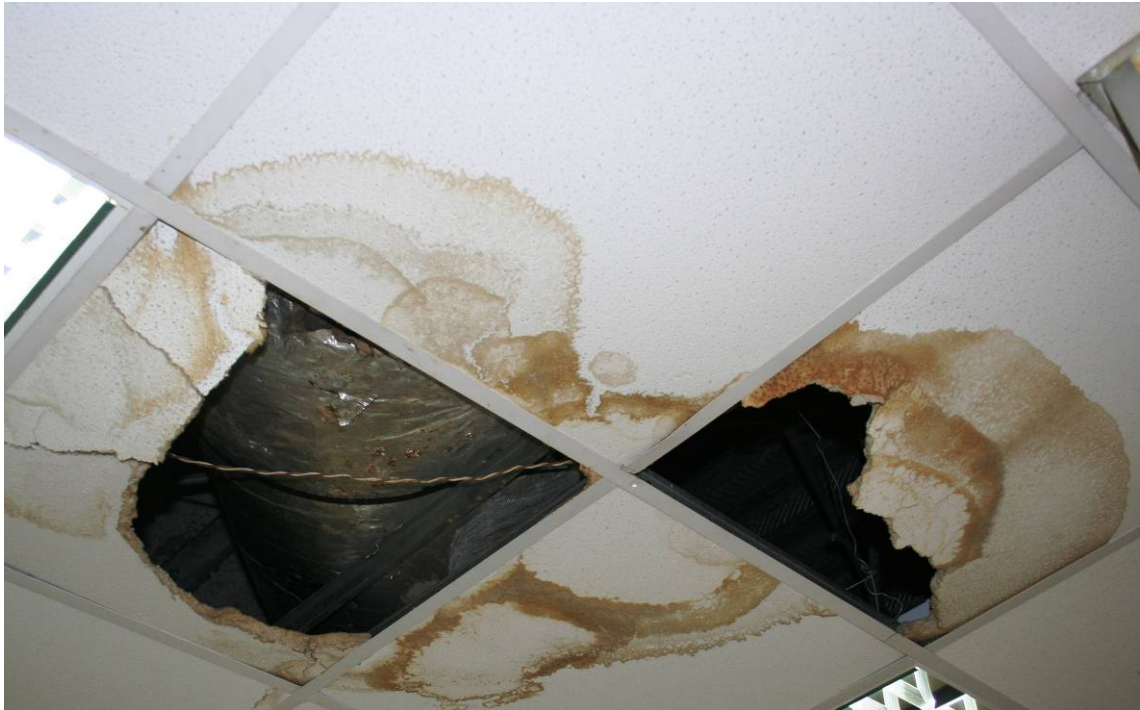
Site Photo 24. Damage from dripping water shown in Site Photo 23.

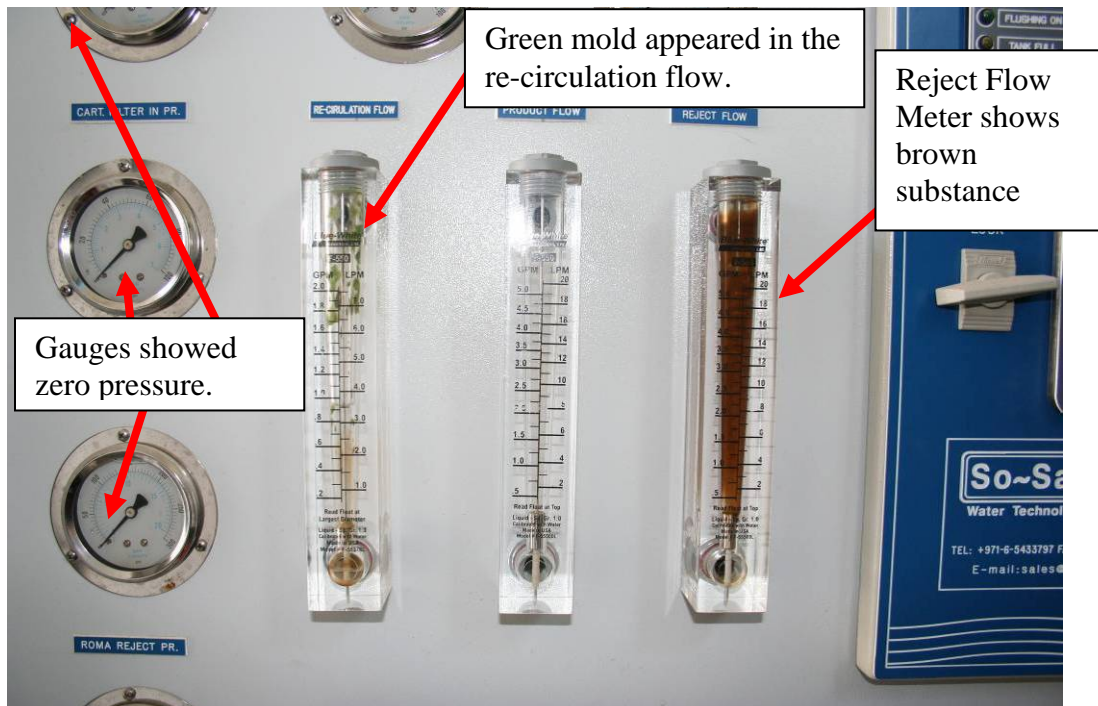
Site Photo 27. RO Unit's instrument panel.

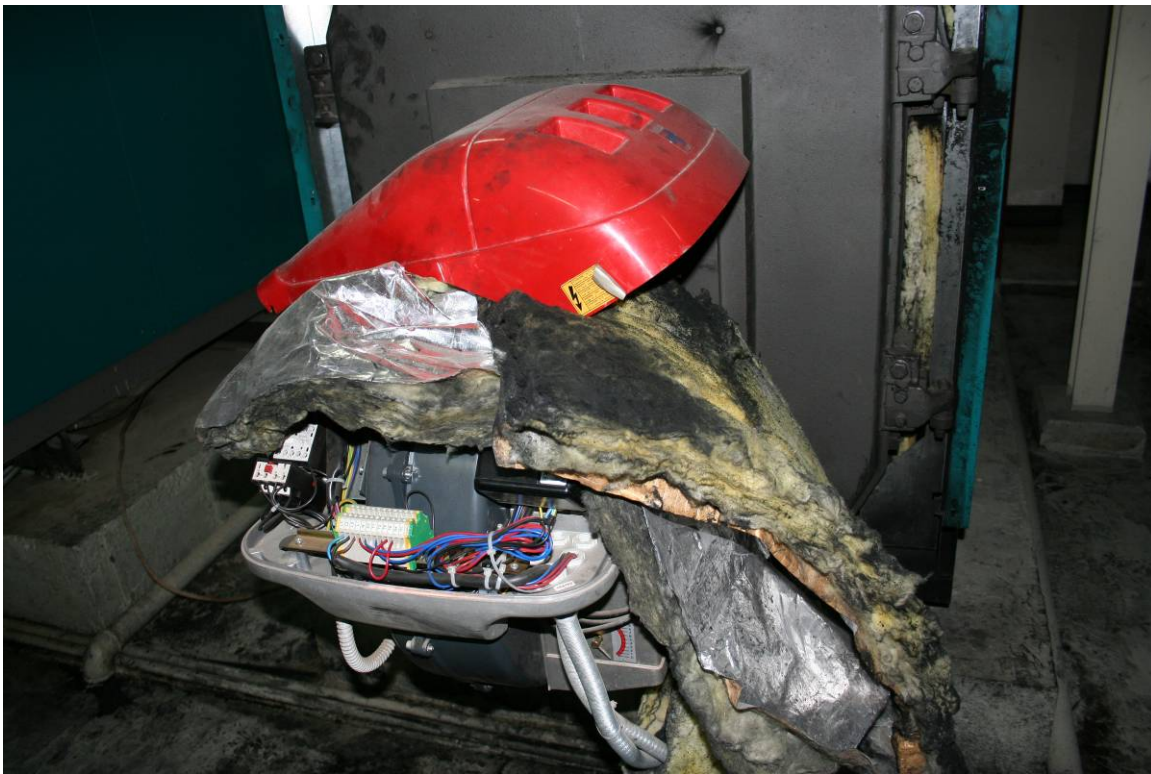
Site Photo 28. One of the three boilers was cannibalized for parts.

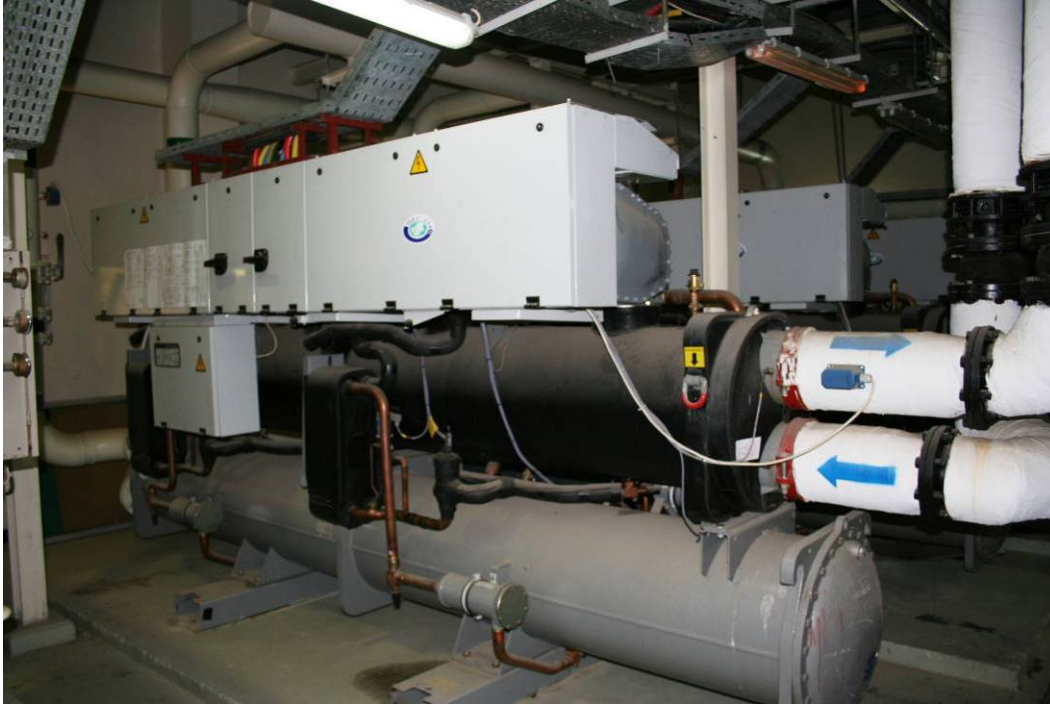
Site Photo 29. Chiller installation appeared satisfactory.

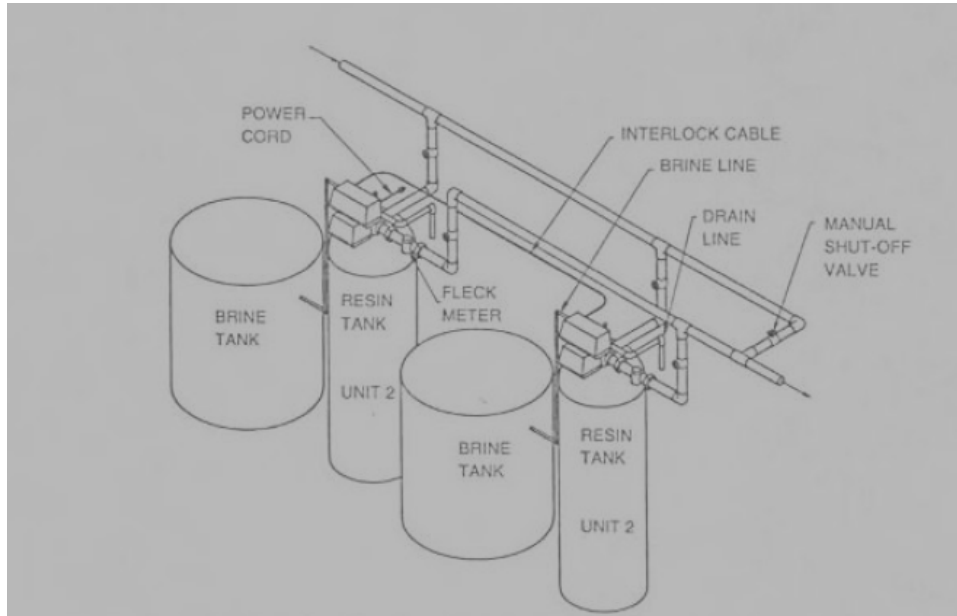
Site Exhibit 2. Diagram shows relative position of the water softening tanks.

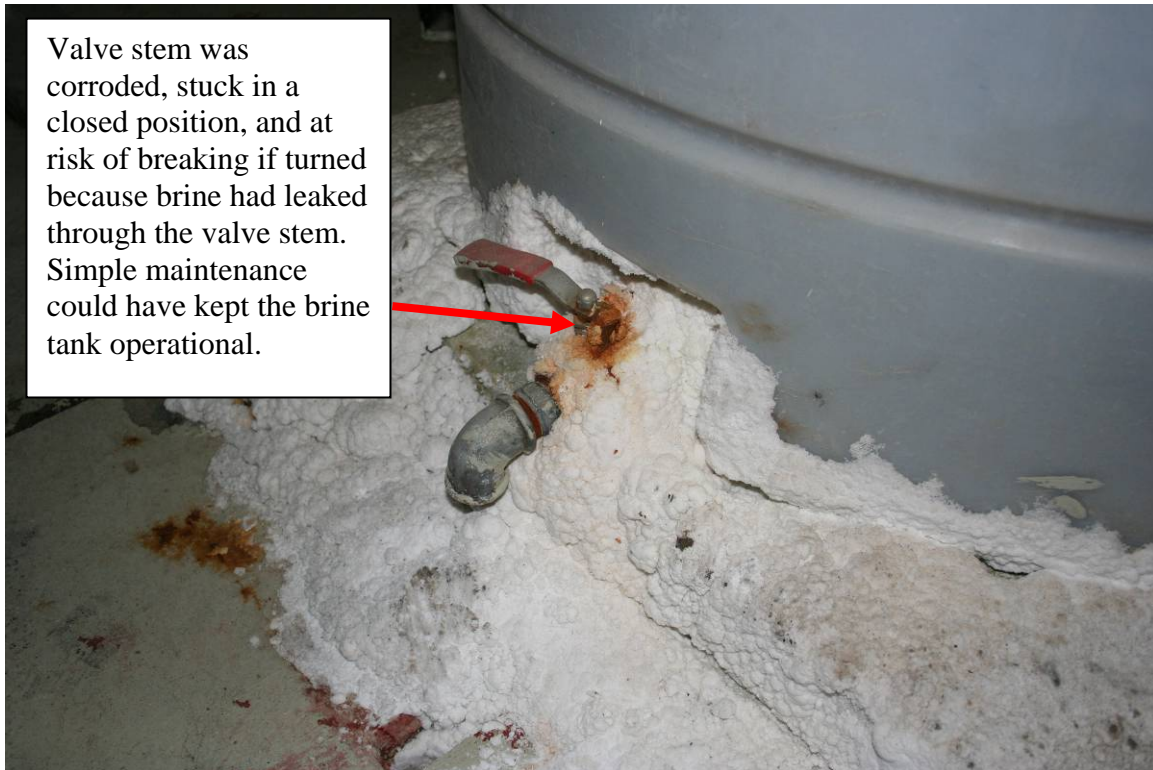
Site Photo 30. Dried salt was layered around the base of the brine tank.

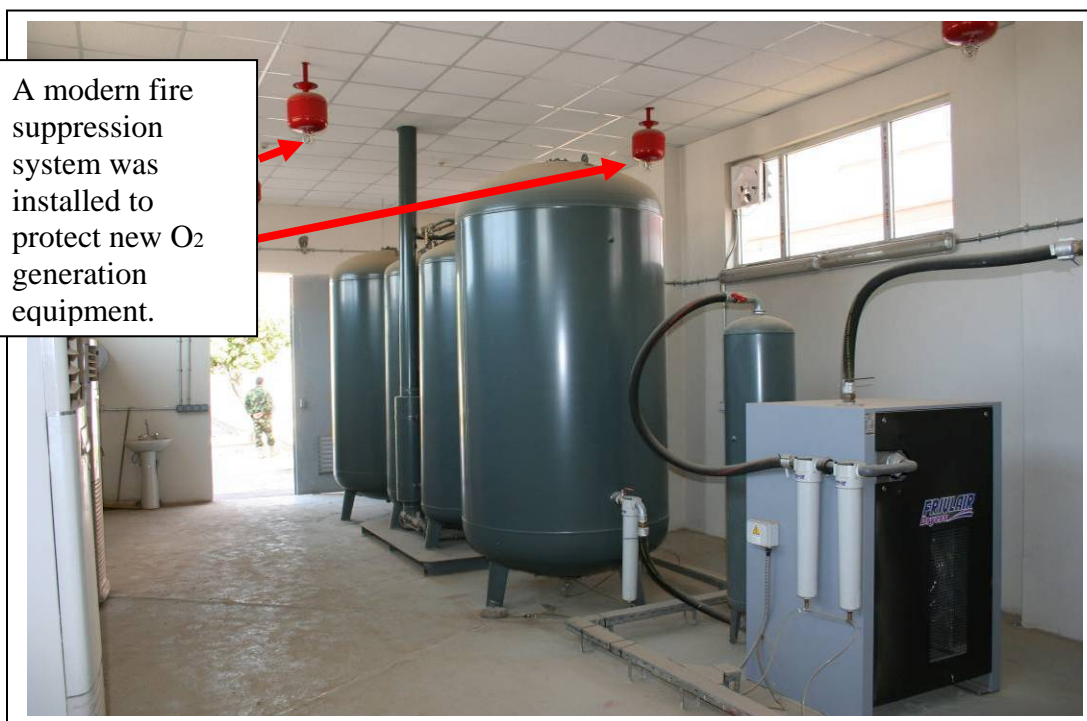
Site Photo 33. Renovation included an O₂ generation system.

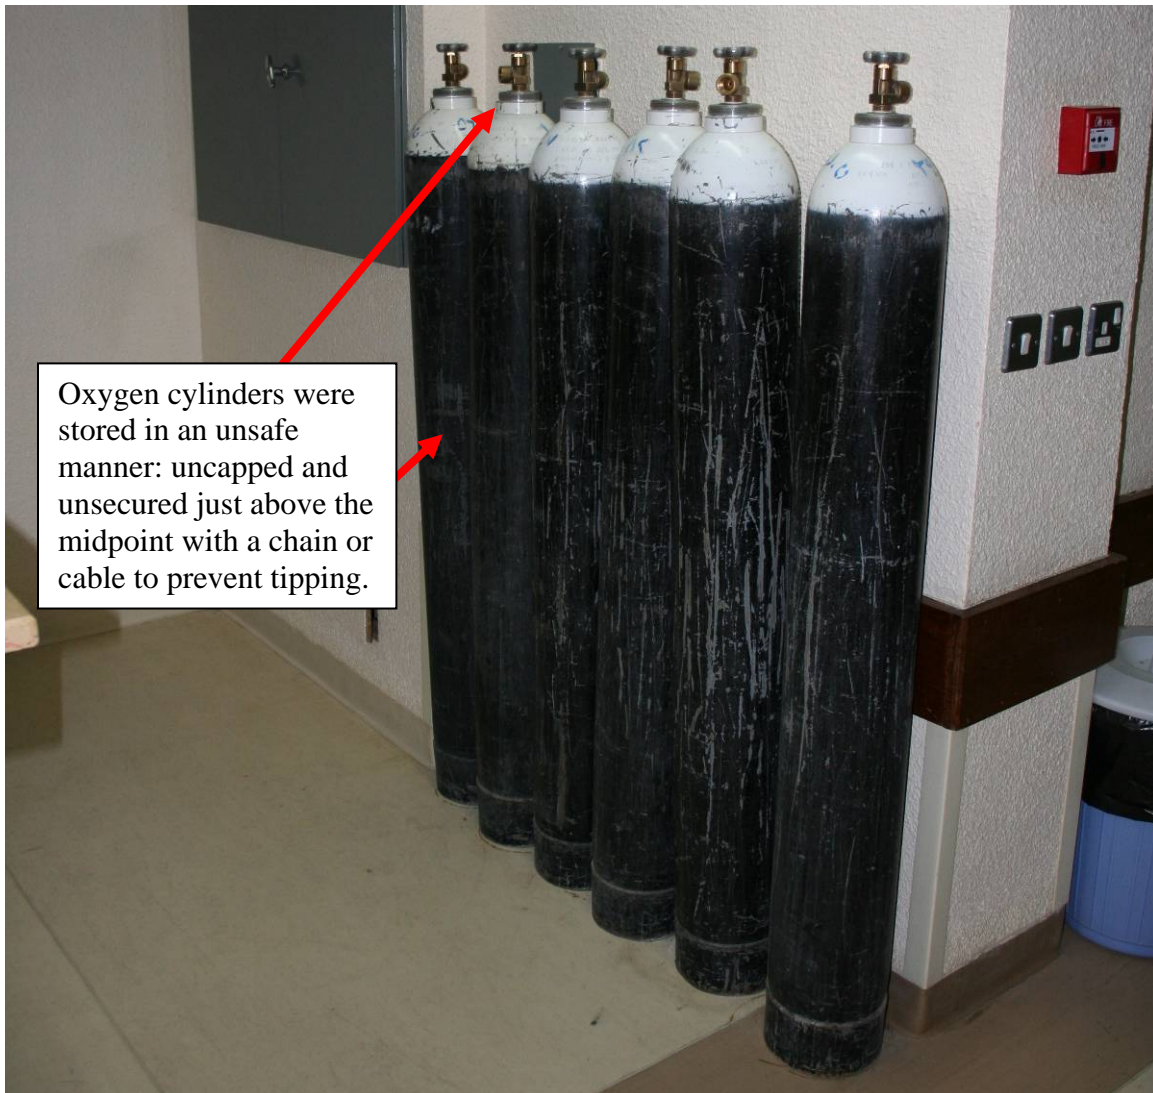
Site Photo 34. O2 bottles were stored in the hallway.

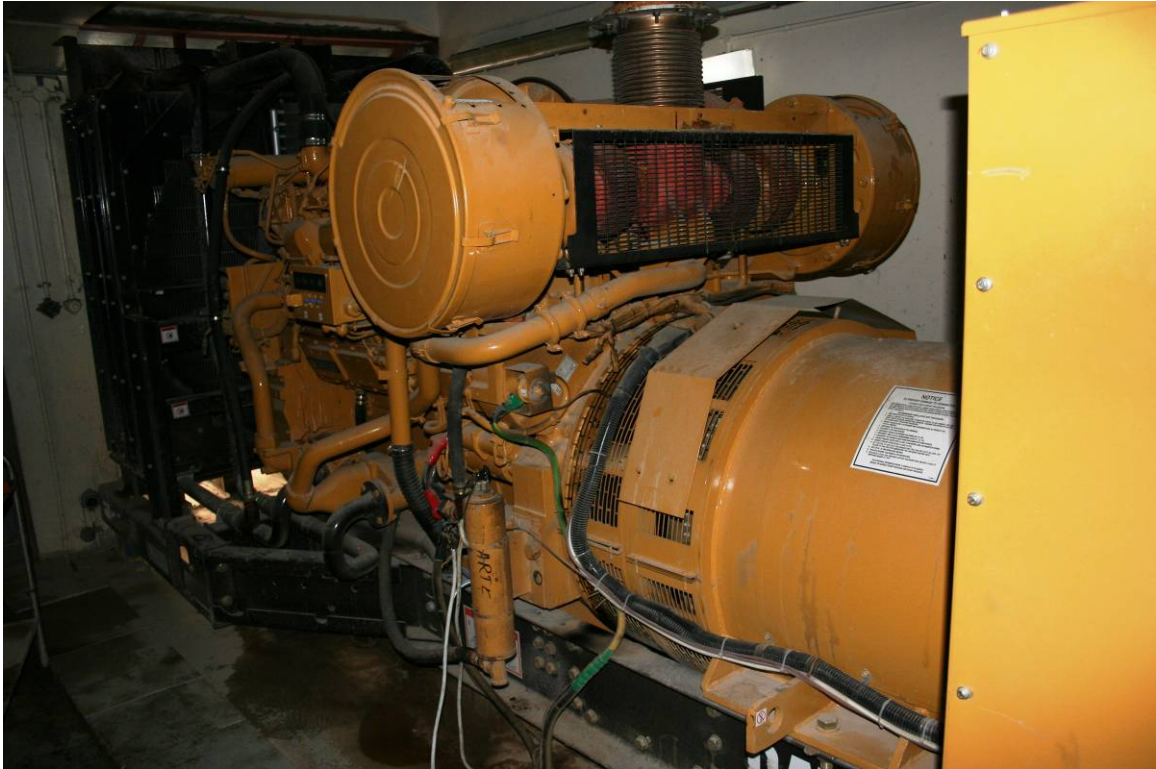
Site Photo 36: New generator was used as a back-up.

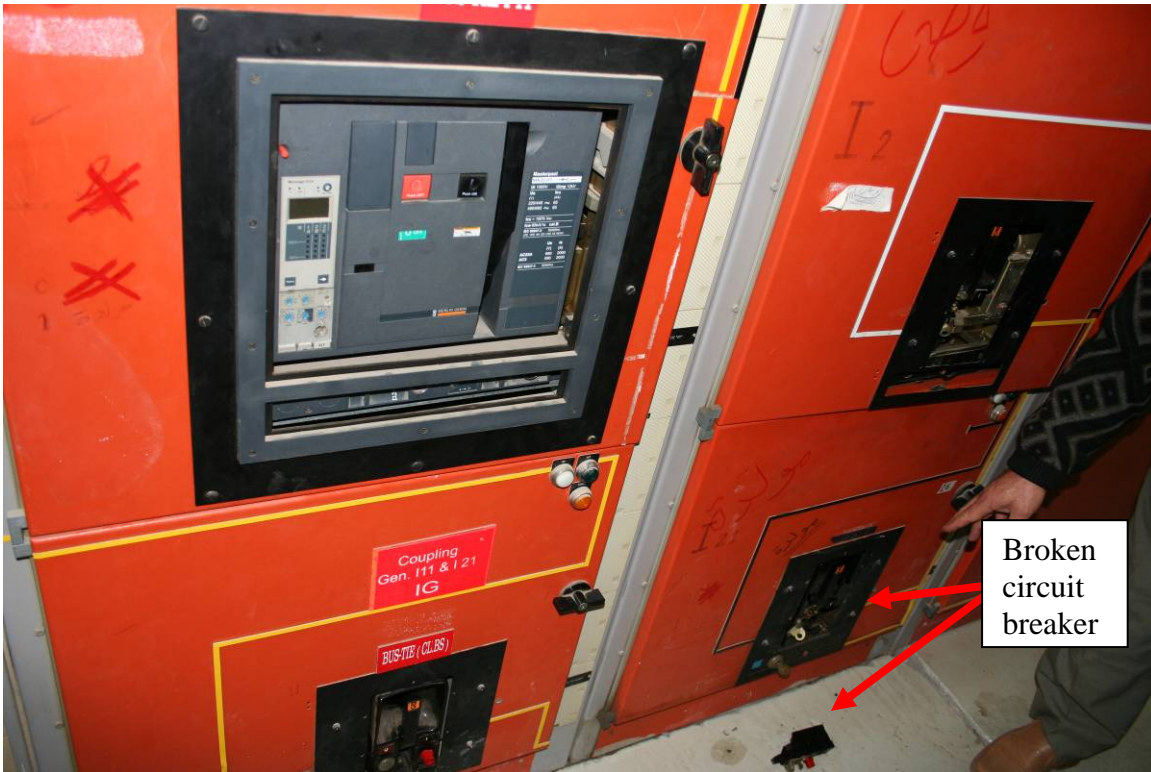
Site Photo 37. Broken circuit breaker that disabled switch gear equipment.
