## Fort Leonard Wood Culvert and Flagpole

Historic American Engineering Record

Chris J. Cochran and Adam Smith

April 2011

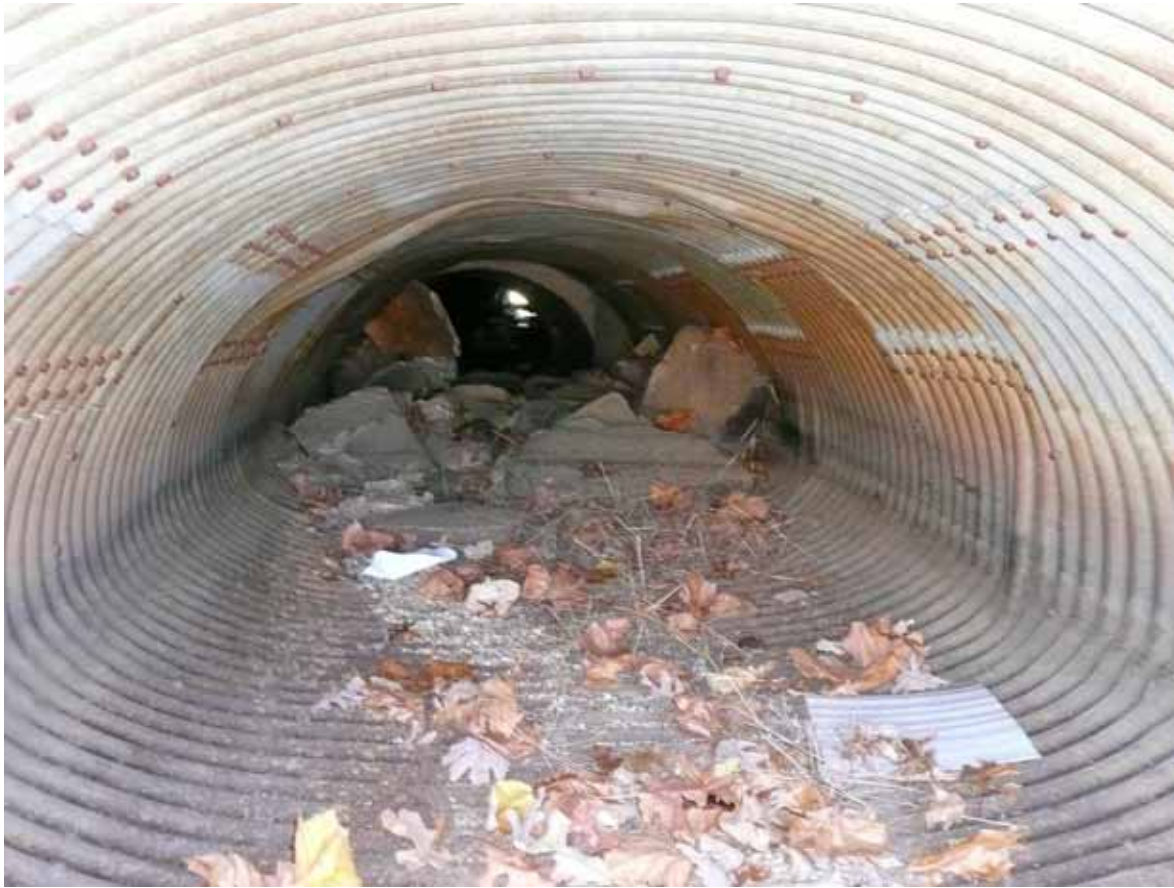
The steel tube is rusted, but appears to be in good condition. The stone wall on the west side of Illinois Avenue is in good condition with the exception of some cracked and missing mortar. The walls of the ditch are in poor condition with almost no mortar and missing stones.

Figure 20. Inside west end of culvert.

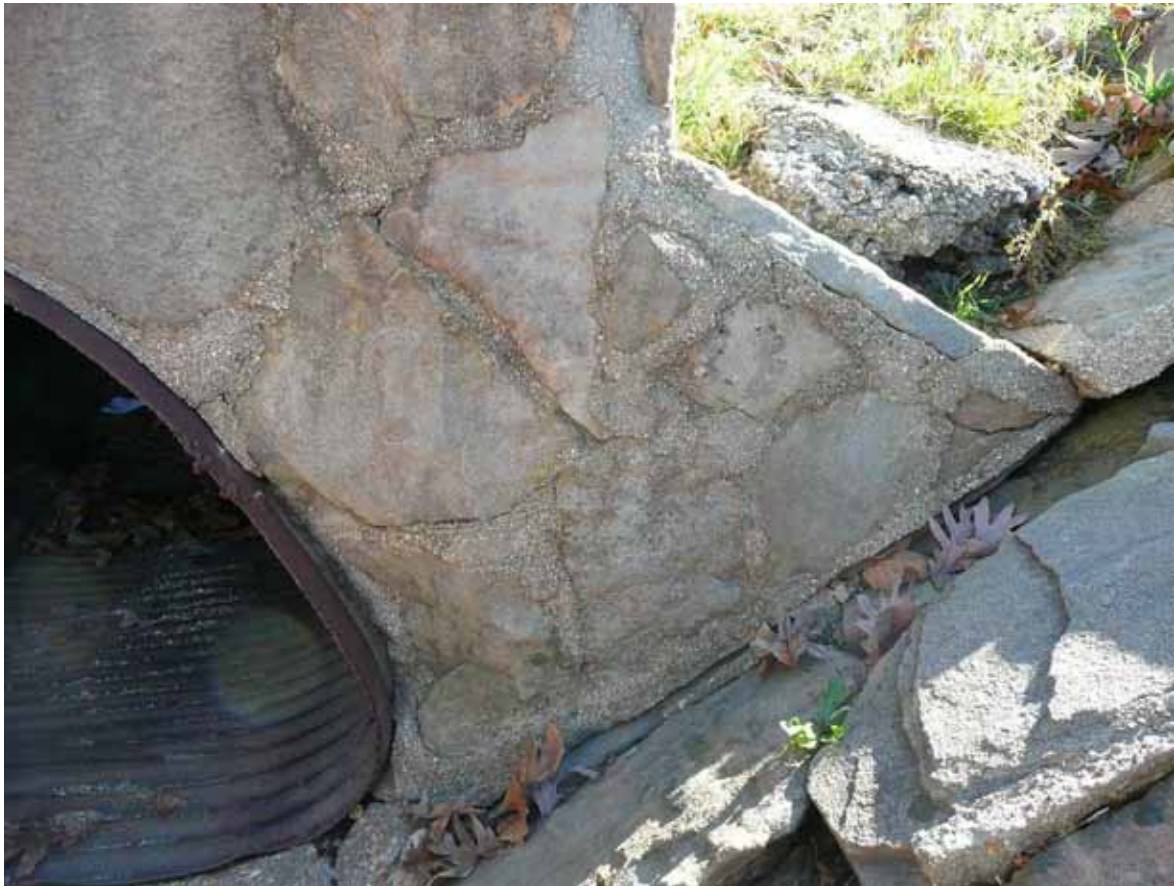
Figure 24. Detail, south base of wall on west end of culvert.

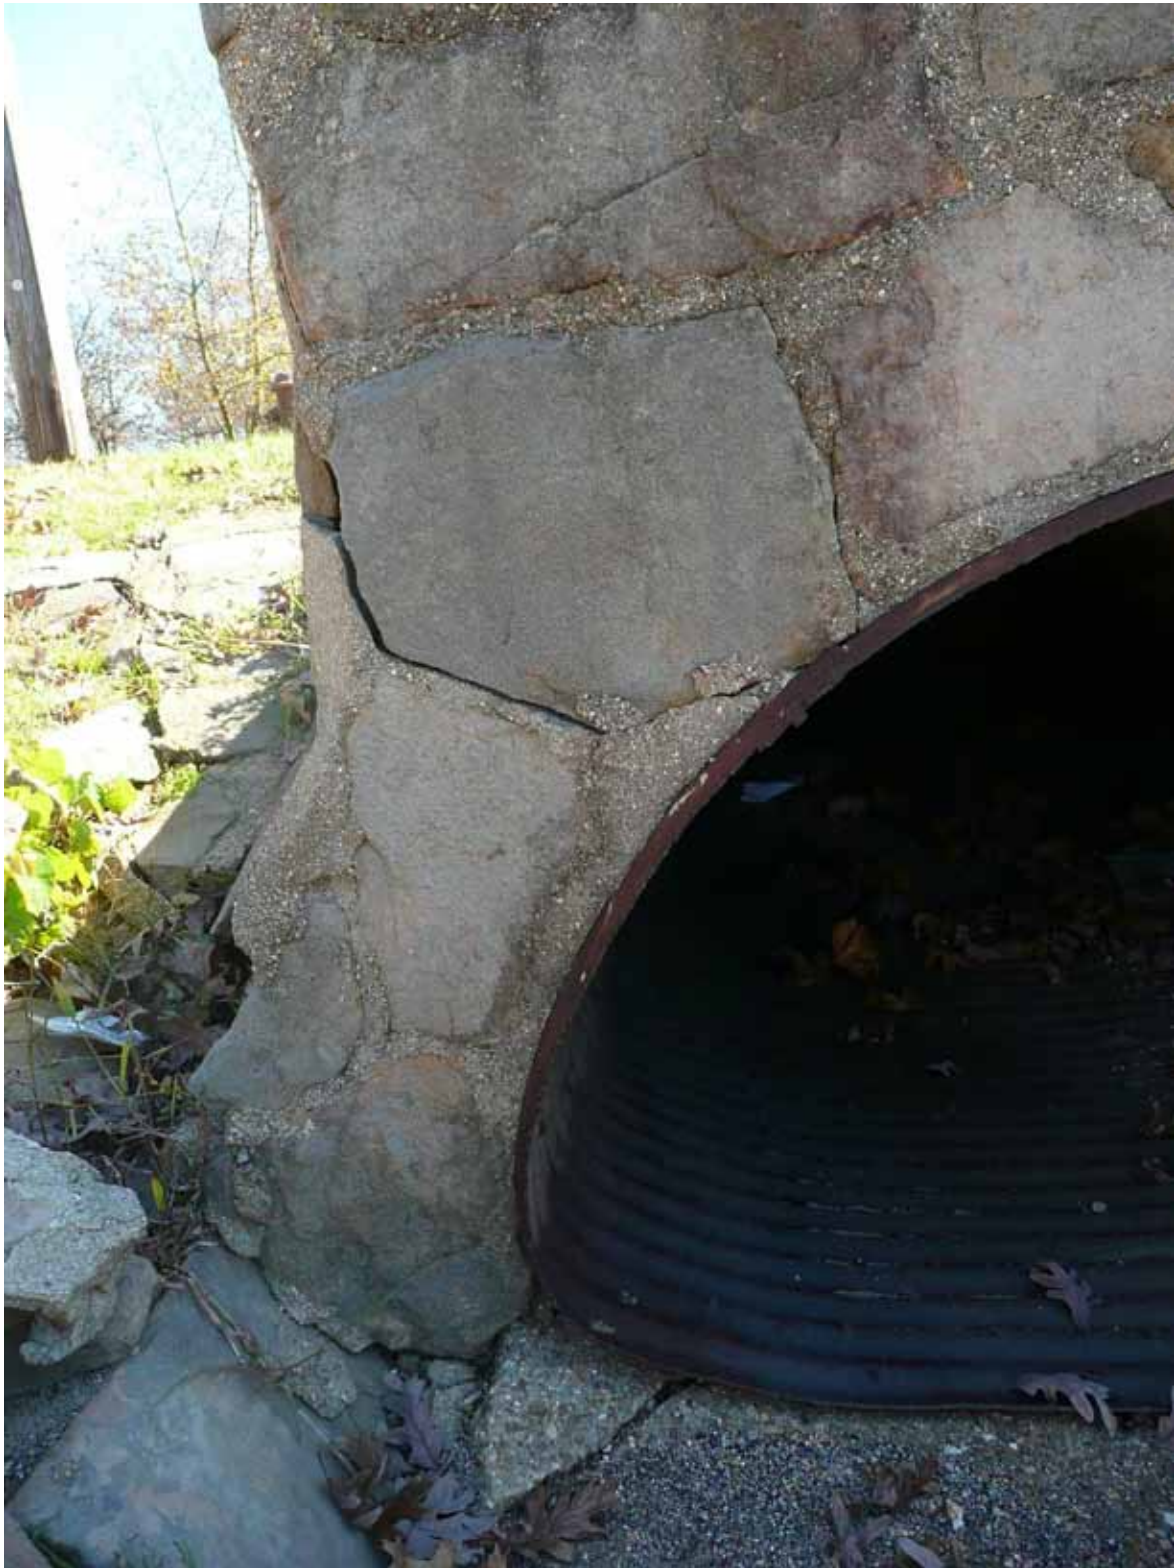
Figure 25. Detail, north base of wall on west end of culvert.

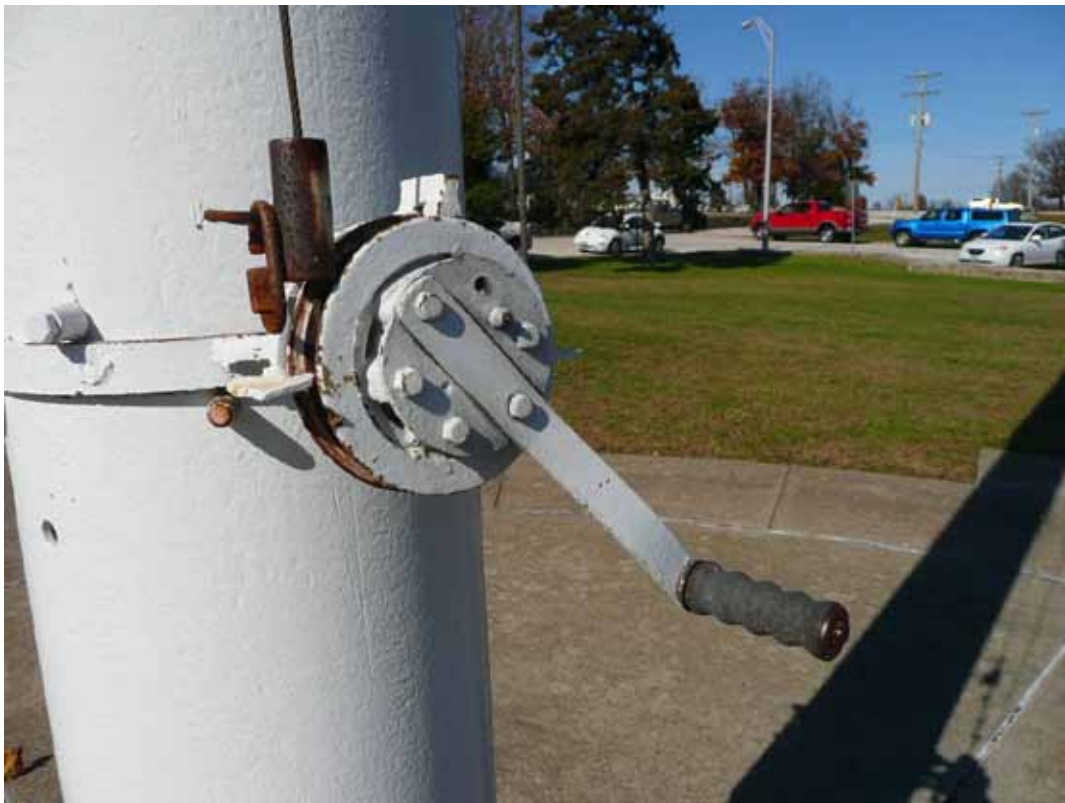
The flagpole is painted white and the paint remains in relatively good condition. A hand crank on the east side of the pole has also been painted white, but rust is beginning to show, especially at the edges.

The steel tube overall seems to be in good condition. The hand crank is somewhat worn and rusted, but seems to be in good condition as well.

Figure 37. Detail of flagpole hand crank.
