**Innovative Masking of Ferrous Inserts in Magnesium  
Aerospace Components Prior to Tagnite Anodization  
(v.1, Unlimited Release)**

**ARL-CR-716**

**July 2013**

**Technology Applications Group, Inc.  
810 S. 48th St.  
Grand Forks, ND 58201**

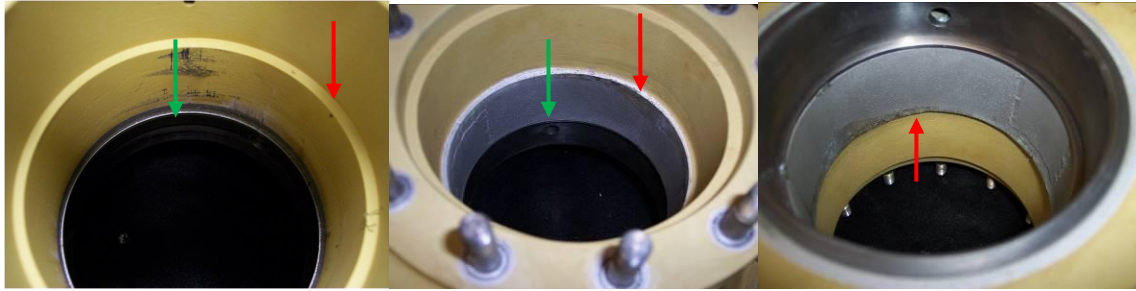
The masking was then installed on a second H-64 tail rotor cover. During the installation of the covers for the steel liner, it was discovered that the steel liner on the second tail rotor cover was installed flush with the interior wall of the cover. Therefore, the lip that the top cover could rest on was no longer present. So the top cover was modified to fit on a second lip that was higher up the interior diameter. The drawback to this approach was that a large area of uncoated magnesium would be present after the masking was removed above the steel liner (figure 45). This would have to be touched up with Brush Tagnite.

Figure 45. H-64 tail rotor cover – steel liner masking. Left: original cover had a raised steel lip that the cover could rest on (green arrow). Second cover did not have the raised lip and cover was installed on lip in the as-cast section of the interior diameter (red arrow). Center and right: second cover after Tagnite showing the large uncovered area after the masking removal.

On the second cover, there was no failure of the masking, but there was a larger area of uncoated magnesium that needed brush Tagnite touch-up.

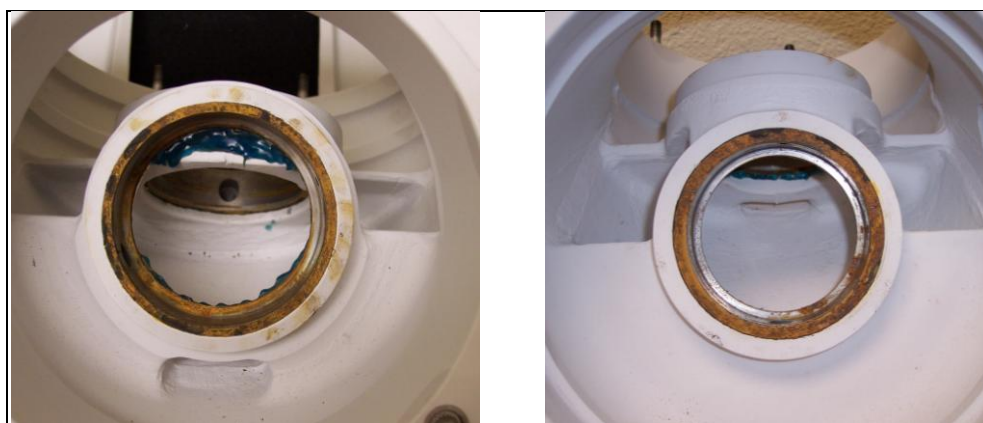
Once the steel liner covers were removed after Tagnite, it was immediately evident that the Acme masking tools were not robust enough to survive the Tagnite process. The steel liners had lots of damage caused by a total lack of sealing around the steel (figure 57). After the rust was removed, there was evidence of pitting on the steel, which indicated that the leakage was present during the Tagnite anodize portion of the process; this leakage left the steel liner unusable. The Acme masking was quickly abandoned because of the extensive leaking during the Tagnite process.

Figure 57. Extensive damage to the steel liners after removal of Acme masking tools. Left: top steel liner. Right: bottom steel liner.

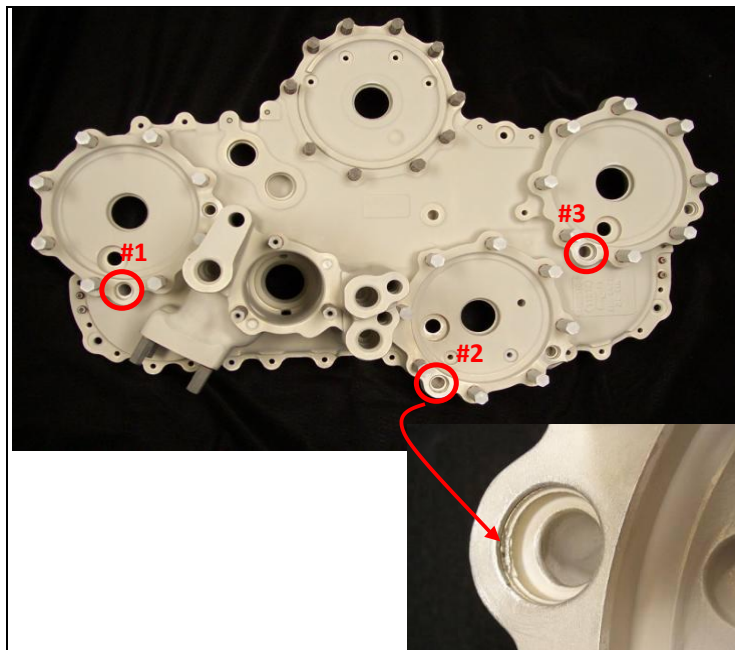
Figure 70. Location of snap ring grooves with corrosion damage. Insert shows location with greatest corrosion damage in snap ring groove.

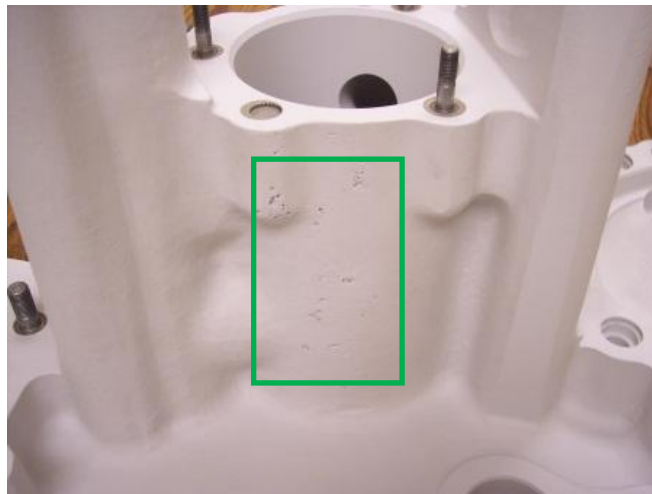
Figure 72. Location of porosity on as-cast surface to be cold spray repaired.
