ESTCP Cost and Performance Report

(WP-200906)

Non-Chromate, ZVOC Coatings for Steel Substrates on Army and Navy Aircraft and Ground Vehicles

December 2014

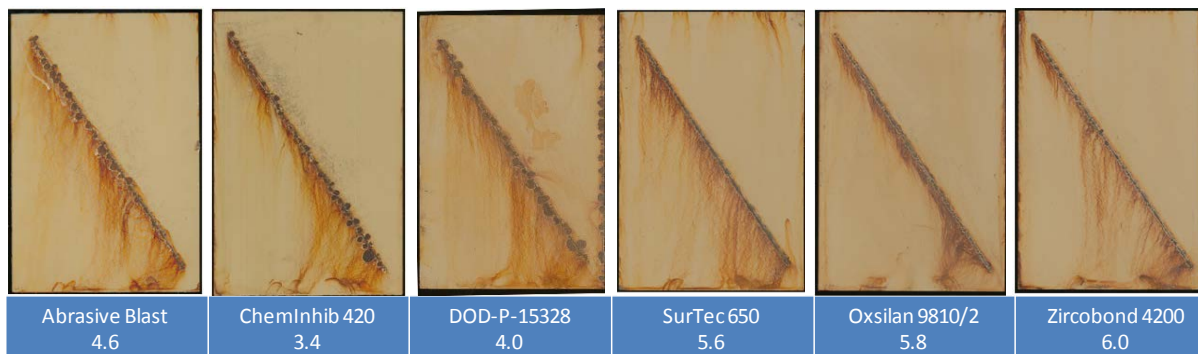
Representative panels from each set of replicates are shown in Figure 5. Ignoring the rust bleeding from the scribe, one can see that there is more pitting and creepback on the Cheminhib 420 and DoD-P-15328 panels.

Figure 5. Abrasive blasted HHA with MIL-DTL-53022/MIL-DTL-53039 scraped after 1000 hrs B117 exposure.

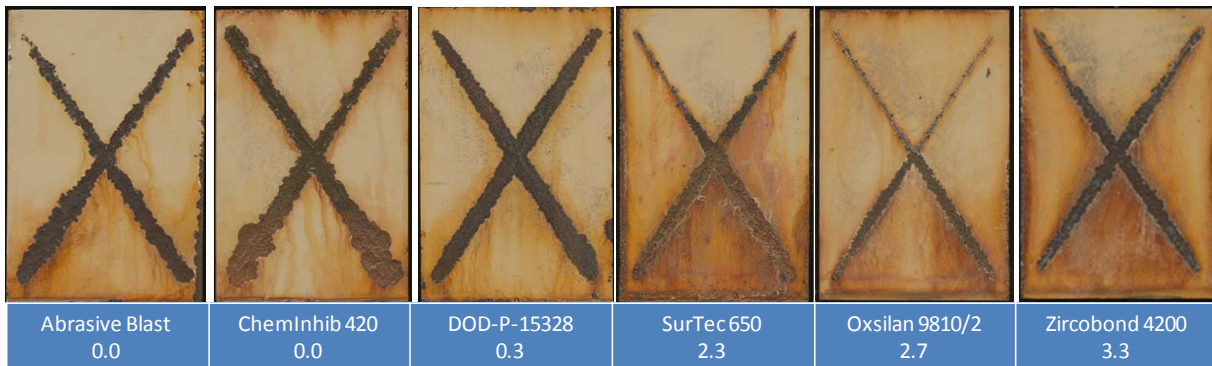
Figure 6. Average ratings of HHA test panels scraped after 80 cycles of GM 9540P with MIL-DTL-53022/MIL-DTL-53039 CARC.

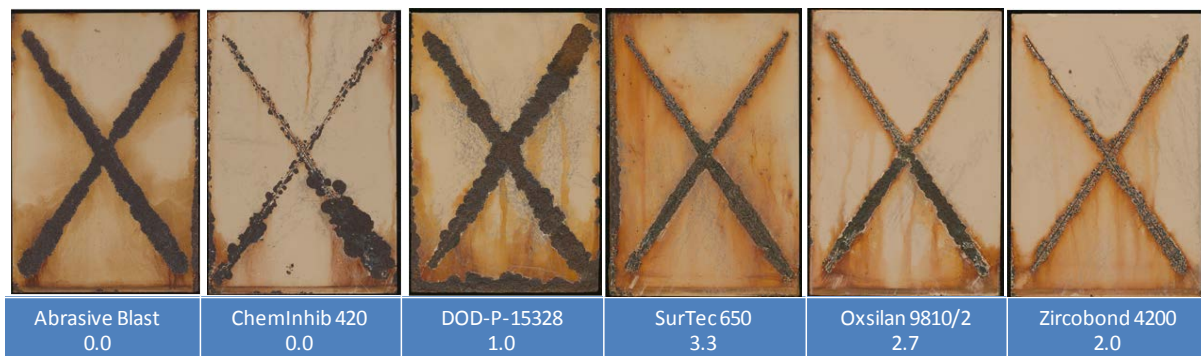
Figure 7. Average ratings of HHA test panels scraped after 80 cycles of GM 9540P with MIL-DTL-53022/MIL-DTL-64159 CARC.

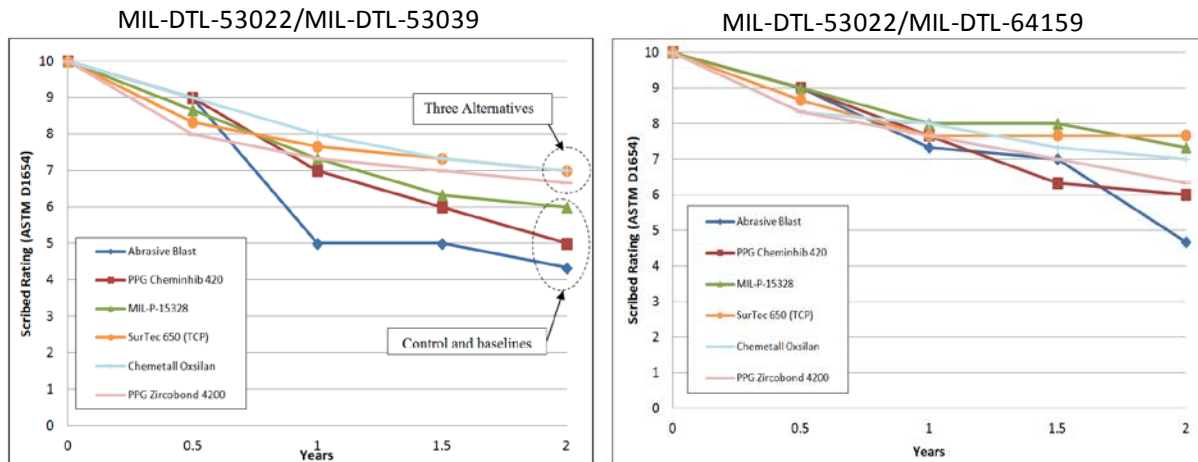
Figure 8. ASTM D 1654 ratings for coated HHA panels after 2 years outdoor exposure.

Visual inspections of the outdoor exposure panels indicate that each of the alternatives is performing better than the Cheminhib baseline. All appear to enhance the corrosion performance of the coating system versus abrasive blasting alone. To date, this suggests that a direct-to-metal process alone may not be a sufficient method for preparing HHA for paint.

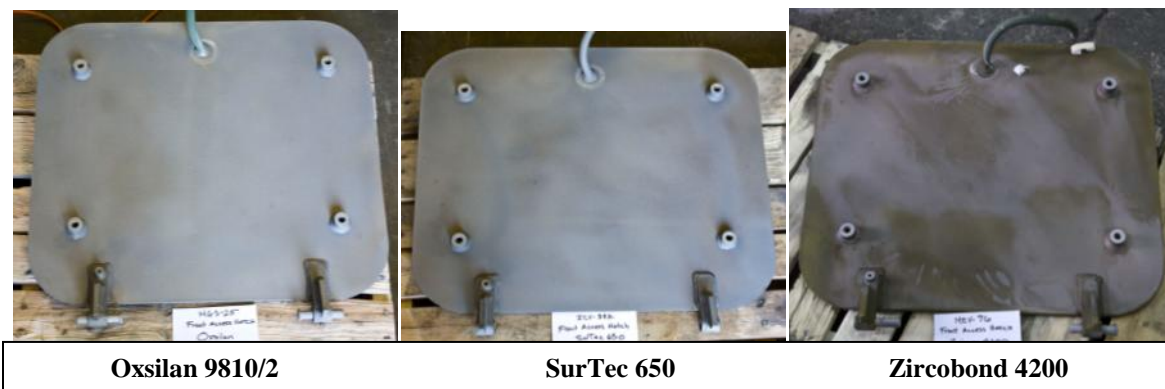
Figure 9 shows three hatches 19 hours after the application of the pretreatments. Only the Zircobond showed noticeable discoloration of the steel. The blotchy color change initially appeared as a pinkish rose color almost immediately after application and turned yellowish as it dried as seen in the picture below. It was not clear whether it was flash rust or an expected result from the reaction of the Zircobond and the steel. The Oxsilan 9810/2 and SurTec 650 showed no significant discoloration. Only slight darkening was observed with these two pretreatments. The lack of color or some type of indicator, however, makes it a challenge to detect if proper coverage was achieved.

Figure 9. Front access hatches after approx 19 hours ambient indoor exposure.

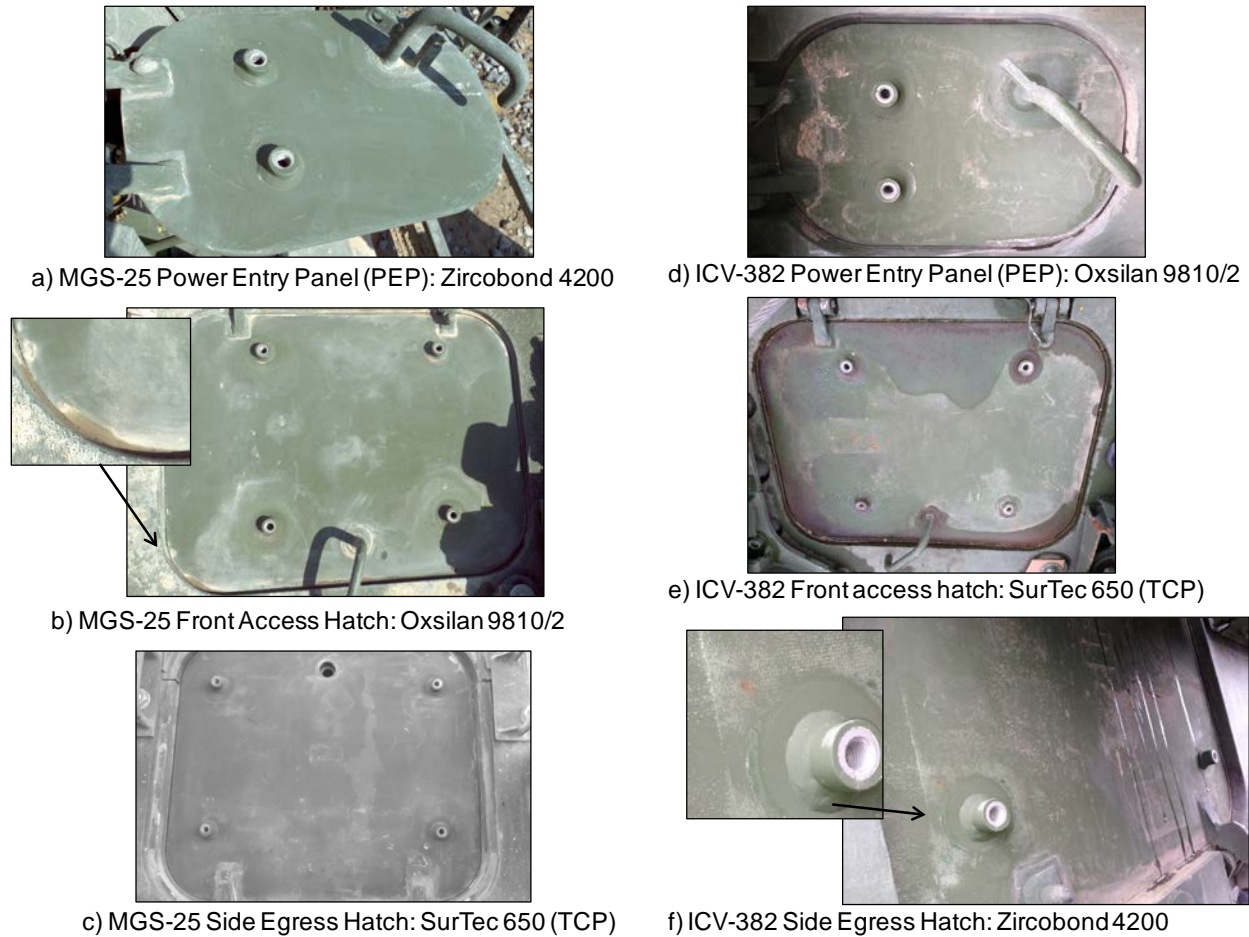
ARL contacted each of the POCs and gained their cooperation. MEV-0076 and ICV-0382 were still located at JBLM, however MEV-0076 was unavailable for inspection or photographing at the time of the inquiry. Even though MGS-0025 was in Afghanistan, contractors were able to locate and provide ARL with the photographs necessary. Because of travel restrictions ARL was unable to physically inspect the hatches at JBLM, therefore the photographs were provided by the POCs listed above. The photographs of the treated hatches on MGS-0025 and ICV-0382 are shown in Figure 10. The photographs in Figure 10 indicate that, overall very little corrosion exists on the hatches after 31 months in service. Even with magnification of the high resolution photos, only the front access hatch shows some indication of wear that may have been caused by rubbing of the composite armor. In an email SFC Jackson-Smith provided an eye witness assessment on the condition of the hatches on ICV-0382. He wrote: "I didn't see any paint peeling on any of the hatches. There were a few small red rust areas on the side egress hatch up towards the top that appeared to me to be just light surface rust." Although one of the hatches, Figure 10e appears to have some red rust near the edges, it is thought that the darker areas around the edge of that hatch may be dirt or clay that darkened when wet. The right side of that hatch, (dry side) is a light brown/tan color, not red. It's possible the darker brown/red is just mud that collected under the composite armor outer. All of the hatches on both vehicles have some type of dirt/sand that collected under the composite armor. The only corrosion damage recognizable from the photographs is the spot in 6-7f, the side egress hatch mentioned by SFC Jackson-Smith. This can be rated using SSPC-VIS-2 as "rust grade 9-S (spot) less than 0.03 percent. At this time, the hatches are considered comparable to the base vehicle.

Figure 10. Photographs of hatches from Stryker vehicles MGS-25 and ICV-382 located at JBLM after 31 months in service.¹³

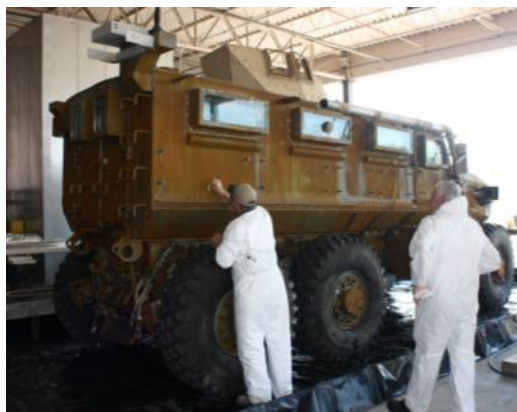
Figure 11 shows MRAP #1 after the application of the Oxsilan 9810/2. These results were completely unexpected and bear no resemblance to the surface finish that was achieved on the earlier demonstration on Stryker hatches treated Oxsilan 9810/2 at ANAD (see Figure 9).

Figure 11. MRAP #1 after application of with Oxsilan 9810/2, June 20, 2011.

During a meeting and conference call with Chemetall America's Product Manager on the evening of June 20, 2011, several possibilities for the unexpected results were discussed: 1) improper solution chemistry, 2) inadequate application rate [not enough flow], 3) surface contamination because MRAP #1 was not abrasive blasted within the required 24 hours prior to pretreatment, but rather 72 hours prior to treatment; and/ or blast media was contaminated.

These results indicate that a combination of events contributed to the undesirable appearance of the pretreated MRAP. The scale-up from laboratory sized and hatch sized parts to a full sized MRAP, was underestimated, resulting in inadequate flow of the applied Oxsilan 9810/2. We also believe that the 72 hours the bare surface of the vehicle was exposed to the environment led to some surface contamination which likely affected the reaction of the Oxsilan 9810/2 with the steel surface. We cannot rule out the possibility that the grit used for abrasive blasting the vehicles may have contained chlorides or other salts that would have also served to contaminate the steel surface. The laboratory tests and the previous demonstration of Strykers indicate that the Oxsilan 9810/2 must be applied to a freshly cleaned, abrasive blasted surface as soon as practical. Preferably within 2-4 hours of abrasive blasting. The flow rate used for the Oxsilan 9810/2 must be sufficient enough to keep the vehicle wet throughout the treatment. Rinsing with clean water should be done using adequate flow rate to thoroughly remove the un-reacted Oxsilan 9810/2. We are confident that the desired results can be achieved by following these recommendations.¹⁵

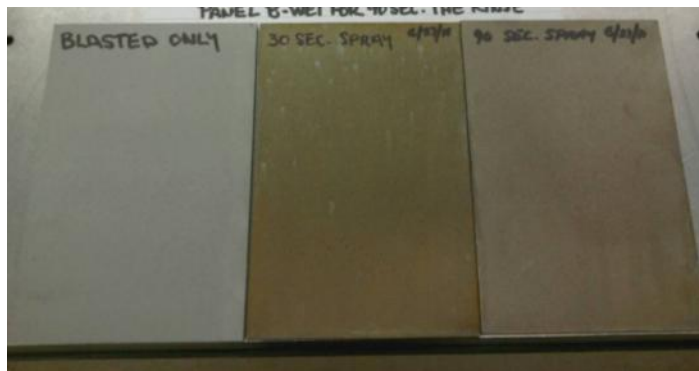
A significant change in the color was evident in the panels with surface contaminants. Figure 12 shows a comparison of a freshly blasted HHA panel (left), with panels that were treated with Oxsilan 9810/2 following 72 hours in an outside environment. The center panel was treated using minimal flow for 30 seconds, and right panel bathed for 90 seconds. The appearance of the center panel is very similar to what was seen on the MRAP during the demonstration at Camp Lejeune (Figure 11). Unique to these test panels vs. all the others was the spotting and streaking of the panel that was only allowed 30 seconds of dwell for the Oxsilan 9810/2; again, similar to

the MRAP. The surface is clearly contaminated, and it appears that the contamination has had an effect on the consistency and ability of the Oxsilan 9810/2 to react with the steel substrate. Although there was also a color change with the panel treated for 90 seconds, it did not resemble the MRAP results.

Figure 12. Comparison of HHA test panels that were weathered then pretreated with Oxsilan 9810/2.

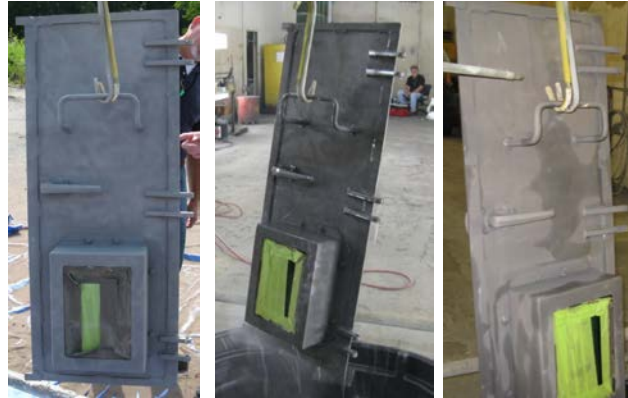
To prove our hypothesis, ARL worked closely with the MRAP-PMO to secure another demonstration of a limited scope. The MRAP-PMO agreed to provide one set of two rear doors from an MRAP variant for pretreatment using Oxsilan 9810/2. During this demonstration, we were very cognizant of the mistakes made at Camp Lejeune. Therefore, two improvements were made over the process used at Camp Lejeune: 1) the freshly abrasive blasted doors were pretreated with Oxsilan 9810/2 within 2 hours of blasting, and 2) adequate flow of the pretreatment solution was achieved by using a Yamada NDP-15 BPT pump with a 4.0 gpm rating. The Oxsilan treated surfaces of the door looked similar to the results seen at ANAD during the Stryker hatch demonstration. As can be seen in Figure 13, they appeared light grayish blue. No reddish/brown discoloration occurred anywhere on the door. The application of the Oxsilan was carried out similar to the Stryker hatches at ANAD. The surfaces were treated with Oxsilan less than 2 hours after abrasive blasting using a pump sprayer with adequate flow to keep the surfaces wet throughout the pretreatment process. This is added evidence that the

undesirable results from the MRAP demonstration at Camp Lejeune was a result of surface contamination, and/or inadequate flow rate of the Oxsilan 9810/2.

Figure 13. MRAP rear doors.

(left: freshly abrasive blasted, center: during application of Oxsilan 9810/2, right: drying)

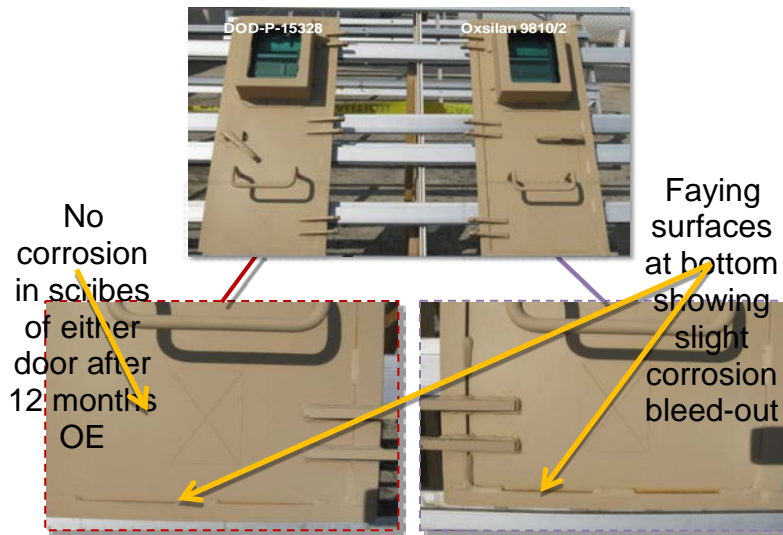
The other of the two doors was pretreated with the DoD-P-15328 washprimer and both doors were then primed with MIL-DTL-53022, and topcoated with MIL-DTL-53039. An “X” was scribed near the bottom of each door and both doors were subjected to outdoor exposure at the Aberdeen Proving Ground (see Figure 14).

Figure 14. MRAP rear doors after 1 year in outdoor exposure at APG.

(Left: DoD-P-15328; on right: Oxsilan 9810/2)
