# FLOOD PROOFING TESTS

Tests of Materials and  
Systems for Flood  
Proofing Structures

August 1988

US Army Corps of Engineers

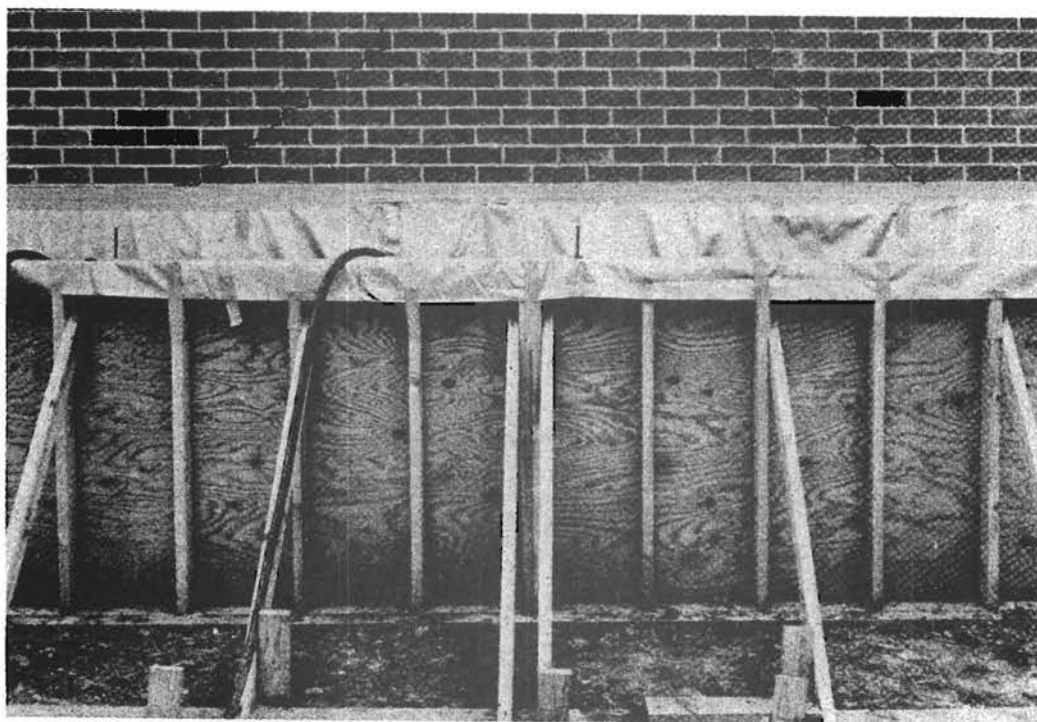
A severe loss of integrity began at 2 ft of water with complete loss occurring at 2.4 ft (Figure 8). The failure at 2.4 ft of water is presented in Figures 10 and 11.

Figure 10. Wall 1. Failure pattern of wall

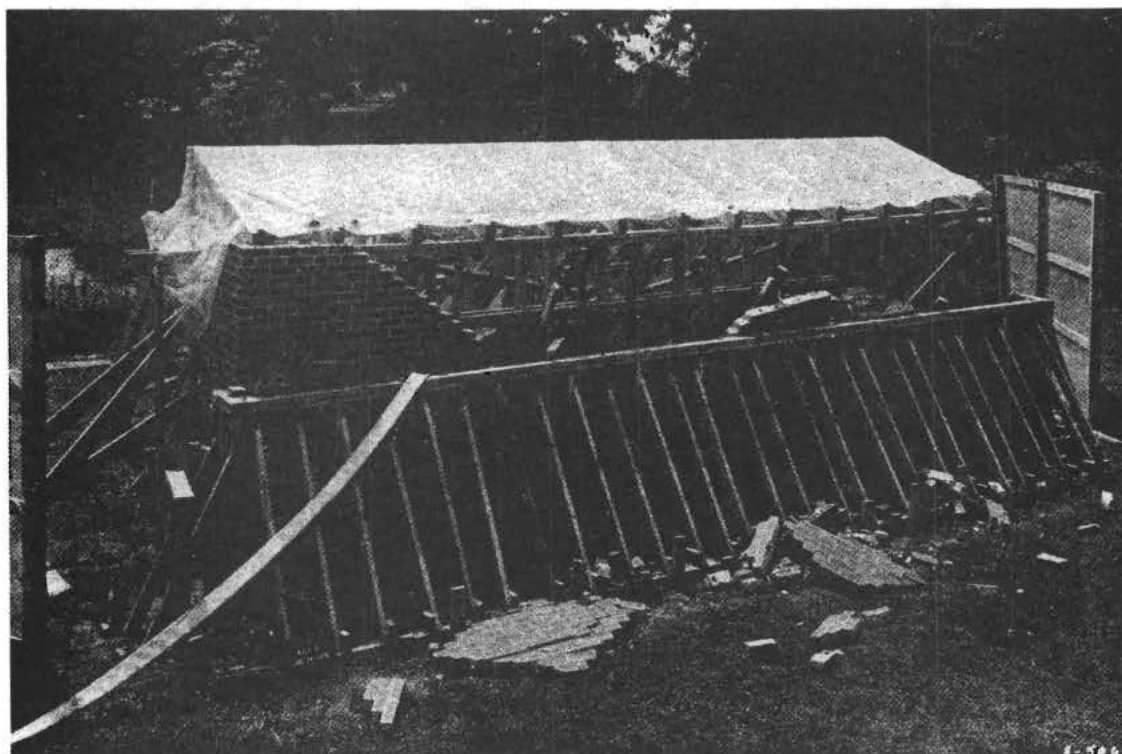
Total collapse of the brick-veneer wall occurred at a depth of 57 in. and at a total applied force of 18,300 lb. This failure was sudden and resulted from the failure of the supporting studs. The remains of the brick-veneer wall after failure are presented in Figures 16 and 17.

Figure 16. Wall 3. Wall failure, front view

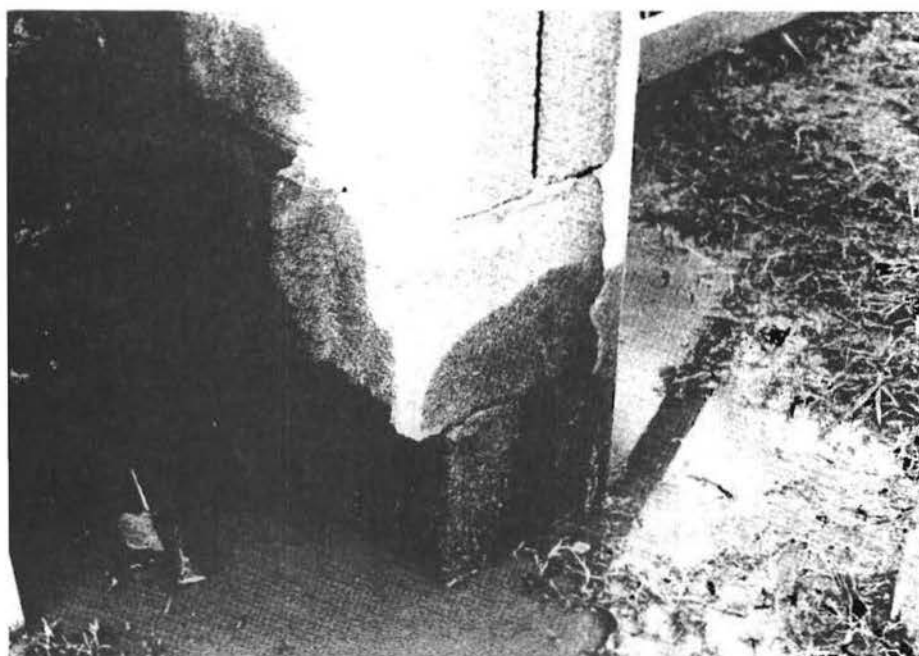
Typical deflection data for Block Wall 1 are presented in Figure 20. As the water level was raised against the surfaced wall, the plaster was weakened and was penetrated by the water; thereby reducing its effectiveness in strengthening the wall against deflection. At a water depth of 3-1/2 ft the block wall was cracked and leaking so badly that the trough could not be kept filled with water from a fire hose connected to the fire hydrant. Water flowed through the cracks faster than it could be put into the trough. Photographs of the leakage are shown in Figure 21.

b. Base of wall

Figure 21. Leakage through block wall

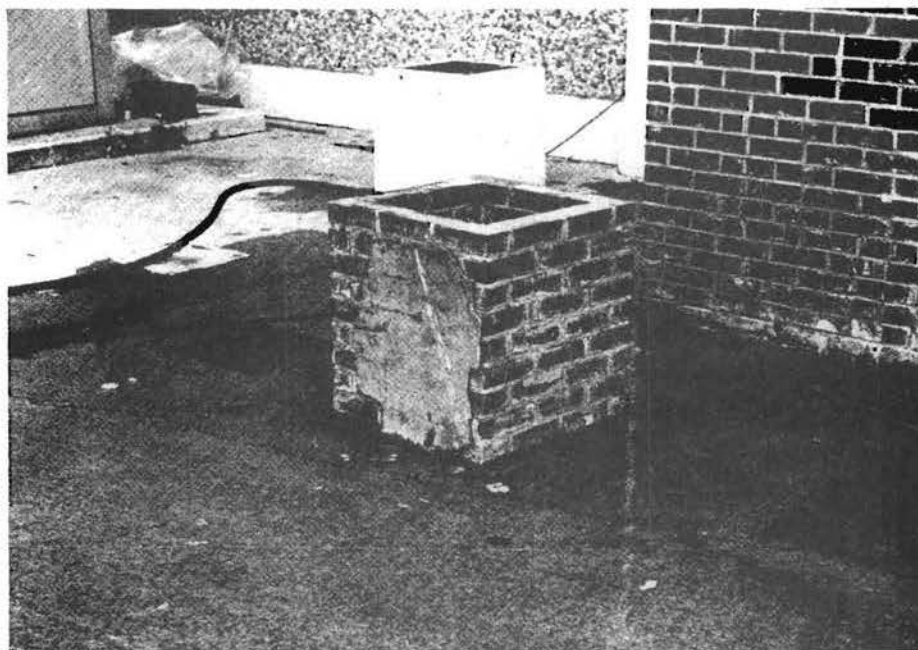
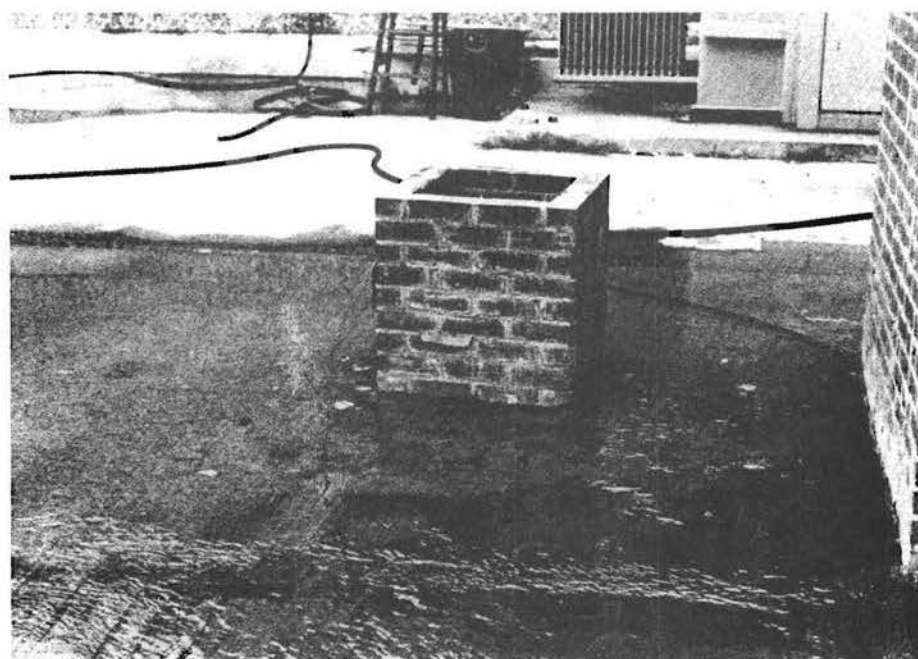
Figure 46. Failure of coating 4

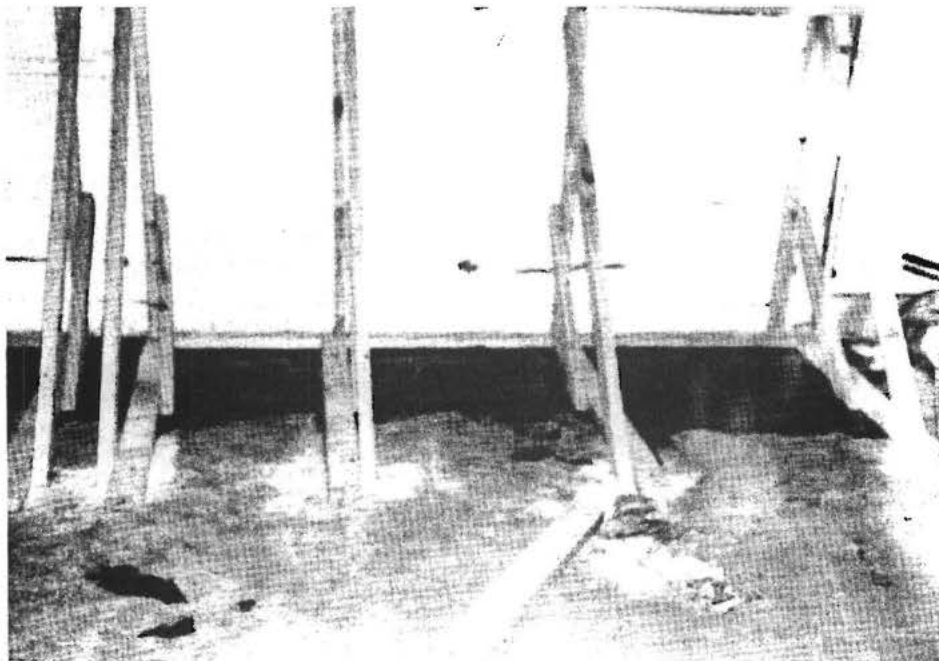
Figure 73. Water seeping under garage door due to excessive water height in sump
