HCAT PROGRESS REPORT SEPTEMBER 2002

13. SUPPLEMENTARY NOTES 21st Replacement of Hard Chrome Plating Program Review Meeting, September 25-26, 2002, Toronto, Ontario. Sponsored by SERDP/ESTCP.

TEST 1: MLG FATIGUE TEST

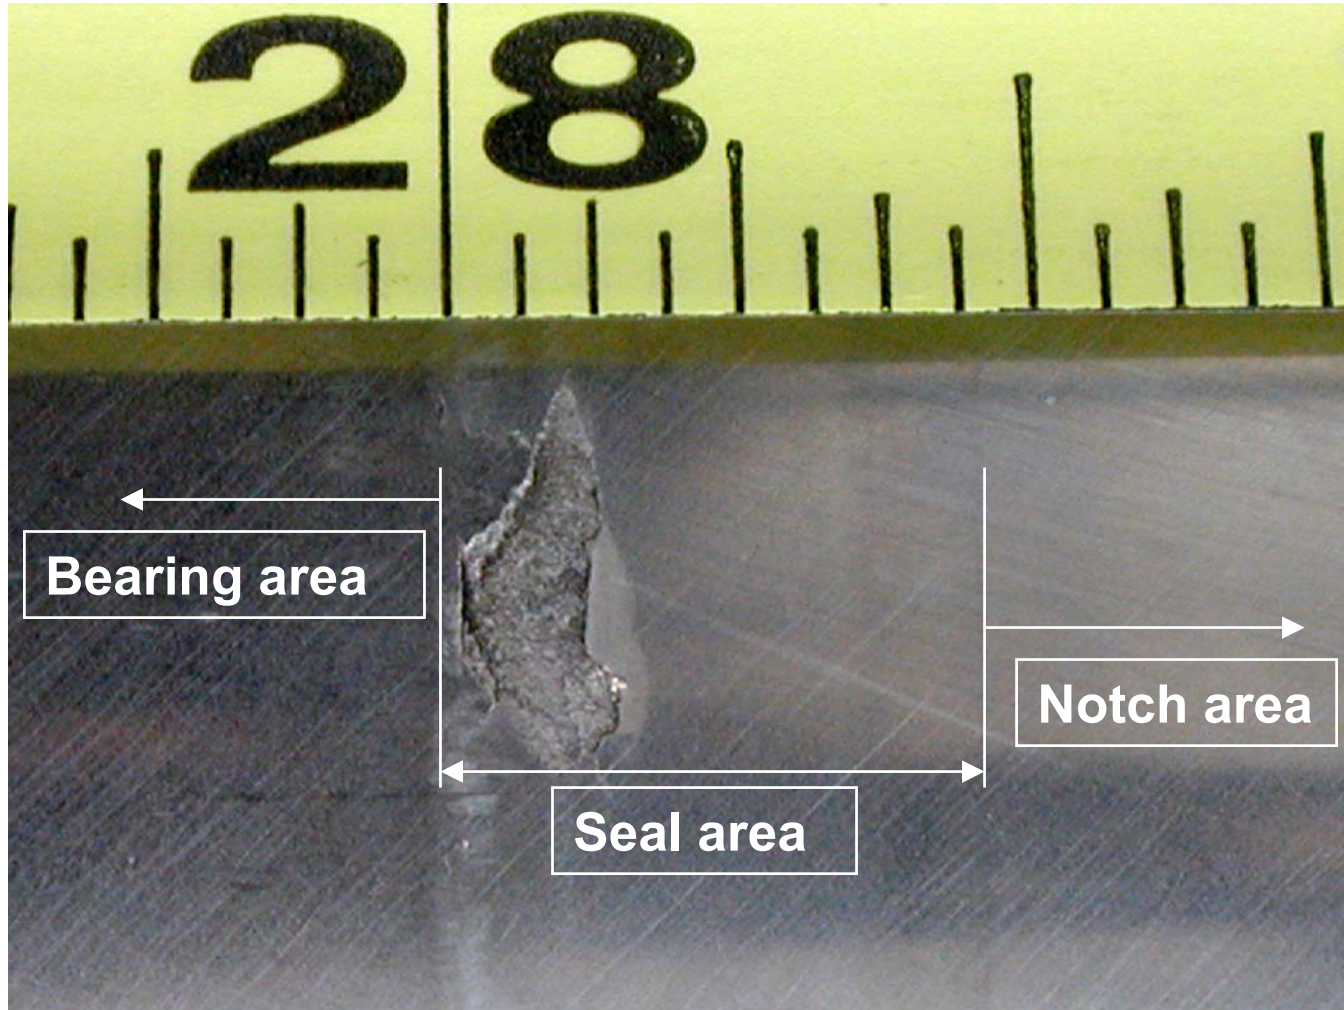
- **1st HVOF coated piston:**
570,000 cycles, i.e. 2 lives, ~ 100ksi at notch
184,500 cycles, ~ 110ksi
- Small area of failed coating (approximately .150" x .350"), between 250,000 - 285,000 cycles at bottom.
- Visual, MPI, LPI and Barkhausen Noise inspection after 570,000 cycles did not find evidence of substrate cracking.
- **Piston failed at bearing contact point**

HVOF COATING AFTER 285,000 CYCLES

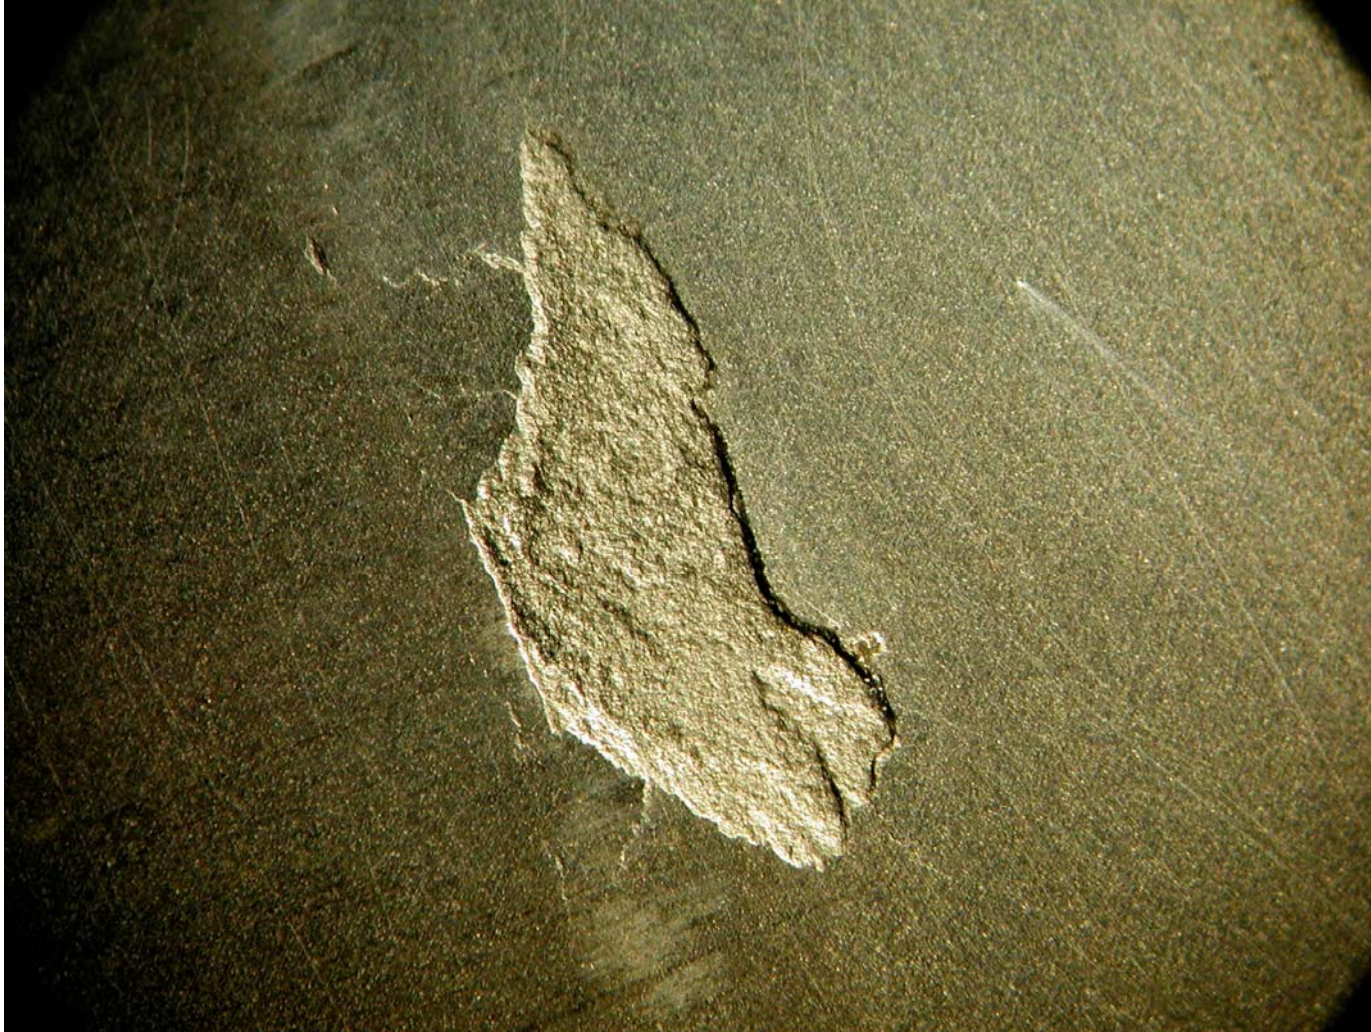
HVOF COATING AFTER 285,000 CYCLES

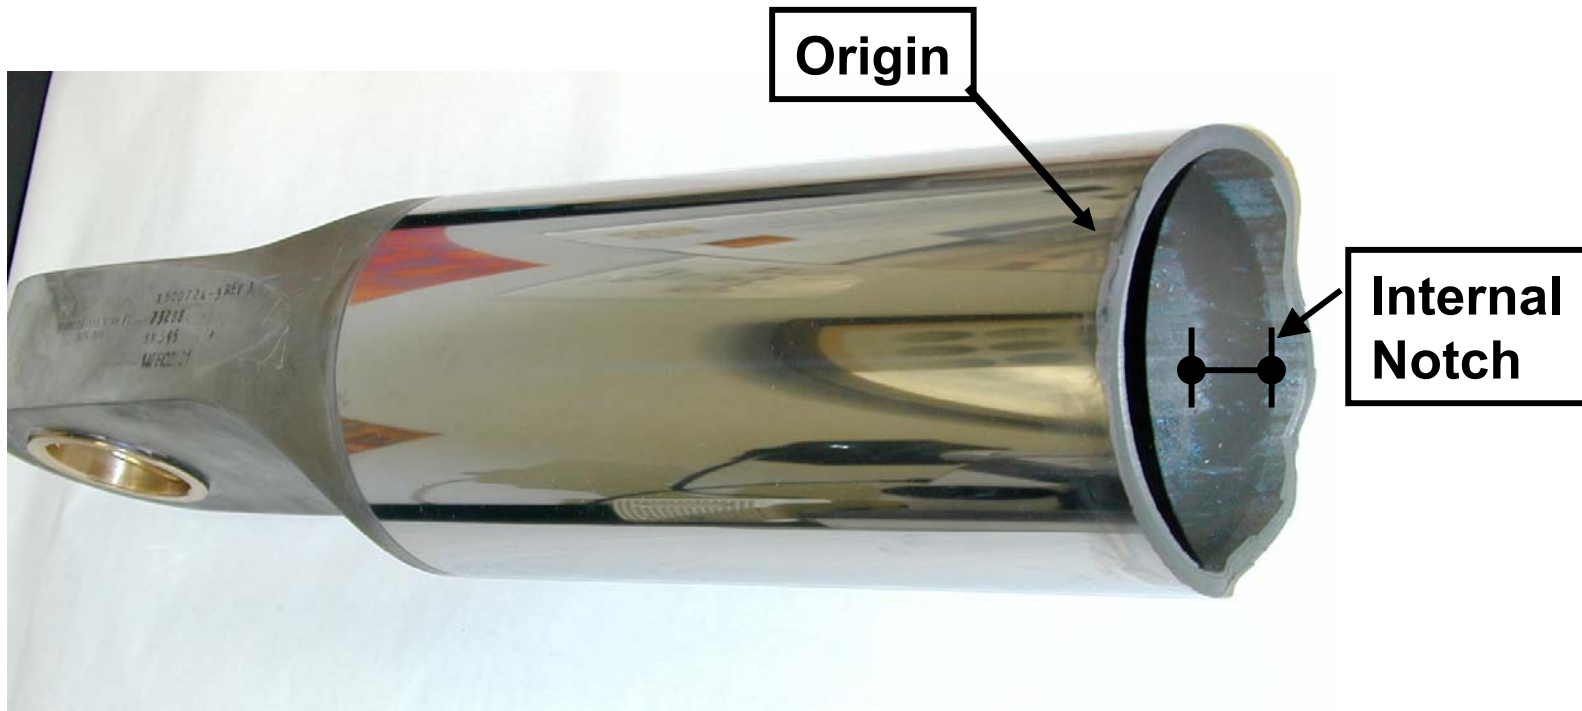
2nd HVOF coated specimen

- **2nd HVOF coated piston:**
33,000 cycles. ~125ksi at notch
- **Piston failed at bearing contact point, large area of coating failure 2"x0.25"- top and bottom**

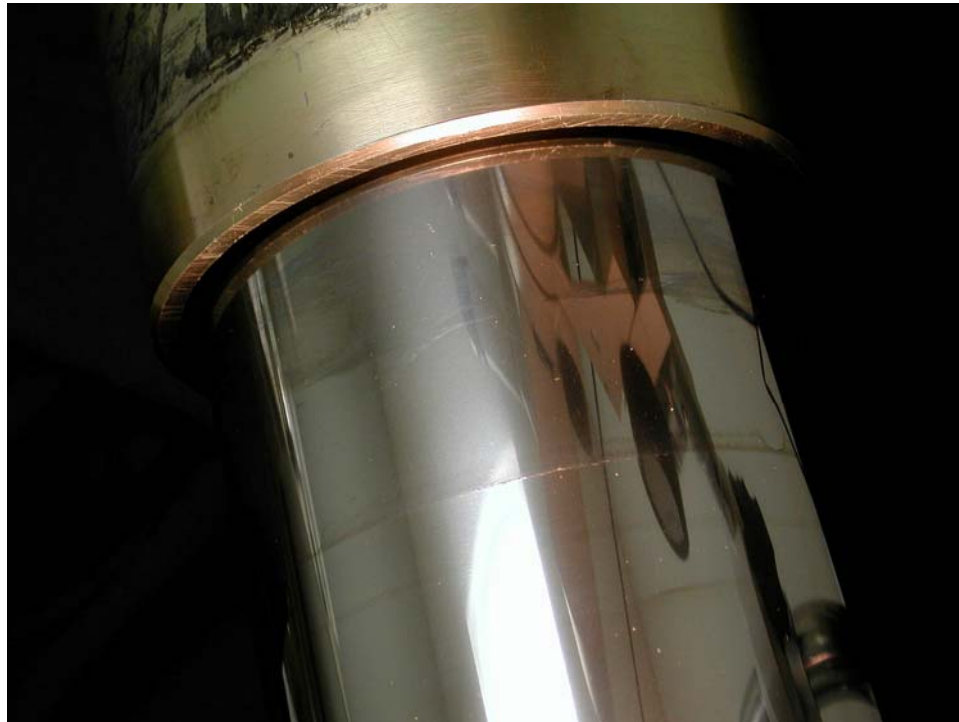
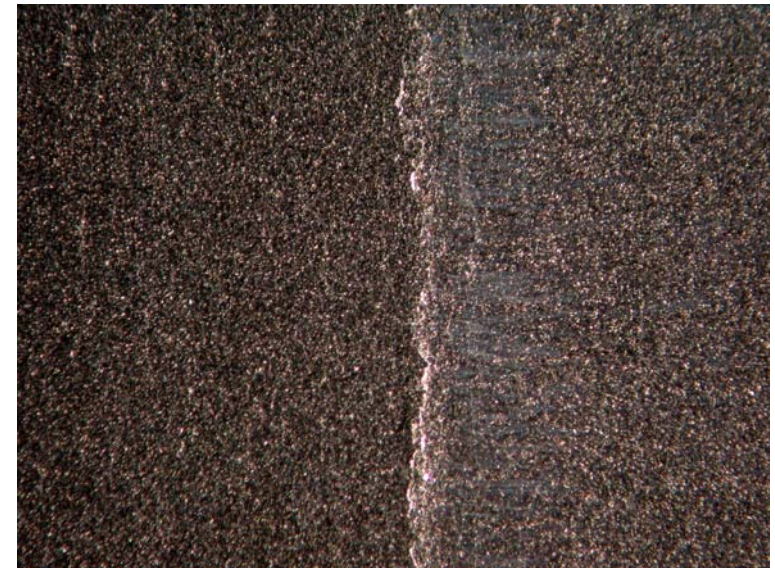
10,000 cycles - significant circumferential cracking

←→
Bearing area

Appearance of coating after 10,000 cycles

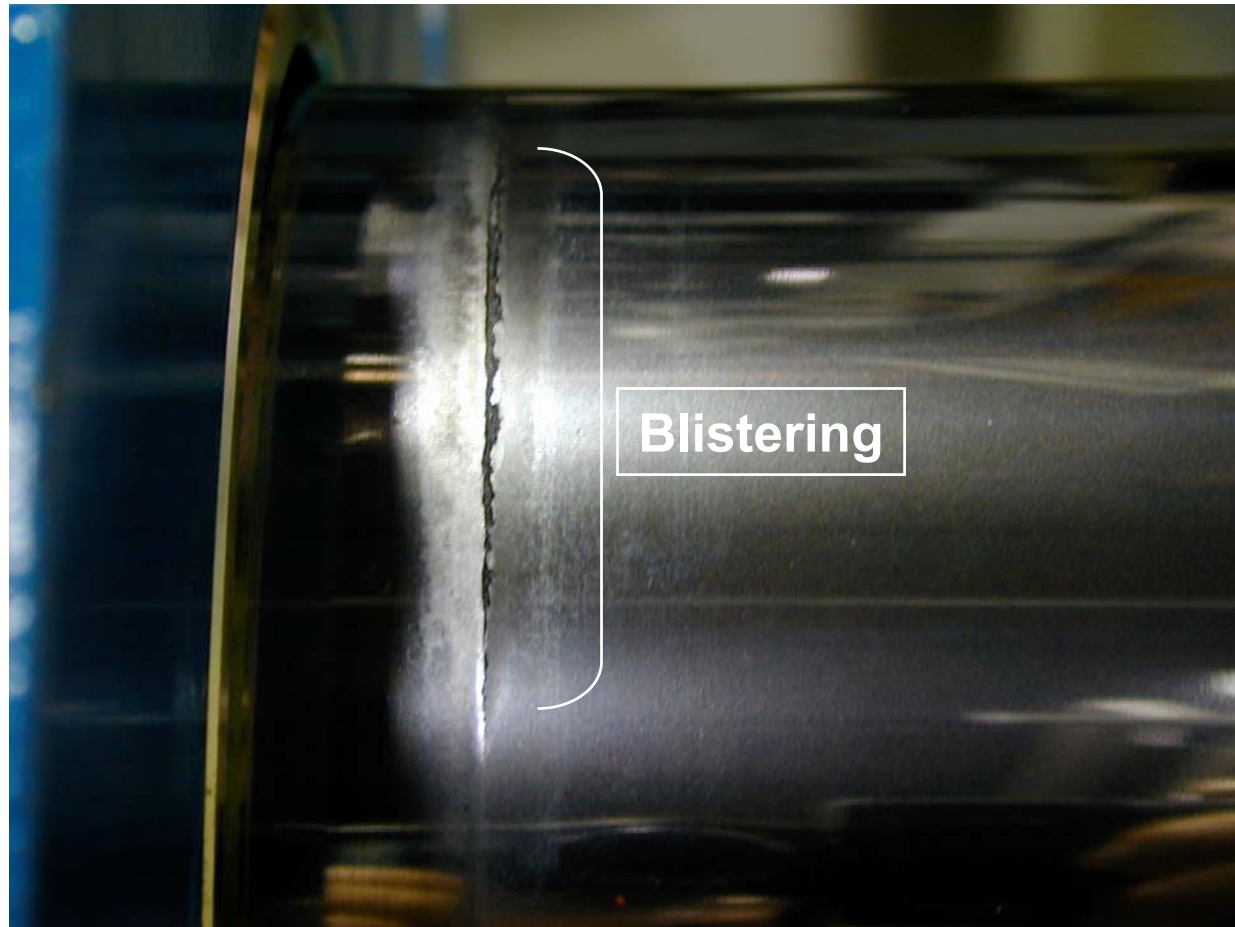
25,300 cycles - failure at the bearing contact point
initiating at bottom

Appearance of coating after 25,000 cycles
