**US Army Corps
of Engineers®**
Engineer Research and
Development Center

ERDC
INNOVATIVE SOLUTIONS
for a safer, better world

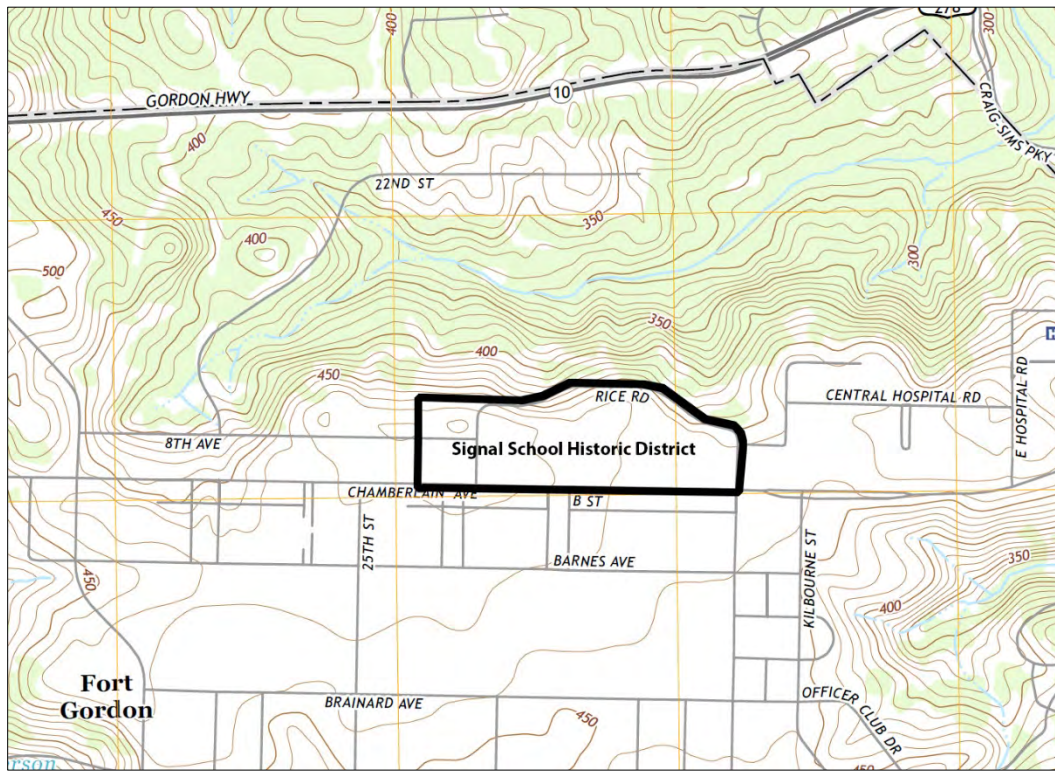
Table 1. List of buildings given to the research team to assess character-defining features for the U.S. Signal School, 2015 (Fort Gordon Real Property Office).

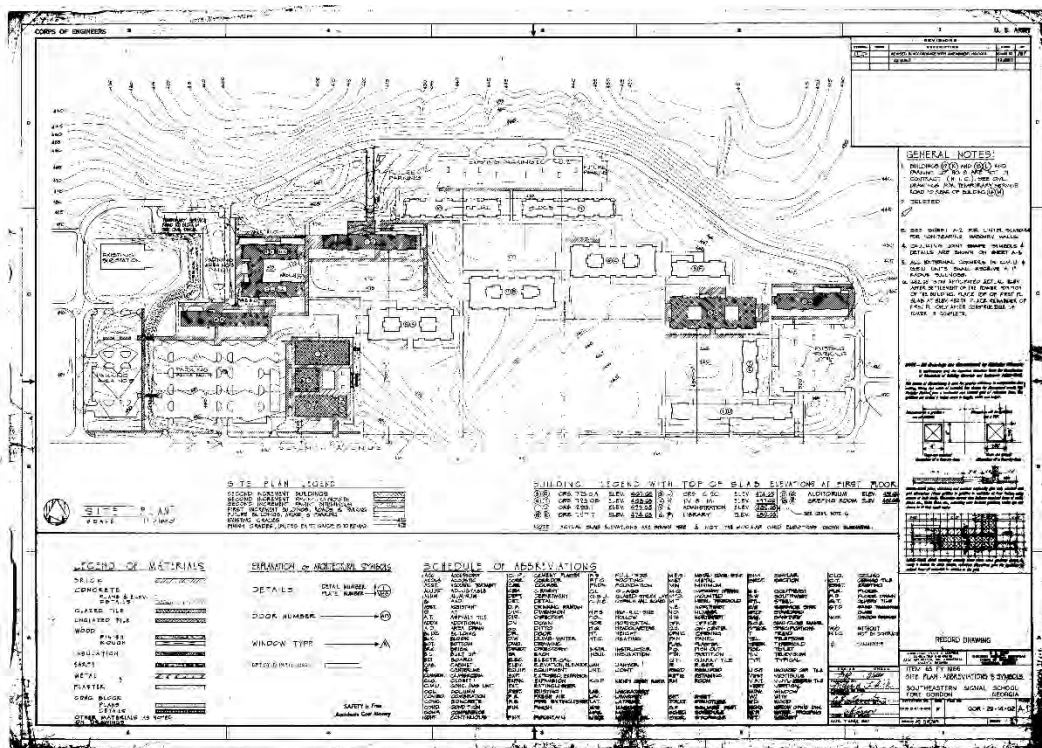
Concurrent with the planning and design of the Southeastern Signal School Campus to the north of Chamberlain Avenue, the Corps of Engineers Savannah District planned the rebuild of the area south of Chamberlain with new barracks (“rolling pin” type), mess halls, company and battalion administration buildings, and chapels (Figure 6 and Figure 7). A women’s enlisted barracks (Building 33800) was planned at the same time, and construction was finished in 1968 (Figure 8). None of these plans and buildings were part of the Aeck master plan for the Signal School.

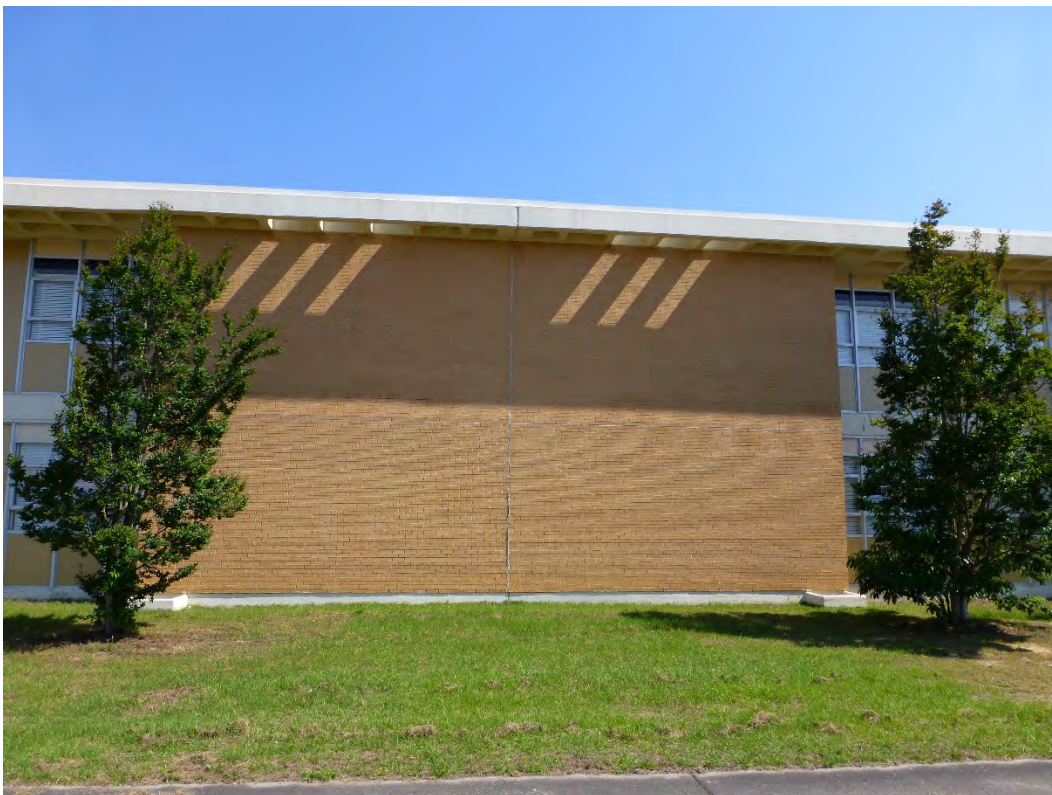
3.1.2 Window systems

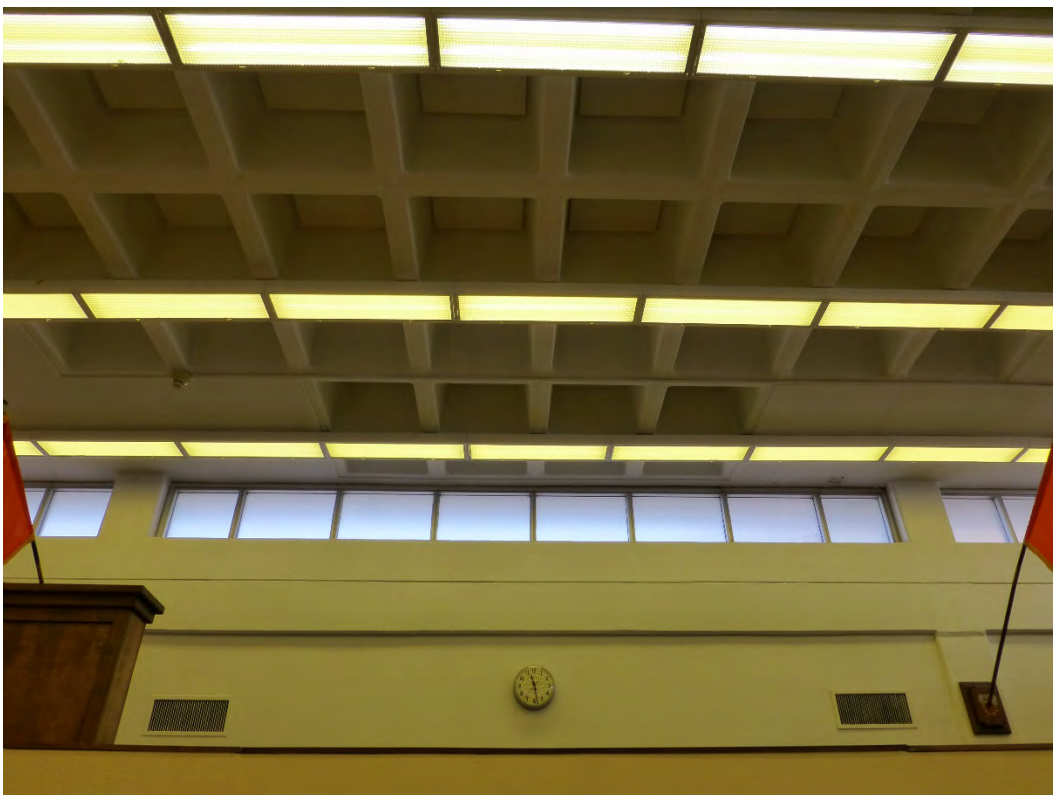
Figure 53. Replacement anodized-bronze aluminum one-over-one windows, Building 29808, Signal Towers (ERDC-CERL, 2015).

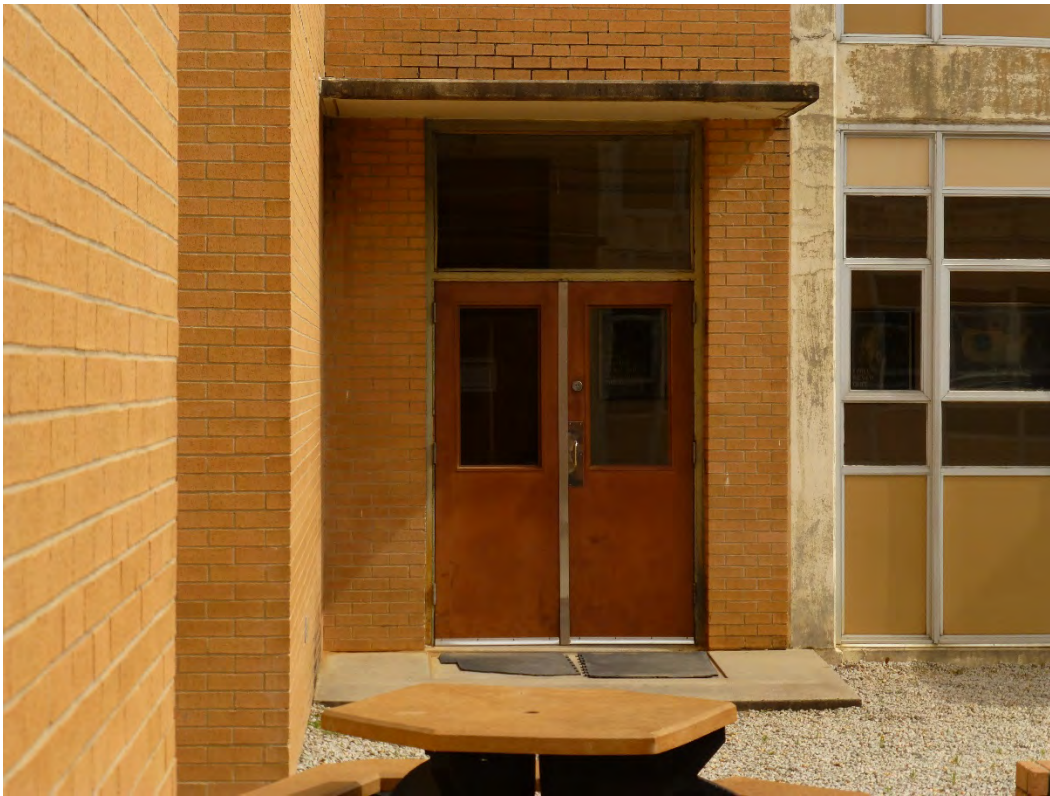
3.1.4 Exposed concrete structural system

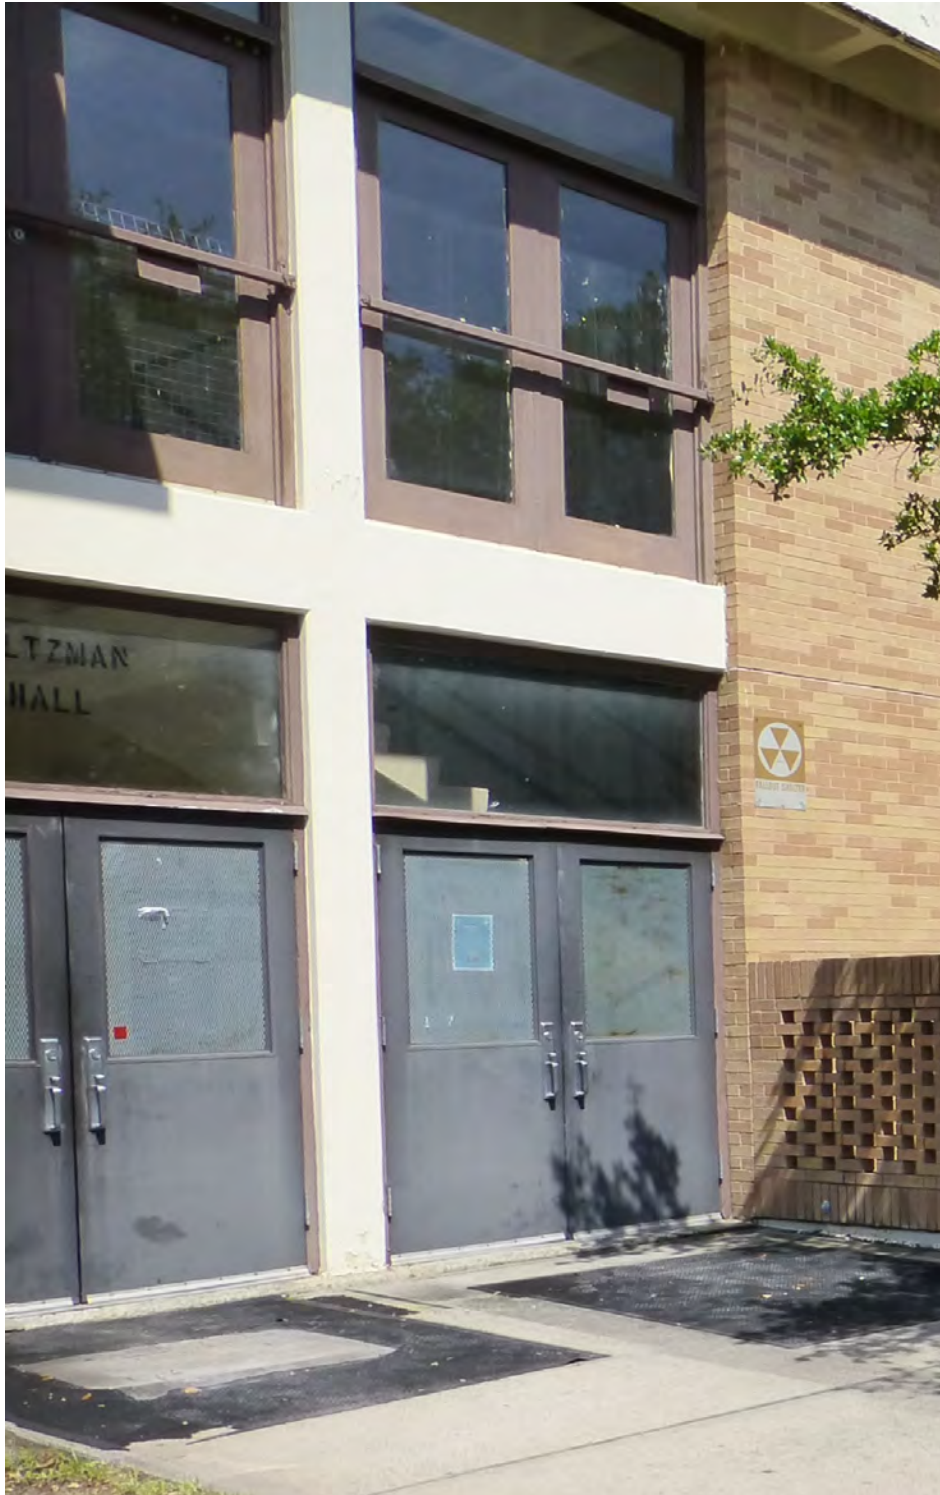
Figure 63. Close-up of the exposed concrete structural system framing the doors and window bays, Building 29815, Hazen Hall (ERDC-CERL, 2015).

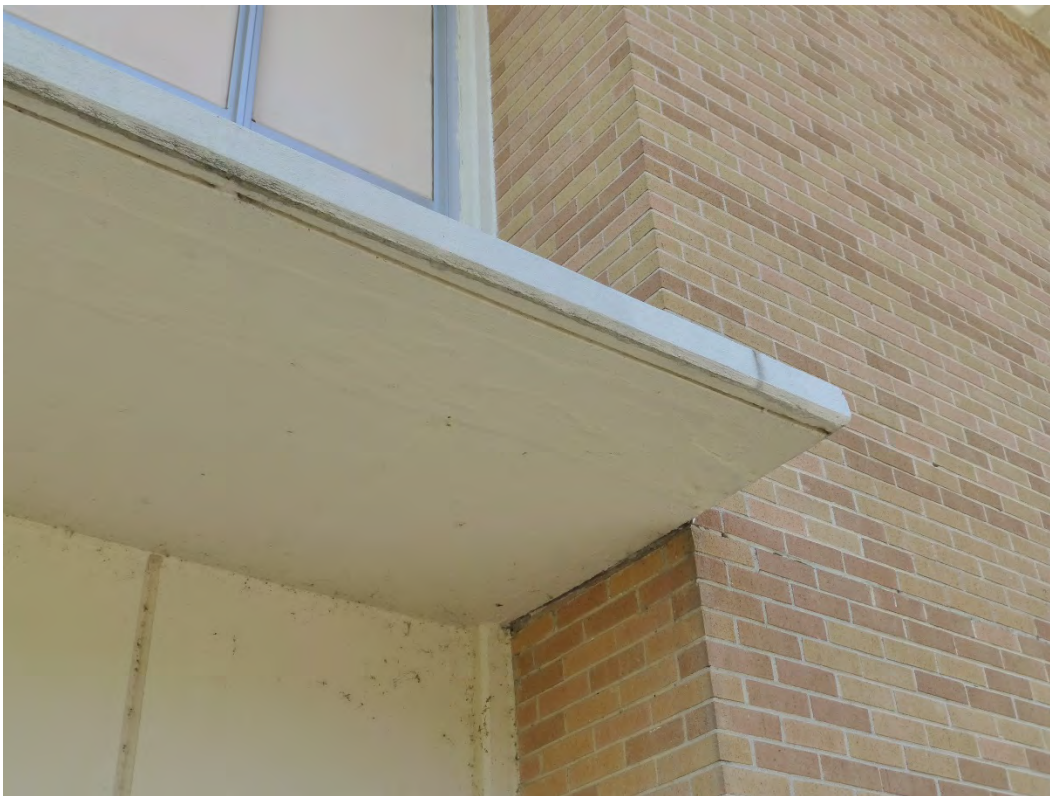
3.1.3 Cylinder exterior light fixtures

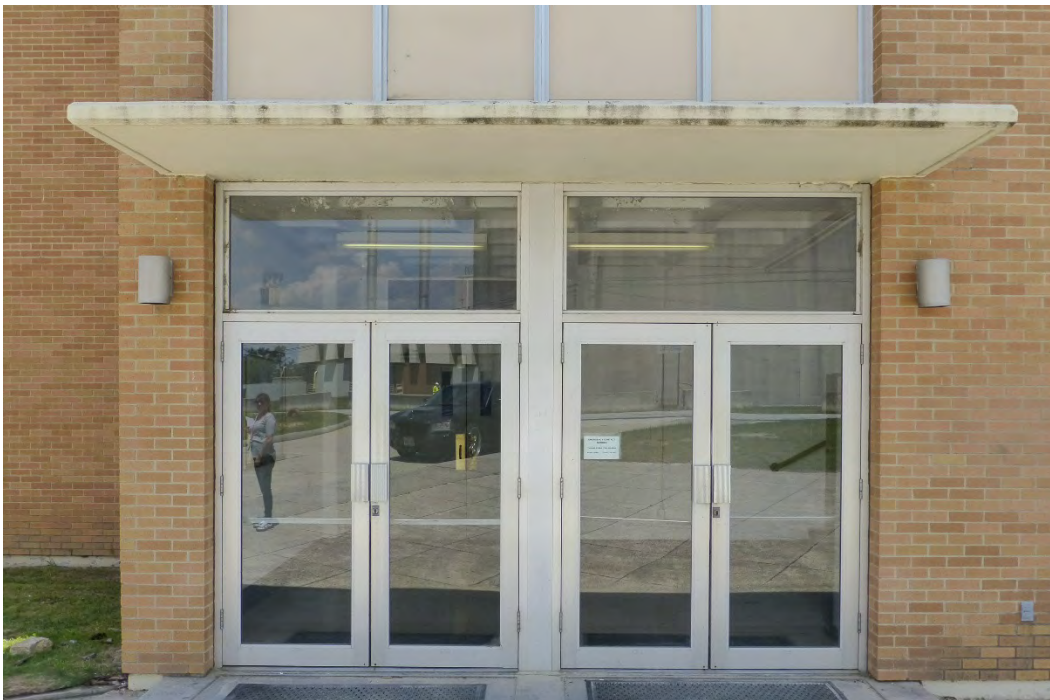
Figure 72. Ceiling-mounted light fixture placed on the underside of the flat concrete canopy, Building 29801, Nelson Hall (ERDC-CERL, 2015).

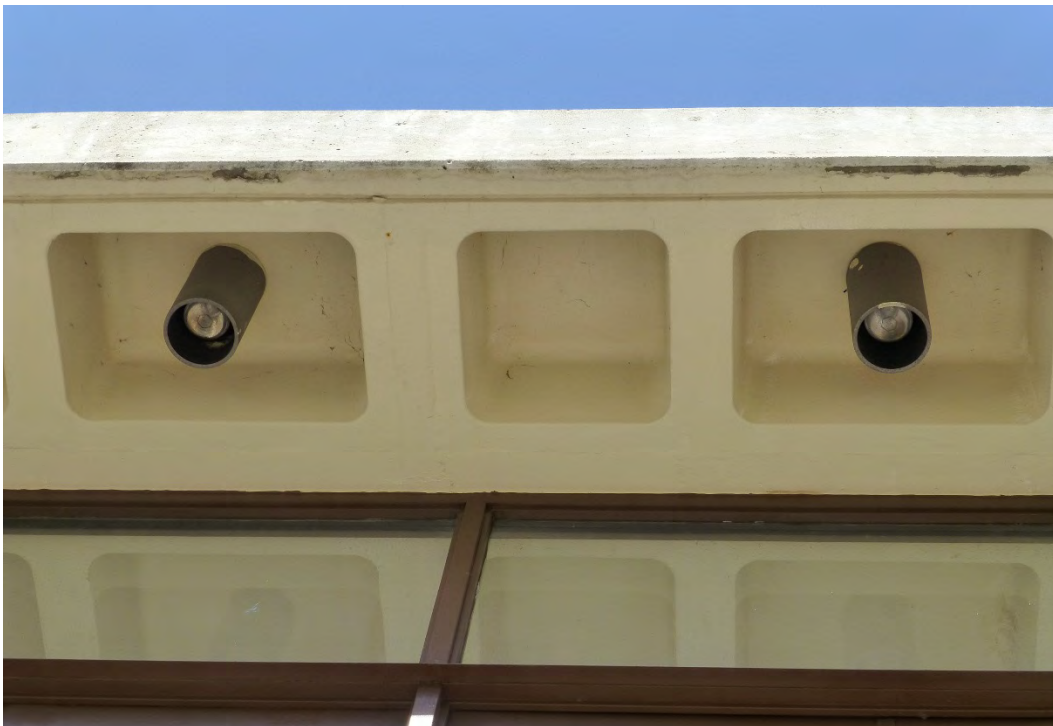
Figure 79. In-kind replacement cylinder—bronze wall-mounted light fixture—located near the main entry on the south elevation of Building 25810, Brant Hall (ERDC-CERL, 2015).

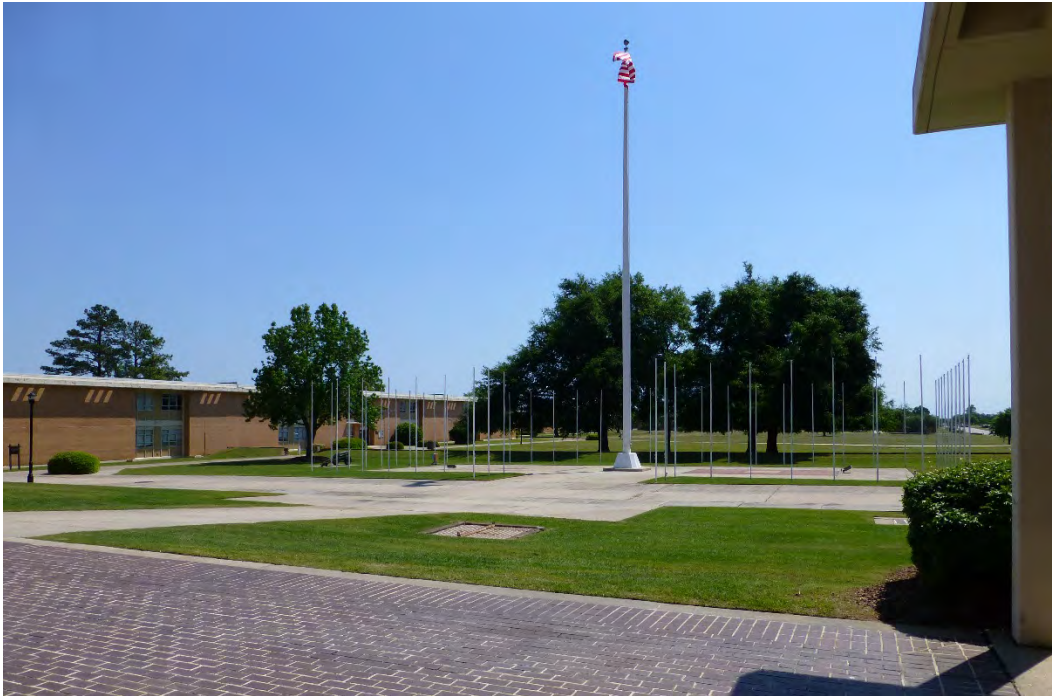
Figure 110. While trees can be found on the landscaping plan from 1966, this large flag plaza is not present on that plan (ERDC-CERL 2015).

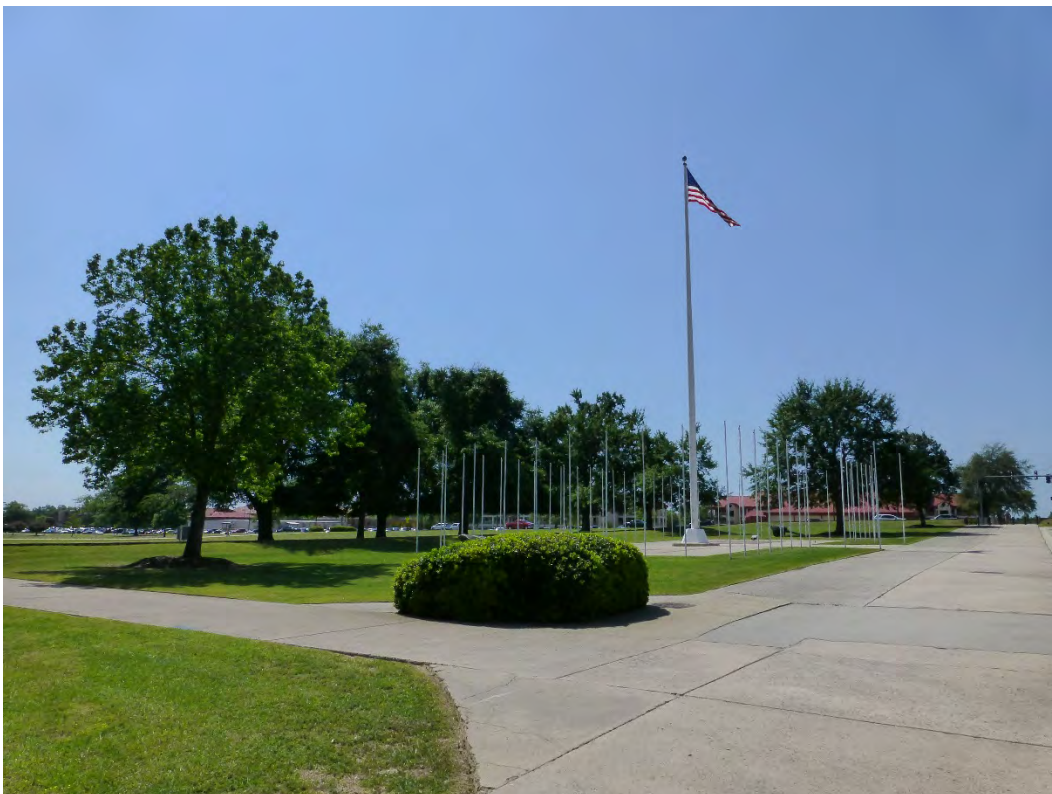
Figure 111. Group of trees located just east of Building 29815 on the east side of the open campus plan (ERDC-CERL, 2015).

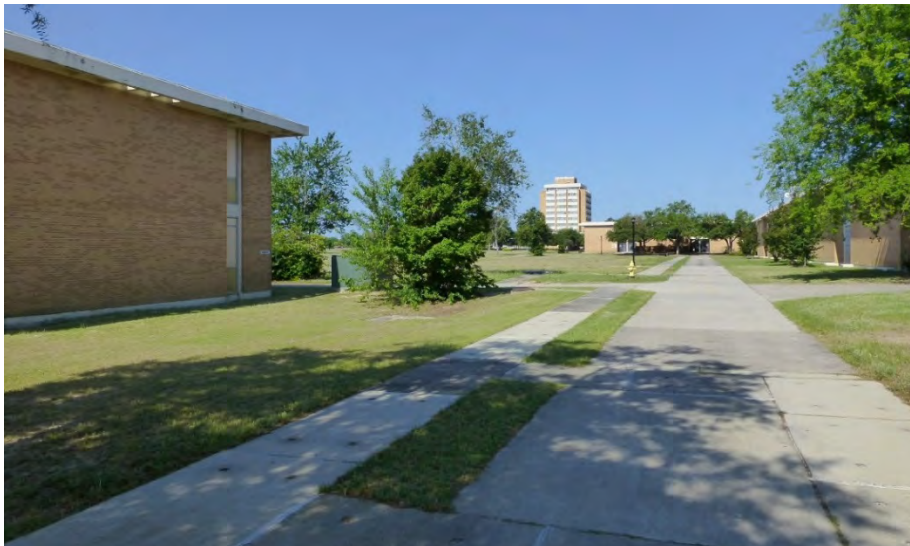
Aeck specified a light standard for illuminating the sidewalks that consisted of an aluminum pole capped by the fixture and then an aluminum “hat” (Figure 119). Some of these are extant, but many of them have been replaced by two types of light standards (Figure 120 and Figure 121).

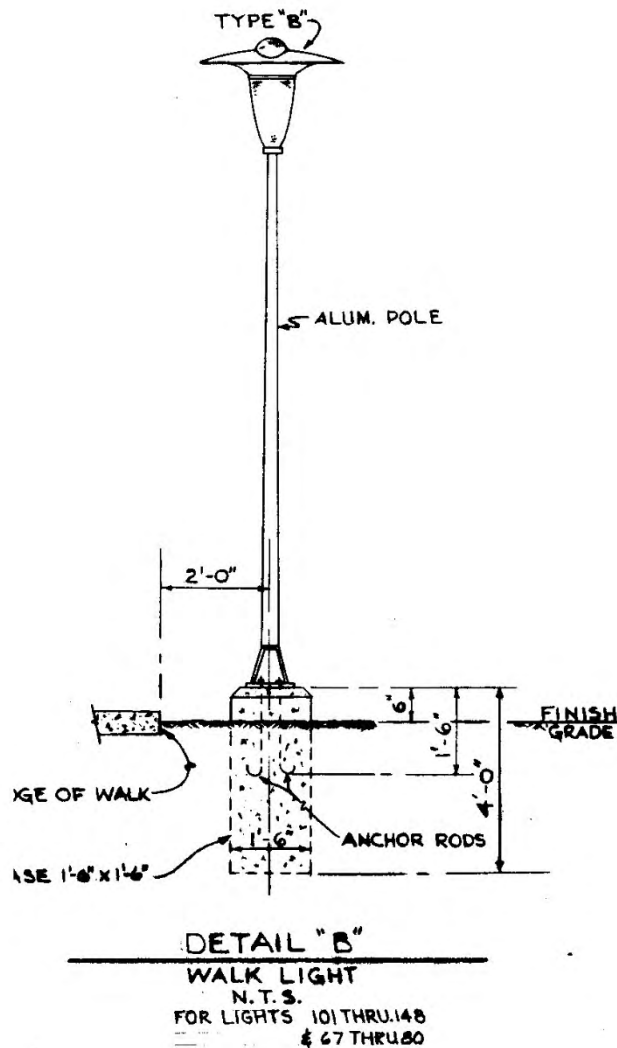
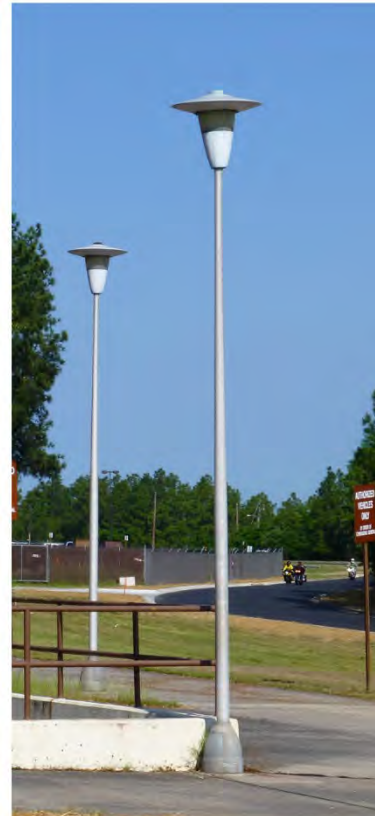
Figure 120. An example of one type of the replacement sidewalk lights (ERDC-CERL, 2015).

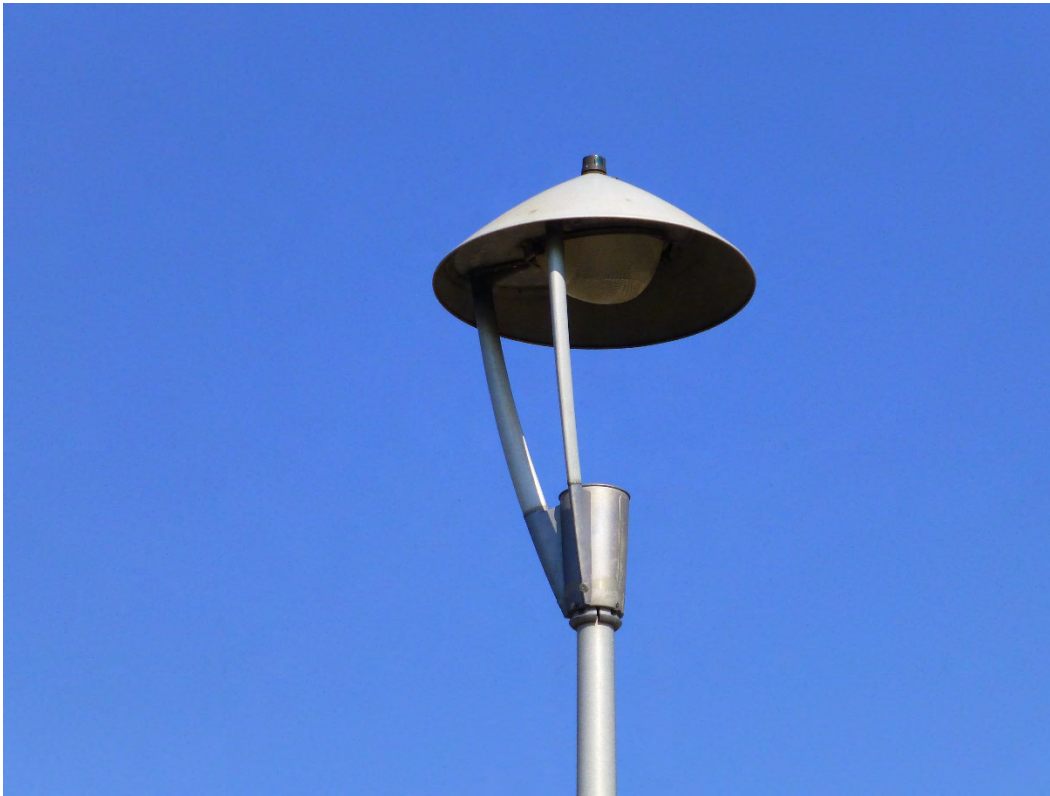
3.2 Interior character-defining feature examples

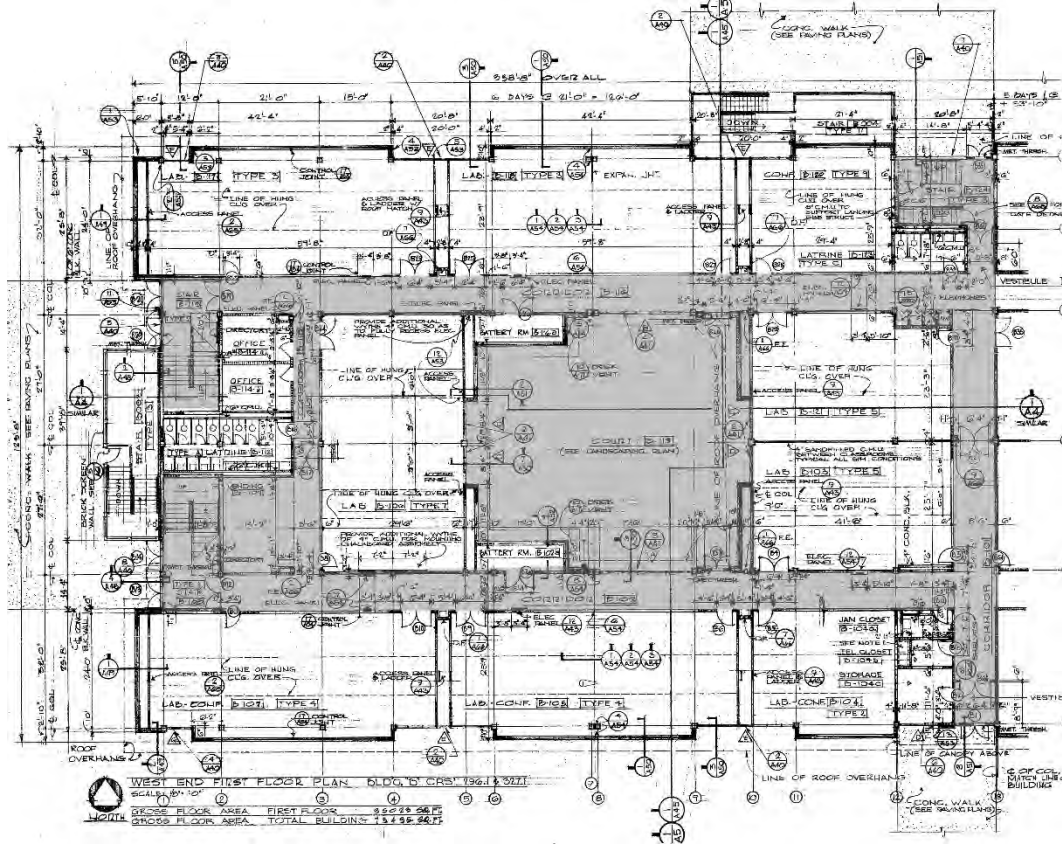
Figure 123. Examples of character-defining space in the interior (gray area) include vestibules, stairwells, hallways, vending space, phone alcoves, and drinking fountain alcoves (Fort Gordon DPW).

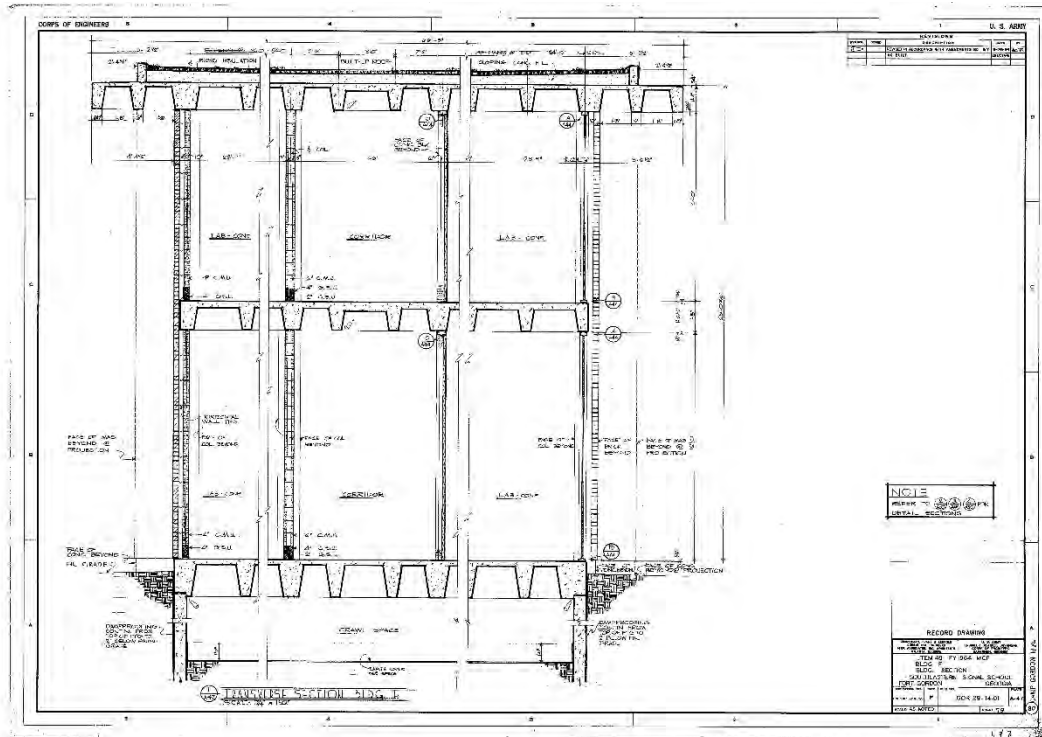
Figure 125. Transverse section through a typical classroom building, with courtyards showing the detail of the exposed concrete waffle ceiling/roof system, 1964 (Fort Gordon DPW).

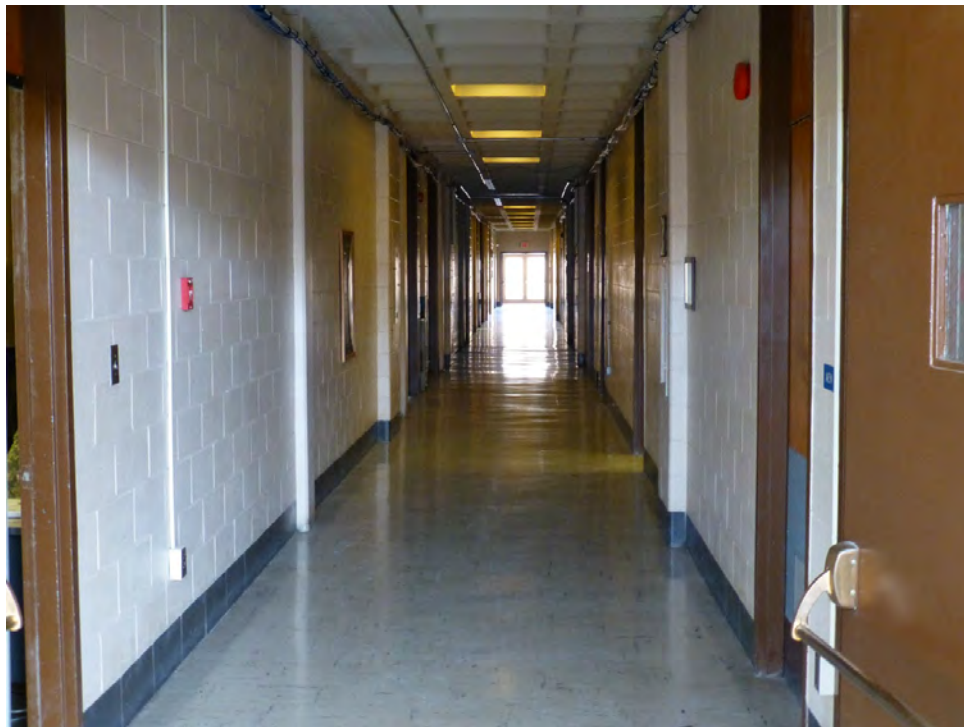
Figure 126. Example of an interior view looking down a central hallway with the exposed concrete waffle ceiling and concrete block walls (ERDC-CERL, 2015).

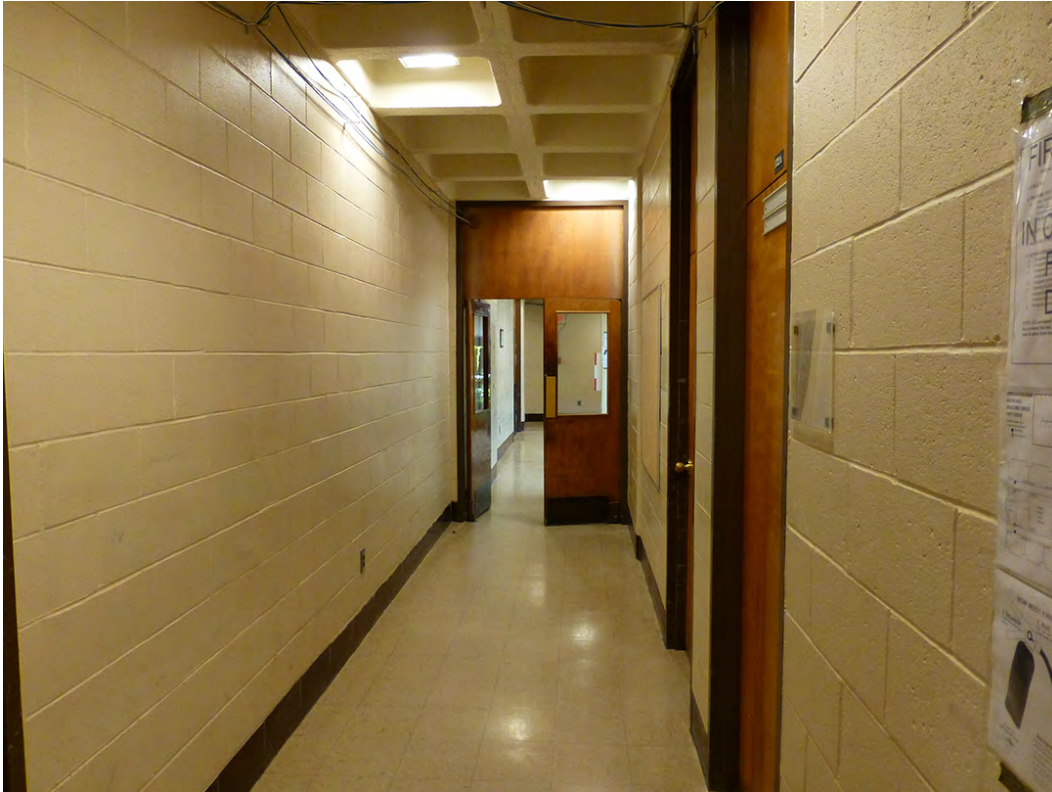
Figure 128. Example of unpainted, exposed brick in vestibules (ERDC-CERL, 2015).

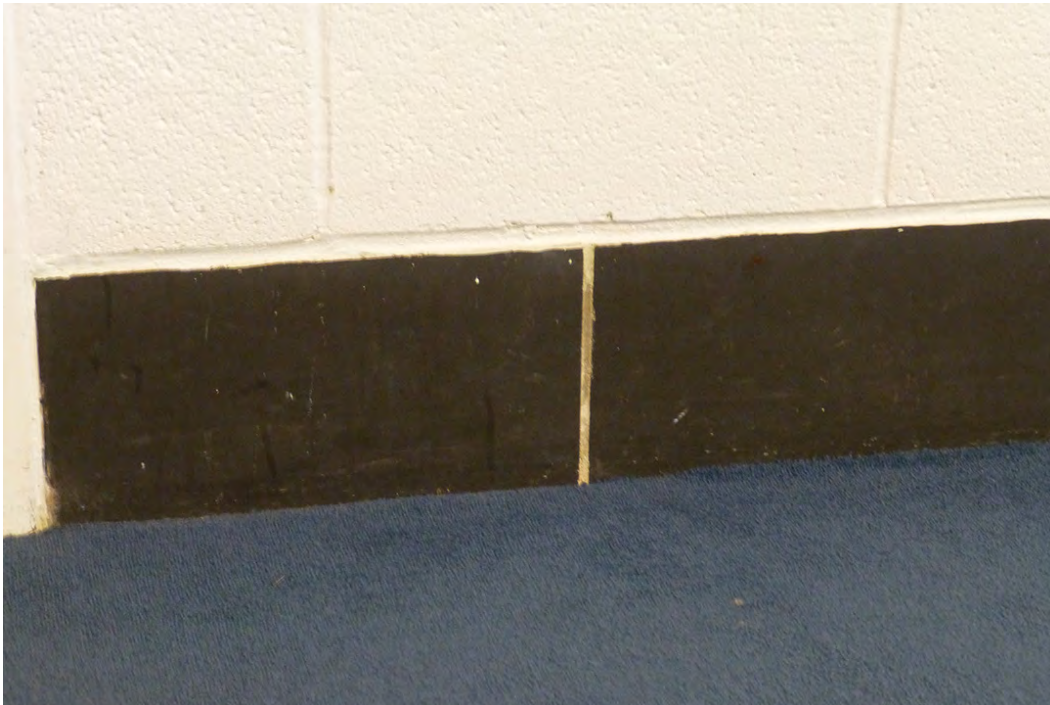
Figure 131. Example of glazed concrete block utilized as a baseboard (ERDC-CERL, 2015).

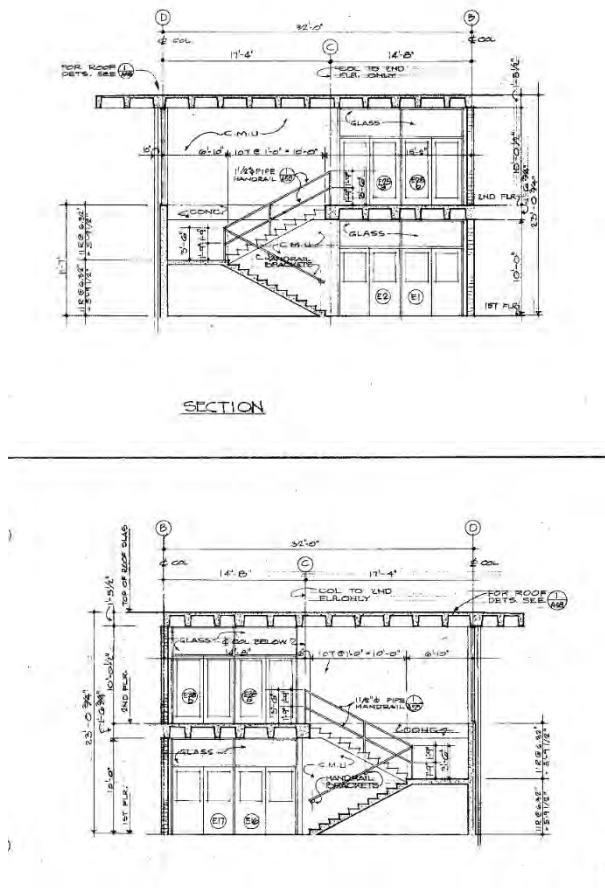
Figure 133. Stairwell plans, elevations, and details, 1964 (Fort Gordon DPW).

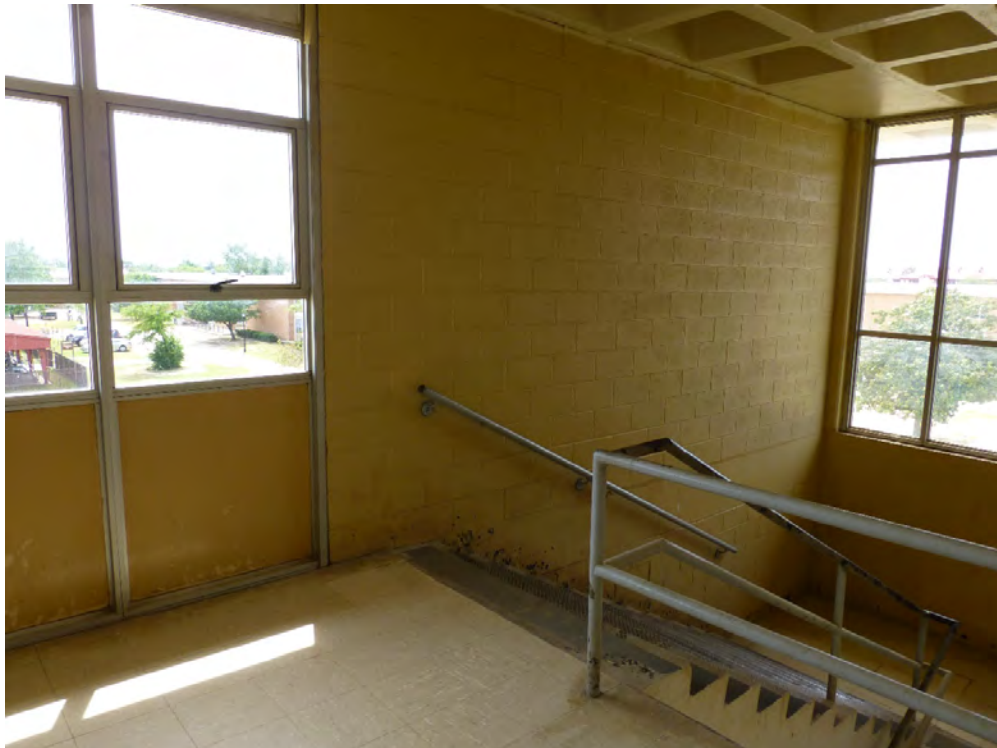
Figure 138. Interior stairwell – comparison of the original design and materials detail drawing from 1964 [left] to the current condition of an interior stairwell [right] (ERDC-CERL, 2015).

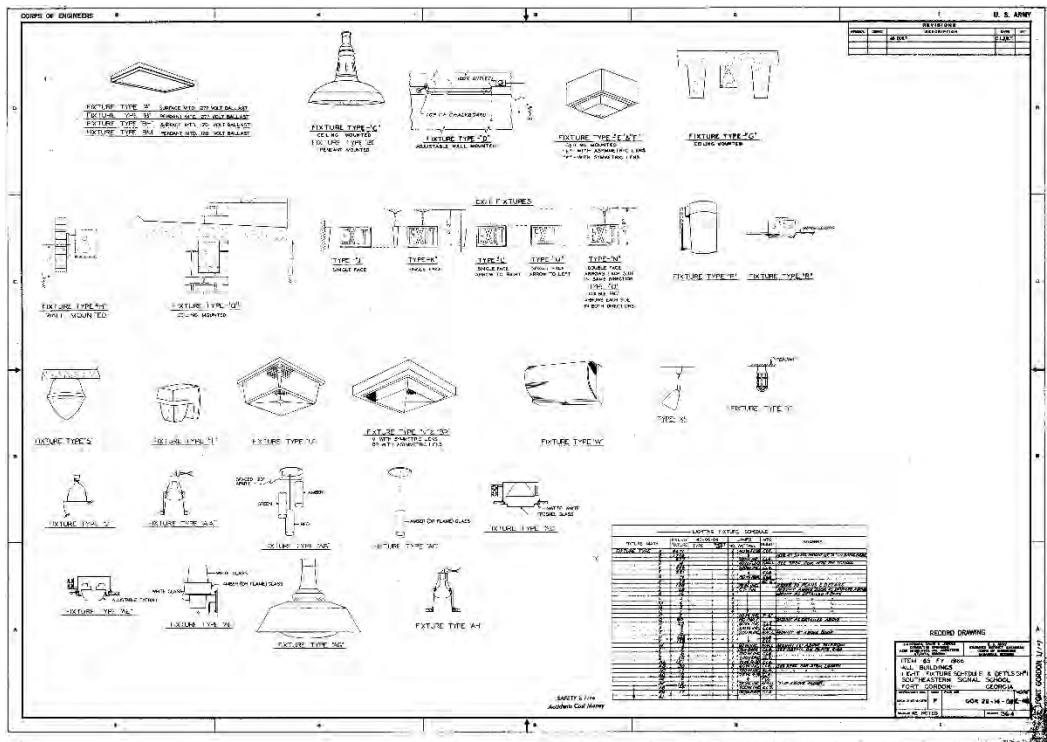
Figure 140. Light-fixture details and schedule for the Signal School buildings, 1964 (Fort Gordon DPW).

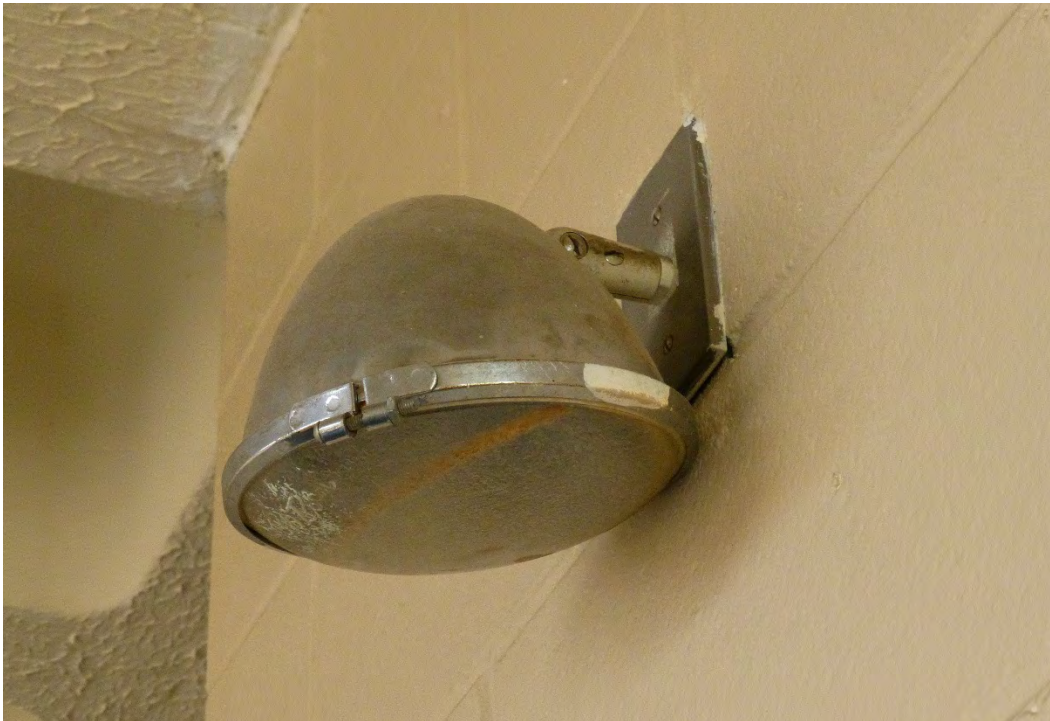
Figure 142. Replacement in-kind, square, ceiling-mounted light fixture set within the waffle ceiling (ERDC-CERL, 2015).

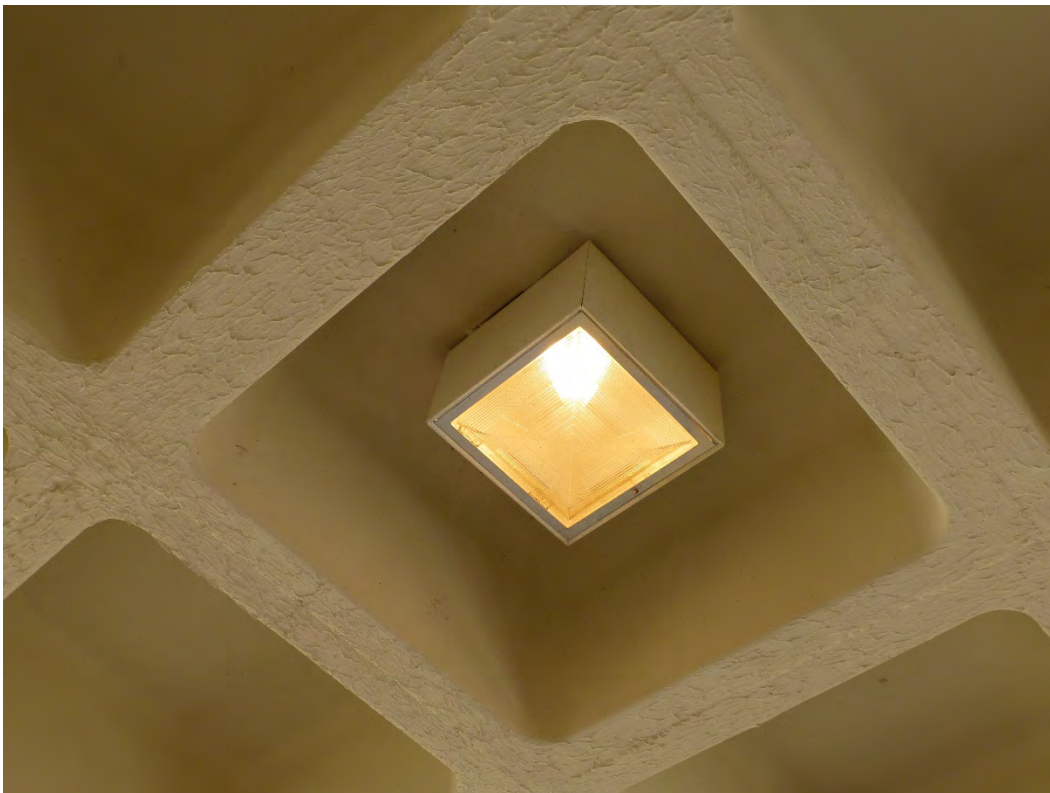
Figure 143. Original, square, ceiling-mounted light fixture set within the waffle ceiling (ERDC-CERL, 2015).

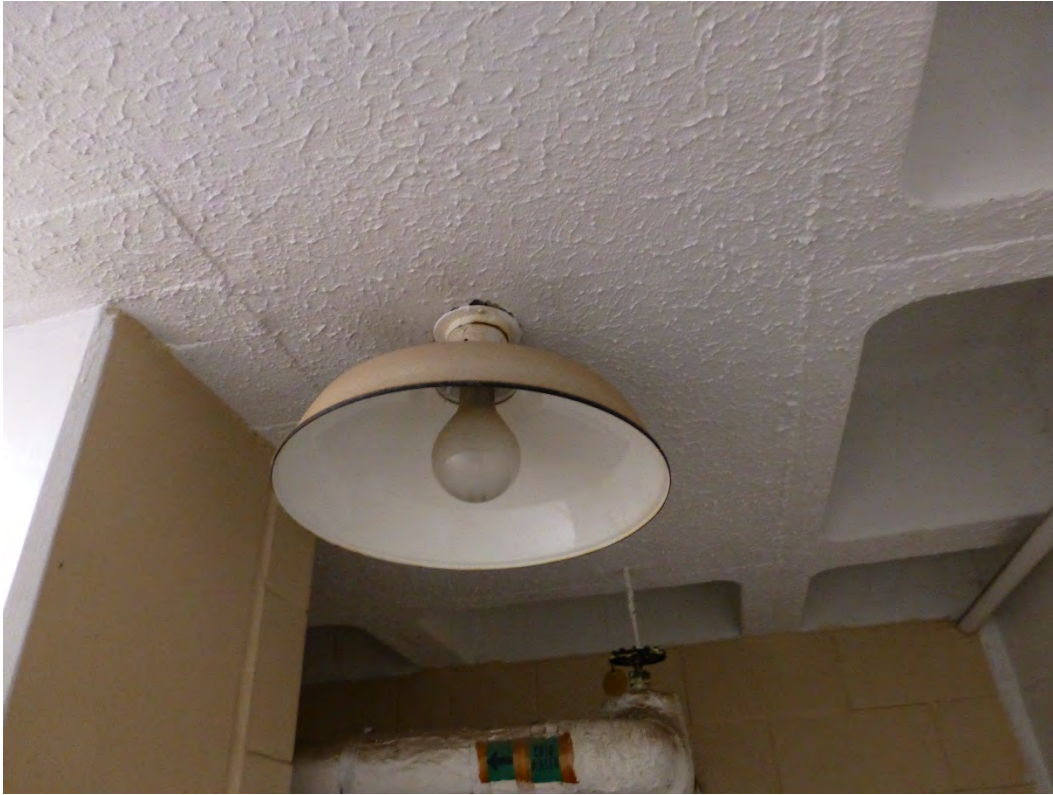
Figure 146. Ceiling-mounted pendant light fixture – comparison of the original design drawing and light fixture type from 1966 [left] to the current condition of the metal ceiling-mounted pendant light fixture [right] (ERDC-CERL, 2015).

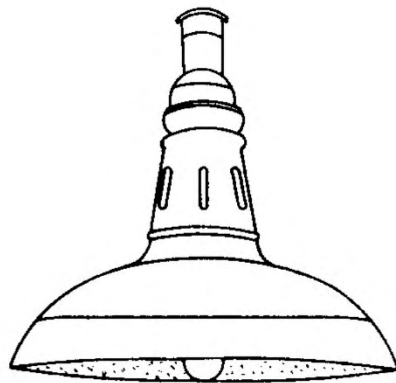
FIXTURE TYPE-"C"
CEILING MOUNTED
FIXTURE TYPE "BL"
PENDANT MOUNTED

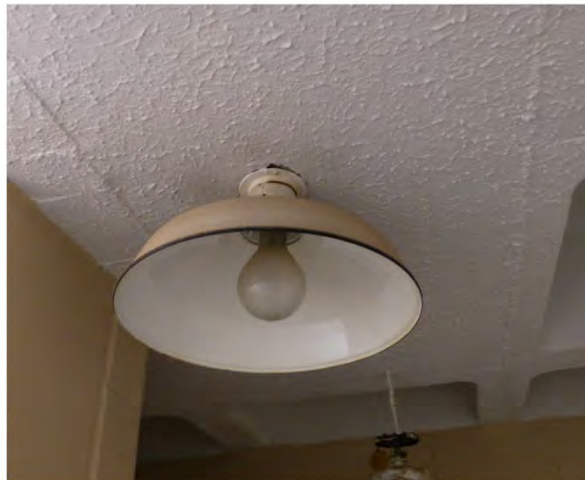
Figure 147. Ceiling-mounted light fixture set within the waffle ceiling – comparison of the original design drawing and light fixture type from 1966 [left] to the current condition of the metal ceiling-mounted light fixture [right] (ERDC-CERL, 2015).

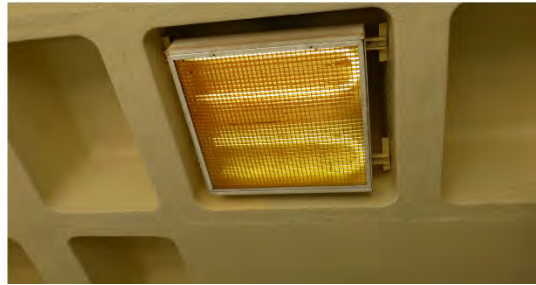
Figure 148. Ceiling-mounted pendant light fixture – comparison of the original design drawing and light fixture type from 1966 [left] to the current condition of the replacement ceiling-mounted light fixture [right] (ERDC-CERL, 2015).

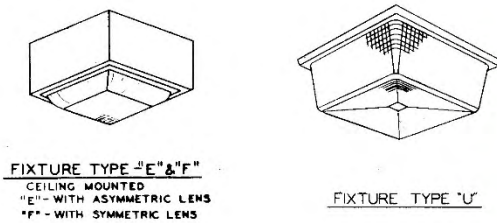
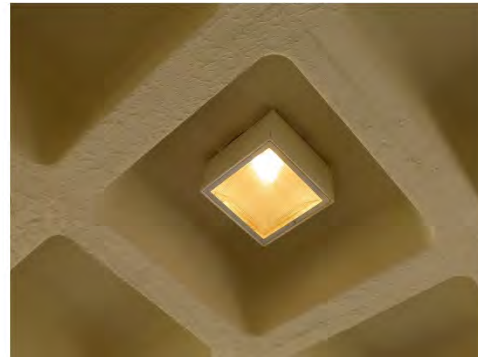
Figure 149. Wall-mounted pendant light fixture – comparison of the original design drawing and light fixture type from 1966 [left] to the current condition of the wall-mounted light fixture [right] (ERDC-CERL, 2015).

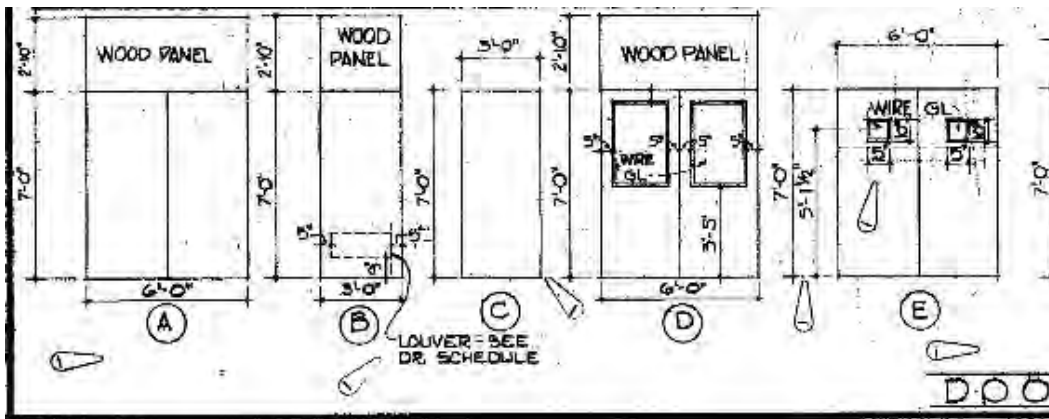
Figure 151. Typical metal security doors with one small pane, leading from the stairwell into the central hall (ERDC-CERL, 2015).
