**US Army Corps
of Engineers®**
Engineer Research and
Development Center

ERDC
INNOVATIVE SOLUTIONS
for a safer, better world

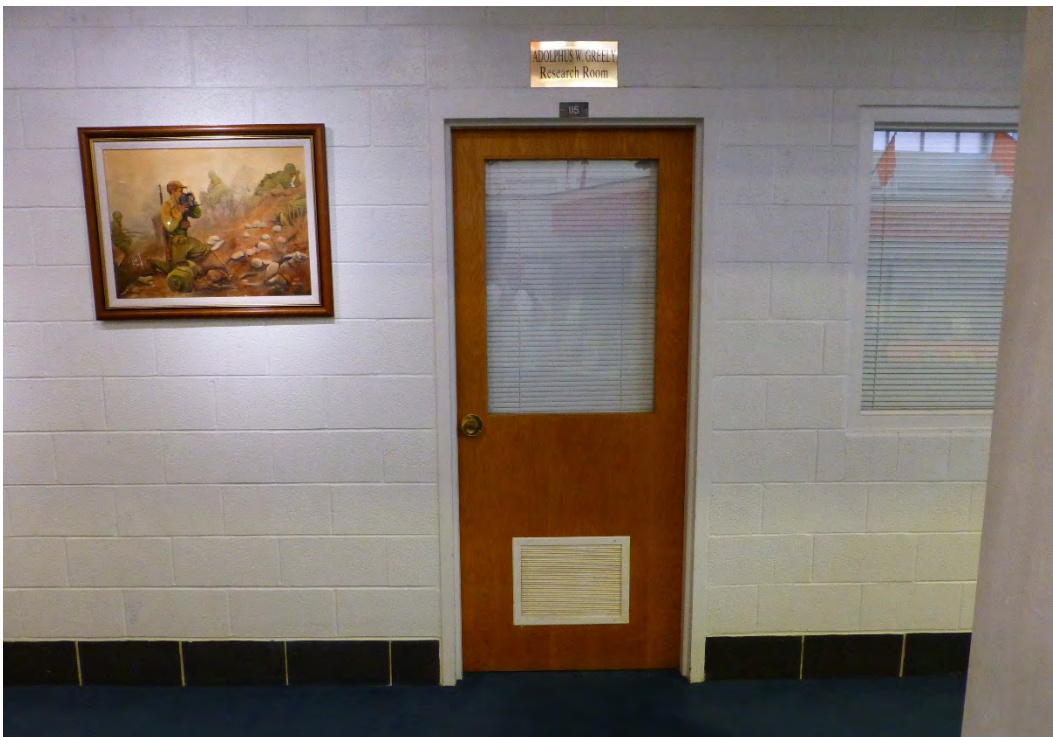
Figure 156. Typical metal door with small pane – comparison of the original design drawing from 1964 [left] to the current condition of the metal doors [right] (ERDC-CERL, 2015).

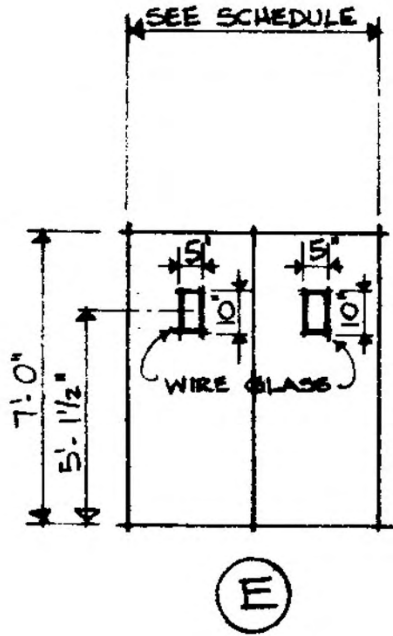
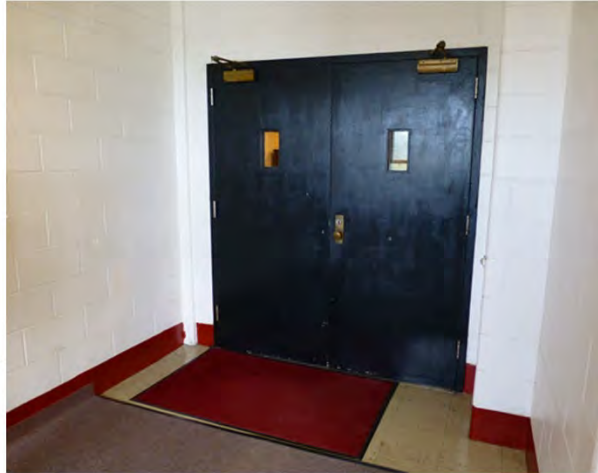
Figure 157. Typical wood door with large pane and wood transom – comparison of the original design drawing from 1964 [left] to the current condition of the wood doors and transom [right] (ERDC-CERL, 2015).

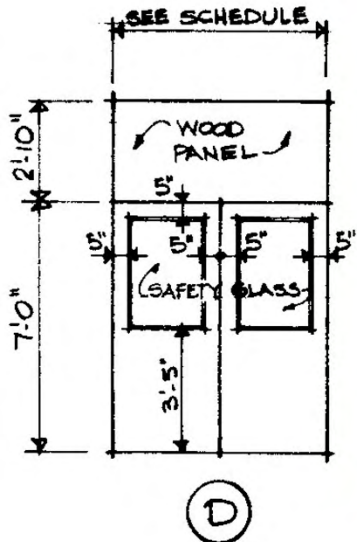
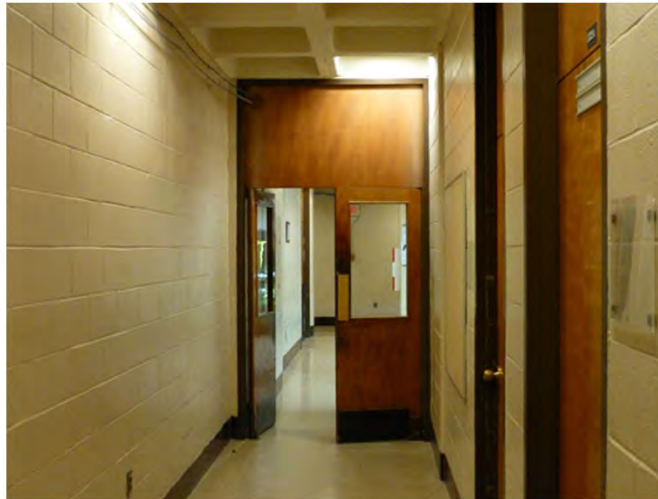
3.2.7 Bright-aluminum display cases

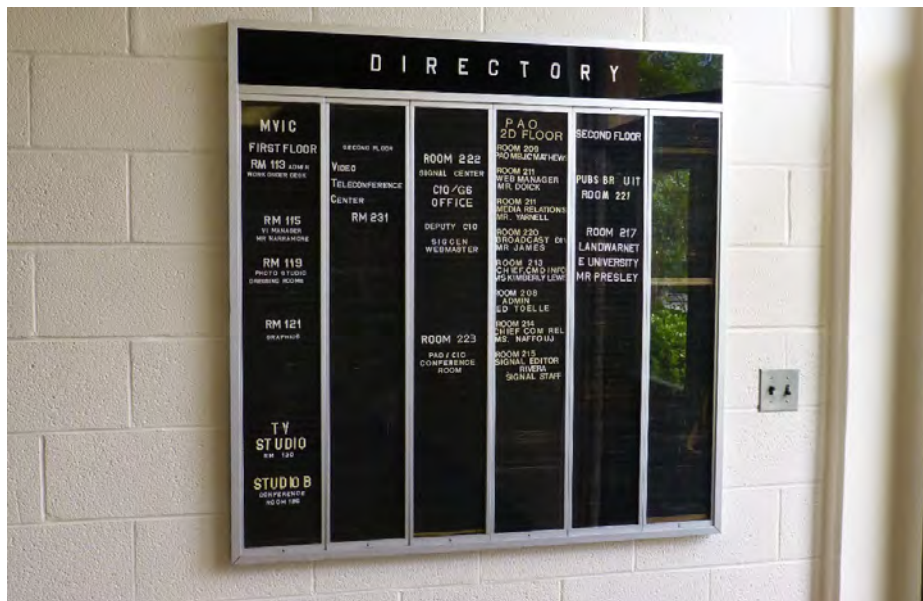
3.2.8 Telephone alcove

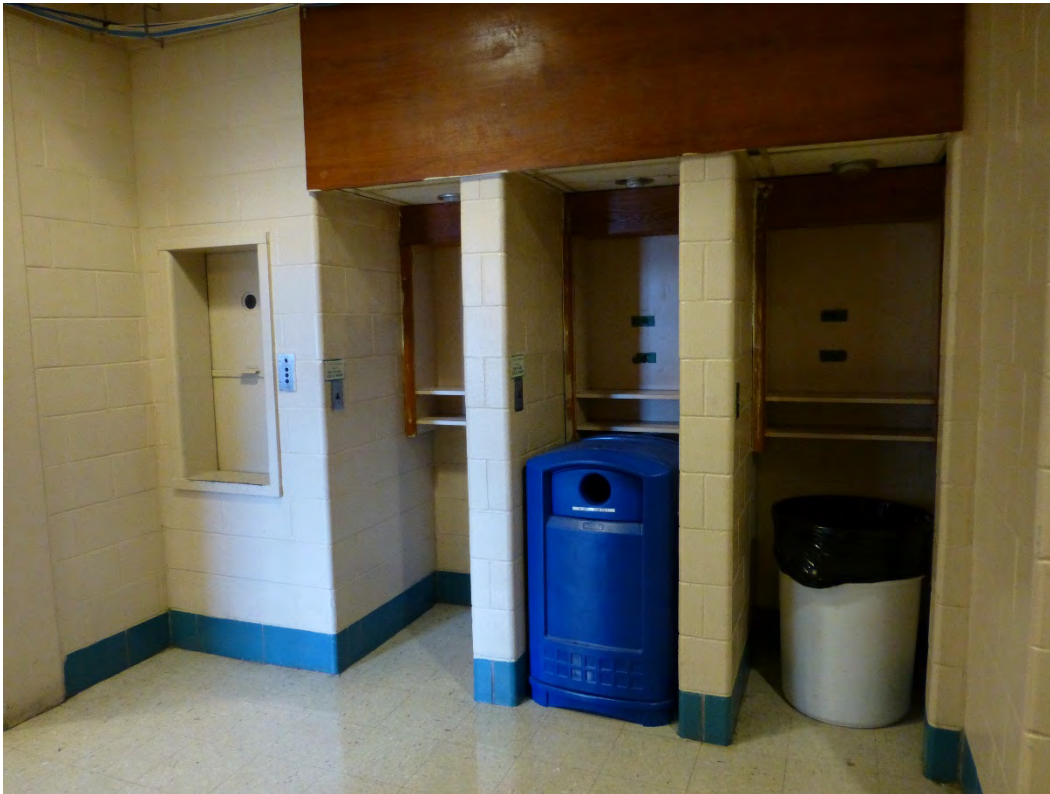
Figure 161. Telephone alcove – comparison of the original drawing from 1964 [left] to the current condition of the alcove [right] (ERDC-CERL, 2015).

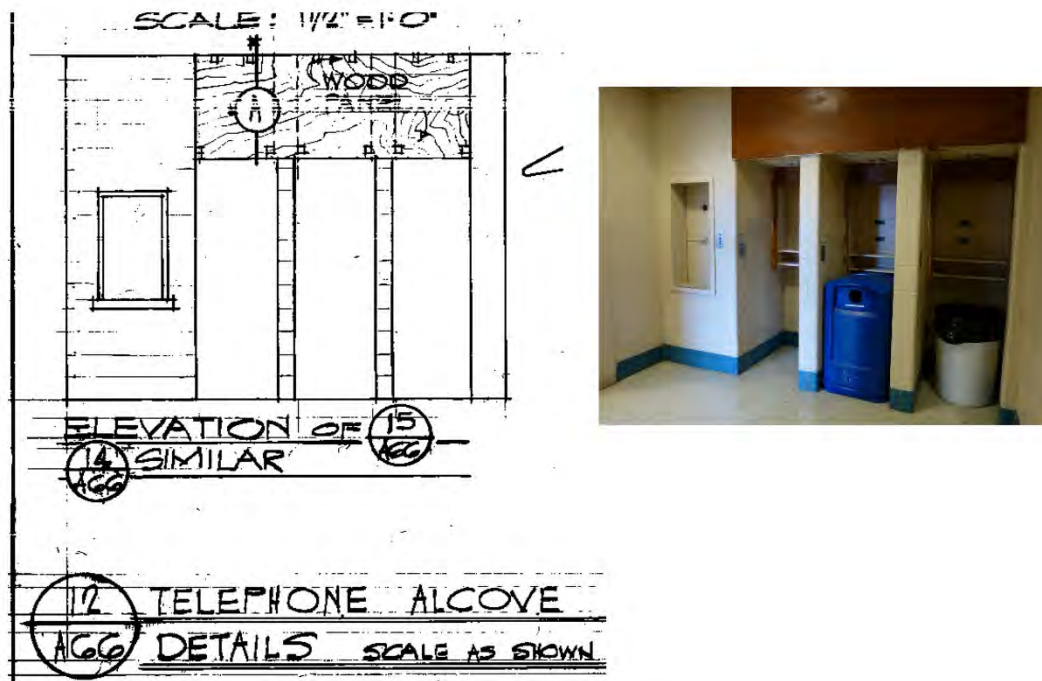
3.2.1 Vending alcove

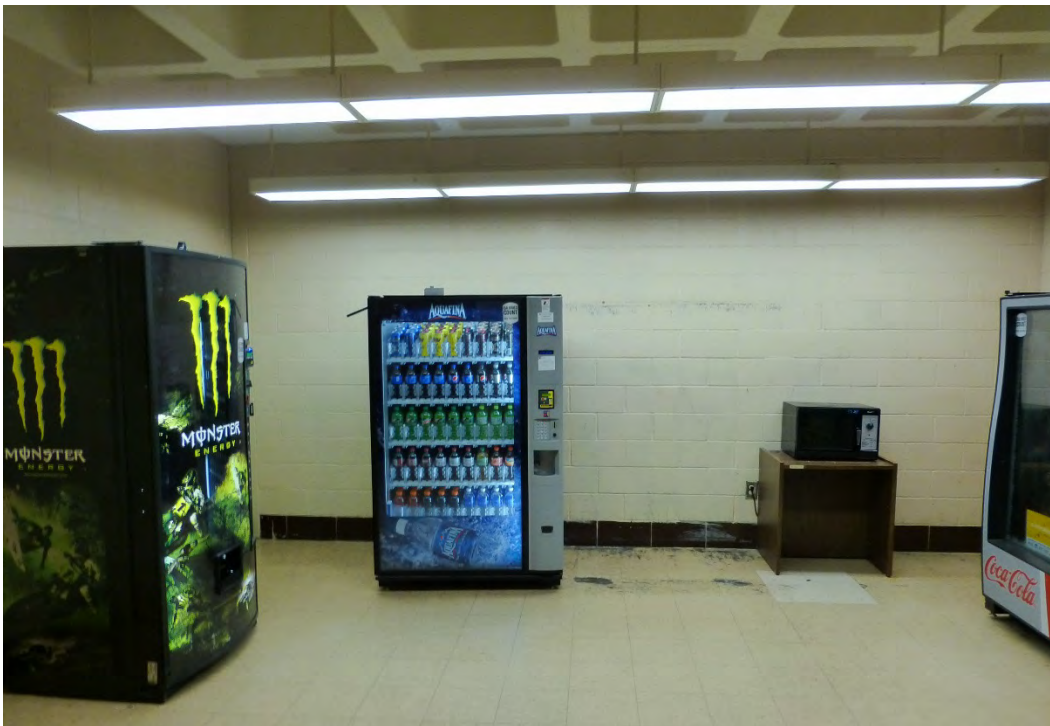
Figure 163. Example of a modified open vending area (ERDC-CERL, 2015).

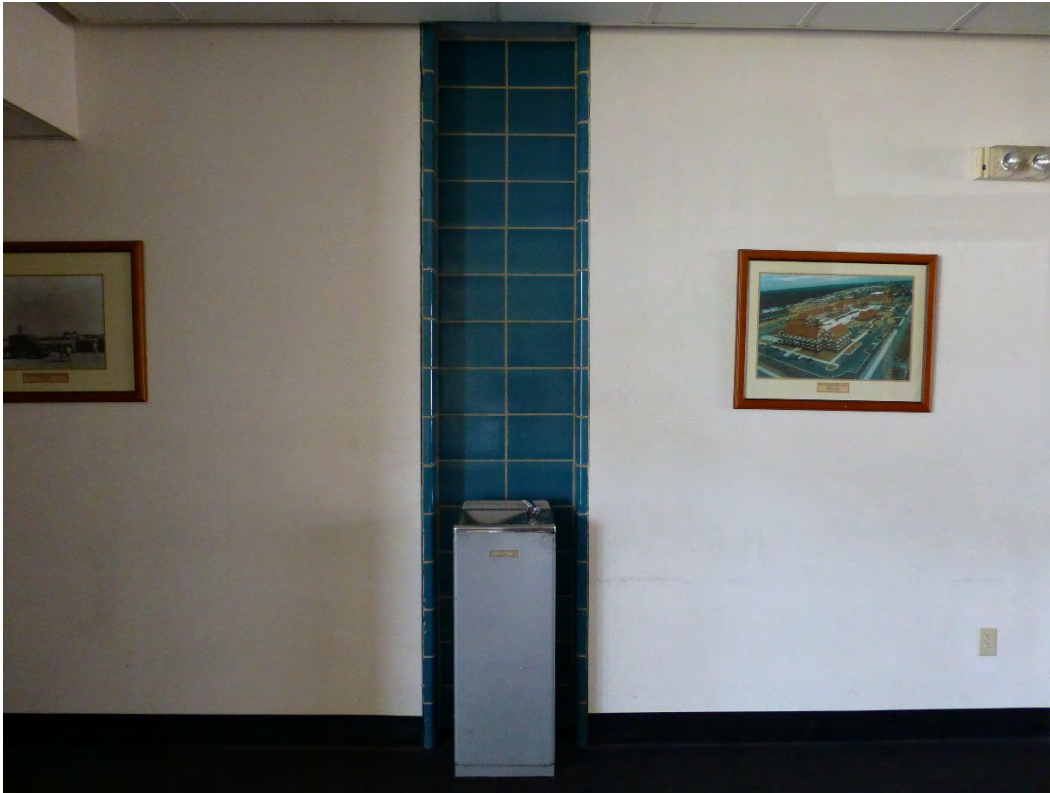
Figure 165. Typical water fountain alcove found in the Signal School classroom buildings (ERDC-CERL, 2015).

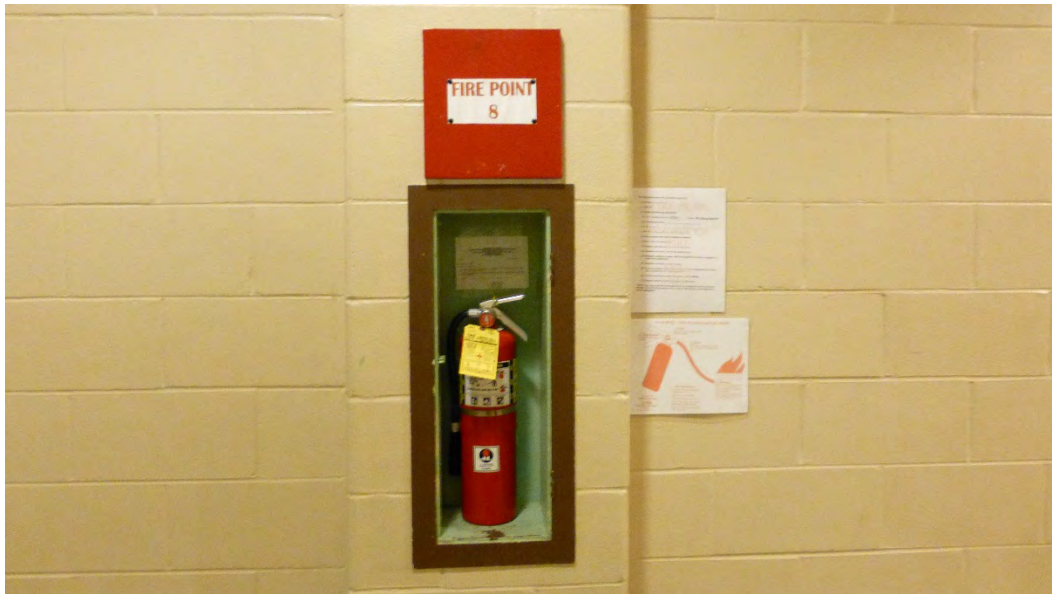
Figure 169. Fire hydrant display case, comparison of the original drawing from 1964 [left] to the current condition of the display case [right] (ERDC-CERL, 2015).

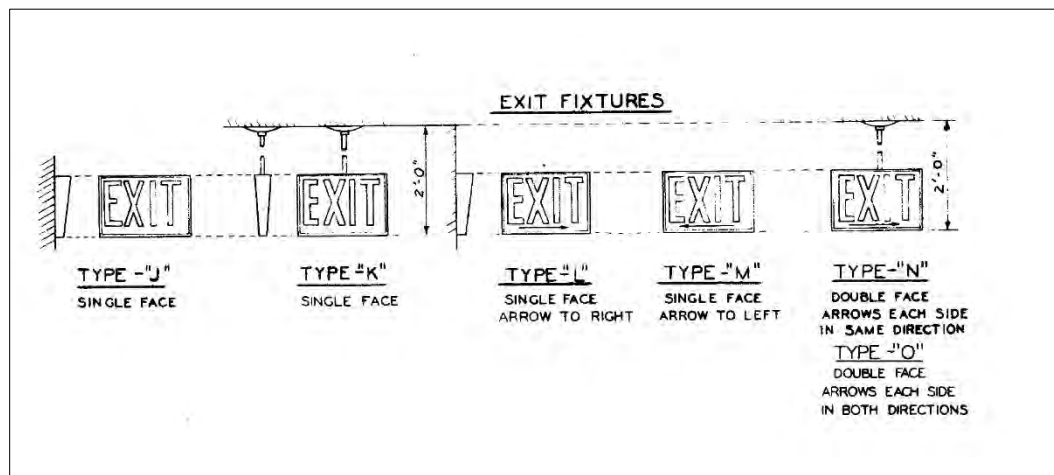
Figure 171. Example of specialty signs located in some of the Signal School buildings, 1966 (Fort Gordon DPW).

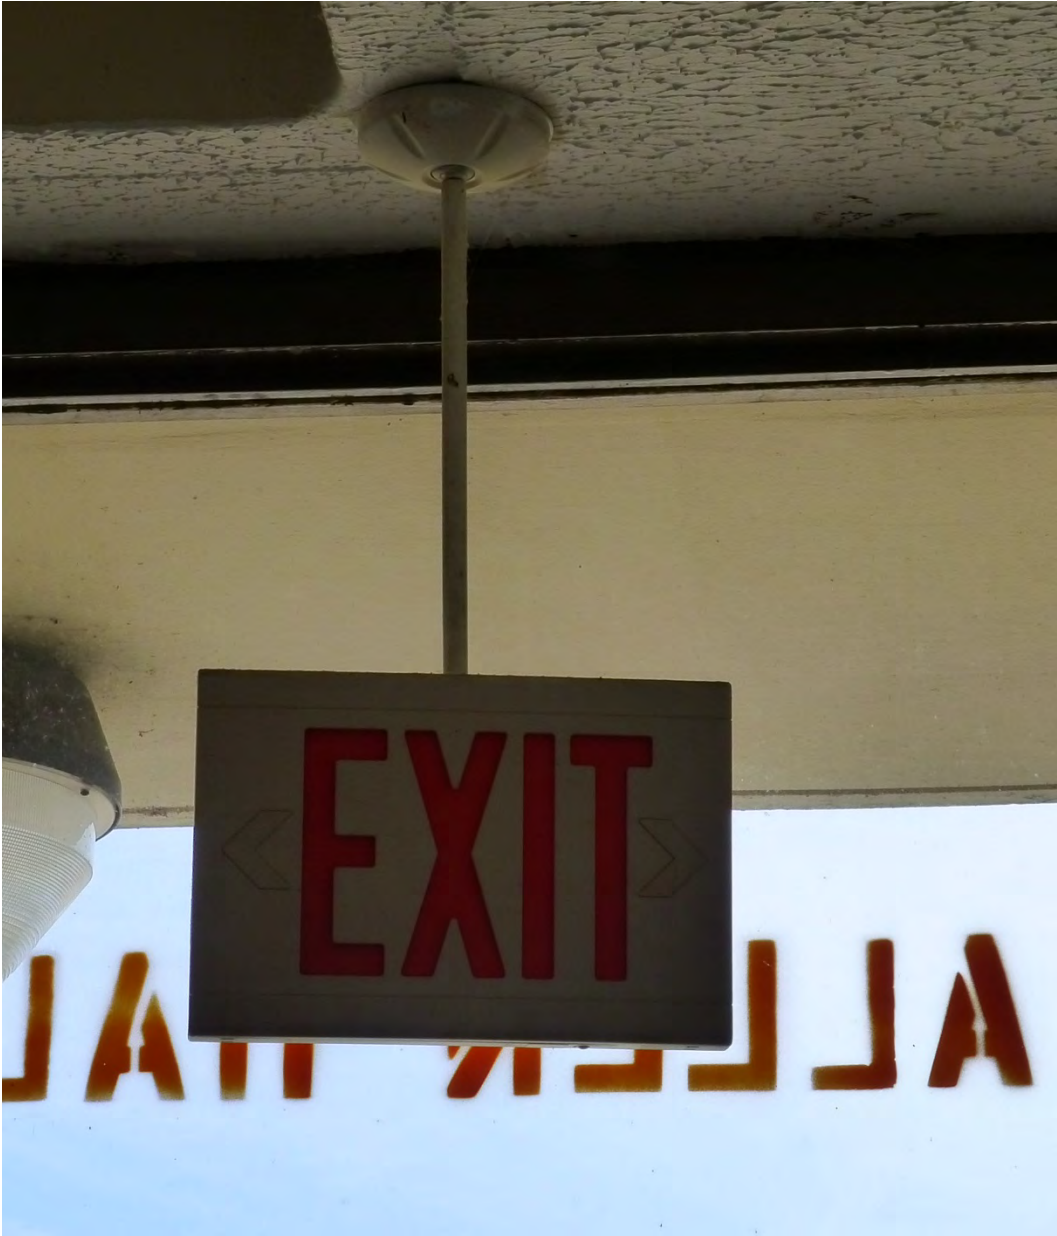
Figure 173. Class in session sign – comparison of the original drawing [left] to the current condition of the sign located in the Signal School classroom buildings [right] (ERDC-CERL, 2015).

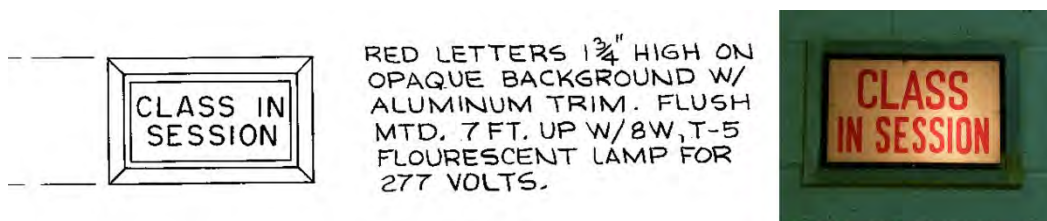
FIXTURE TYPE "SP"
WALL MOUNTED

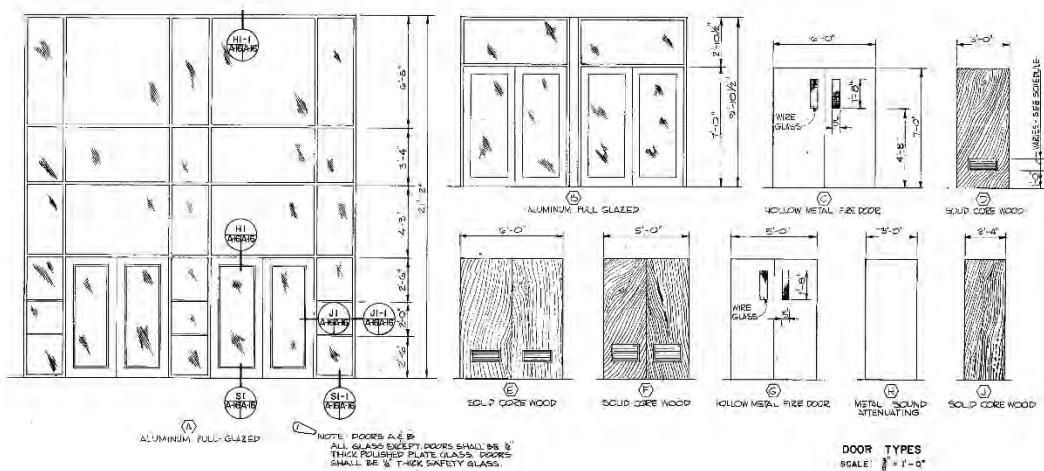
3.3.1.1 Character-defining features

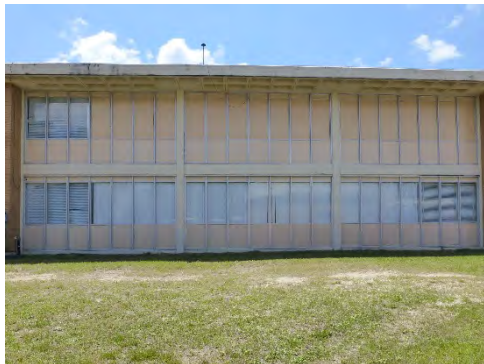
Groups of windows; bright-aluminum frame with fixed panes and insulated panels divided by concrete columns and beam. *Note: the removal of the second-floor windows replaced with new panel inserts.

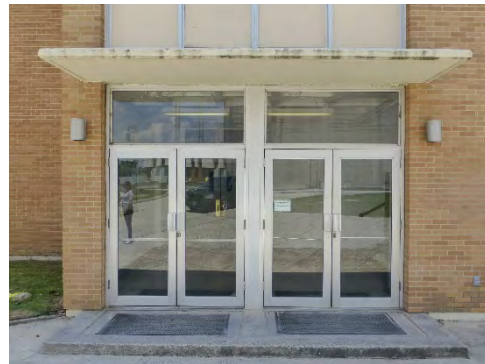
Bright-aluminum and plate-glass doors with transoms protected by a flat concrete canopy.

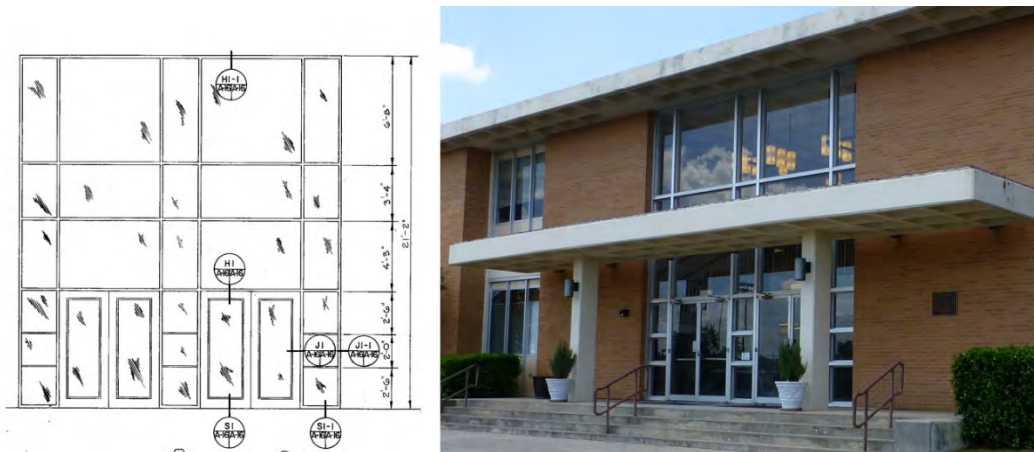
Figure 186. Paired entry doors with concrete canopy – comparison of the original drawing detail from 1973 [left] to the current condition of the bright-aluminum and plate-glass doors [right] (ERDC-CERL, 2015).

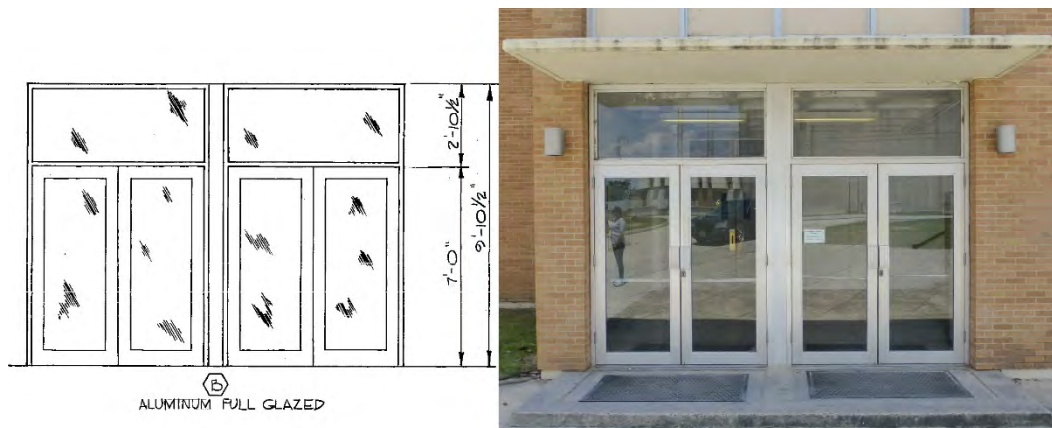
Figure 187. Large group of windows and panel inserts on the northwest elevation of the north wing – comparison of the original drawing detail from 1973 [left] to the current condition of the bright-aluminum fixed windows and panel inserts on the first floor and the modified window openings with newer panel inserts [right] (ERDC-CERL, 2015).

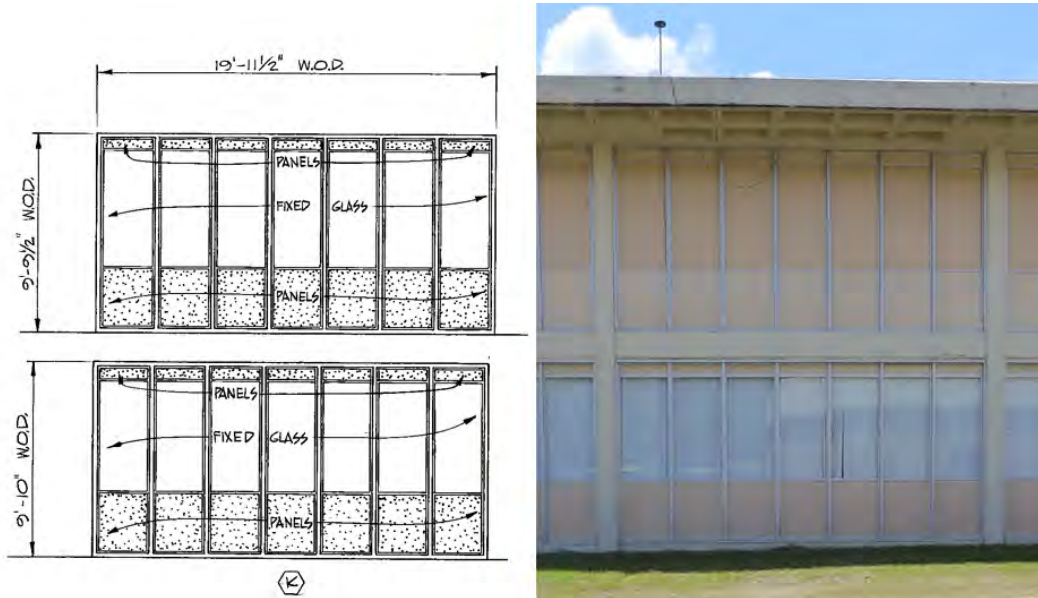
Figure 188. Second-floor windows - Comparison of the original drawing detail from 1973 [left] to the current condition of the bright-aluminum fixed windows and panel inserts on the second floor [right] (ERDC-CERL, 2015).

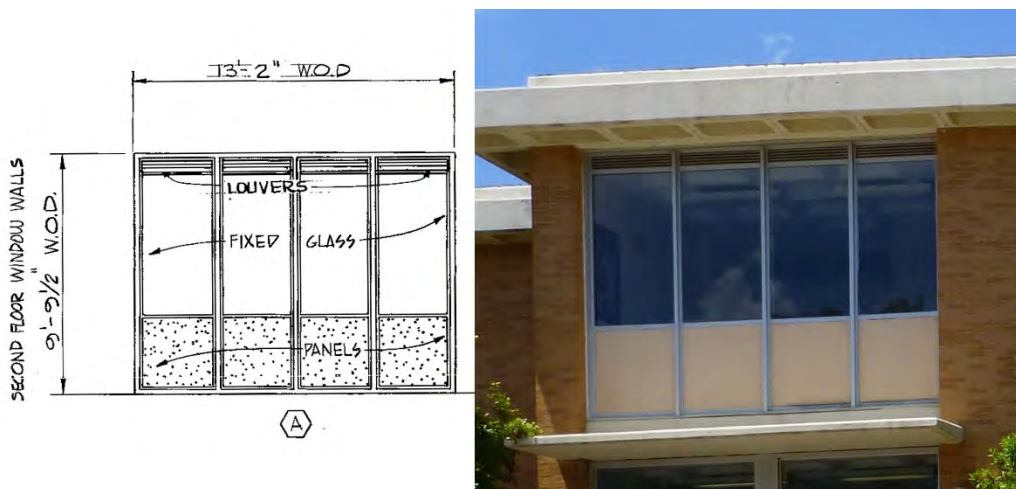
Figure 189. Wall mounted exterior light fixture type "H" - comparison of the original drawing detail from 1966 [left] to the current condition of the light fixture [right] (ERDC-CERL, 2015).

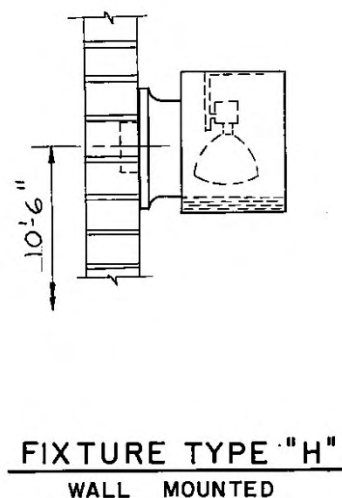
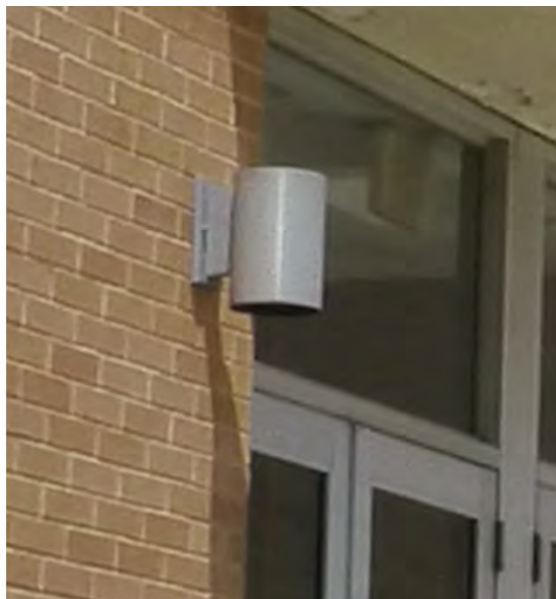
3.3.2 Building 29801, Nelson Hall (1969)

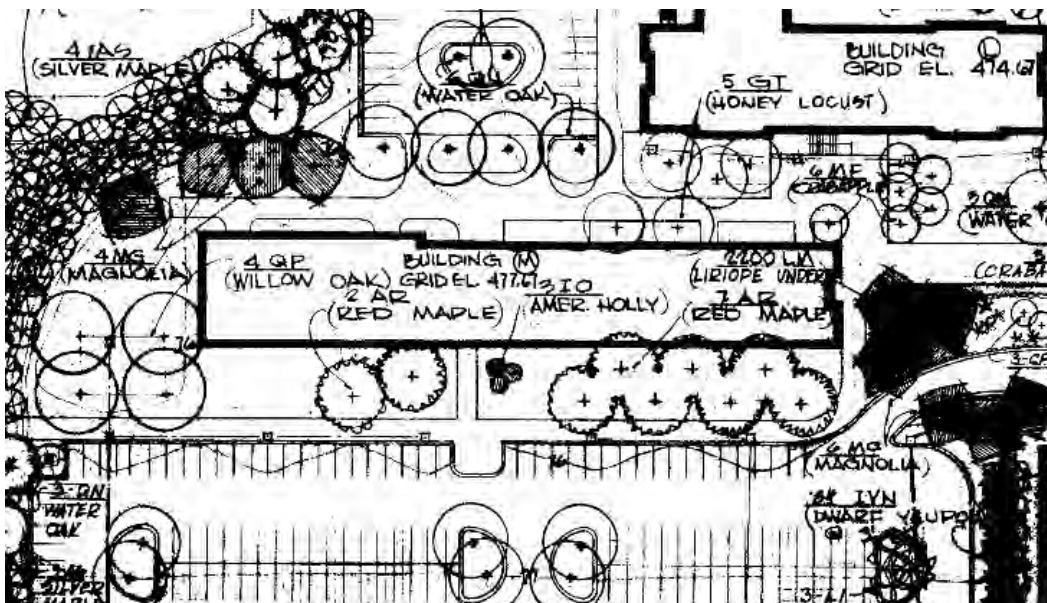
3.3.2.1 Character-defining features

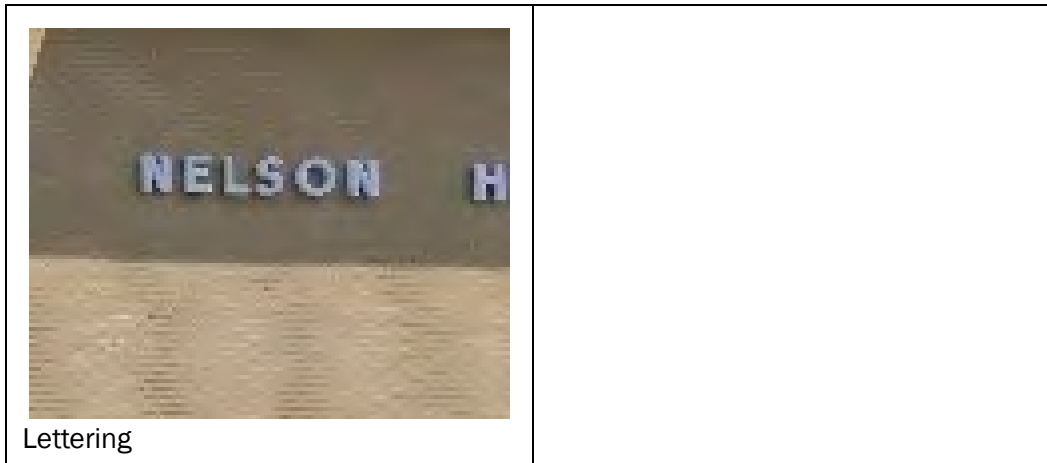
3.3.2.2 Character-defining features that have been removed

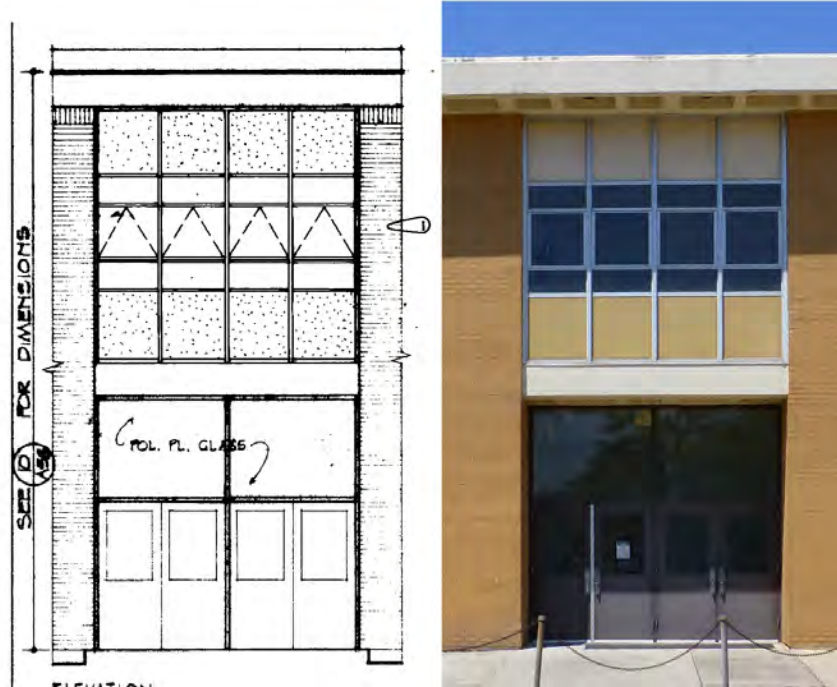
Figure 200. Northeast window/door bay - comparison of the original drawing detail from 1966 [left] to the current condition of concrete panels, metal and glass doors with transom above on the first floor and the bright-aluminum awning windows with panel inserts on the second floor [right] (ERDC-CERL, 2015).

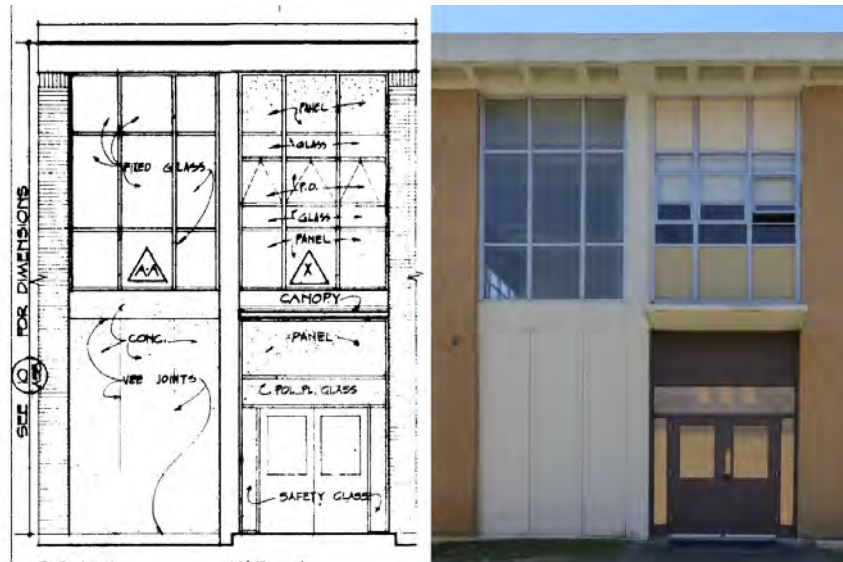
Figure 201. South elevation window bay - comparison of the original drawing detail from 1966 [left] to the current condition of the bright-aluminum awning windows with panel inserts separated by the concrete structure [right] (ERDC-CERL, 2015).

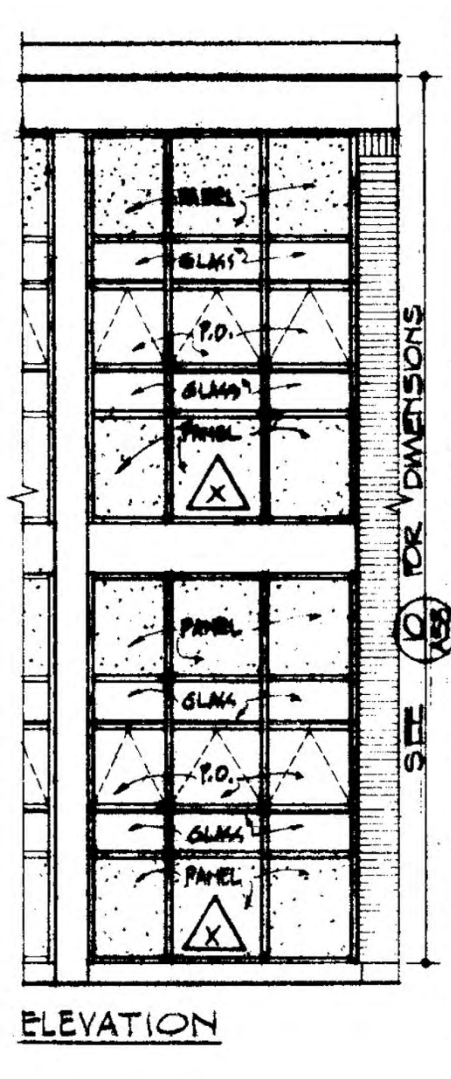
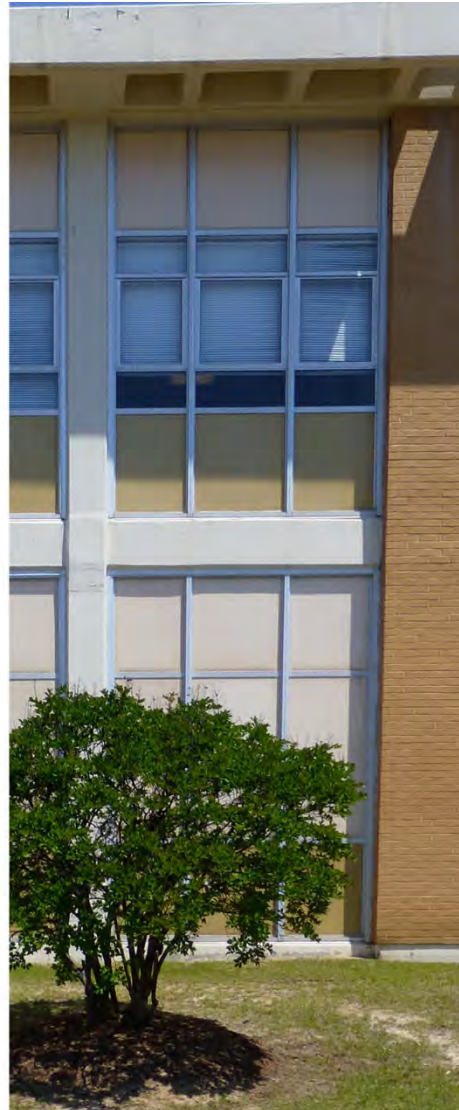
Figure 202. Ceiling mounted light fixture set within the waffle overhang - comparison of the original drawing detail, no date [left] to the current condition of the light fixture [right] (ERDC-CERL, 2015).

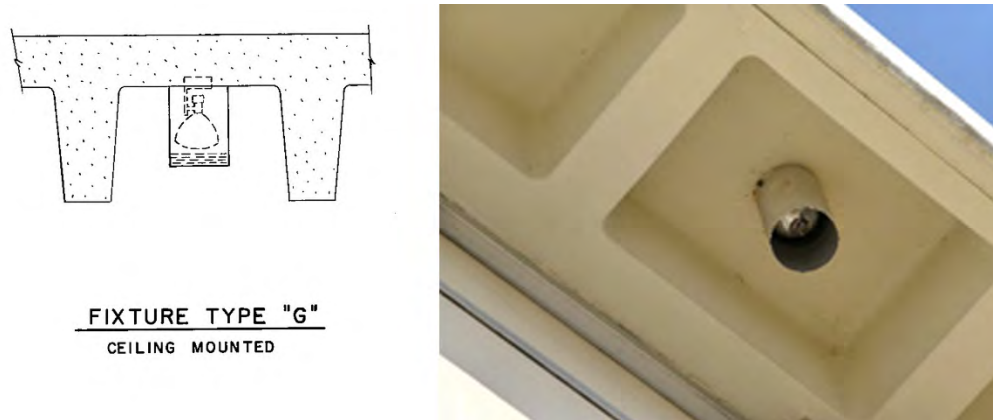
Figure 203. Ceiling mounted light fixture under the concrete canopy - Comparison of the original drawing detail, from 1966 [left] to the current condition of the light fixtures [right] (ERDC-CERL, 2015).

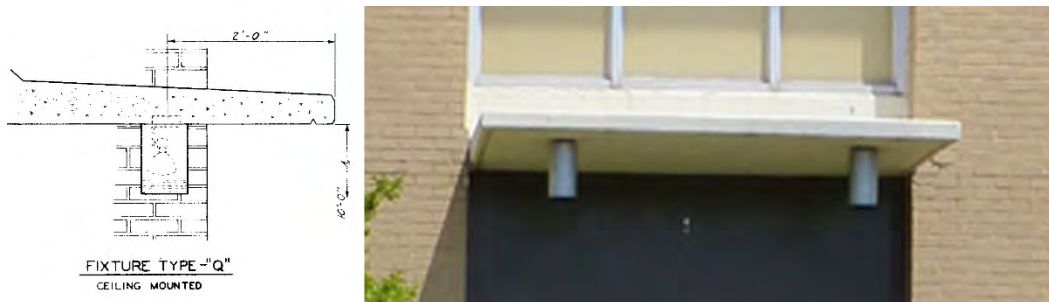
3.3.3 Building 29802, Moran Hall [south] (1973)

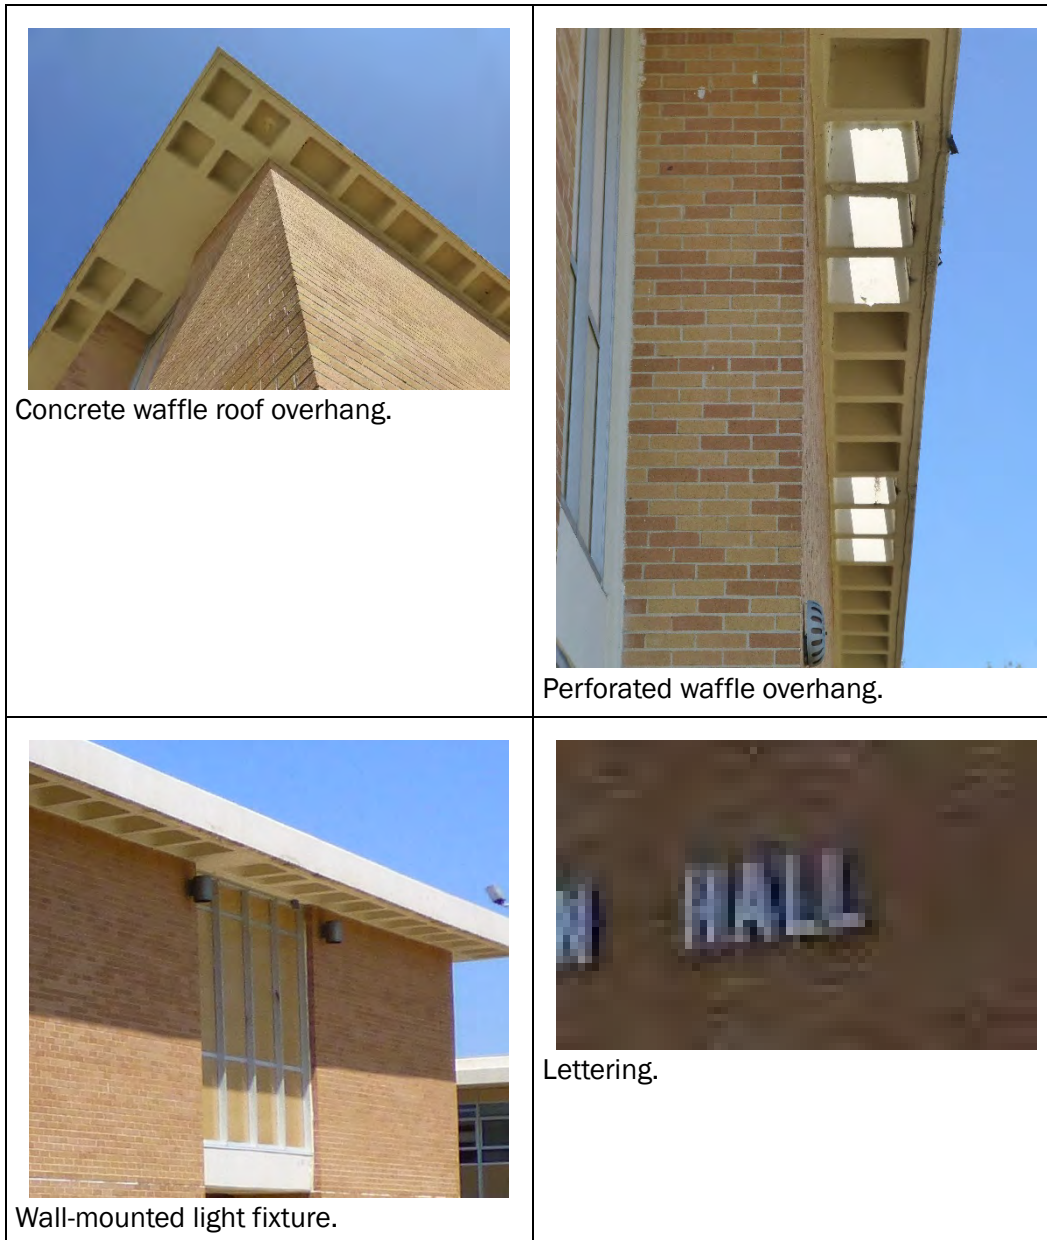
3.3.3.2 Character-defining features that have been removed

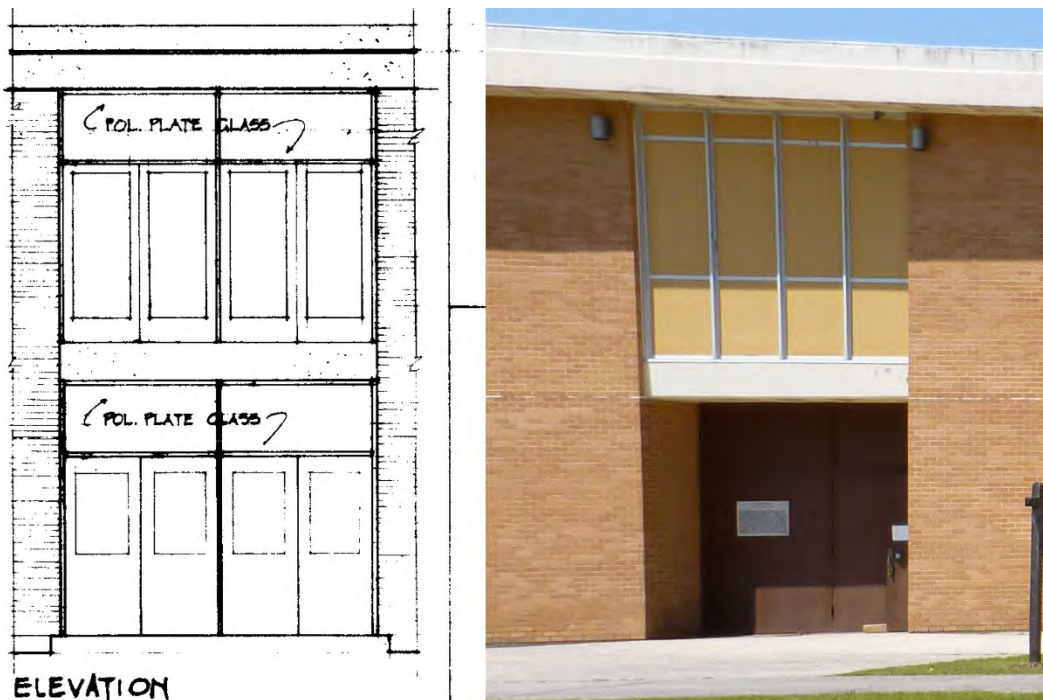
Figure 212. Wall-mounted light fixtures - comparison of the original drawing detail from 1966 [left] to the current condition of the wall-mounted light fixtures on the east and west elevations [right] (ERDC-CERL, 2015).

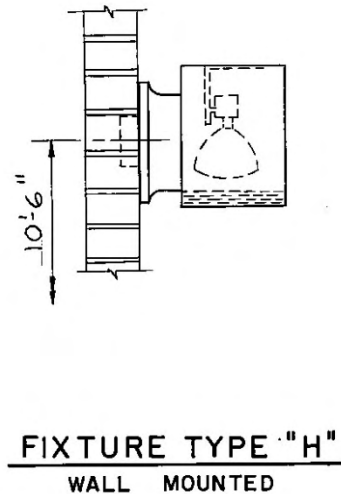
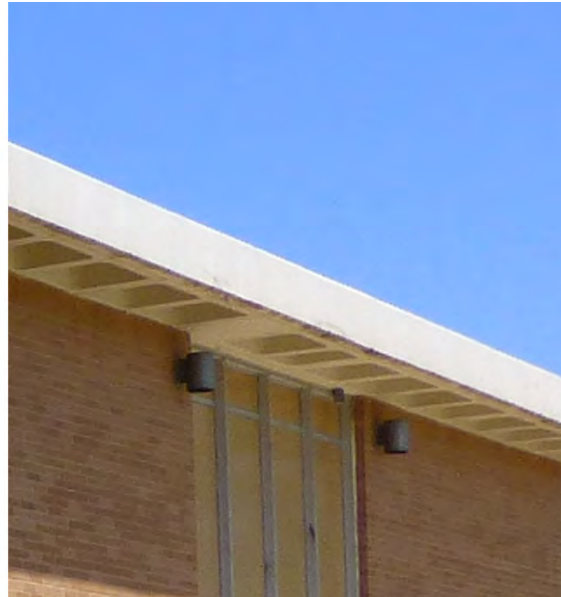
3.3.4 Building 29803, Moran Hall north (1973)

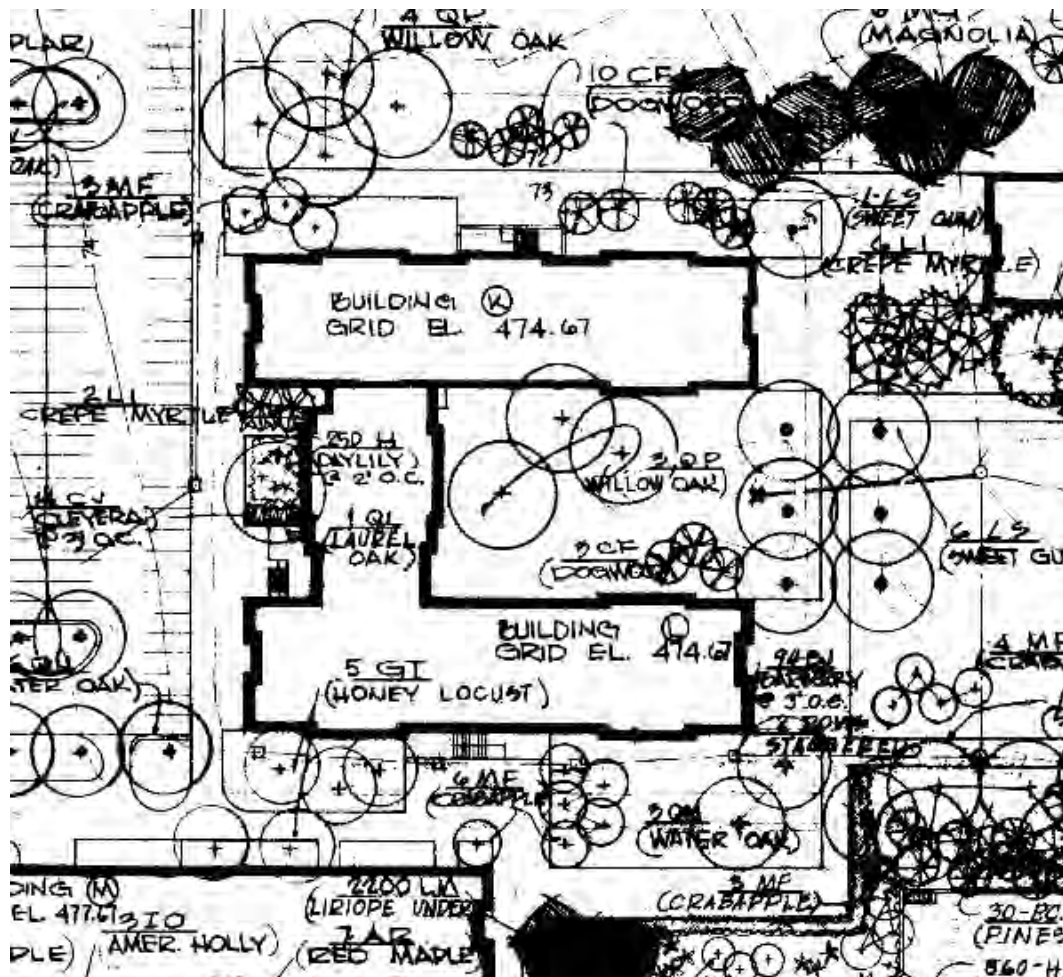
3.3.4.1 Character-defining features

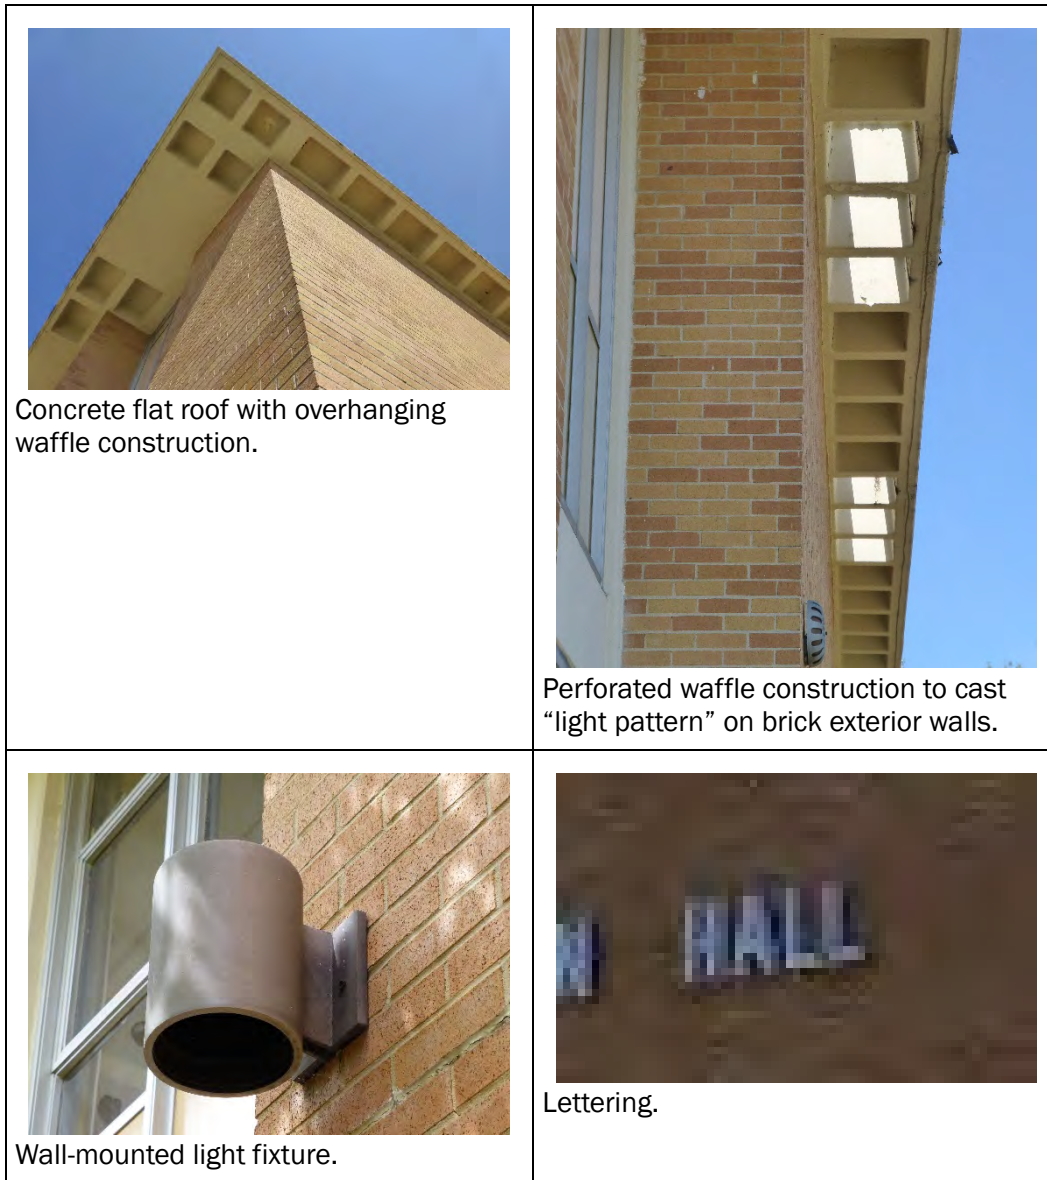
3.3.4.2 Character-defining features that have been removed

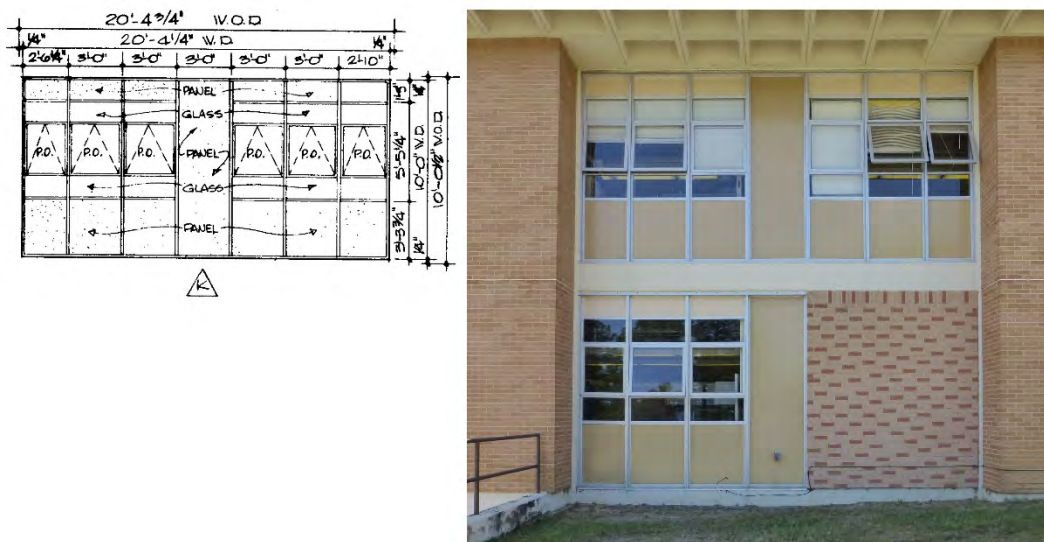
Figure 221. Window bay - comparison of the original drawing detail from 1966 [left] to the current condition of the bright-aluminum awning windows and panel inserts [right] (ERDC-CERL, 2015).

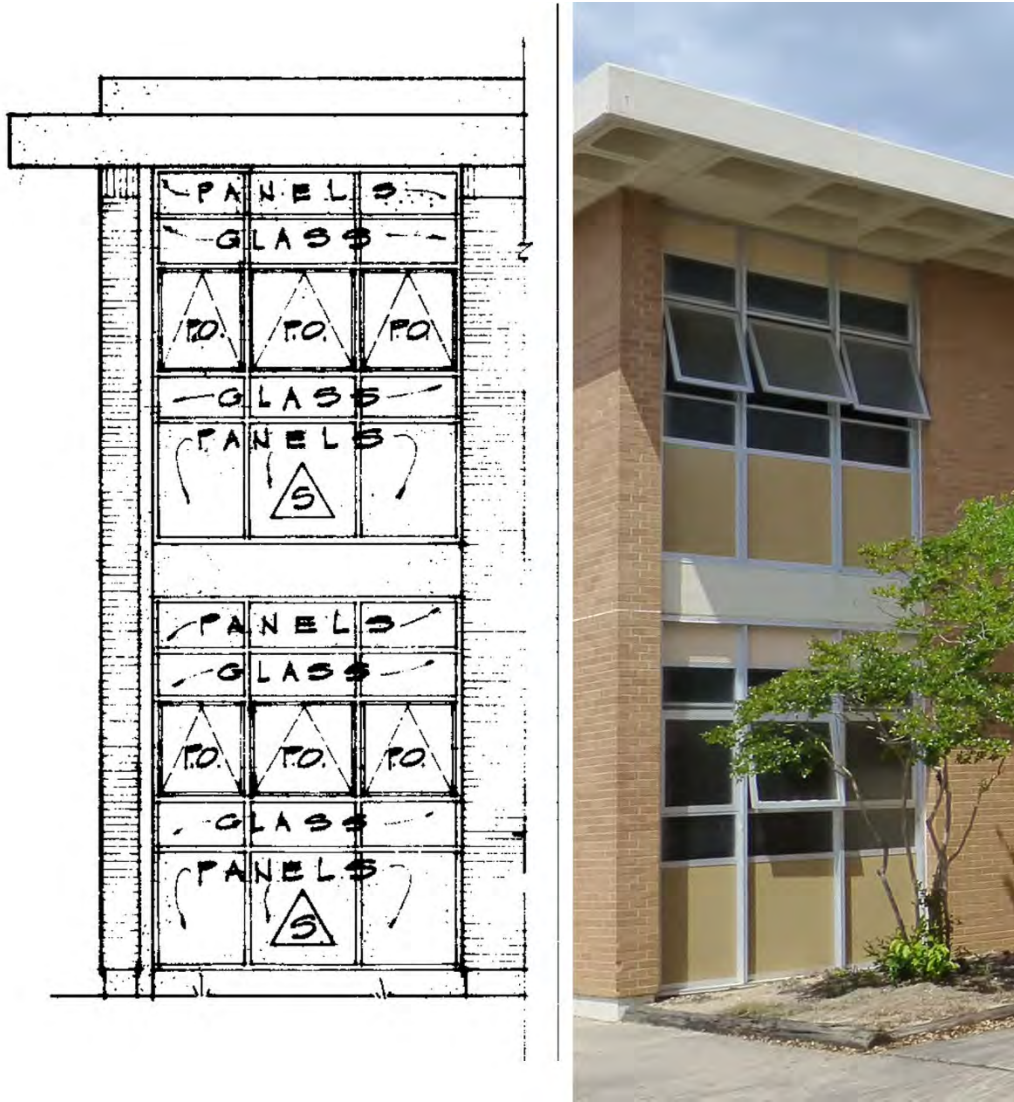
Figure 222. Window bay - comparison of the original drawing detail from 1966 [left] to the current condition of the replacement bright-aluminum windows [right] (ERDC-CERL, 2015).
