**US Army Corps
of Engineers®**
Engineer Research and
Development Center

ERDC
INNOVATIVE SOLUTIONS
for a safer, better world

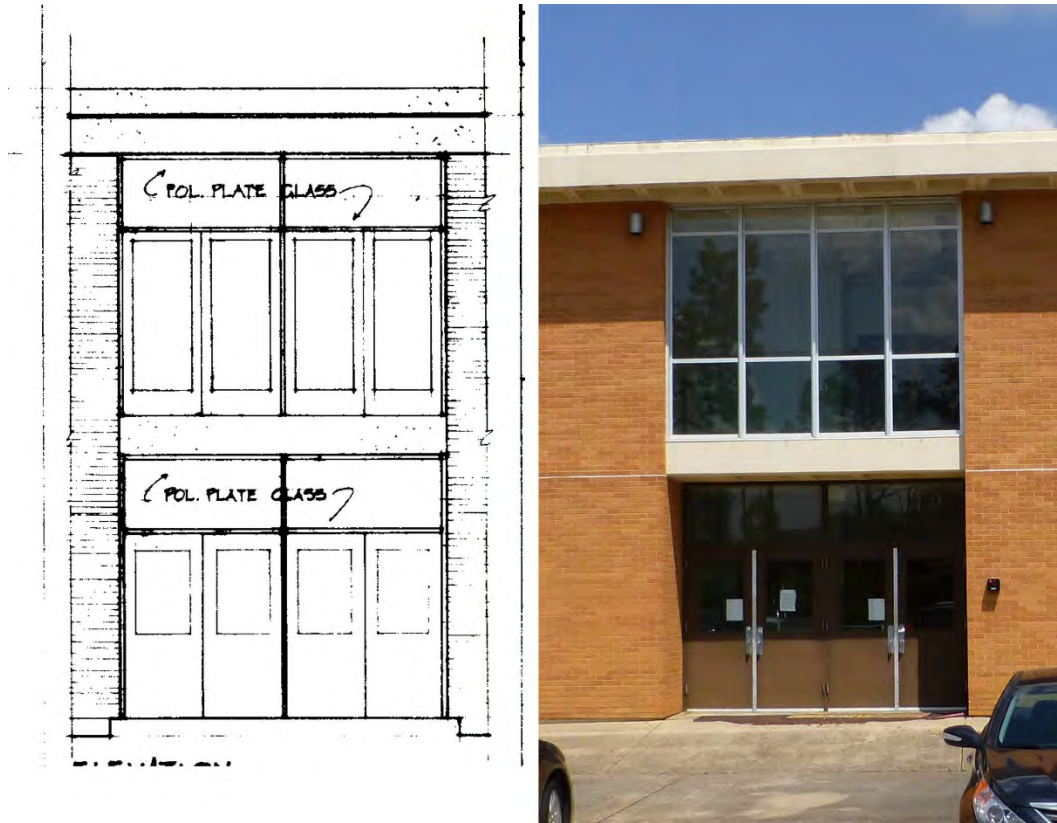
Figure 223. Wall-mounted light fixture – comparison of the original drawing detail from 1966 [left] to the current condition of the wall-mounted light fixtures located on the east and west elevations [right] (ERDC-CERL, 2015).

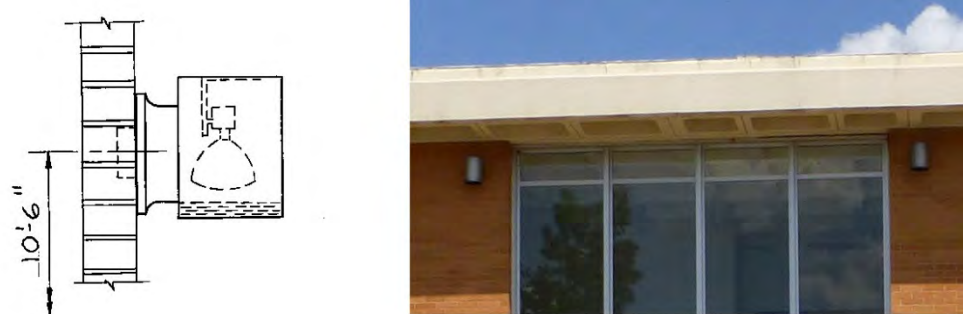
FIXTURE TYPE "H"
WALL MOUNTED

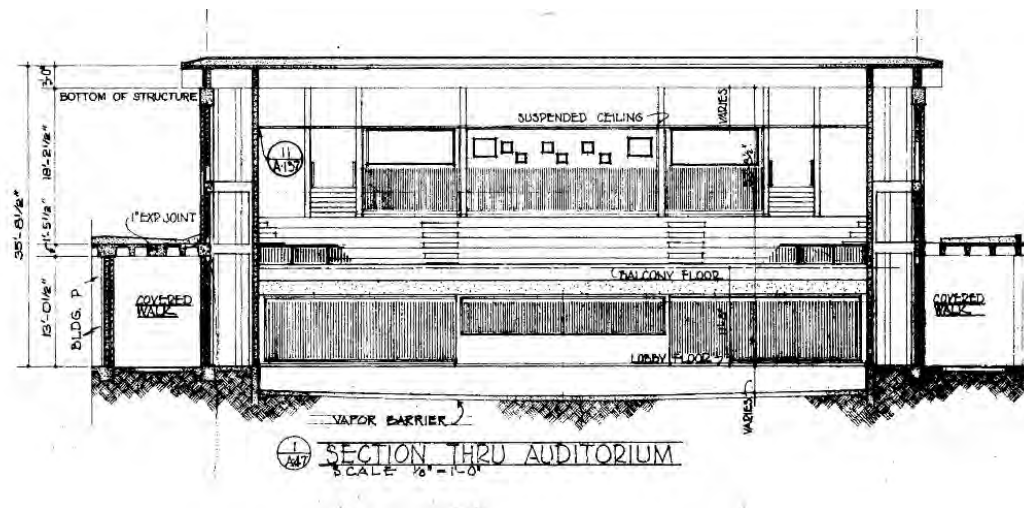
3.3.5.1 Character-defining features

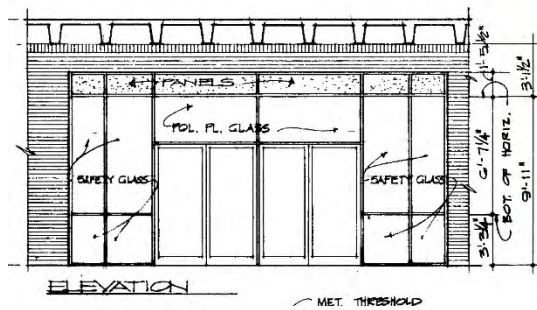
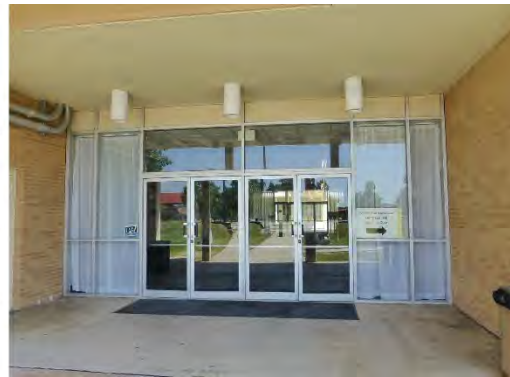
Figure 243. Ceiling-mounted light fixture – Comparison of the original drawing detail from 1966 [left] to the current condition of the ceiling-mounted light fixture under the concrete waffle canopy [right] (ERDC-CERL, 2015).

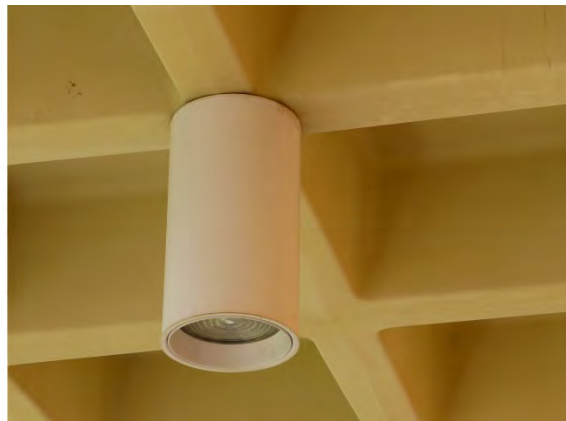
Figure 244. Interior auditorium doors - Comparison of the original drawing detail from 1966 [left] to the current condition of the acoustical doors [right] (ERDC-CERL, 2015).

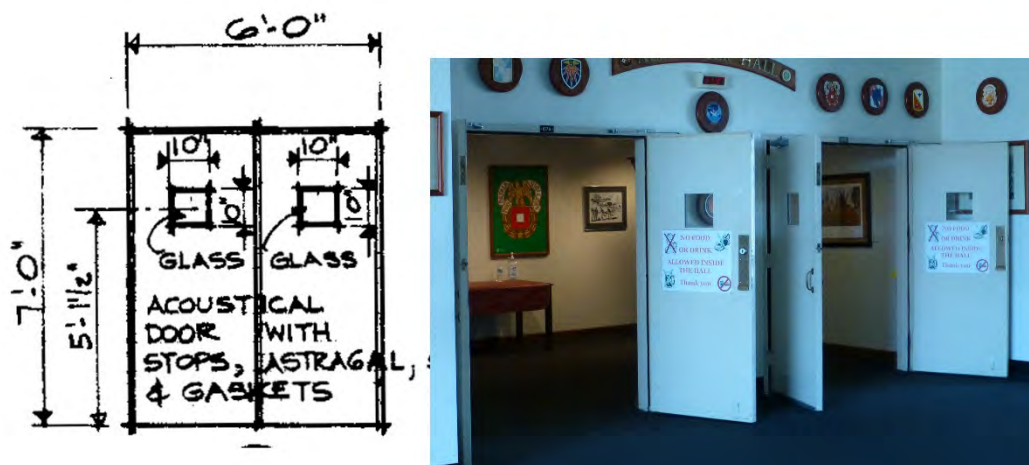
3.3.6 Building 29807, Museum [Conrad Hall] (1970)

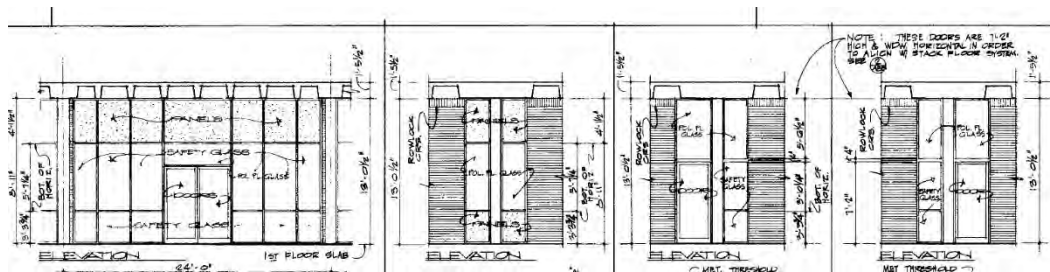
3.3.6.1 Character-defining features

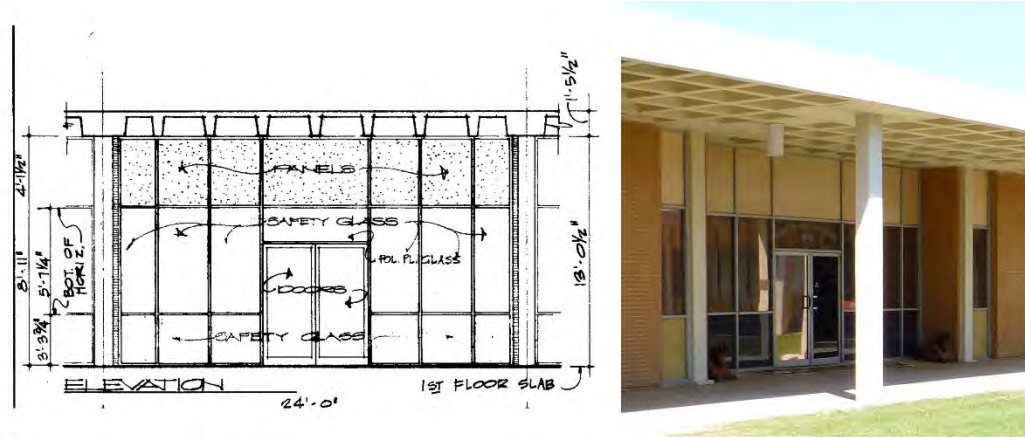
Figure 256. Ceiling-mounted light fixture – comparison of the original drawing detail from 1966 [left] to the current condition of the ceiling-mounted light fixture under the concrete waffle canopy [right] (ERDC-CERL, 2015).

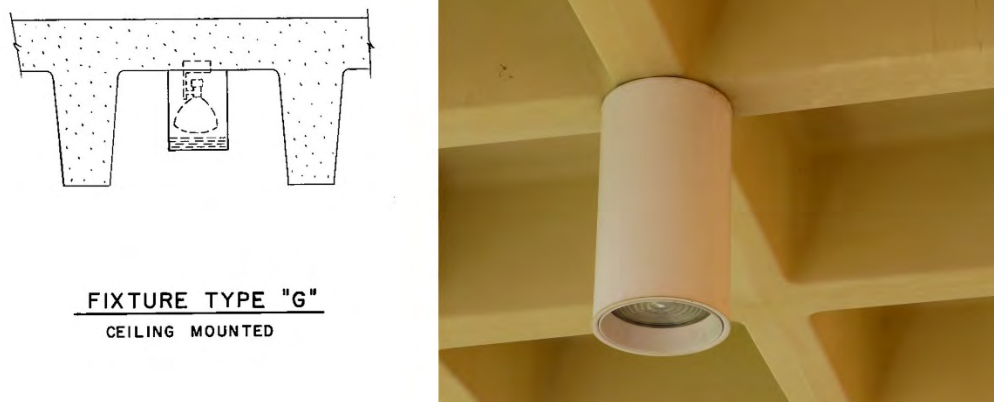
3.3.7 Building 29808, Signal Towers (1970)

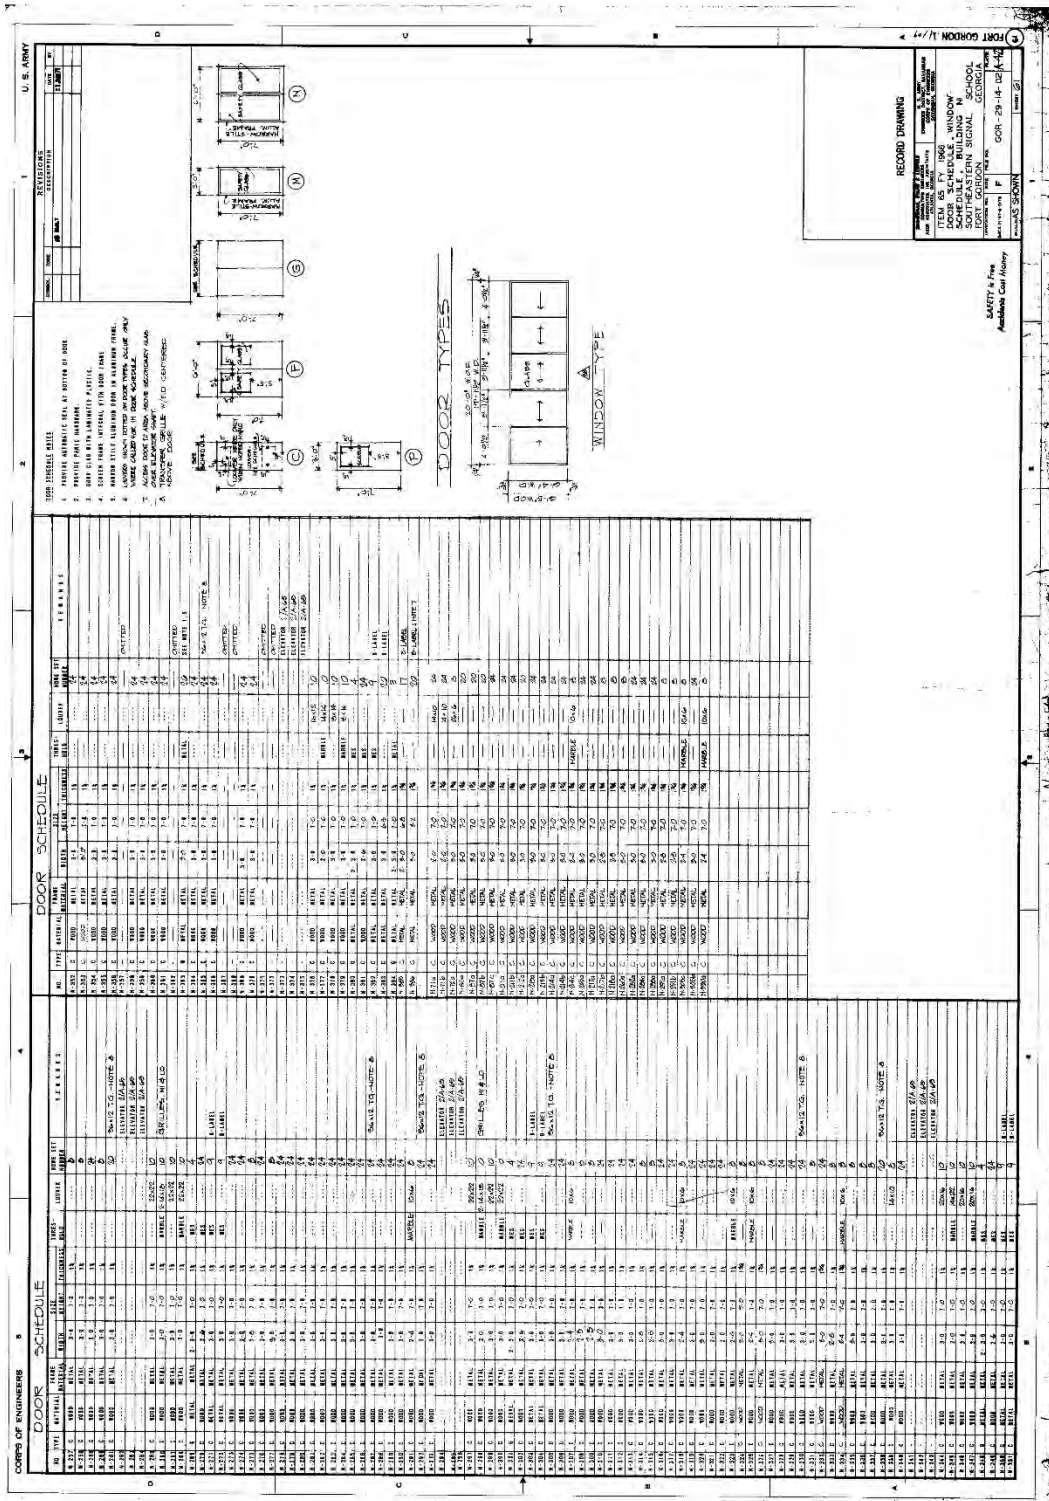
3.3.7.1 Character-defining features

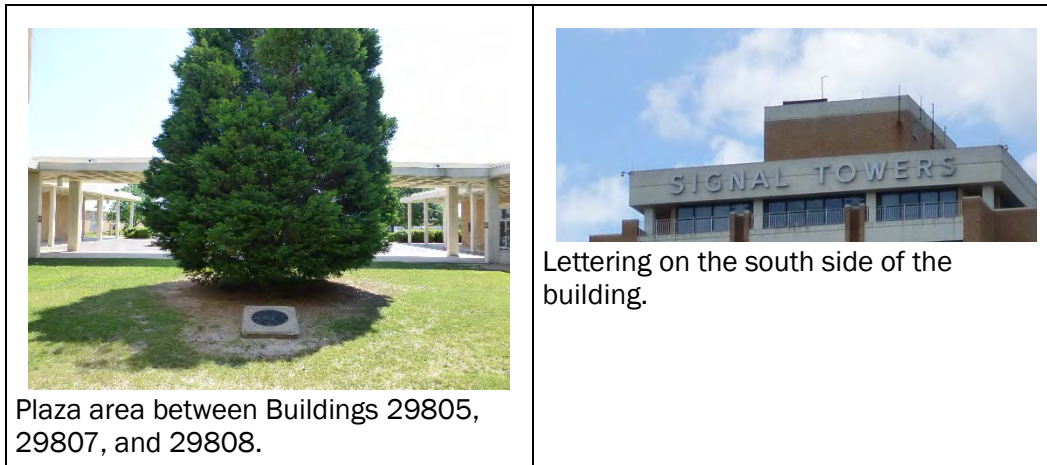
3.3.7.2 Character-defining features that have been removed

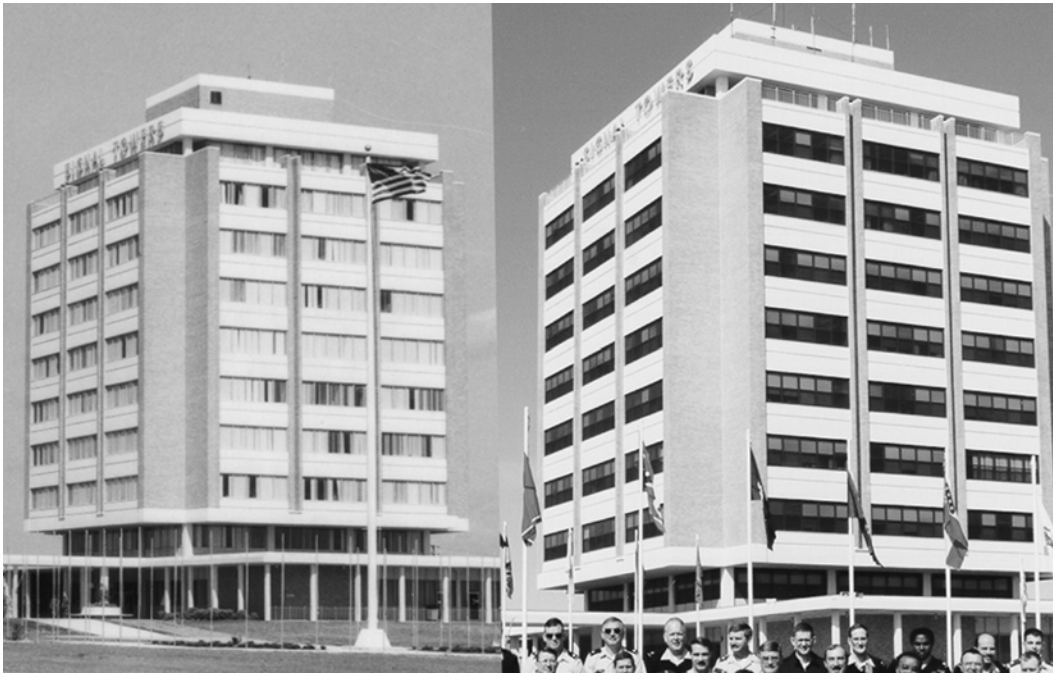
Figure 269. Entry bay for Building 29808, comparison of the original drawing detail from 1966 [left] to the current condition of the bright-aluminum and plate-glass doors and windows with insulated panels [right] (ERDC-CERL, 2015).

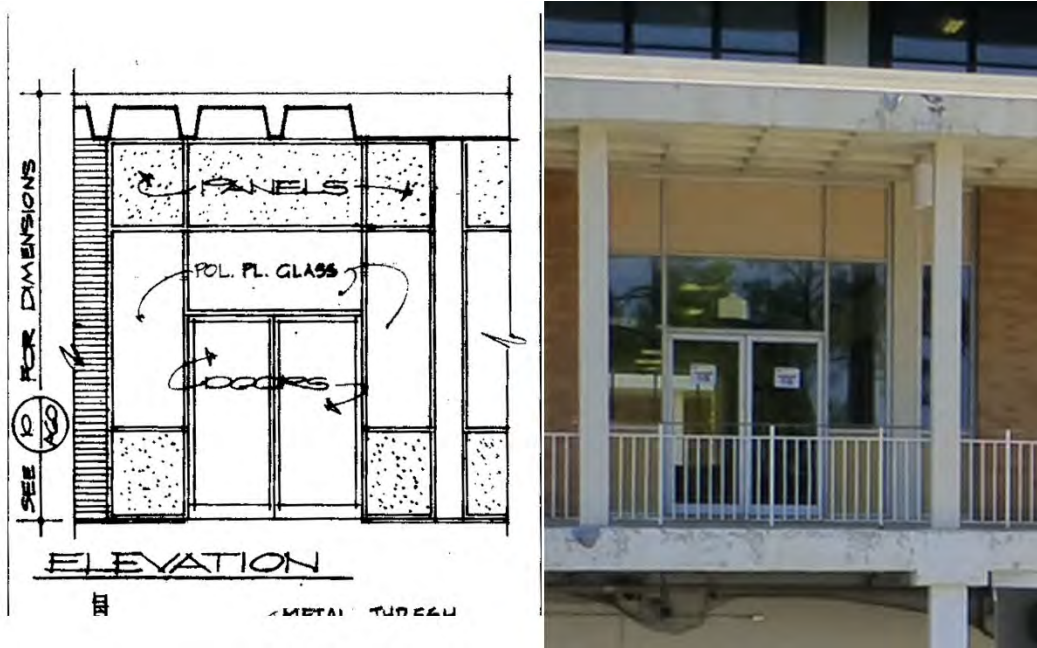
Figure 270. Ceiling-mounted light fixture – comparison of the original drawing detail from 1966 [left] to the current condition of the ceiling-mounted light fixture under the concrete waffle canopy [right] (ERDC-CERL, 2015).

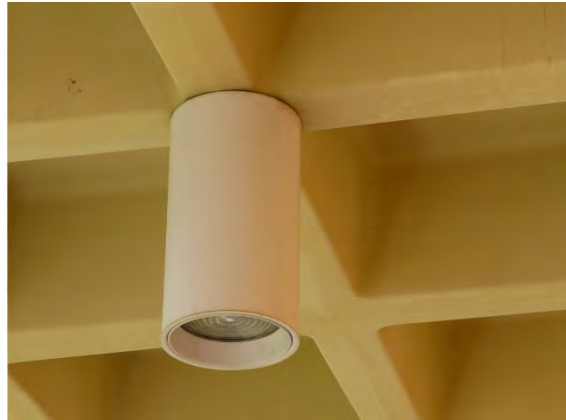
Figure 271. Wall-mounted light fixture – comparison of the original drawing detail from 1966 [left] to the current condition of the wall-mounted interior light fixture [right] (ERDC-CERL, 2015).

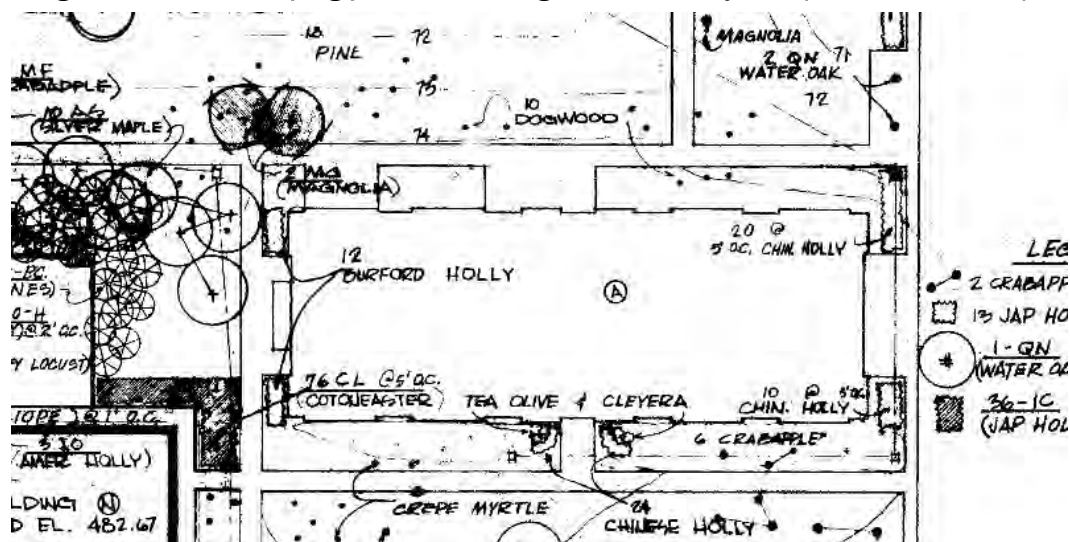
3.3.8.1 Character-defining features

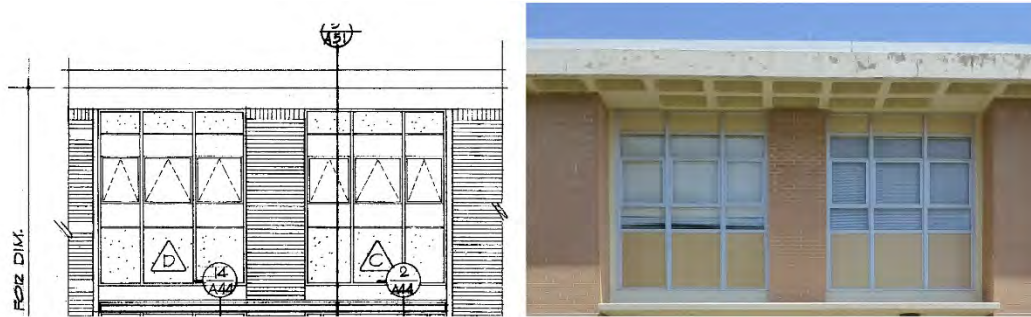
Figure 292. North entry bay second-floor windows - comparison of the original design and materials from 1964 [left] to the current condition of bright-aluminum fixed-pane windows [right] (ERDC-CERL, 2015).

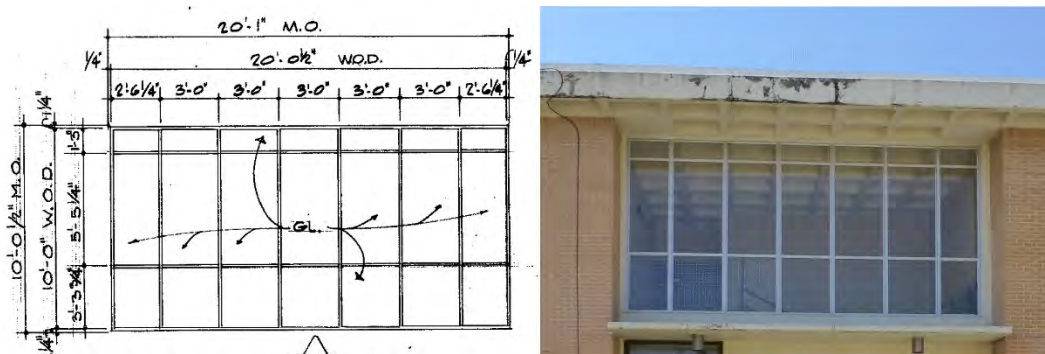
Figure 293. Window bay located on the left and right sides of the north and south elevations - comparison of the original design and materials from 1964 to the current condition of the three-pane awning-style windows sandwiched between insulated panels (ERDC-CERL, 2015).

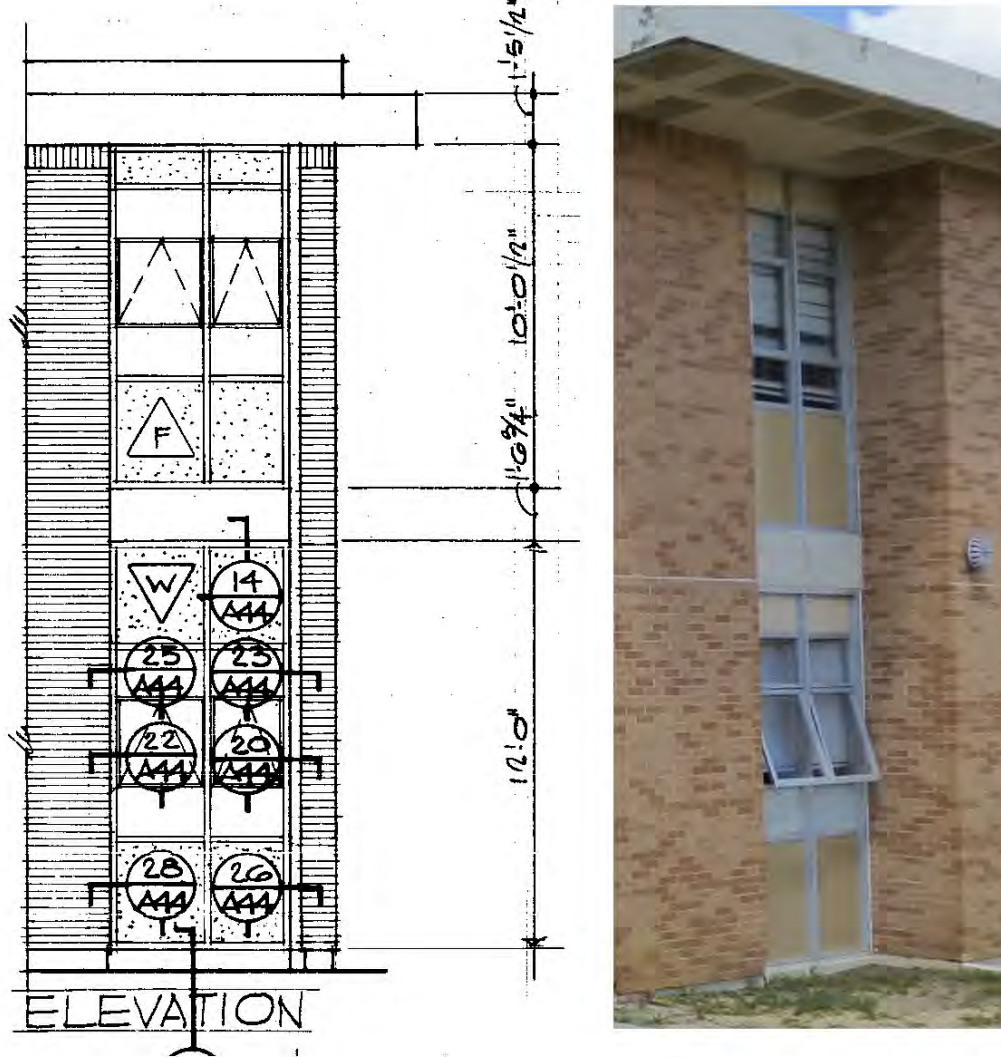
Figure 294. Doors on the east and west elevations – comparison of the original design and materials from 1964 [left] to the current condition of the metal doors with pane and transoms on the first floor and the metal and plate-glass doors with security bars on the second floor [right] (ERDC-CERL, 2015).

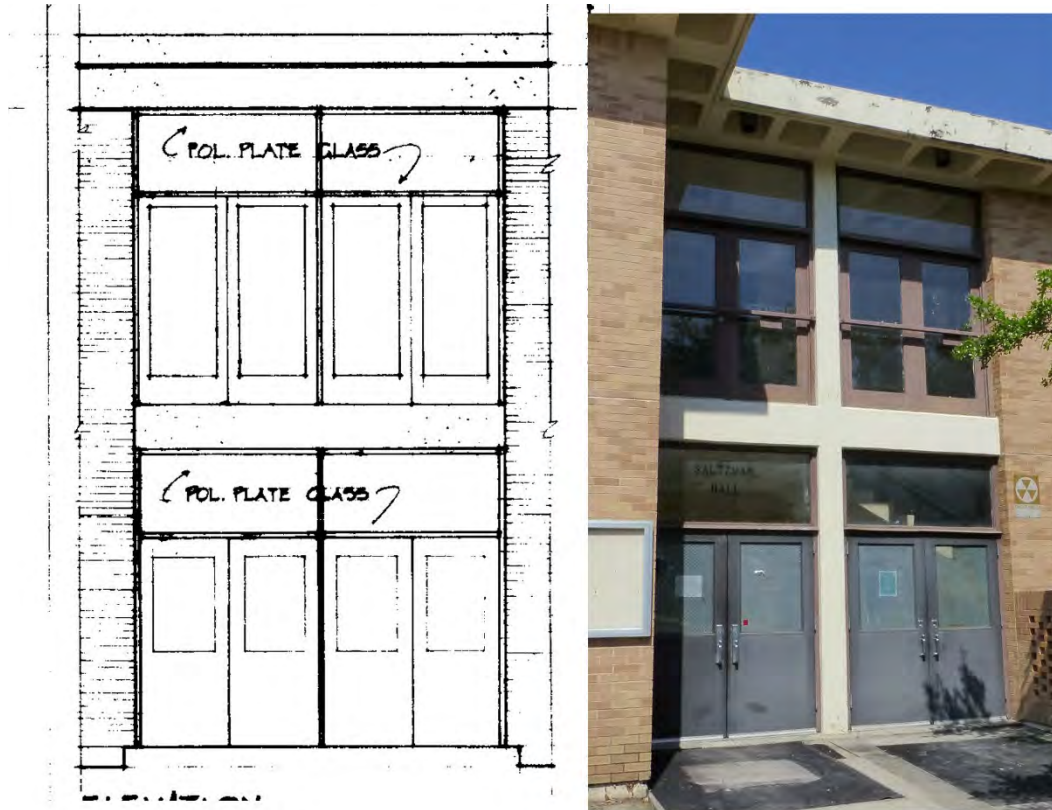
Figure 295. North wall of the right courtyard and south wall of the left courtyard – comparison of the original design and materials from 1964 [left] to the current condition of the metal doors, canopy, and window system [right] (ERDC-CERL, 2015).

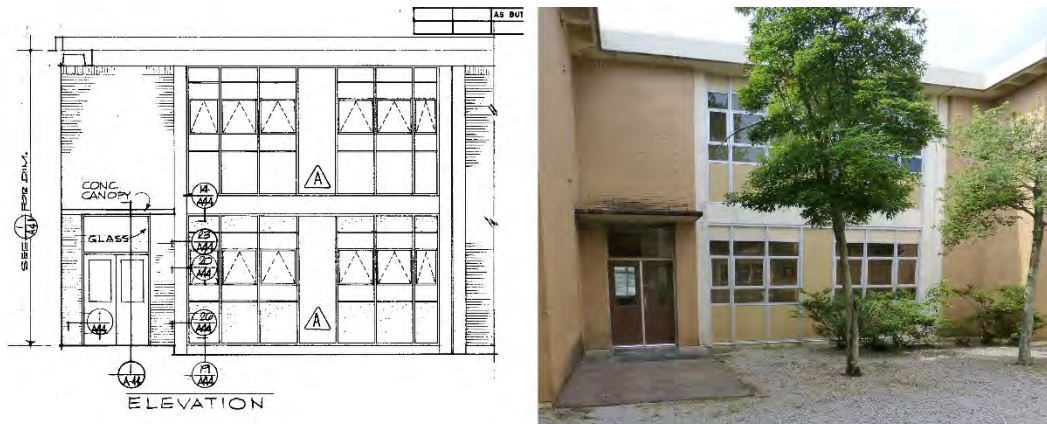
Figure 296. East and west walls of the courtyards – comparison of the original design and materials from 1964 [left] to the current condition of the window system [right] (ERDC-CERL, 2015).

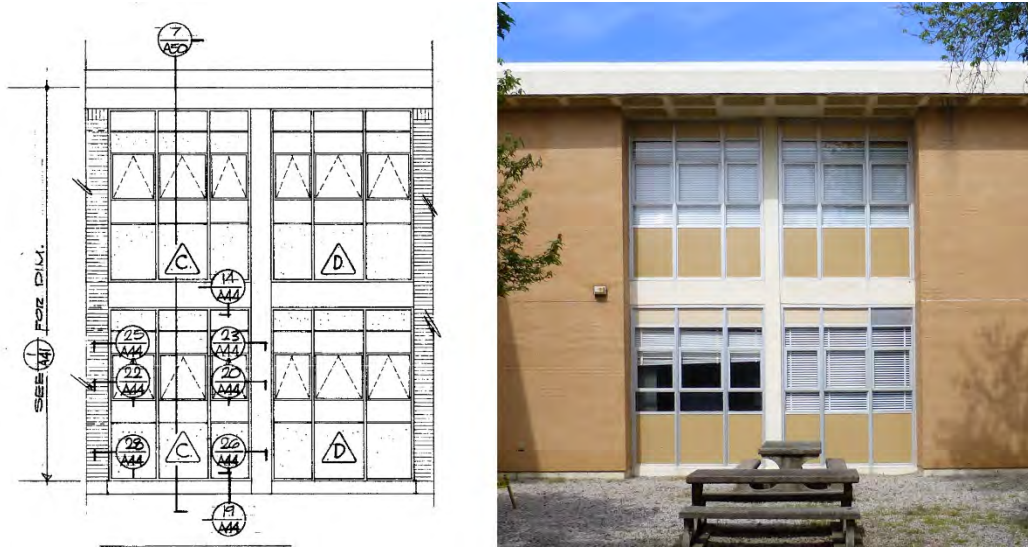
Figure 297. Ceiling-mounted light fixtures under waffle overhang – comparison of the original design and materials from 1966 [left] to the current condition of the ceiling-mounted light fixture [right] (ERDC-CERL, 2015).

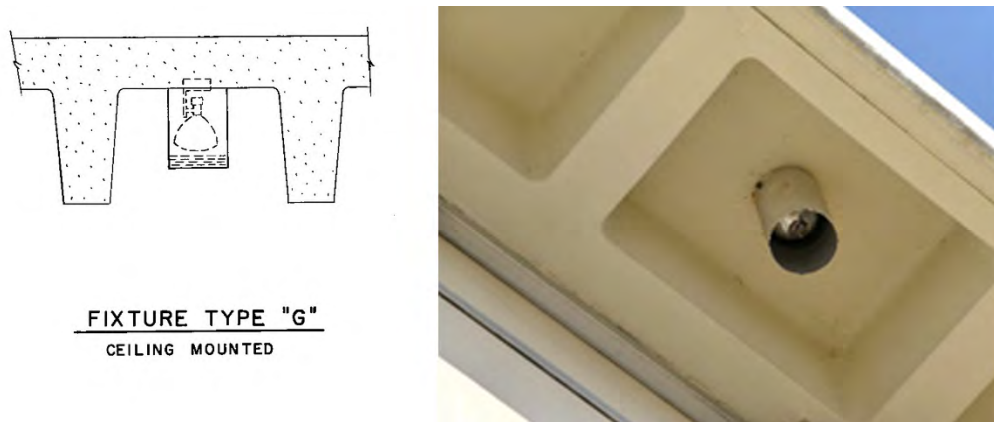
Figure 298. Ceiling-mounted light fixture under flat concrete canopy – comparison of the original design and material from 1966 [left] to the current condition of the ceiling-mounted light fixture [right] (ERDC-CERL, 2015).

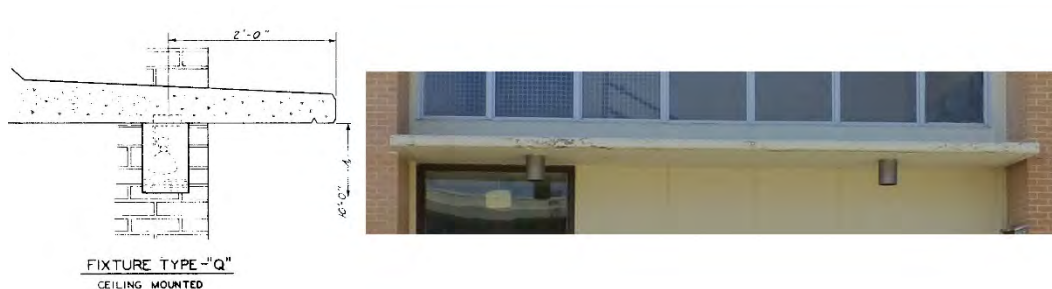
3.3.9 Building 29810, Burkhardt Hall (1970)

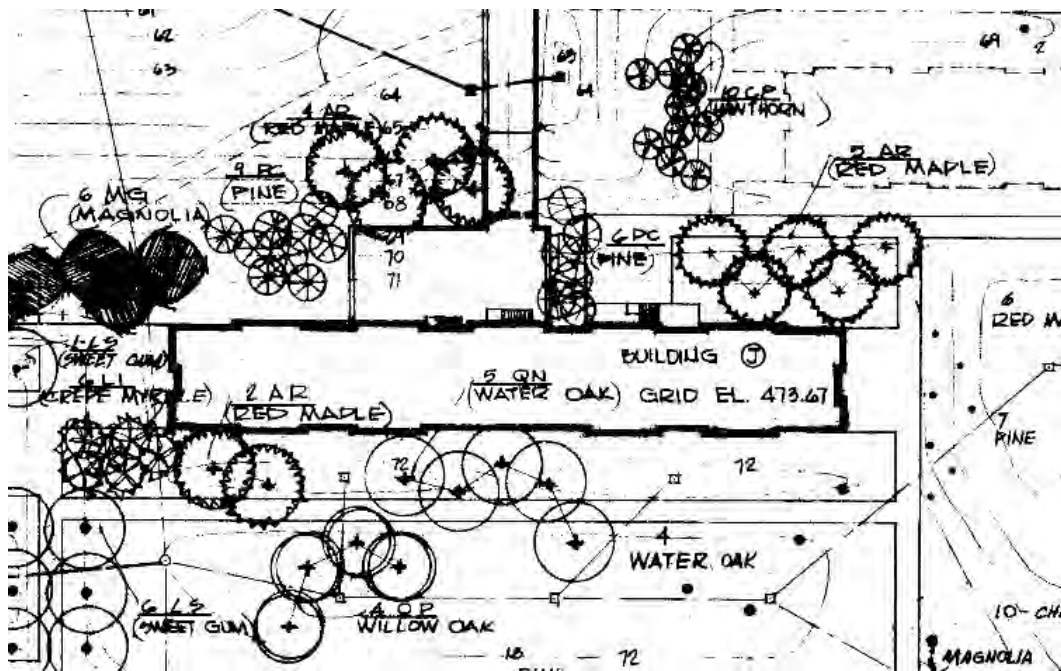
3.3.9.1 Character-defining features

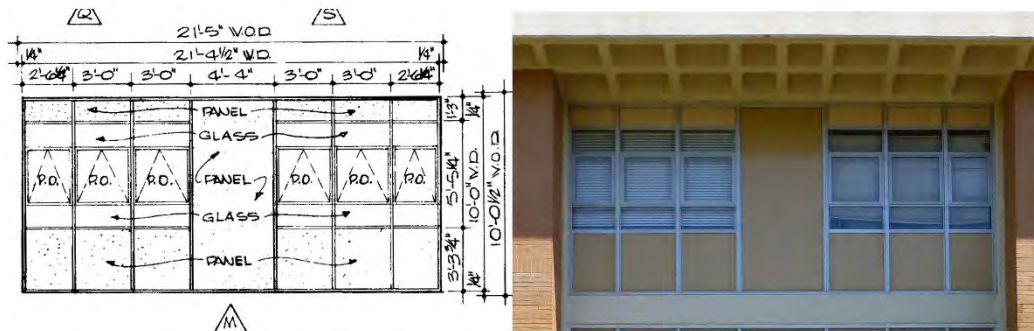
Figure 309. Entry bays on the east and west elevations – comparison of the original design⁵ and materials from 1966 [left.] to the current condition of the three-story entry bay with metal doors with pane and transom above and groups of four bright-aluminum framed three-pane awning-style windows sandwiched between insulated panels [right] (ERDC-CERL, 2015).

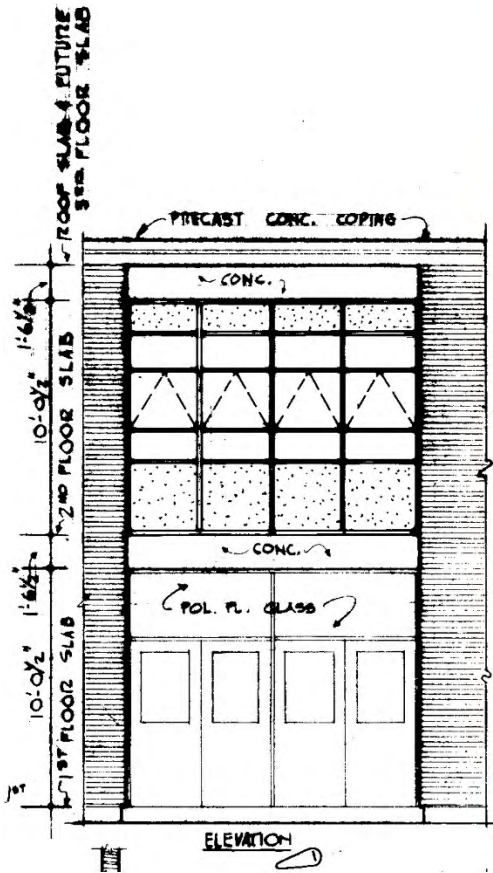
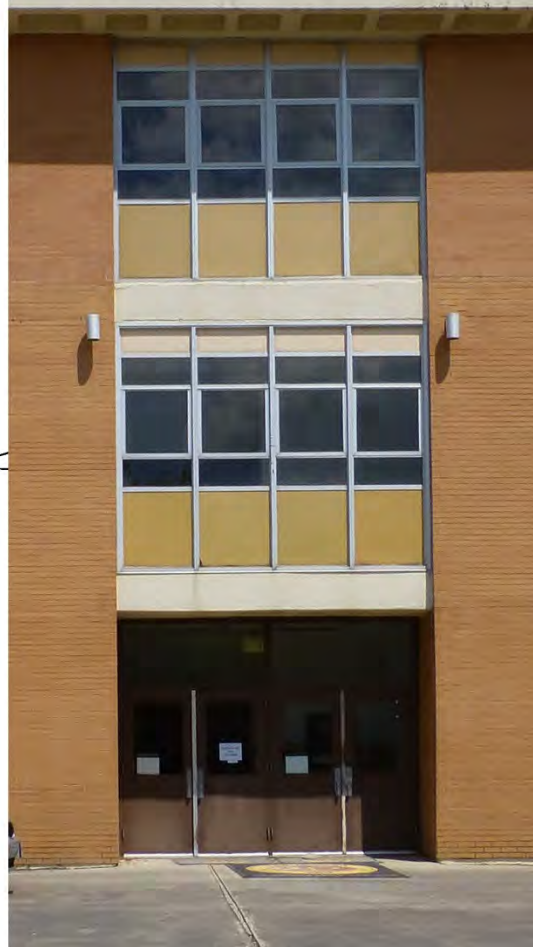
⁵ Note the drawing is only two stories tall, but it has a notation of “roof slab for future 3rd floor slab.”

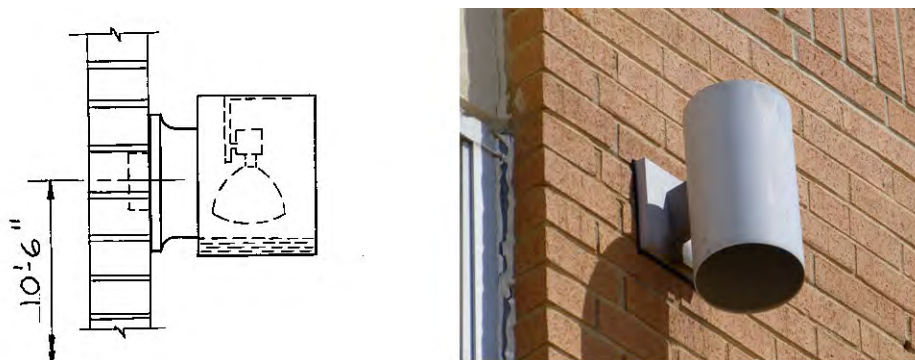
FIXTURE TYPE "H"
WALL MOUNTED

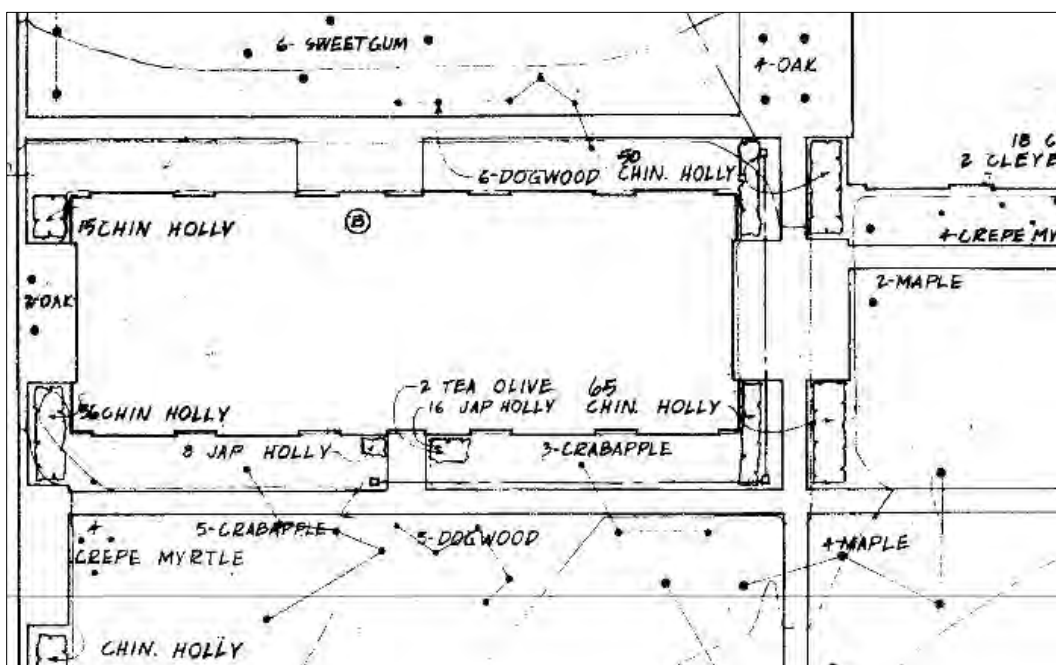
3.3.10.1 Character-defining features

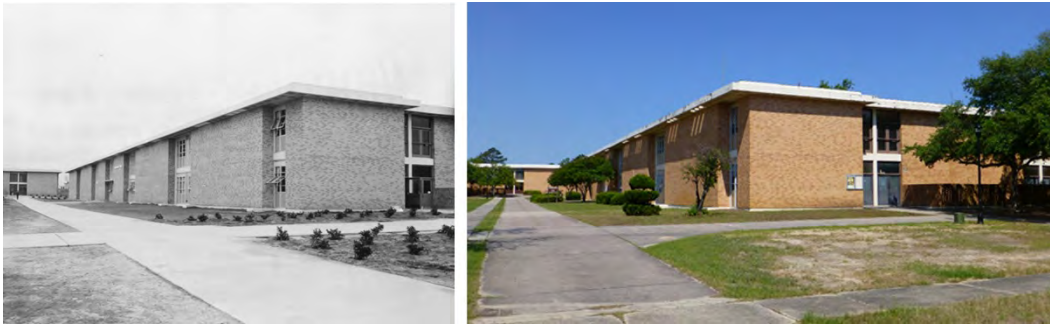
Figure 335. Second-floor window bay on the north and south elevations – Comparison of the original design and materials from 1964 [left] compared to the current condition of bright-aluminum three-pane awning style-windows and insulated panels [right] (ERDC-CERL, 2015).

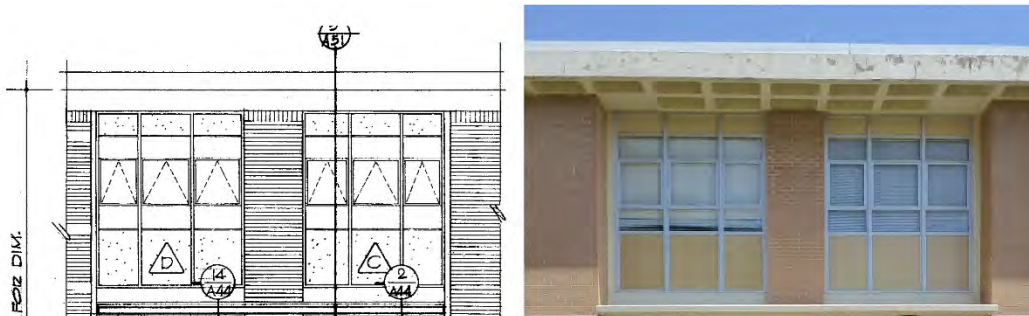
Figure 336. Window bay located on the left and right sides of the north and south elevations –original design and materials from 1964 [left] compared to the current condition of the three-pane awning-style windows sandwiched between insulated panels [right] (ERDC-CERL, 2015).

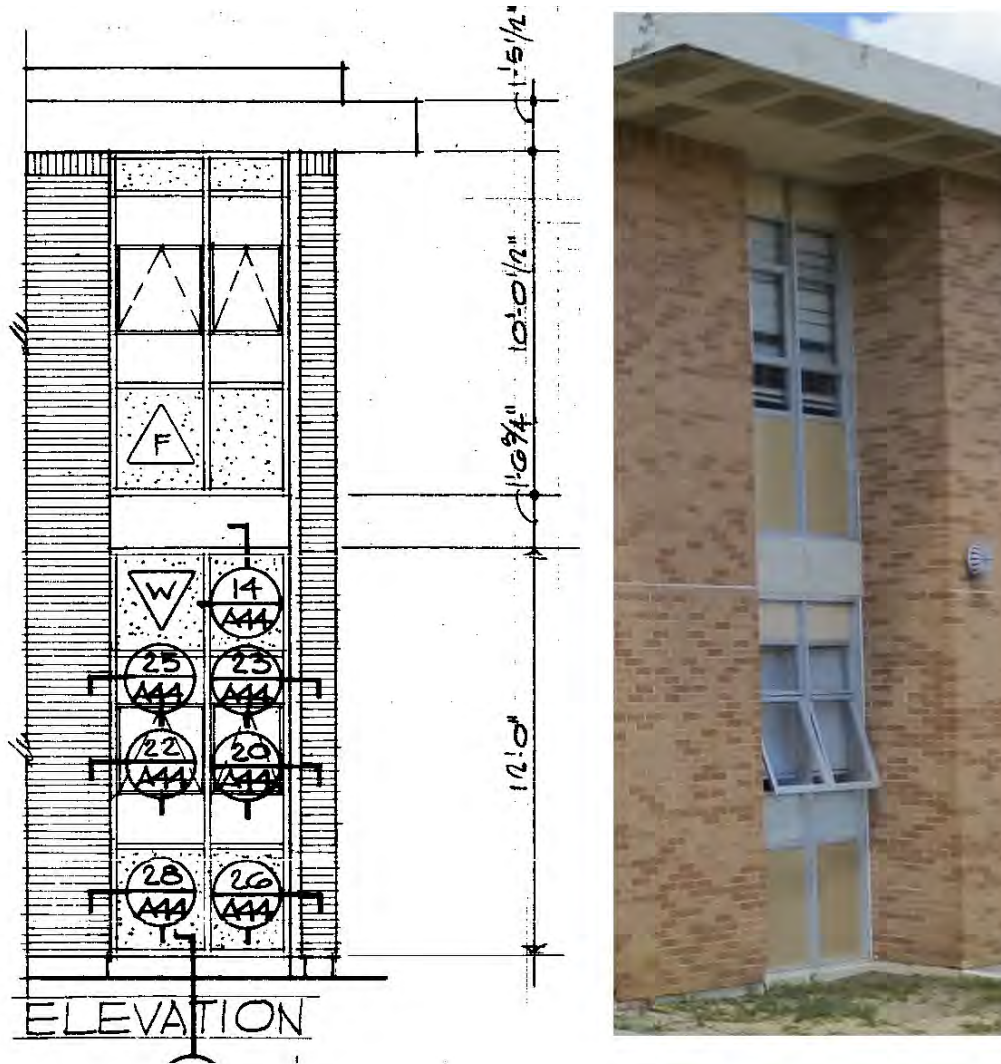
Figure 337. Doors on the east and west elevations – comparison of the original design and materials from 1964 [left] to the current condition of the metal doors with pane and transoms on the first floor and the metal and plate-glass doors with security bars on the second floor [right] (ERDC-CERL, 2015).

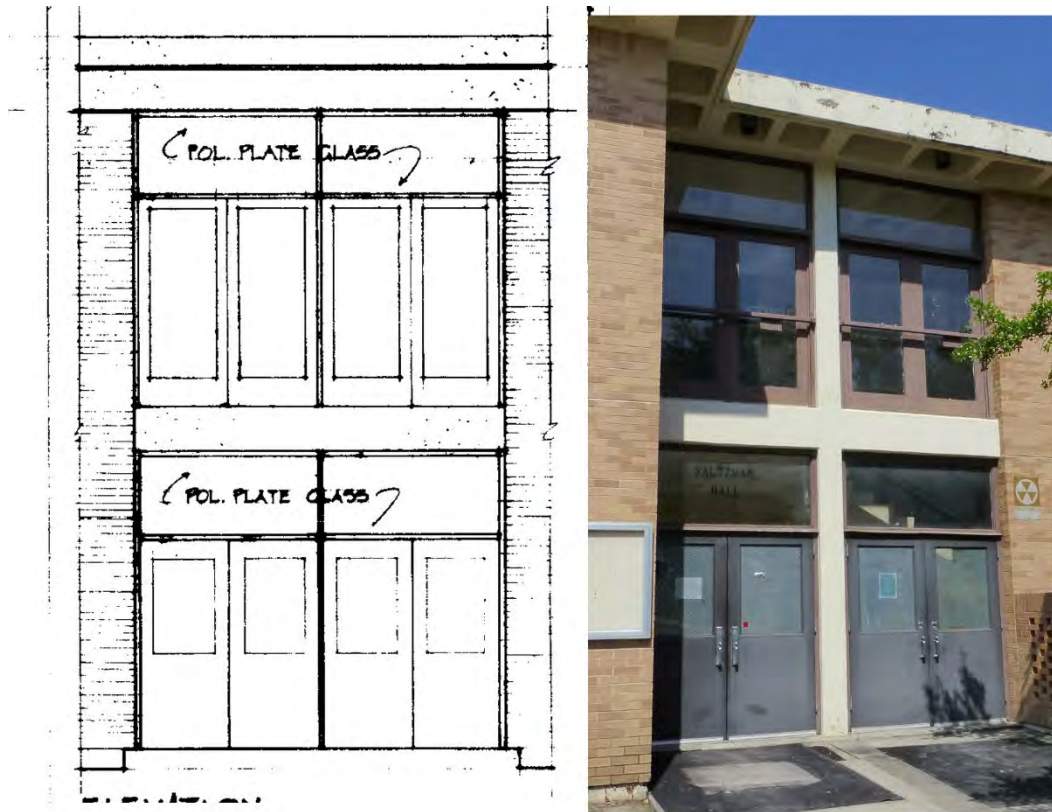
Figure 338. North wall of the right courtyard south wall of the left courtyard – comparison of the original design and materials from 1964 [left] to the present day [right] (ERDC-CERL, 2015).

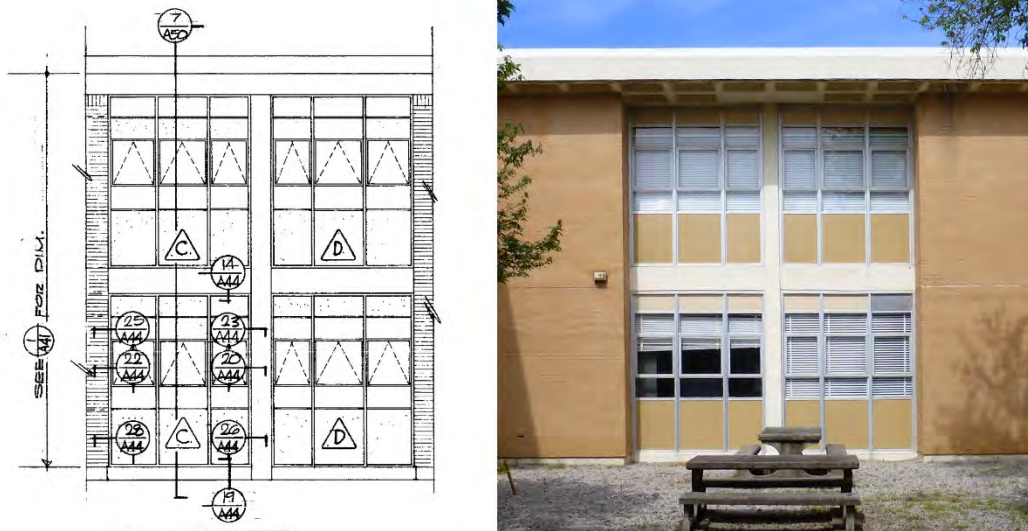
Figure 340. Ceiling-mounted light fixture under the waffle overhang – comparison of the original design and material from 1966 [left] to the current condition of the ceiling-mounted light fixture [right] (ERDC-CERL, 2015).

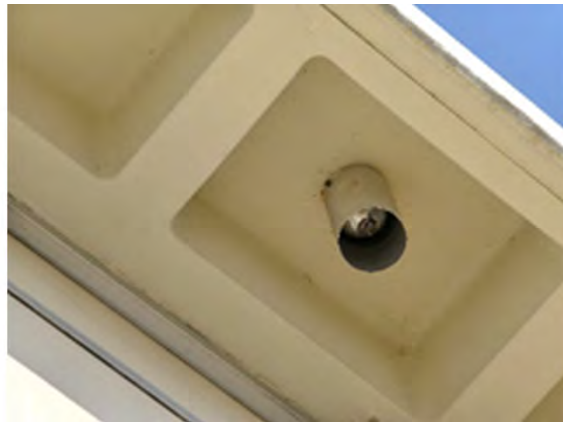
Figure 341. Ceiling-mounted light fixture under flat concrete canopy – comparison of the original design and material on the left from 1966 to the current condition of the replacement ceiling-mounted light fixture [right] (ERDC-CERL, 2015).

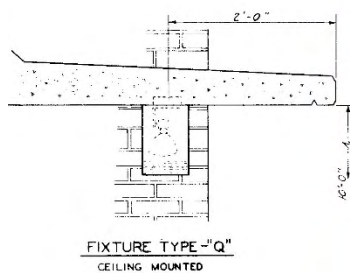
FIXTURE TYPE "Q"
CEILING MOUNTED

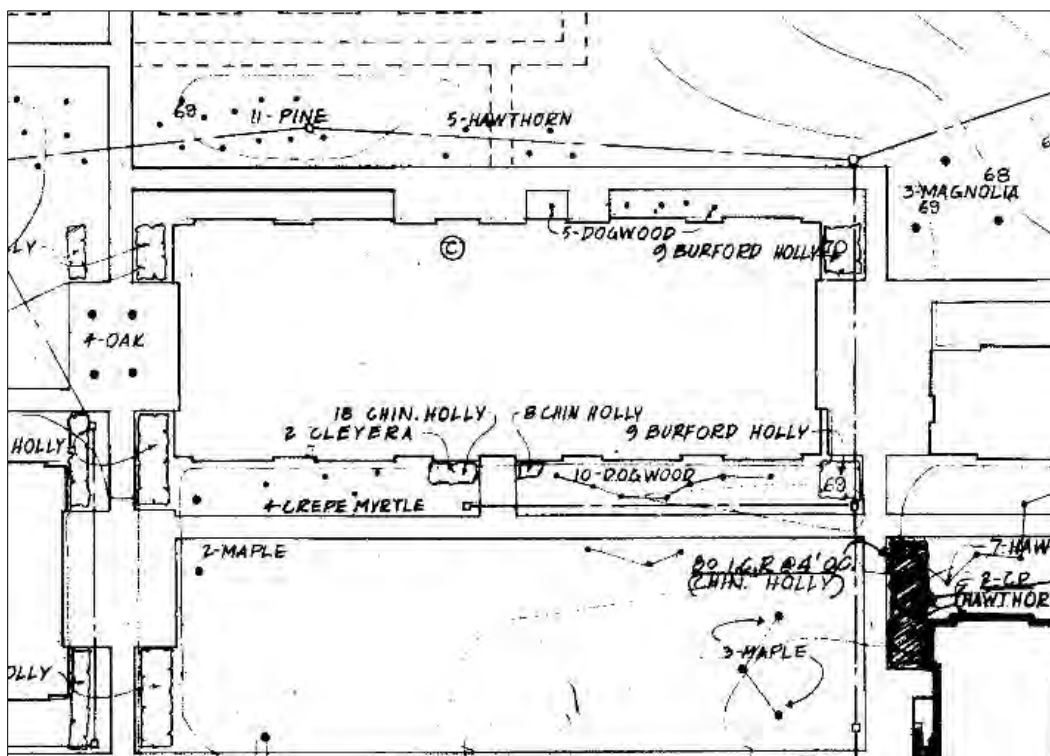
3.3.11.1 Character-defining features

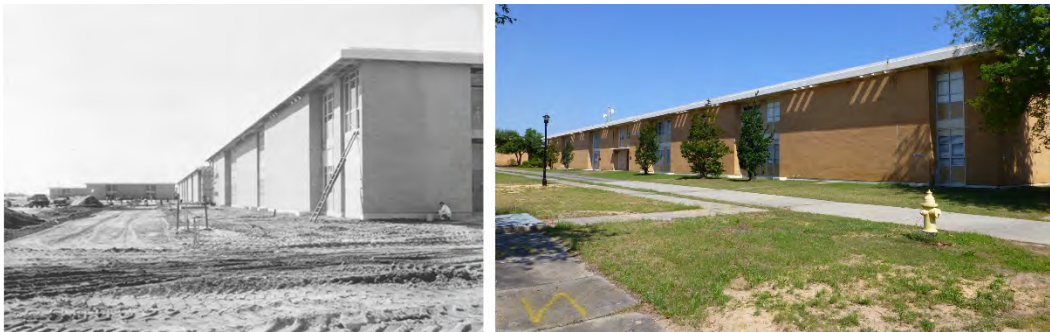
Figure 363. Second-floor window bay on the north and south elevations – comparison of the original design and materials from 1964 [left] to the current condition of bright-aluminum three-pane awning style-windows and insulated panels [right] (ERDC-CERL, 2015).

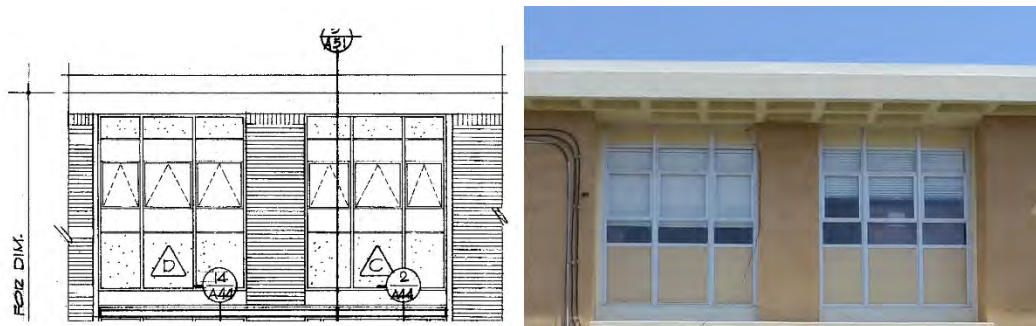
Figure 364. Window bay located on the left and right sides of the north and south elevations – comparison of the original design and materials from 1964 [left] to the current condition of the three-pane awning-style windows sandwiched between insulated panels [right] (ERDC-CERL, 2015).
