**US Army Corps
of Engineers®**
Engineer Research and
Development Center

ERDC
INNOVATIVE SOLUTIONS
for a safer, better world

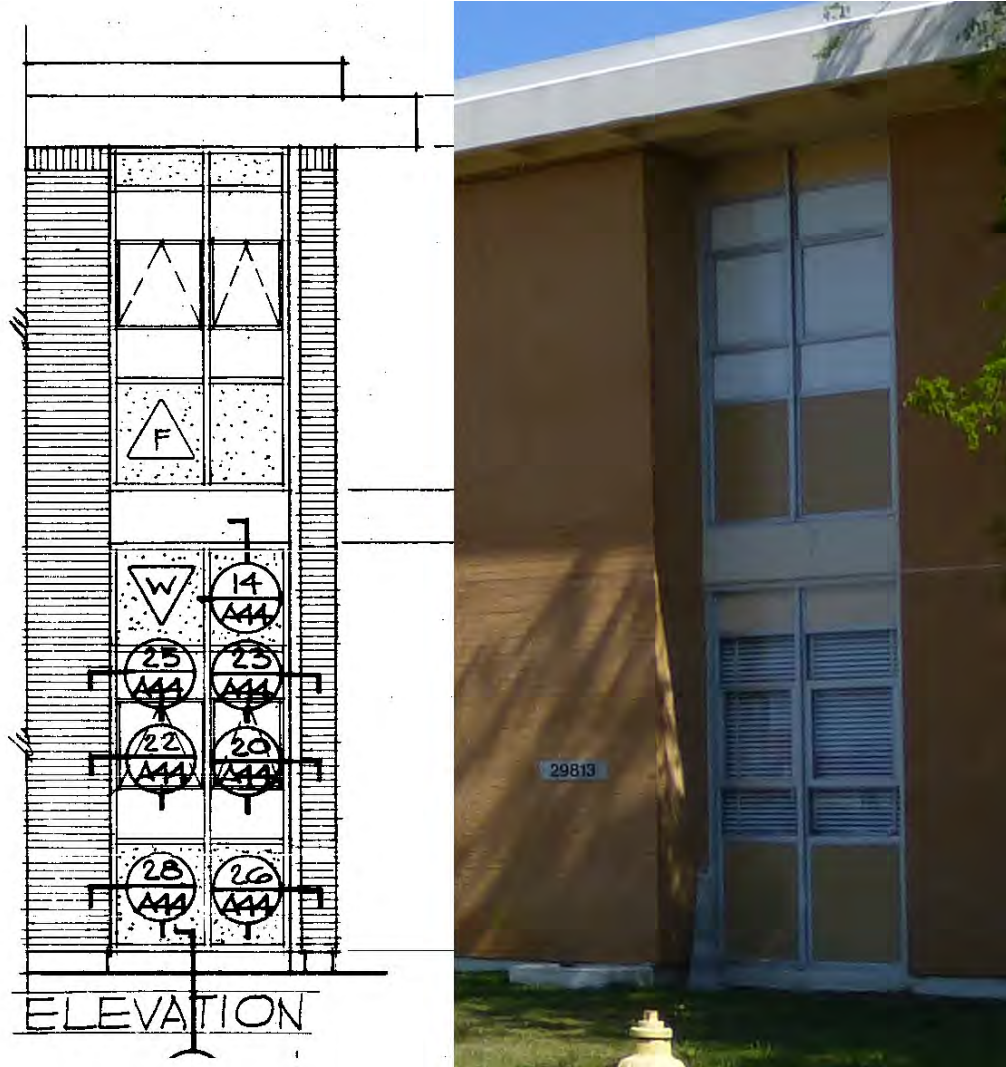
Figure 365. Doors on the east and west elevations – comparison of the original design and materials from 1964 [left] to the current condition of the metal doors with pane and transoms on the first floor and the metal and plate-glass doors with security bars on the second floor [right] (ERDC-CERL, 2015).

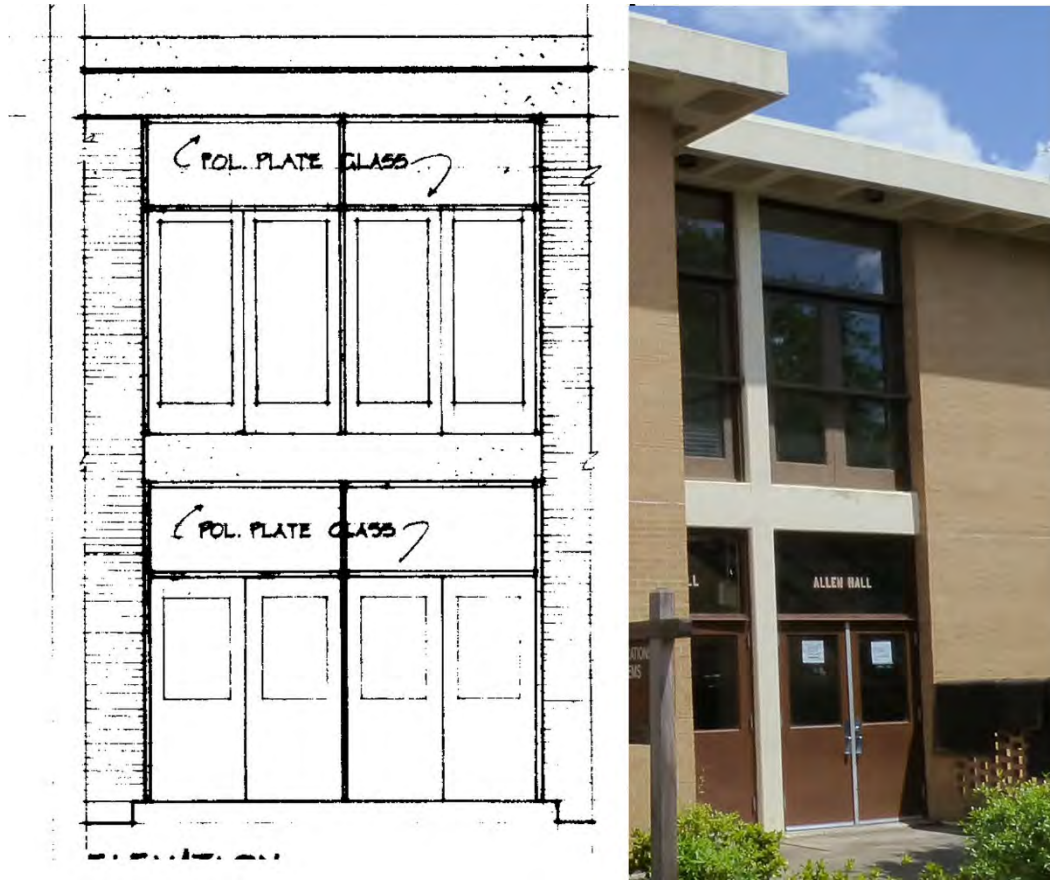
Figure 366. North wall of the right courtyard comparison of the original design and materials from 1964 [left] to the present-day [right] (ERDC-CERL, 2015).

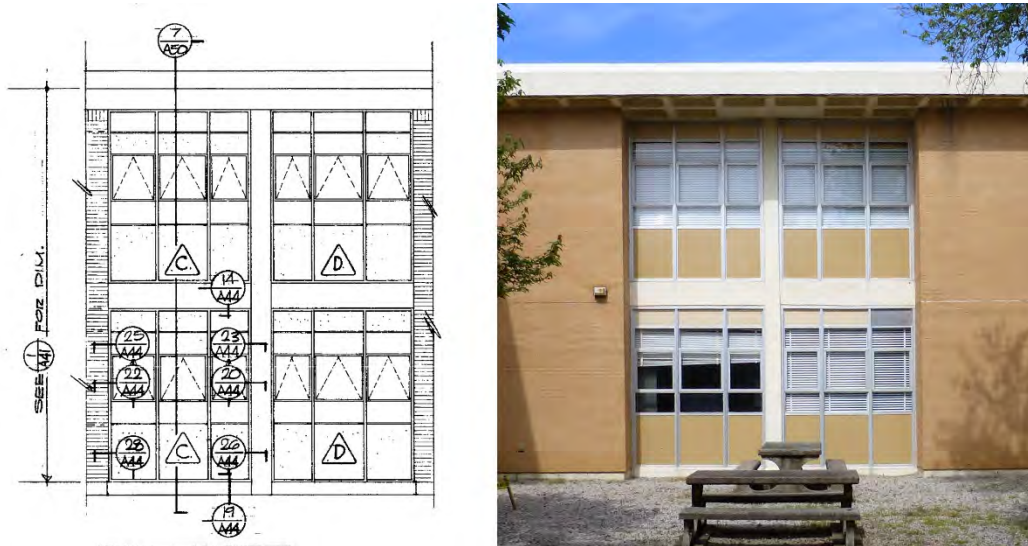
Figure 368. Ceiling-mounted light fixture under the waffle overhang – comparison of the original design and material from 1966 [left] to the current condition of the ceiling-mounted light fixture [right] (ERDC-CERL, 2015).

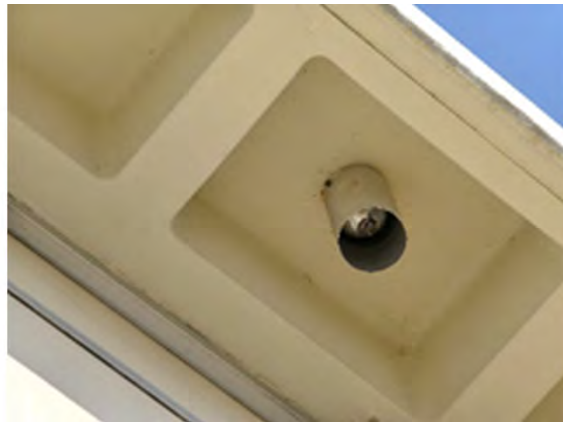
Figure 369. Ceiling-mounted light fixture under flat concrete canopy – comparison of the original design and material from 1966 [left] to the current condition of the replacement ceiling-mounted light fixture [right] (ERDC-CERL, 2015).

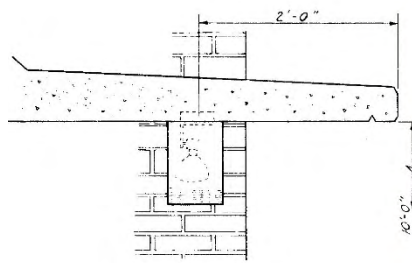
FIXTURE TYPE "Q"
CEILING MOUNTED

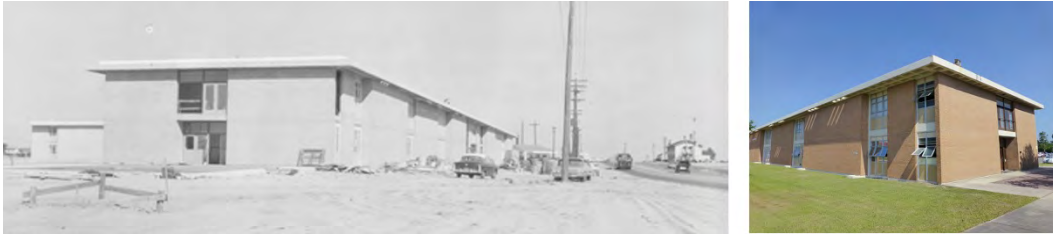
Figure 383. Large six-window bay - comparison of the original design and materials from 1964 [left] to the current condition of bright-aluminum three-pane awning-style windows and insulated panels [right] (ERDC-CERL, 2015).

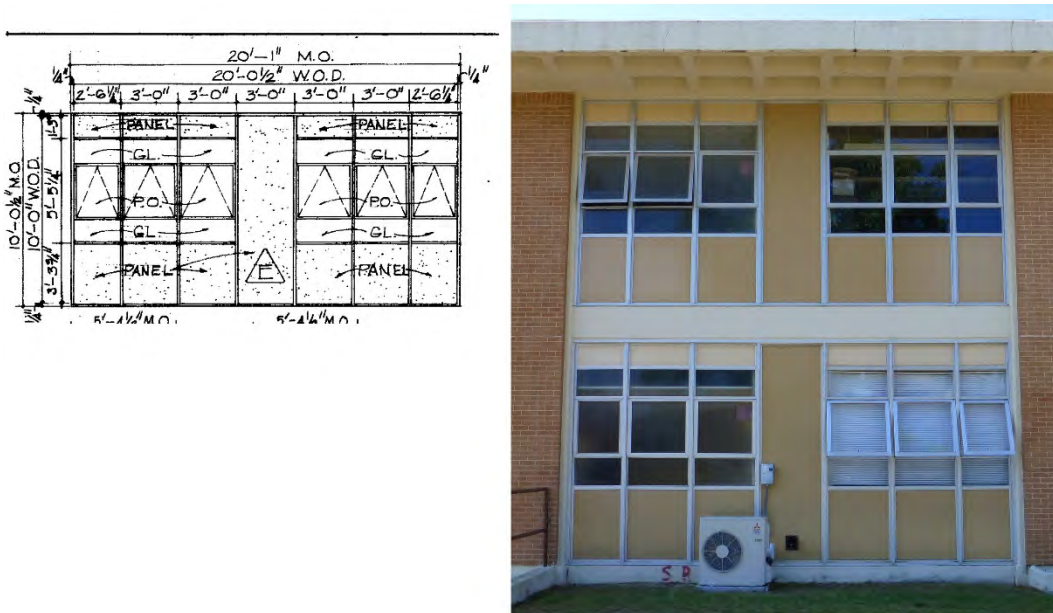
Figure 384. East and west elevations - comparison of the original design and materials from 1964 [left] to the current condition of the metal doors with panes and transoms above and the three-pane awning-style windows sandwiched between insulated panels on the second floor [right] (ERDC-CERL, 2015).

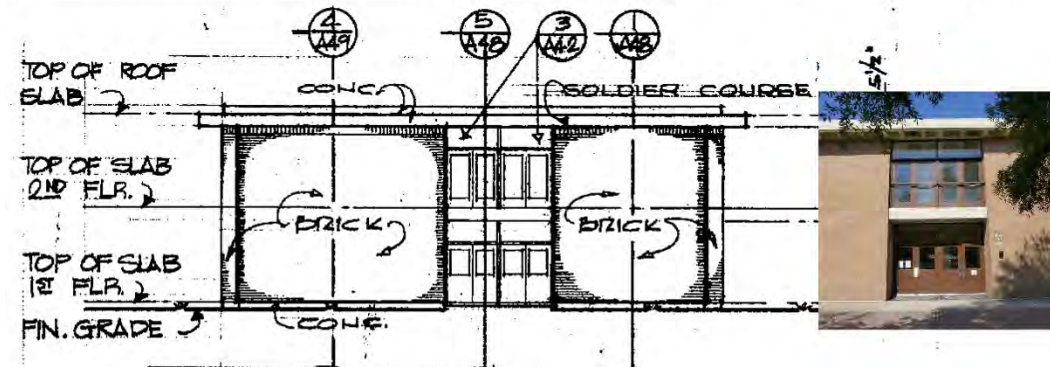
Figure 385. Ceiling-mounted light fixture under the waffle overhang - comparison of the original design and material from 1966 [left] to the current condition of the ceiling-mounted light fixture [right] (ERDC-CERL, 2015).

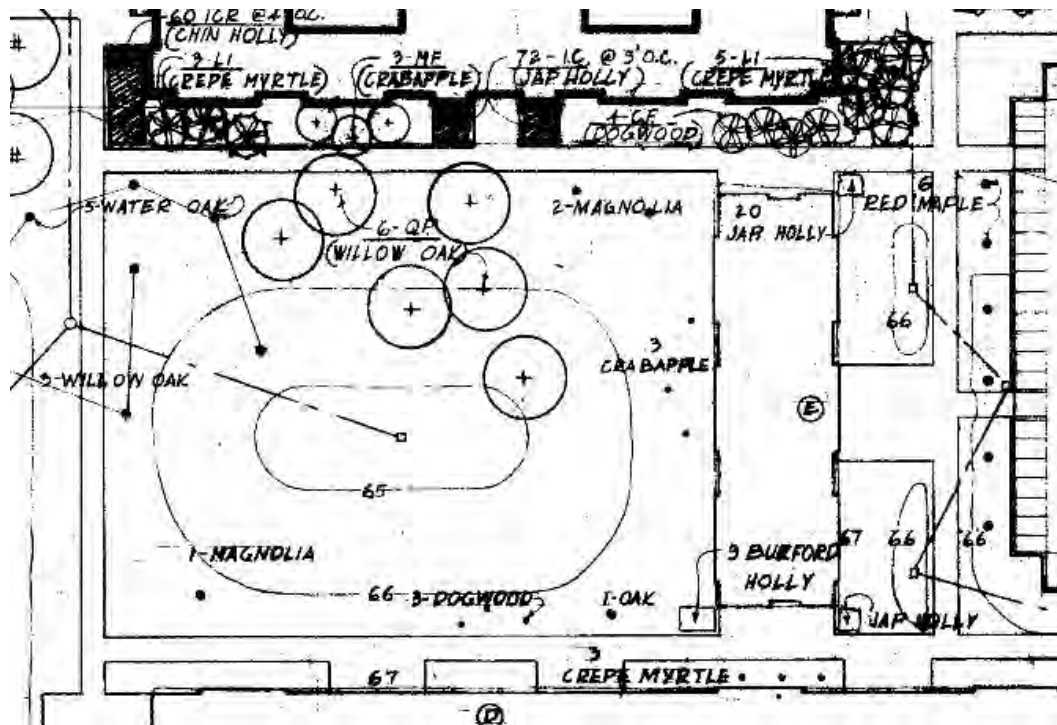
3.3.13.1 Character-defining features

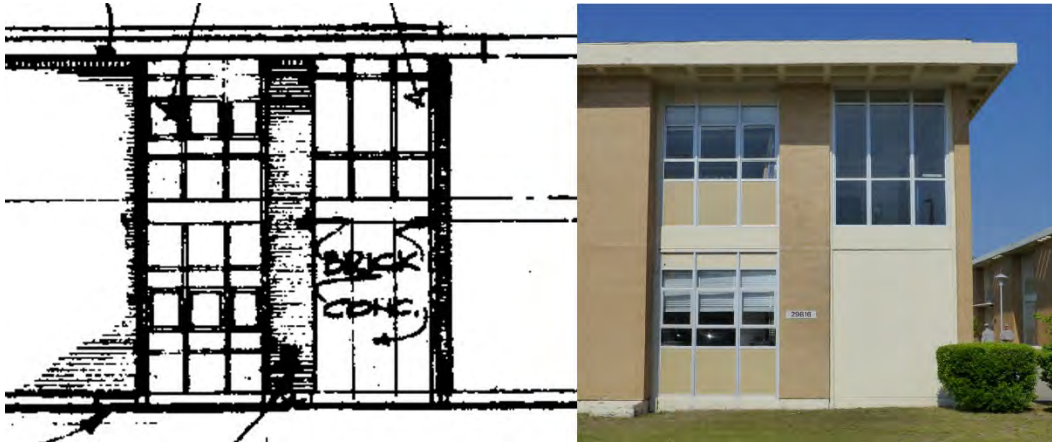
Figure 400. Large window group – comparison of the original design and materials from 1964 [left] to the current condition of the bright-aluminum three-pane awning-style windows with insulated panels and exposed concrete structure [right] (ERDC-CERL, 2015).

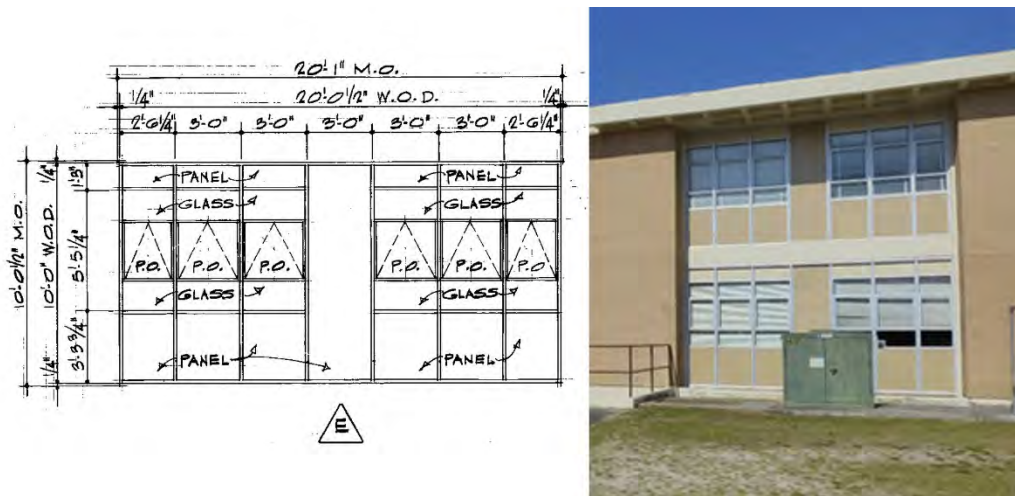
Figure 401. Ceiling-mounted light fixture under the waffle overhang – comparison of the original design and material from 1966 [left] to the current condition of the ceiling-mounted light fixture [right] (ERDC-CERL, 2015).

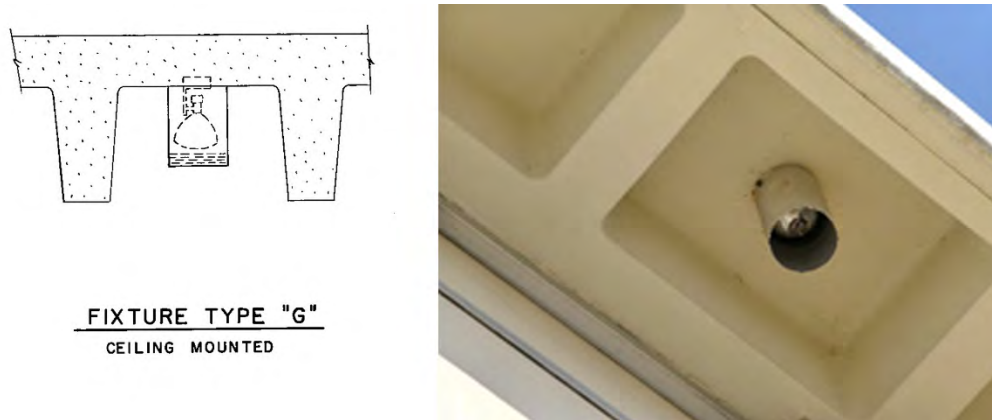
3.3.14 Building 29817, Allison Hall (1970)

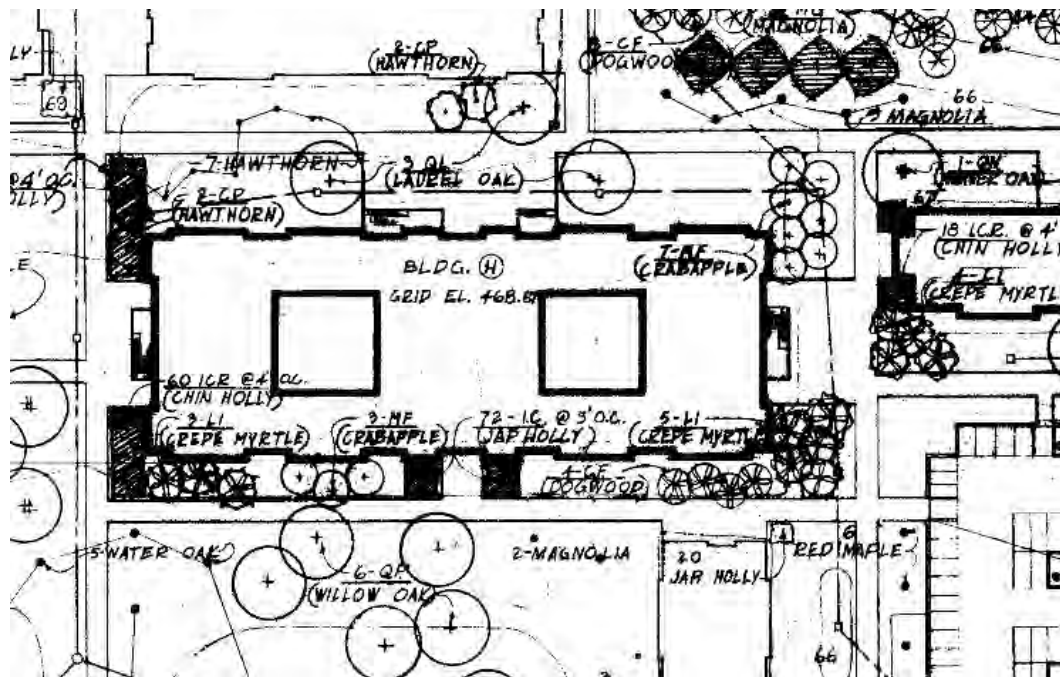
3.3.14.1 Character-defining features

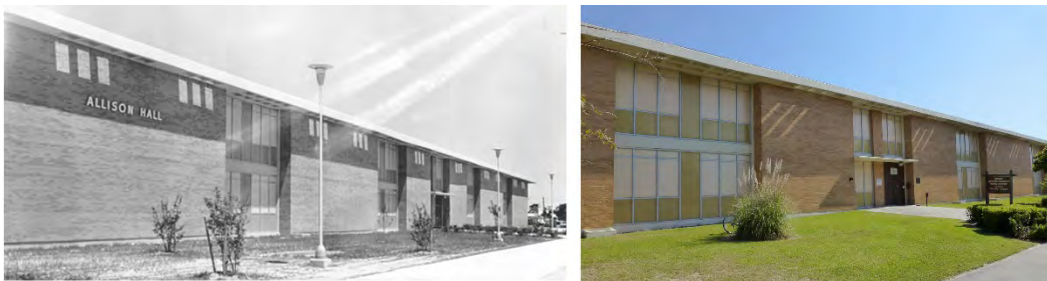
Figure 417. Main entry on the south elevation – comparison of the original design and materials detail drawing from 1966 [left] to the current condition of the concrete canopy, bright-aluminum framed insulated panels, and replacement metal entry doors [right] (ERDC-CERL, 2015).

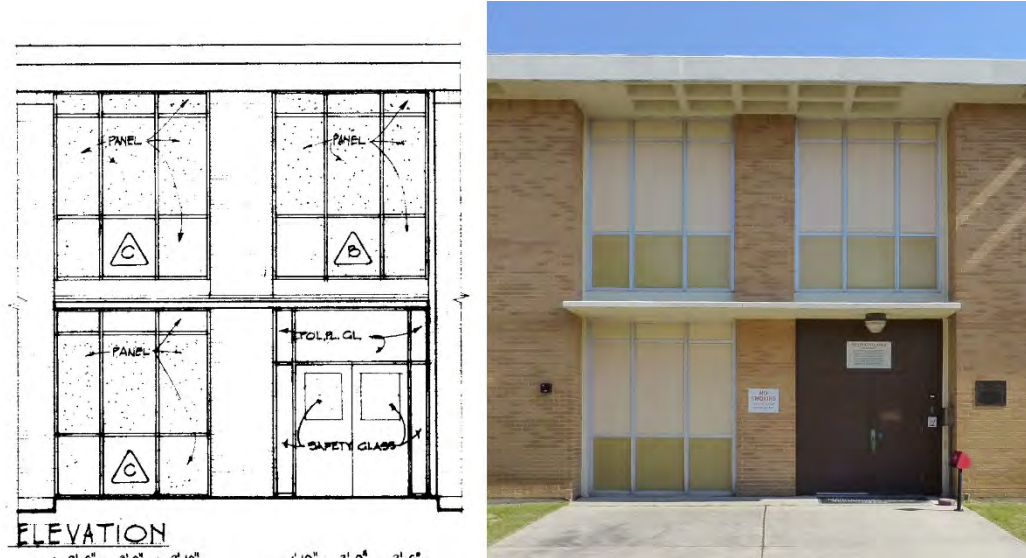
Figure 418. Entry bay on the north elevation – comparison of the original design and materials detail drawing from 1966 [left] to the current condition of the metal doors, concrete panels, concrete canopy, and bright-aluminum framed insulated panels [right] (ERDC-CERL, 2015).

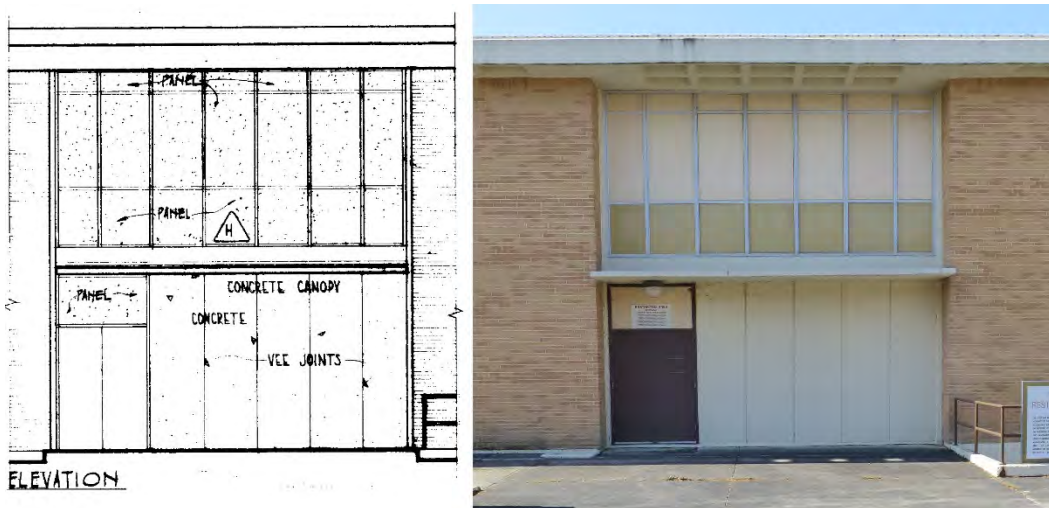
Figure 419. Entry bays on the east and west elevations – comparison of the original design and materials detail drawings from 1966 [left] to the current condition of the metal entry doors with insulated panels above and bright-aluminum framed insulated panels on the second floor [right] (ERDC-CERL, 2015).

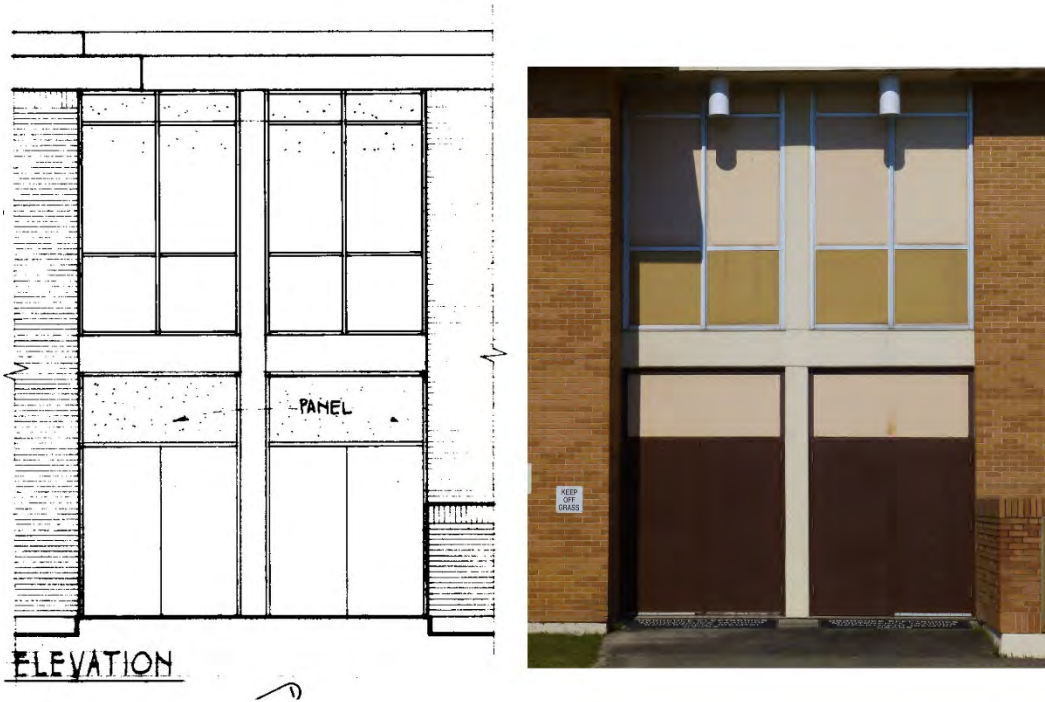
Figure 420. Large window bay on the north and south elevations – comparison of the original design and materials from 1966 [left] to the current condition of the bright-aluminum framed insulated panels [right] (ERDC-CERL, 2015).

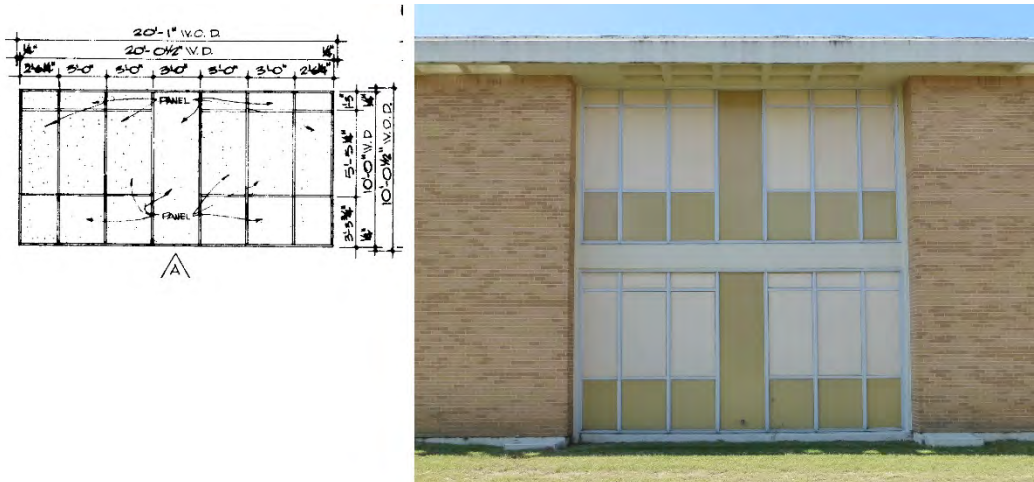
Figure 421. Ceiling-mounted light fixture under concrete canopy – comparison of the original ceiling-mounted light fixture detail drawing from 1966 [left] to the current condition of the replacement light fixture [right] (ERDC-CERL, 2015).

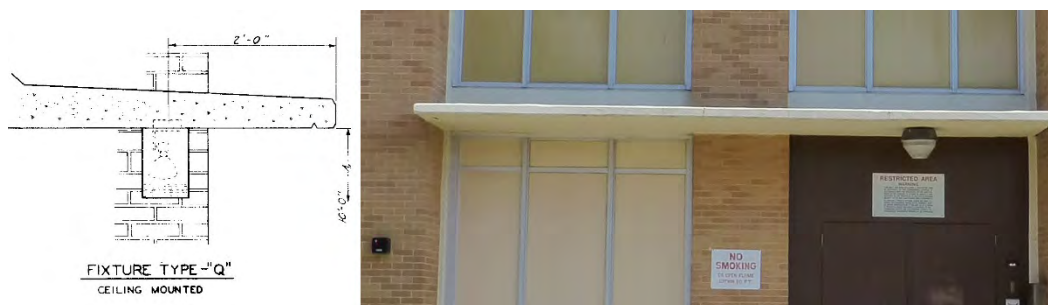
3.3.15 Building 29818, Johnston Hall (1966)

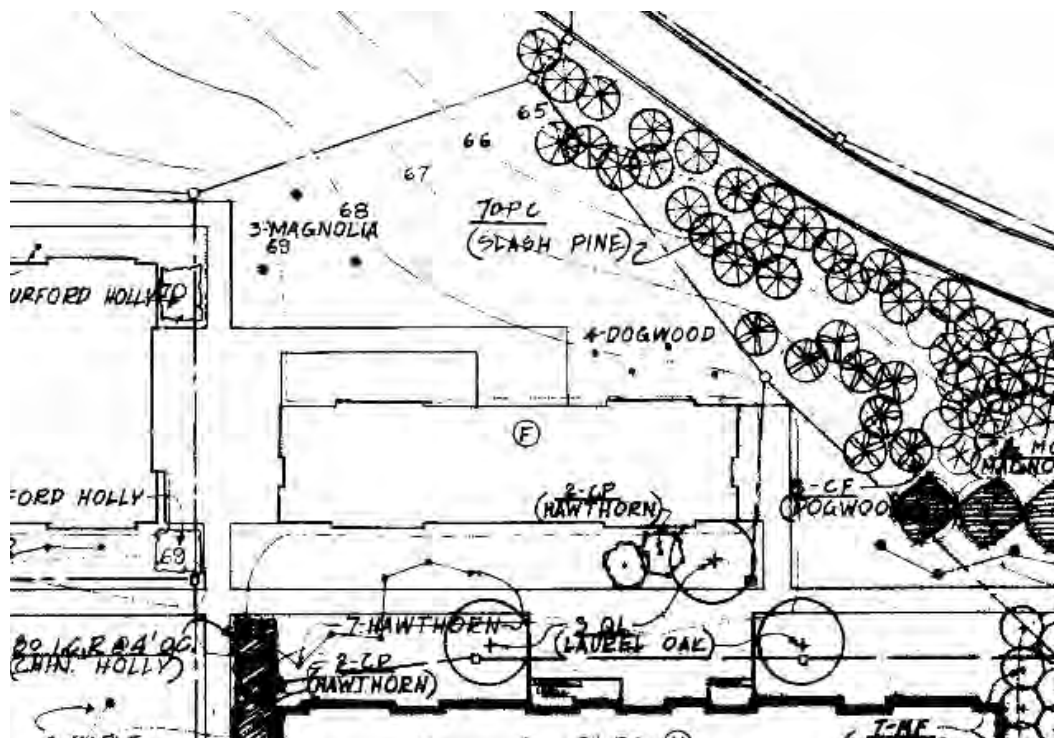
3.3.15.1 Character-defining features

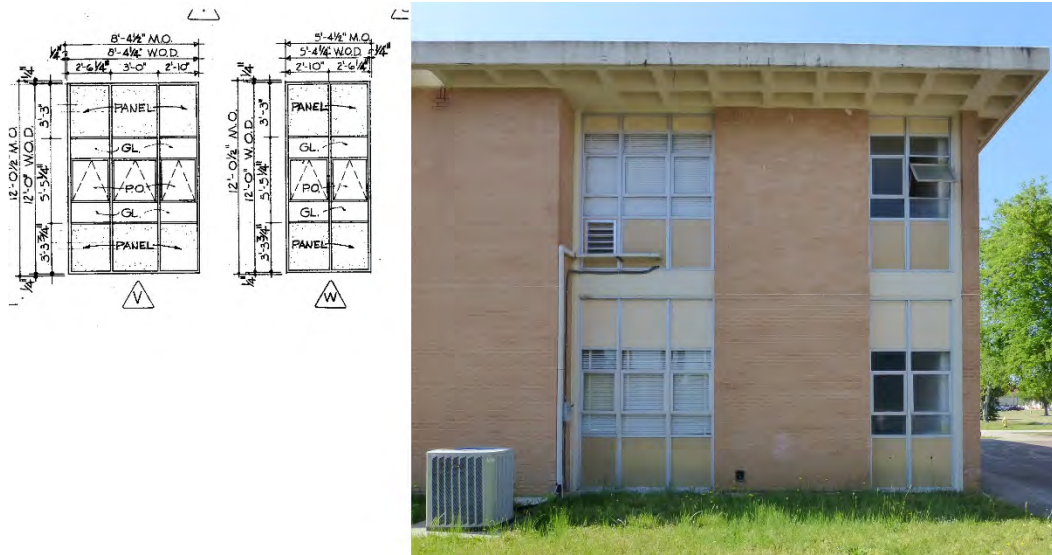
Figure 437. Large window group – comparison of the original design and materials from 1964 [left] to the current condition of the bright-aluminum three-pane awning-style windows with insulated panels and exposed concrete structure [right] (ERDC-CERL, 2015).

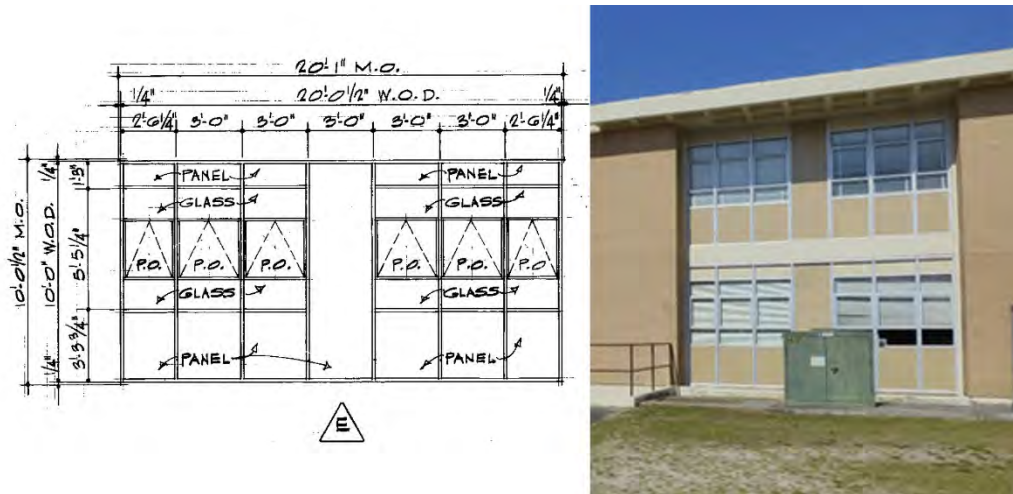
Figure 438. East and west entries – comparison of the original design and materials detail drawing from 1964 [left] to the current condition of the metal and pane doors with transom and the metal and plate-glass doors with transoms [right] (ERDC-CERL, 2015).

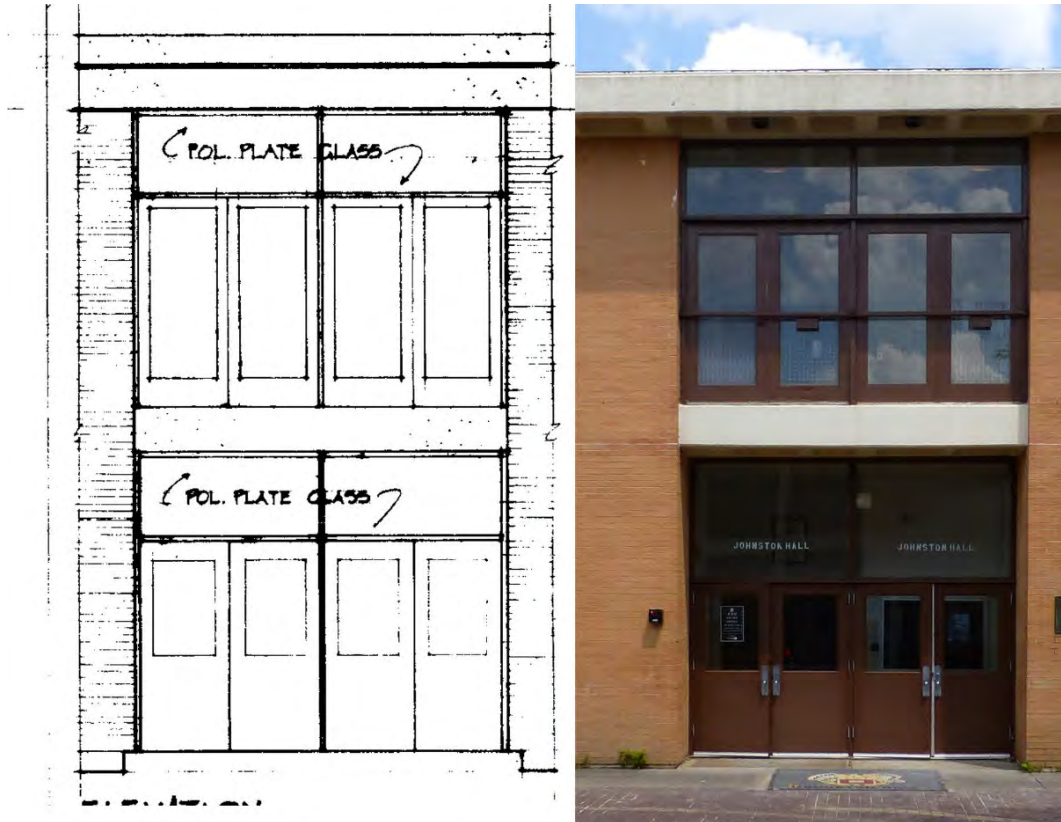
Figure 439. Ceiling-mounted light fixture under the waffle overhang – comparison of the original design and material from 1966 [left] to the current condition of the ceiling-mounted light fixture [right] (ERDC-CERL, 2015).

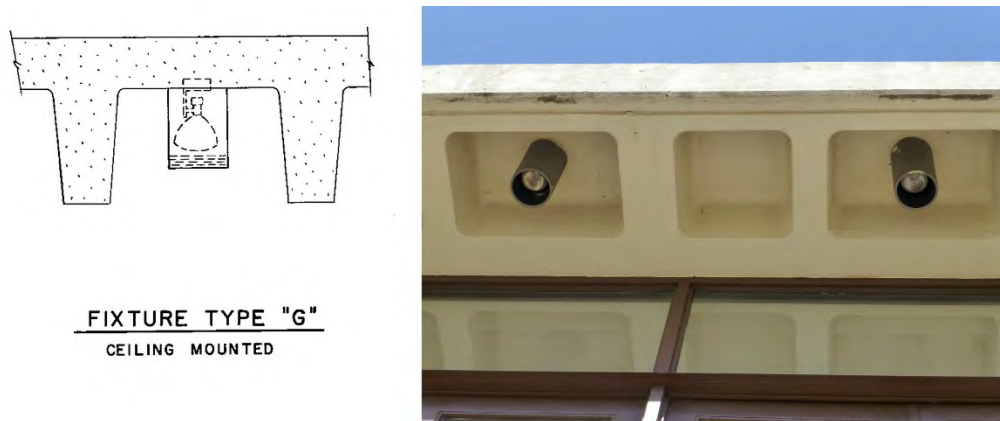
3.3.16 Building 29819, Stansell Hall (1970)

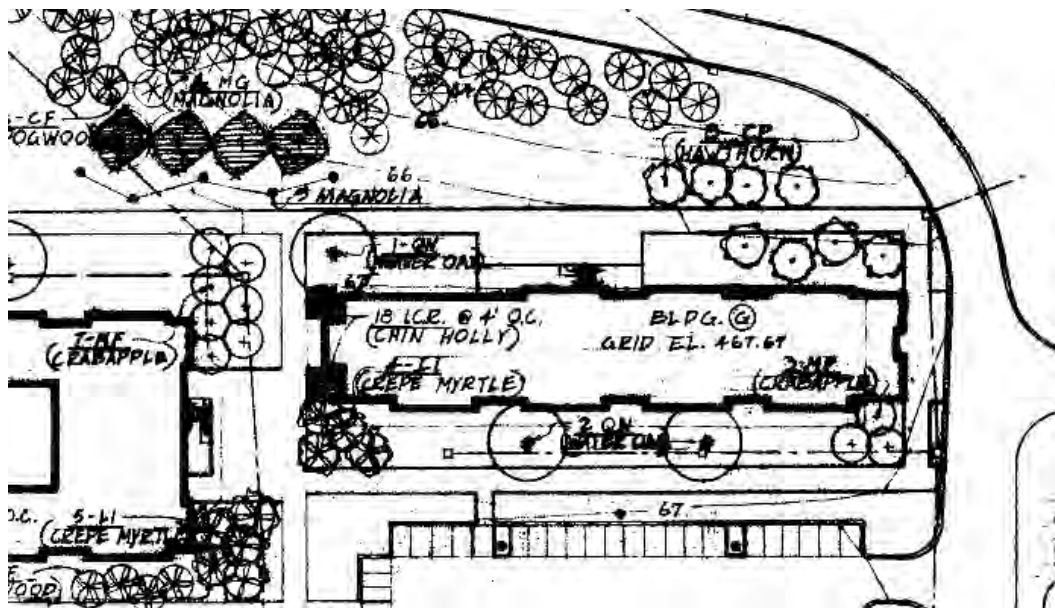
3.3.16.1 Character-defining features

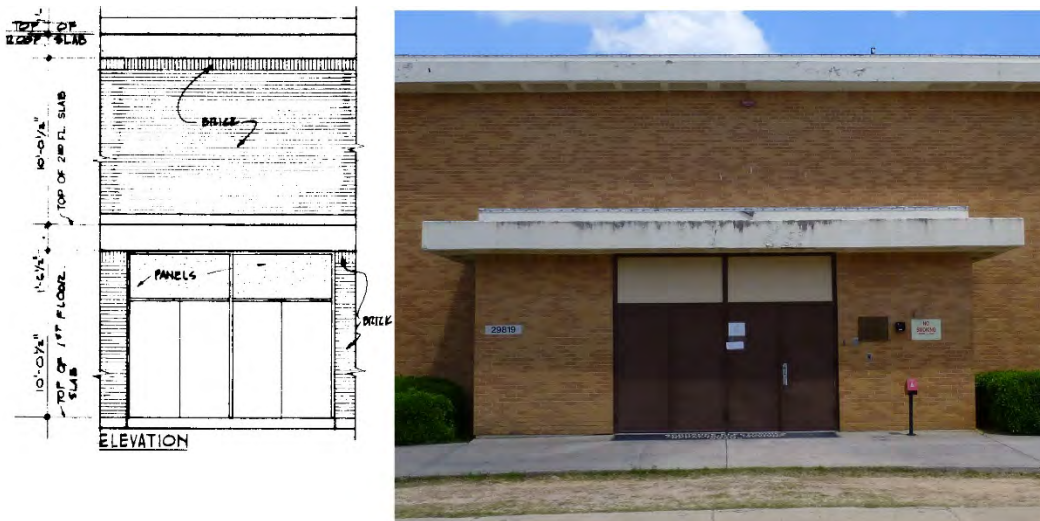
Figure 451. East elevation entry – comparison of the original design and materials detail drawing from 1966 [left] to the current condition of the metal doors and bright aluminum framed insulated panels [right] (ERDC-CERL, 2015).

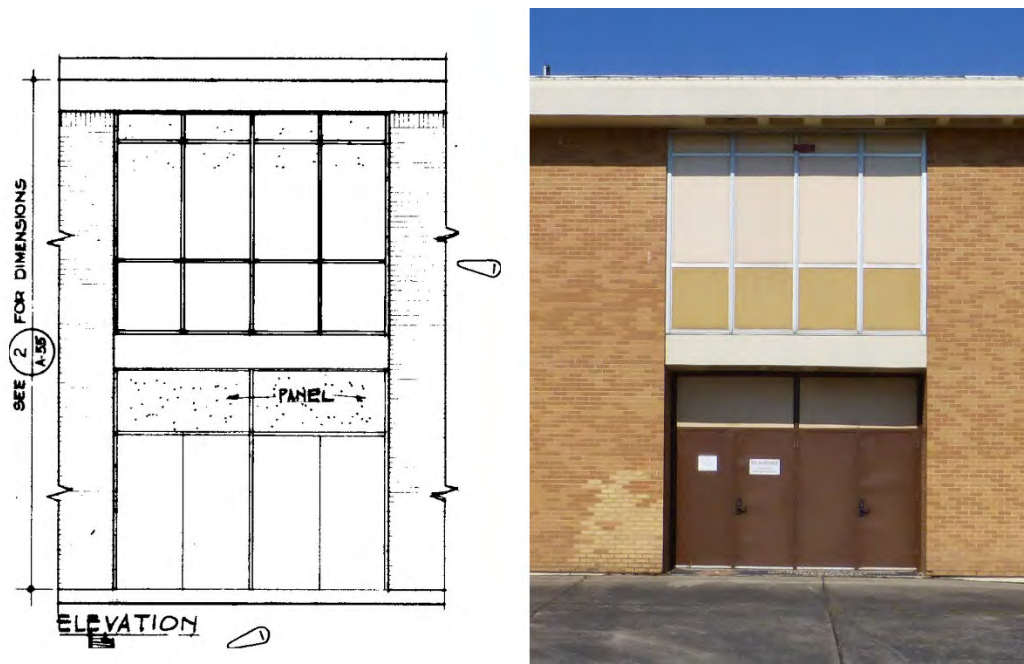
Figure 452. Northeast window bays – comparison of the original design and materials detail drawing from 1966 [left] to the current condition of the concrete panels and bright-aluminum framed insulated panels [right] (ERDC-CERL, 2015).

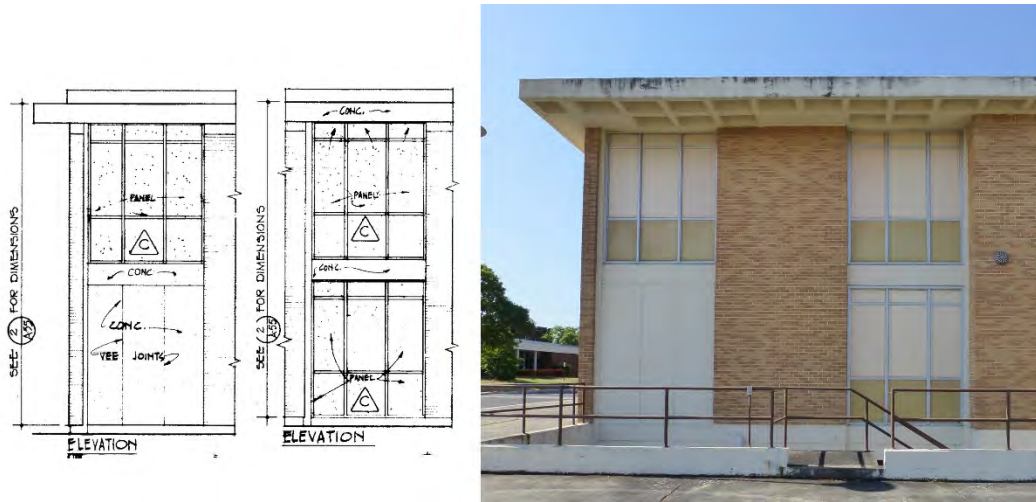
Figure 453. Large window bay on the north elevation – comparison of the original design and materials detail drawing from 1966 [left] to the current condition of the bright-aluminum framed insulated panels separated by exposed concrete structural system [right] (ERDC-CERL, 2015).

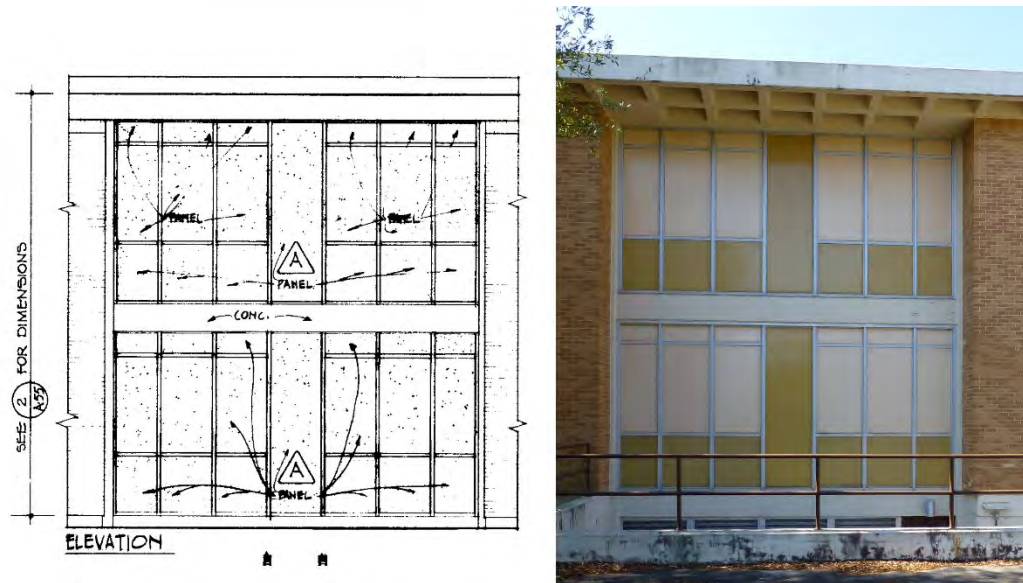
Figure 454. Ceiling-mounted exterior light fixture under waffle overhang - comparison of the original design and materials details drawing from 1966 [left] to the current condition of the light fixture [right] (ERDC-CERL, 2015).

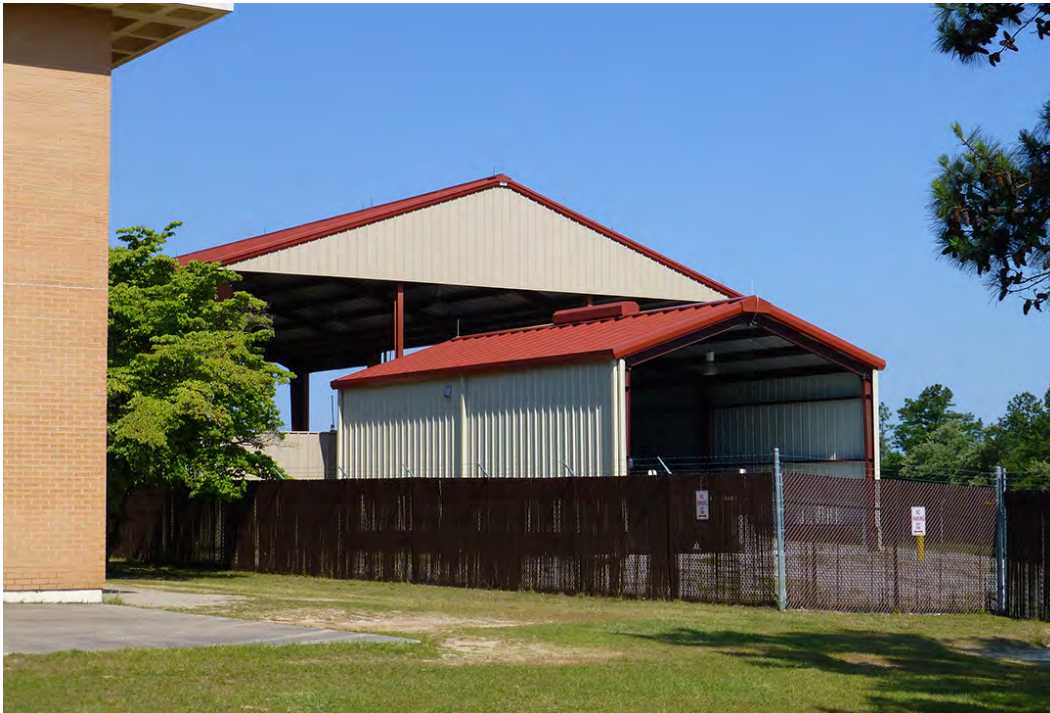
The Heat/AC Plant (25910) (Figure 460) was designed by Sewell and Associates and constructed in 1966. It and its associated cooling towers (Figure 461) were not part of the Aeck master plan. The cooling towers were replaced in 1985 and 2000. The water storage tank (25912) (Figure 462) was added to the Heat/AC Plant in 2000 and it has an associated mechanical room (25911). In 1975 an electrical substation was added to the complex to help with an increase in power needs for the complex (Figure 463).

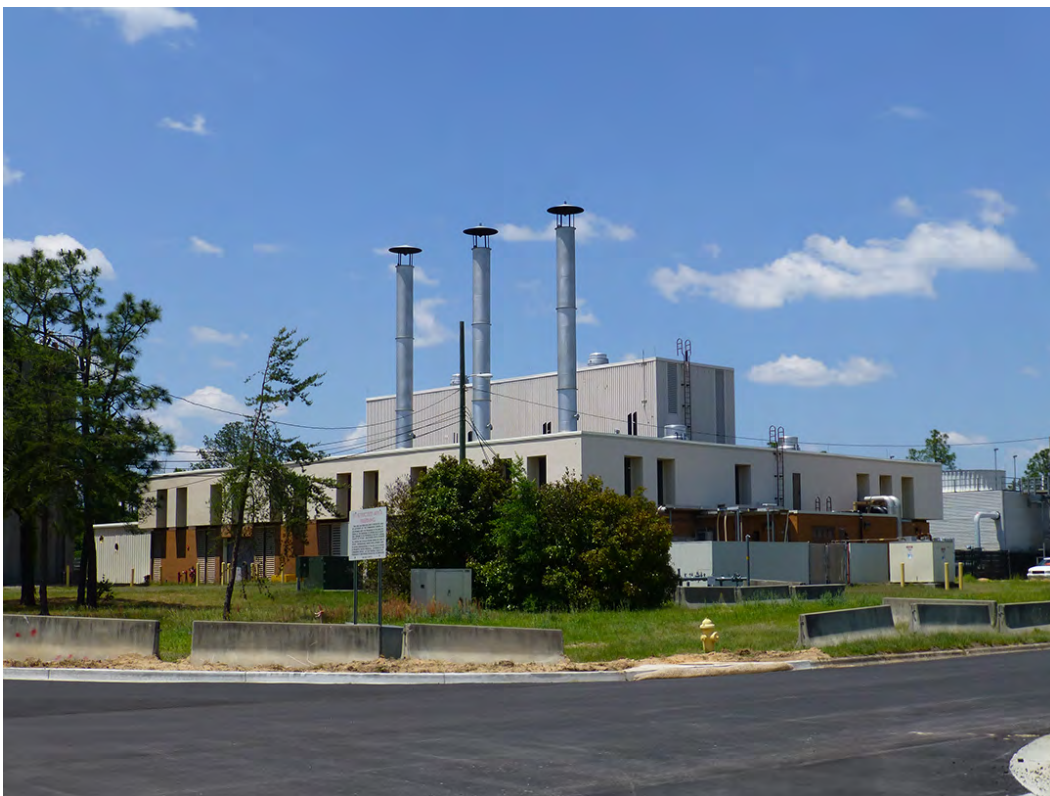
Figure 461. Building 25910 AC Cooling Towers, north of the Heating/AC Plant (ERDC-CERL, 2015).
