Weldability of Rare Earth Treated
Homogeneous Armor Steel Plate
Interim Report No. 1

Contract No. DA-36-034-ORD-1423RD

February 14, 1955

Major Report No. 207

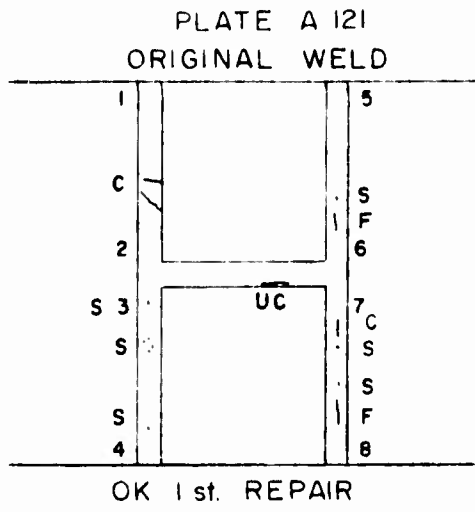
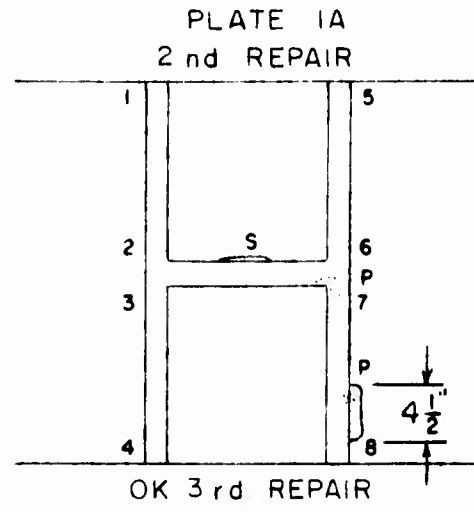
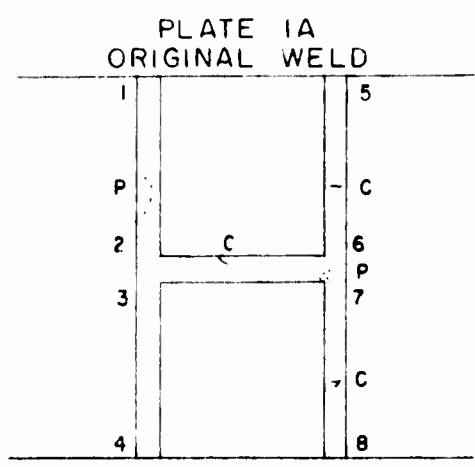
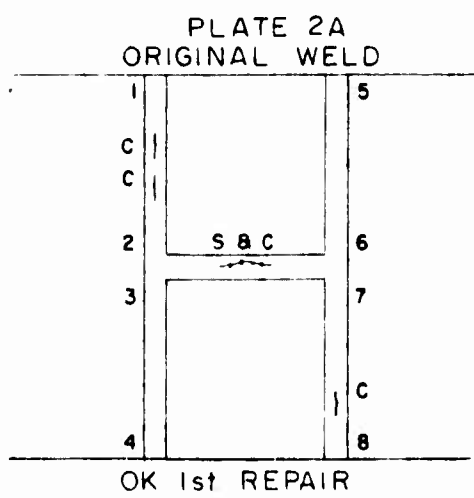
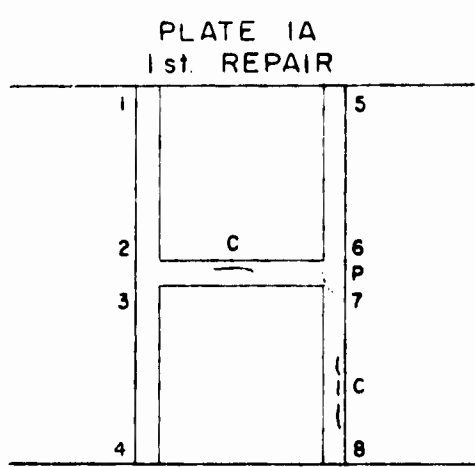
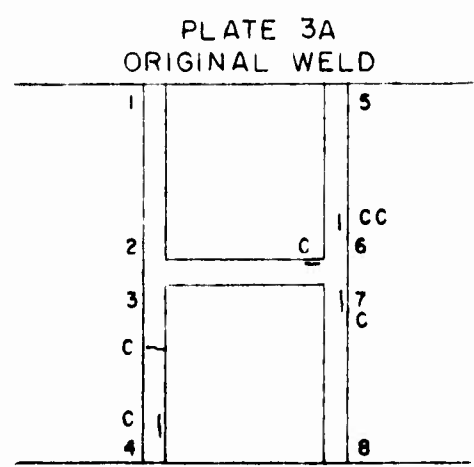
Figure 12

difficulty was encountered with each of the three heats involved. On heat JL 0681 it was necessary to scrap plate No. All5 for laminations, with replacement being made from other available material. Of the twelve plates completed, considerable cracking difficulty was encountered with one plate from each of the three heats and under ordinary circumstances these plates would have been scrapped and replaced, however, in an effort to furnish the full complement of four plates of each heat, the plates were subjected to repeated repairs until found to be radiographically acceptable. Figures 12 through 19 show the defects and number of repairs required on each of the twelve plates. It will be noted that in all cases considerable difficulty was encountered with slag porosity, and cracking.

"H" PLATE WELDING DEFECTS
HEAT JL 0681

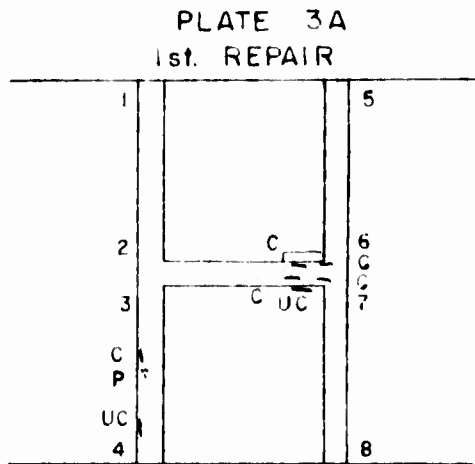
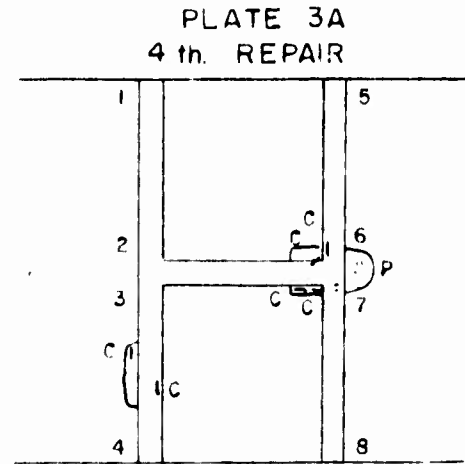
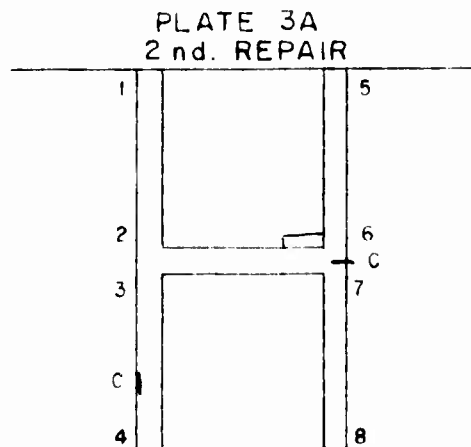
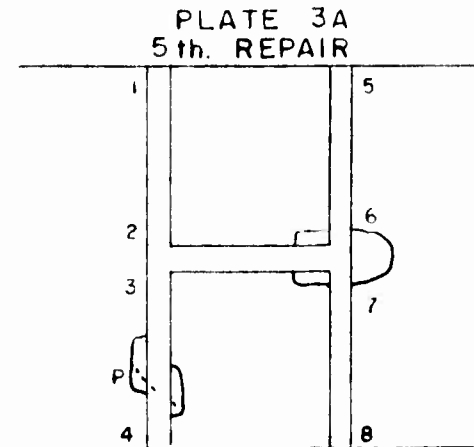
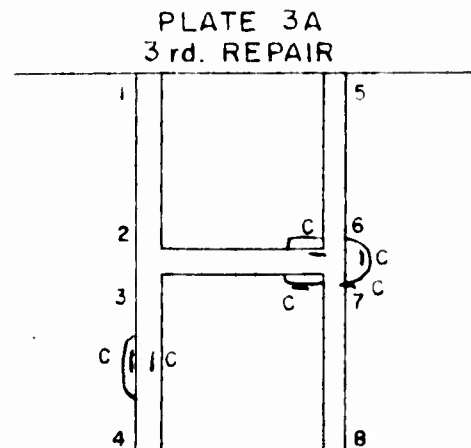
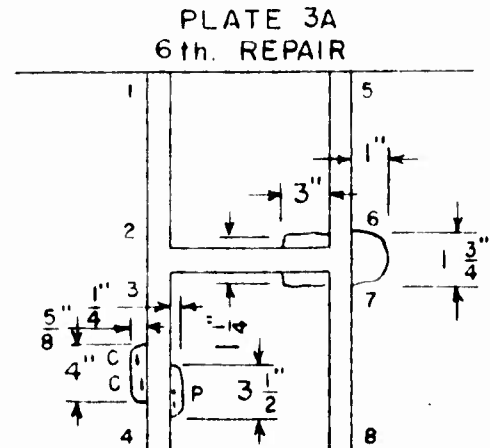
Figure 13

"H" PLATE WELDING DEFECTS

OK 7th. REPAIR

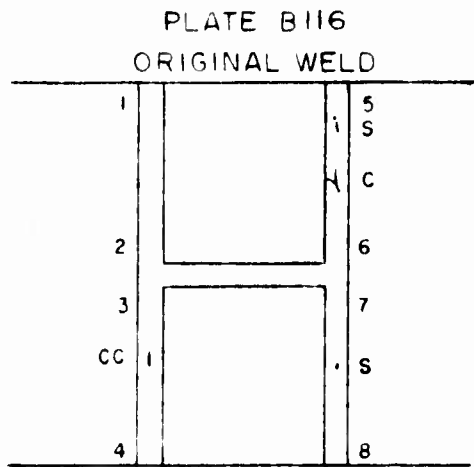
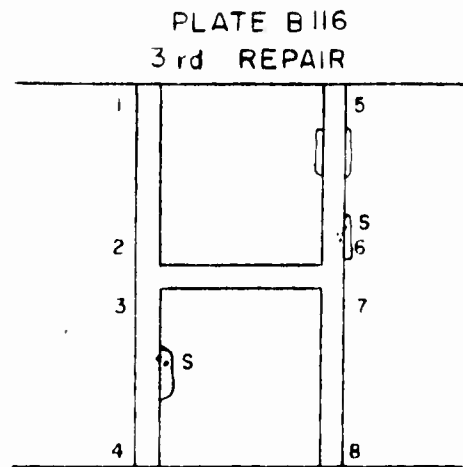
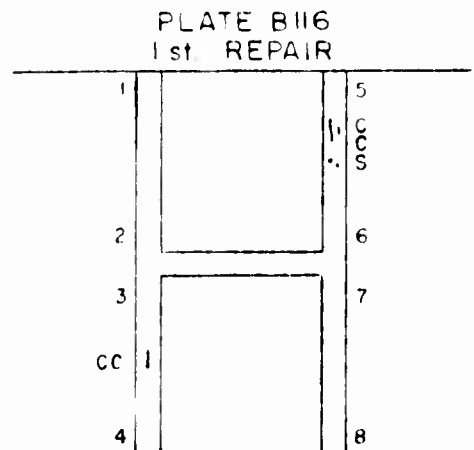
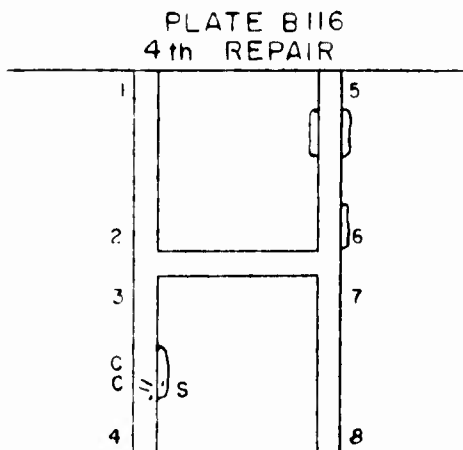
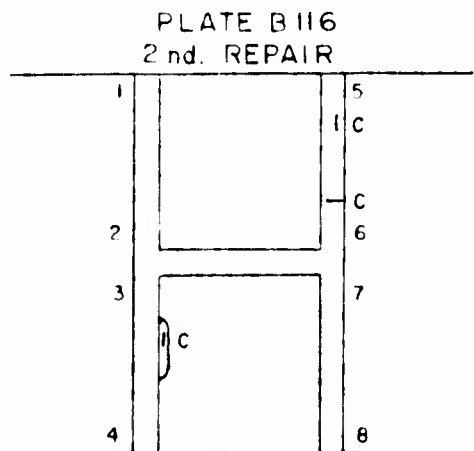
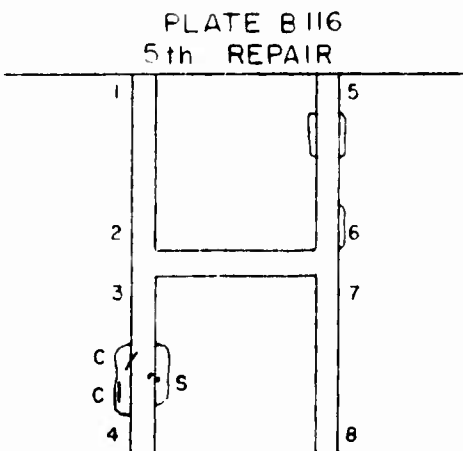
Figure 14

"H" PLATE WELDING DEFECTS
HEAT JL 0724

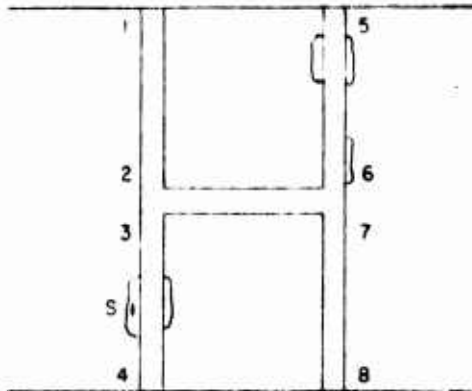
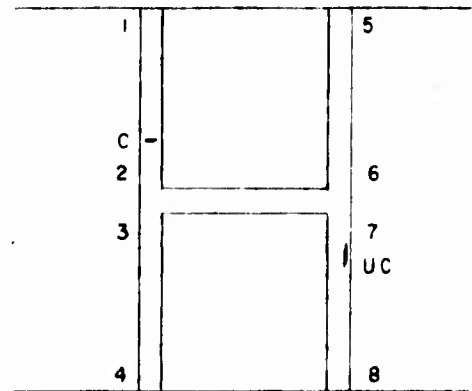
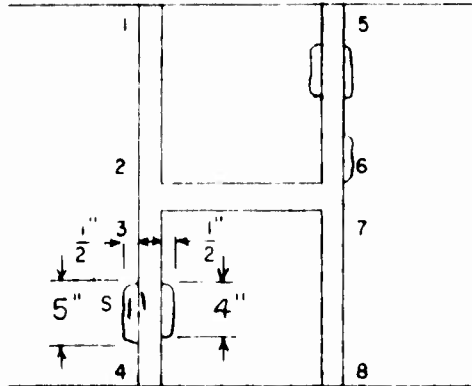
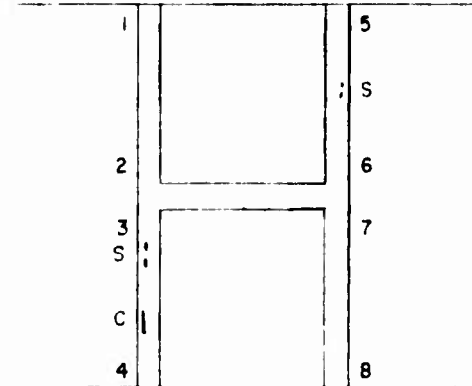
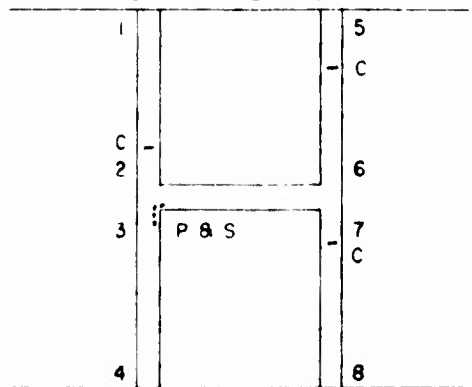
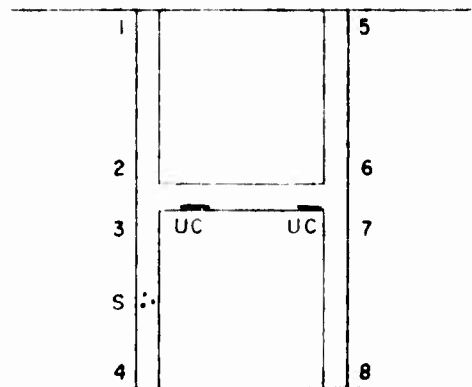
"H" PLATE WELDING DEFECTS
HEAT JL 0724

PLATE B 116
6th. REPAIR

PLATE 1B
1st. REPAIR

OK 2nd. REPAIR

PLATE B 116
7th. REPAIR

OK 8th. REPAIR

OK 1st REPAIR

OK 1st. REPAIR

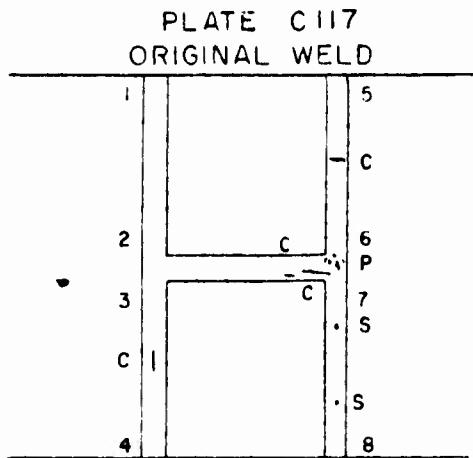
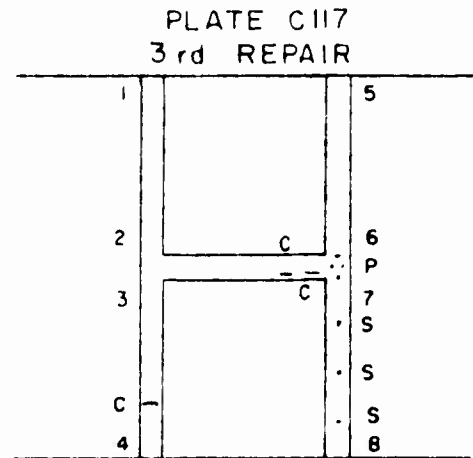
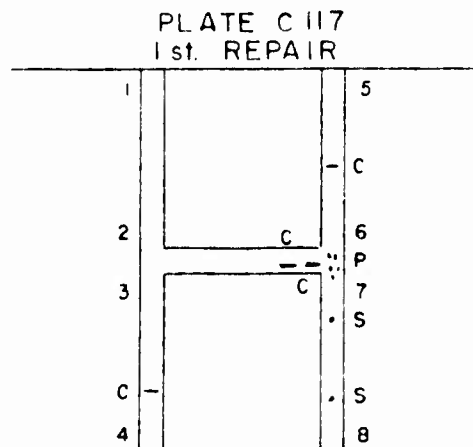
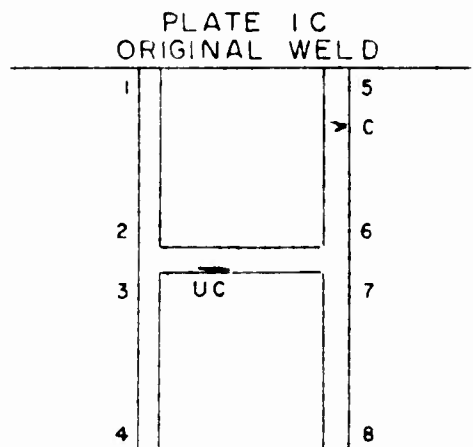
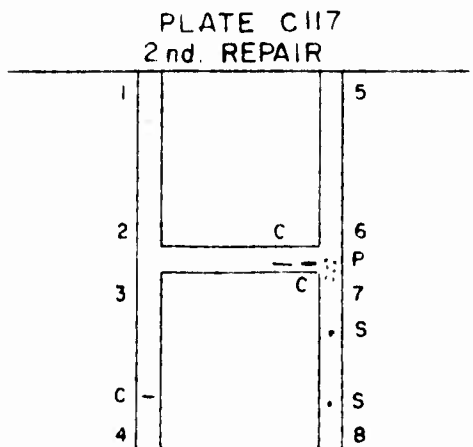
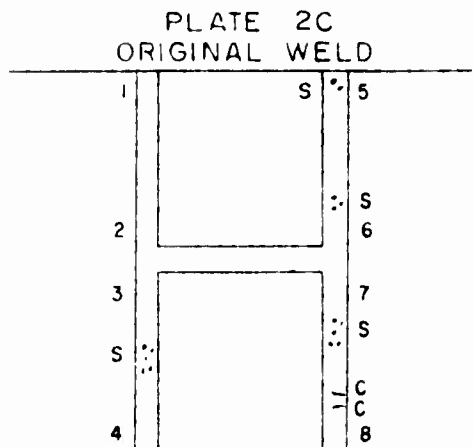
"H" PLATE WELDING DEFECTS
HEAT JL 0823

OK 4th REPAIR

OK 1st REPAIR

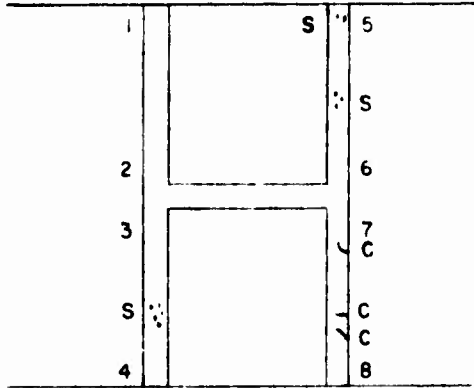
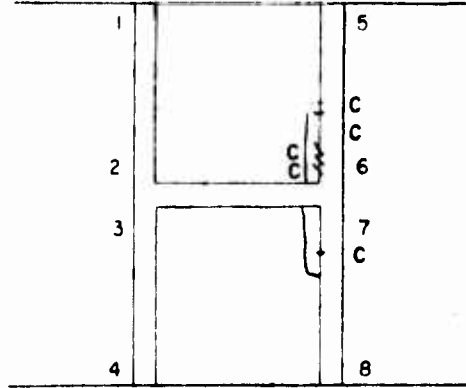
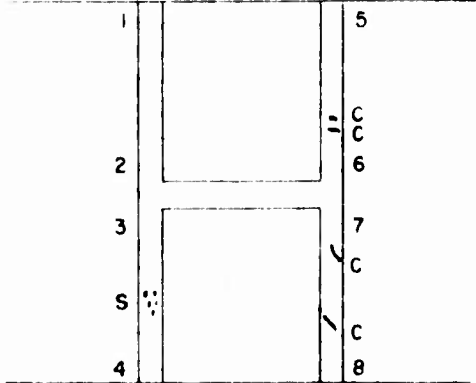
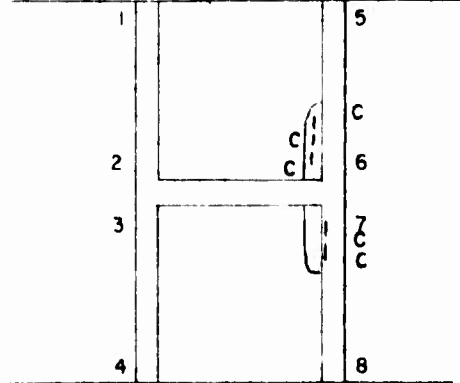
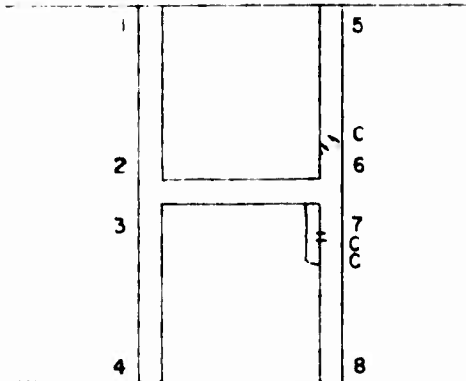
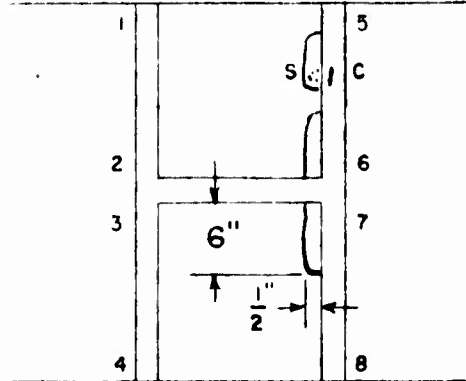
Figure 16

"H" PLATE WELDING DEFECTS
 HEAT JL 0823

PLATE 2C
1st. REPAIR

PLATE 2C
4th. REPAIR

PLATE 2C
2nd. REPAIR

PLATE 2C
5th. REPAIR

PLATE 2C
3rd. REPAIR

PLATE 2C
6th. REPAIR

OK 7th. REPAIR

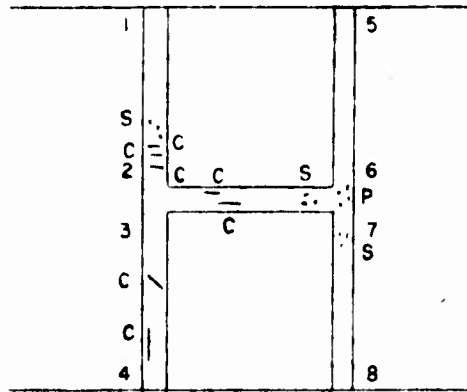
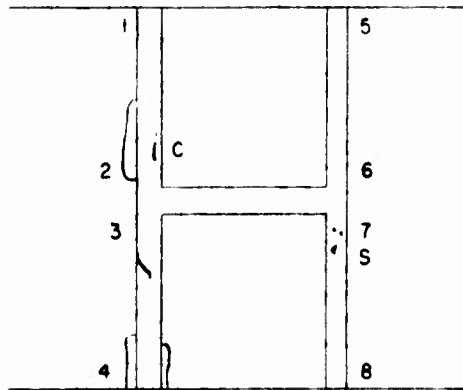
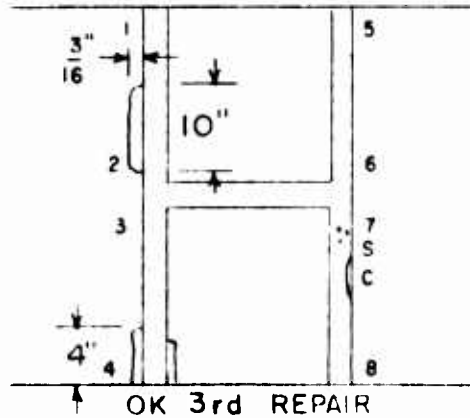
Figure 18

"H" PLATE WELDING DEFECTS

PLATE 3C
1st. REPAIR

PLATE 3C
2nd. REPAIR

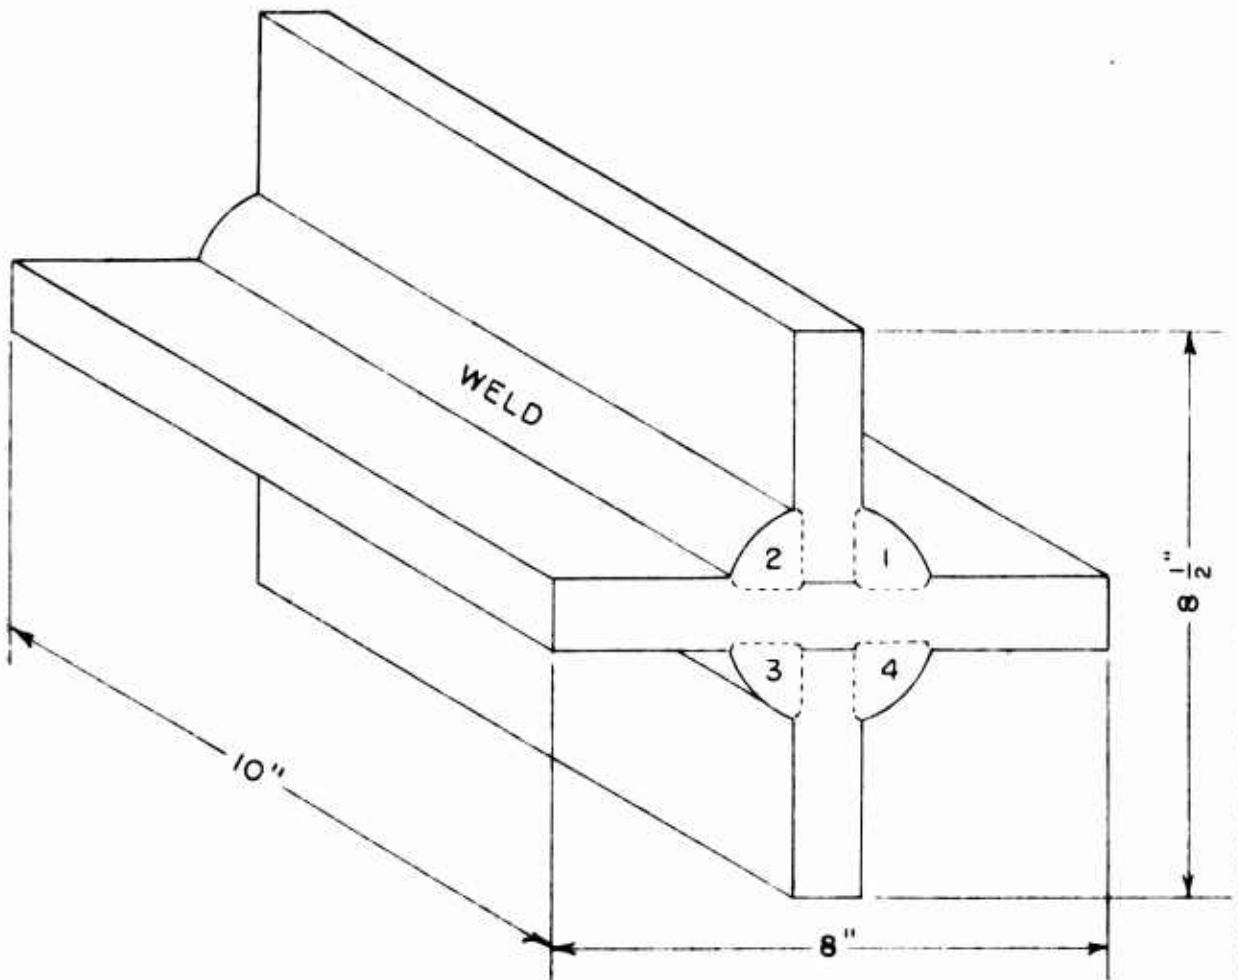
CRUCIFORM TEST

34. After the completed weldments were stress relieved at 1100° F for prevention of propagation of any inherent or incipient cracks, seven one-inch slices were cut from the center of each weldment with both ends being discarded. The slices were surface ground, etched with nital and subjected to macroscopic examination for detection of evidence of cracking and the results of this examination are shown in tabular form in Table IV.

35. In this test the No. 4 weld is the most significant as it is made under the condition of greatest restraint. On the plates of the "A" and "C" series materials cracking occurred in the heat affected zones and fusion zones in twelve of the fourteen sections examined on each material. On plates of the "B" series material cracking occurred at this location in eight of the twelve sections examined. Cracking also occurred in the No. 1, 2, and 3 welds on ten of the fourteen sections of "A" series material, five of twelve sections of "B" series material and seven of fourteen sections of "C" series material. Therefore, on the basis of cruciform test, it is indicated that series "A" and "C" material are of approximately equal weldability with the "C" material being somewhat superior. Series "B" material is the most superior in weldability.
