POST. Lab.  
WATERTOWN ARSENAL  
WATERTOWN, MASS.

REPORT NO. 710/197

A STUDY OF  
THE MECHANISM OF PENETRATION OF HOMOGENEOUS  
ARMOR PLATE

June 14, 1937

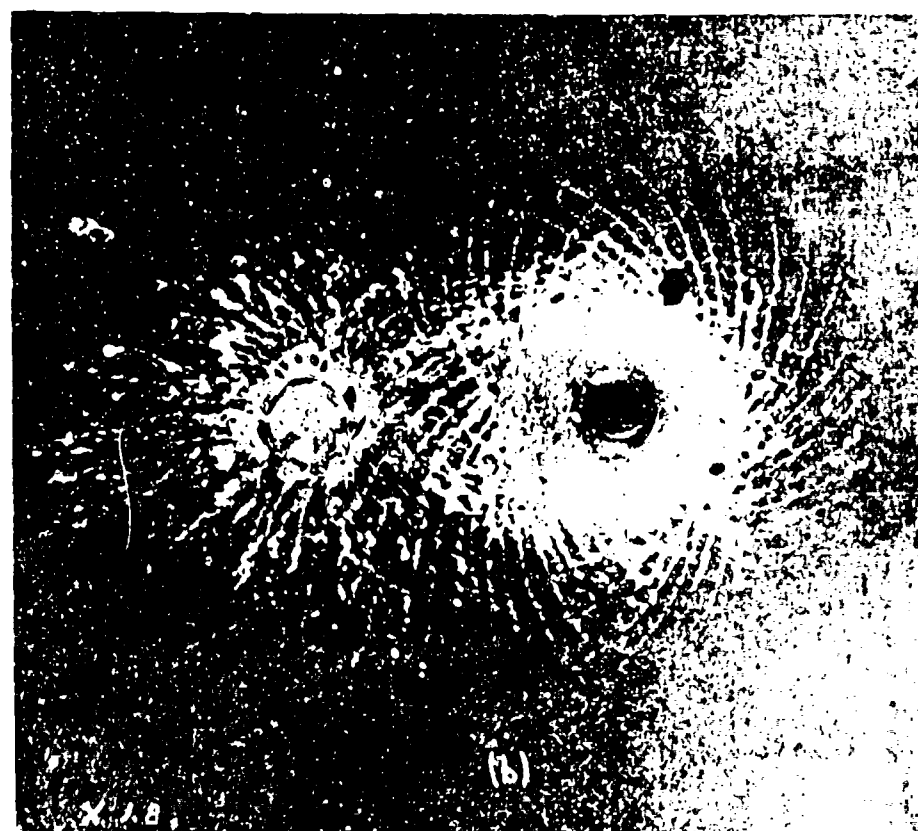
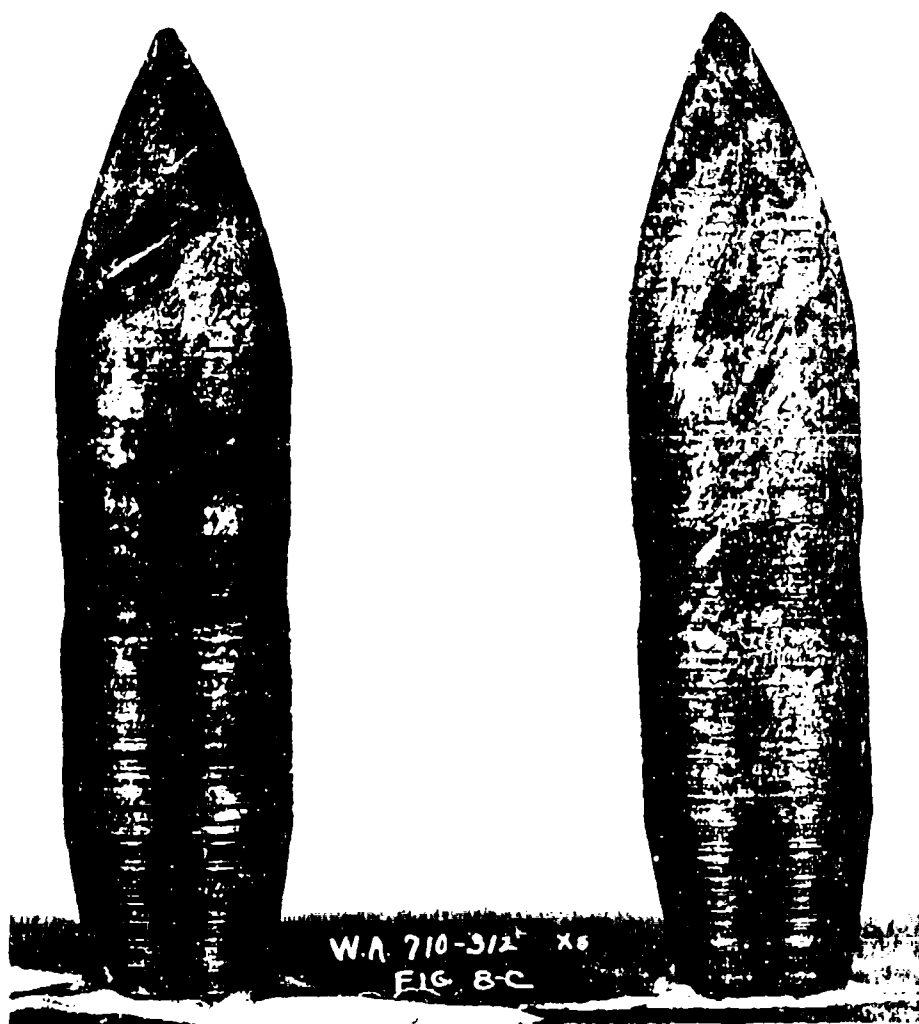
FIGURE 8.

It is interesting to note that Lders on the rear face of low carbon steel plate affected by bullet impact, as revealed by the Fry reagent, are quite similar to the strain markings on the rear face of the same plate shown by blowing off scale, see Figure 8 (c).

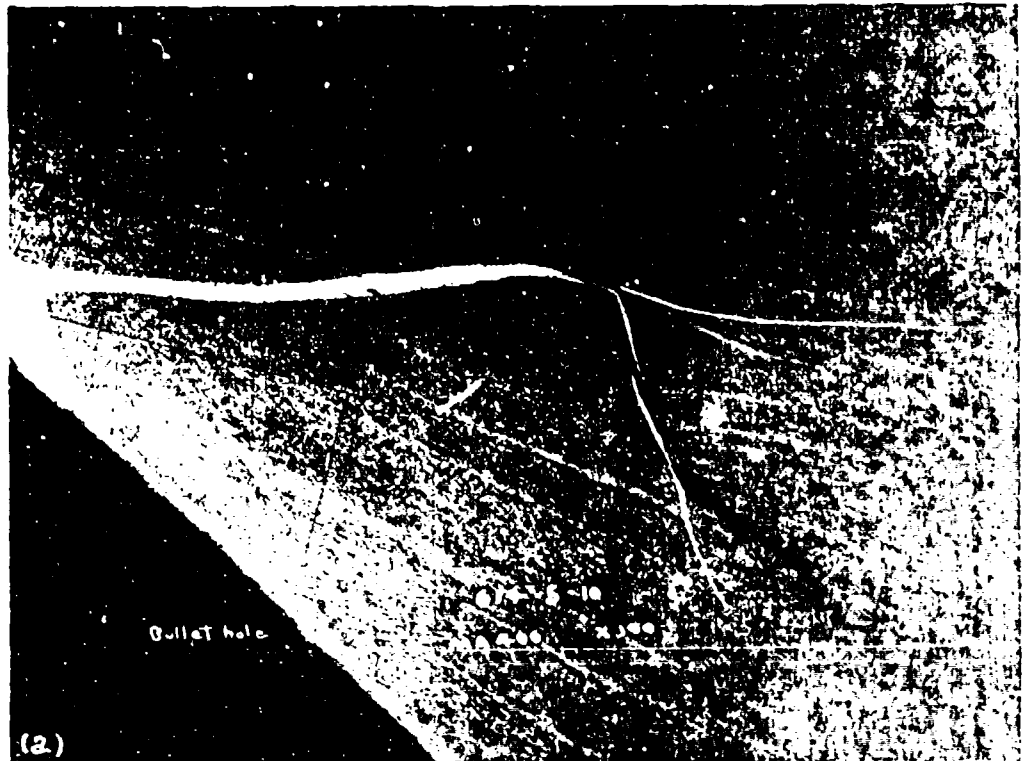
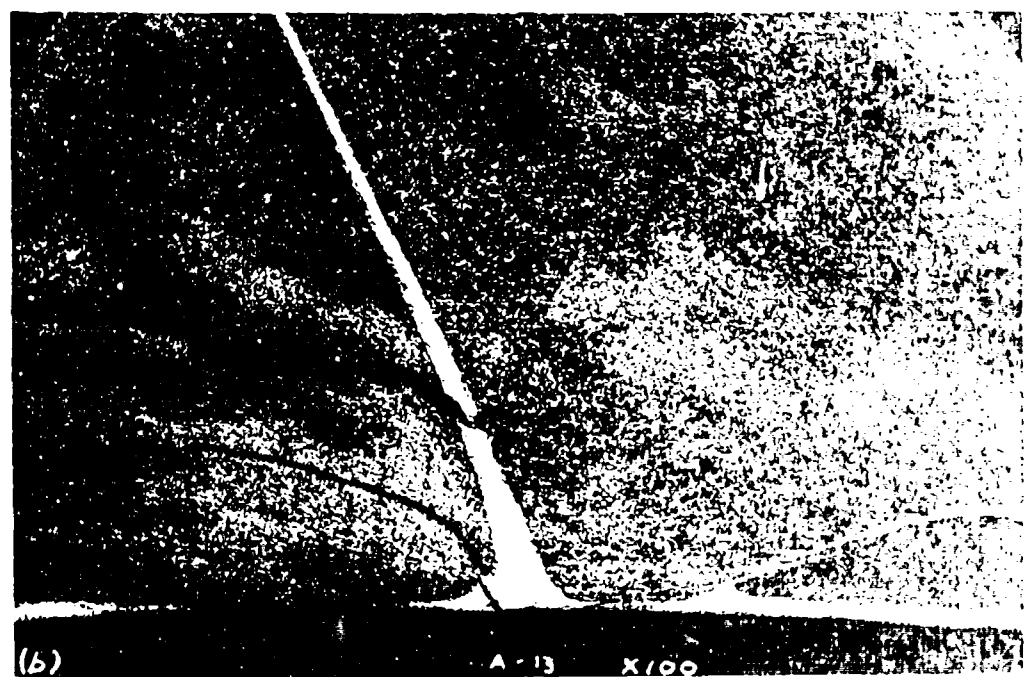
FIG 13

- (a) An interesting concurrence of crack and "white layer", although no inference can be drawn as to any inter-relation of the two.

- (b) This shows an abrupt shift in the crack's continuity at the boundary of the "white layer", indicating either a slipping of this whole layer after the formation of the crack, or a slipping of the metal after the crack's formation that was part of the process of layer formation.

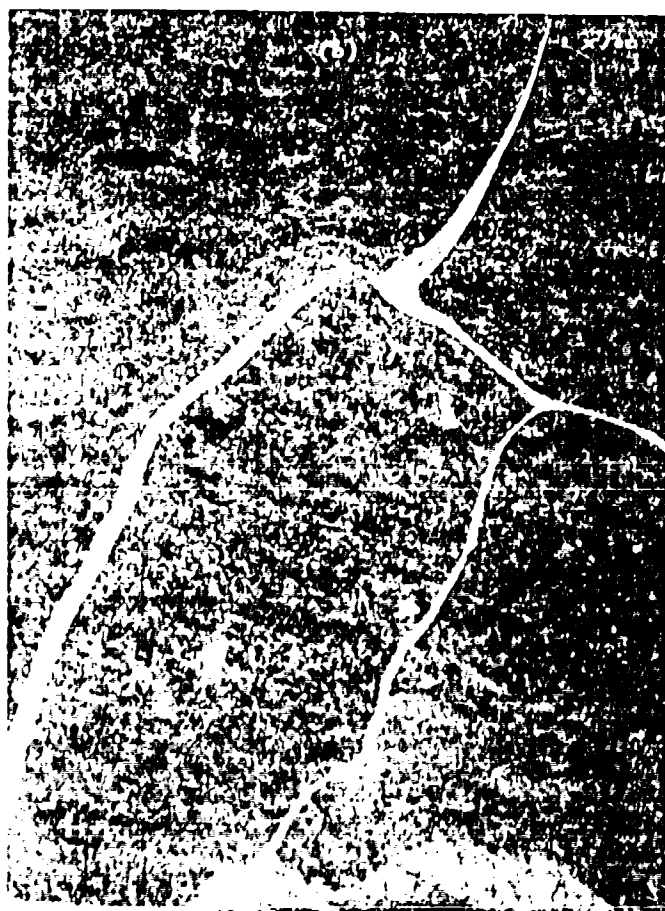
Tempering a standard chromium-molybdenum-vanadium armor plate at 200°C for half an hour causes a transformation at the borders of the "white layers" into a constituent which closely resembles troostite, see Figures 20 (a), (b), and (c).

Tempering this composition at 300°C for half an hour causes a nearly complete transformation of what is believed to be martensite in the "white layer" into troostite, Figures 20 (d), and (e). In several instances, the exact center of the layer was not fully transformed at the 300°C temper, see Figure 20 (e).

- (d) After 300°C temper, showing a precipitation of carbides on the layer that are slightly larger than those found in the normal metal. The ease with which the layers etched after this tempering confirms the deduction from (b) and (c) that some transformation is beginning to take place.

- (e) Another layer in this same specimen. The fine "feather" appearance caused by flow lines on the outer portions of the layer are similar to those shown in the untempered specimen, Figure 7 (b).

- (f) A different composition steel, also tempered at 300°C for 30 minutes. This also shows a carbide precipitation, but more uniformly than the other specimen. Troostite-sorbite.

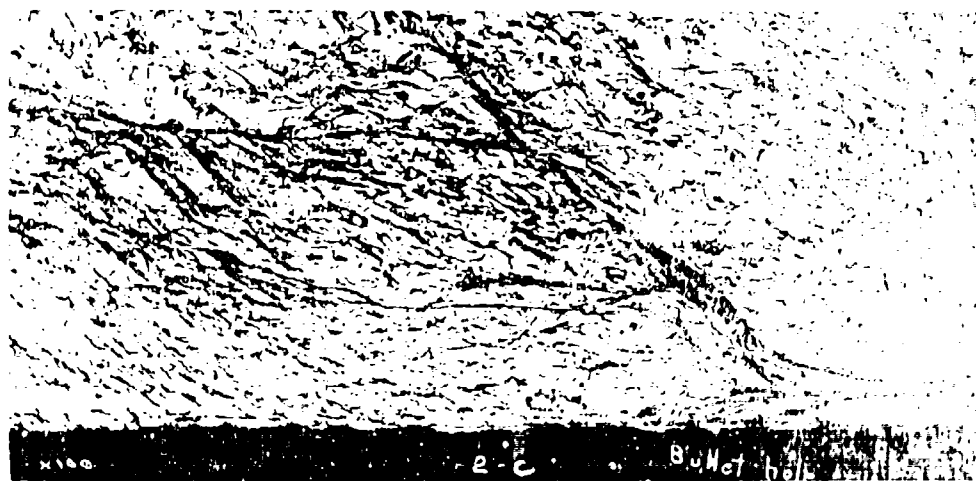
FIGURE 21.

- (a), (b), (c), (d), These all show a characteristic blackening about the bullet hole which is a carbide precipitation caused by heat effect of the penetrating bullet.

- (f) Microstructure of plate in an area far removed from the penetration.

- (i) Carbides found in selected areas as well as grain boundaries.

The structure of the manganese steel plate at considerable distance away from the bullet penetrations consists of a normal austenitic grain with no evidence of carbides at the grain boundaries, Figure 21 (f).
