Progress Report on
Cold Heading Versus Hot Heading
and Rivet Design

Memorandum
Report No. 710/373
Watertown Arsenal

July 8, 1941

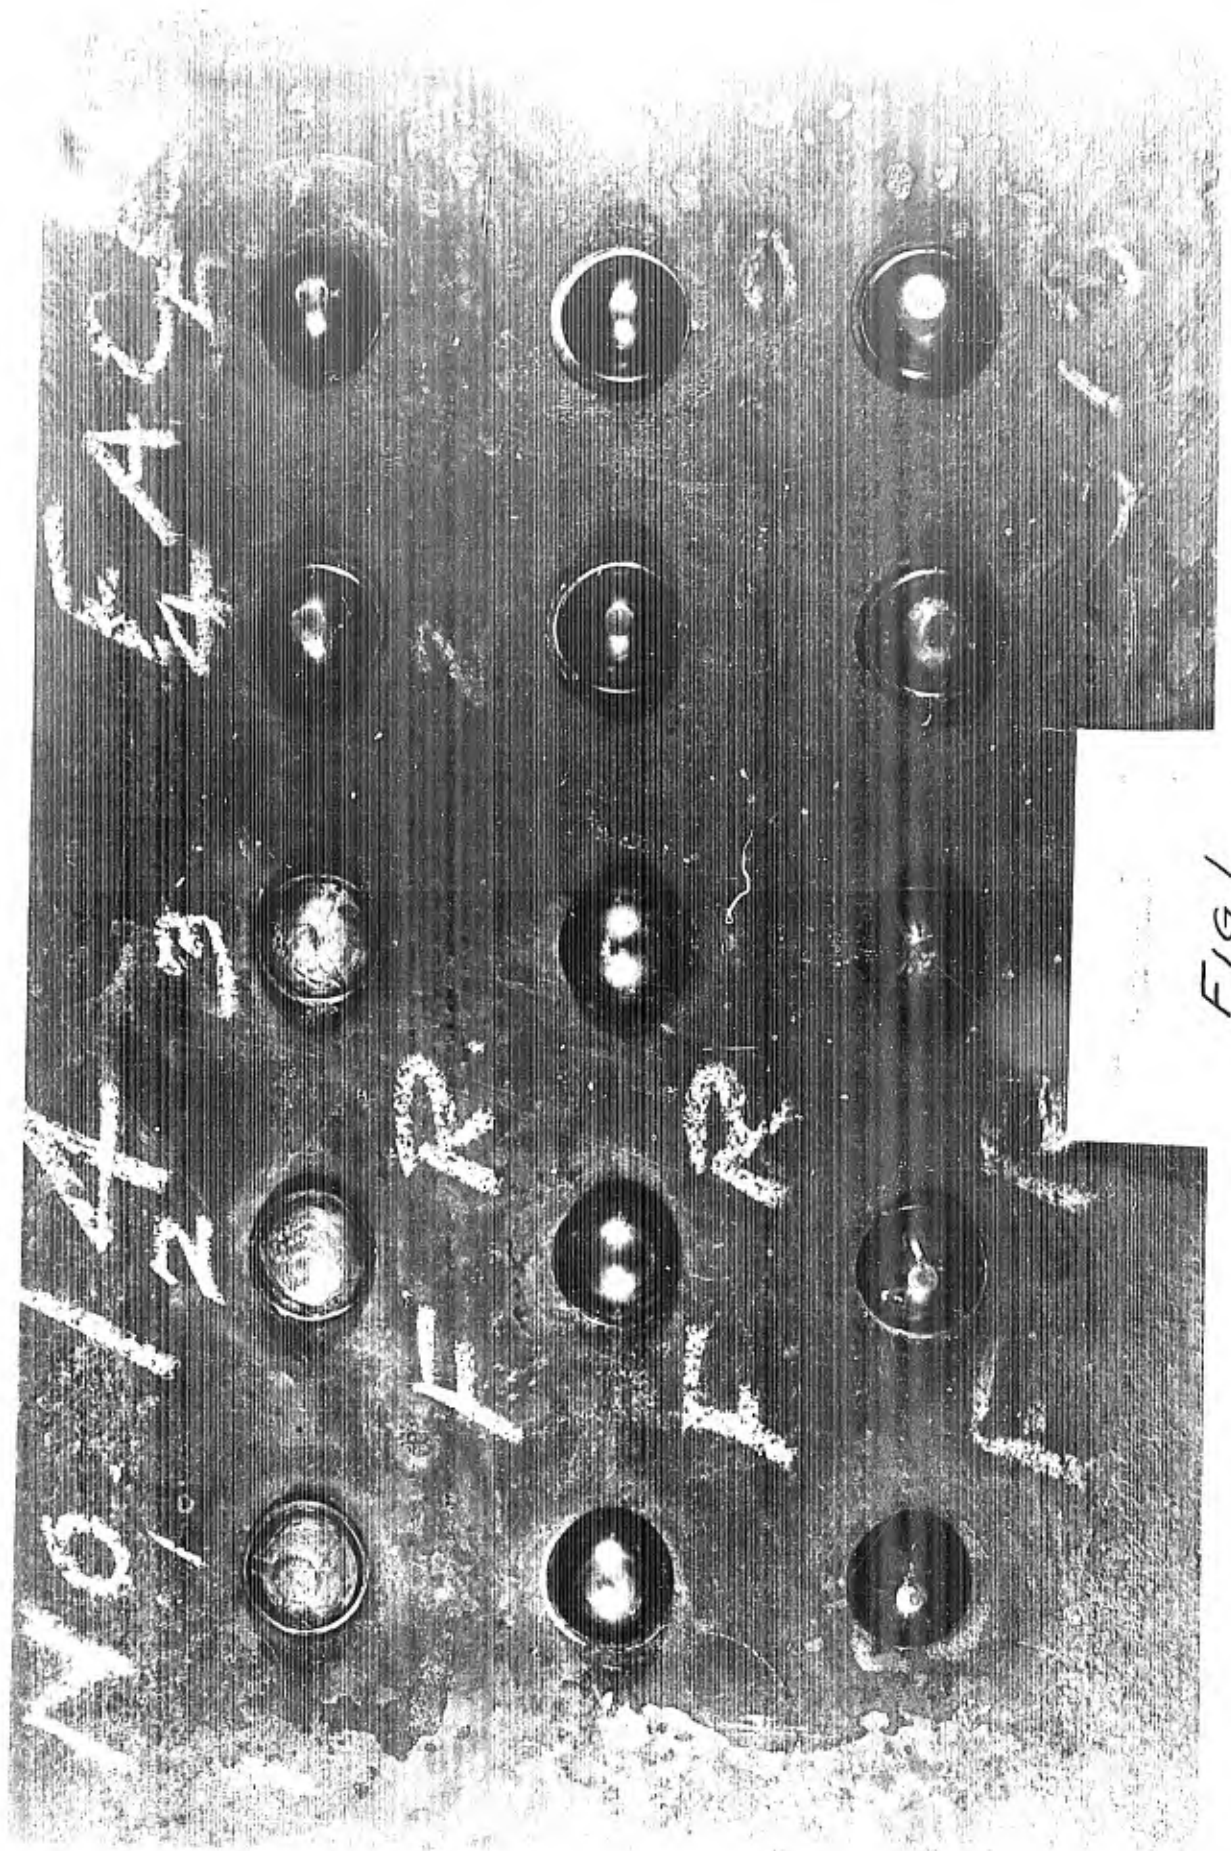
Fig. 1

3. Section No. 14, see Figures #1 and #2 attached, was made up of a 1/2" face hardened plate on the face riveted to a 1/4" structural steel backing plate with the rivets spaced on 3" centers. All rivets were normalized from 1550°F.

Row 1	Rivets 1-3	Manganese high tensile steel (.20 C - 1.25 Mn) hot headed from the rear.
Row 2	Rivets 1-3	Manganese high tensile steel, hot headed from the front.
Row 3	Rivets 1-3	Manganese high tensile steel, cold headed from the rear.

The manganese steel rivets, obtained from the Navy, were filleted with a 3/32" radius fillet under the original head. The drilled holes on both faces of the section were machined to form a 1/8" radius fillet to accommodate the filleted rivets and produce a fillet on the formed head. Rows 1 and 2, Rivets 4 and 5, SAE 2315, cold headed from the front.

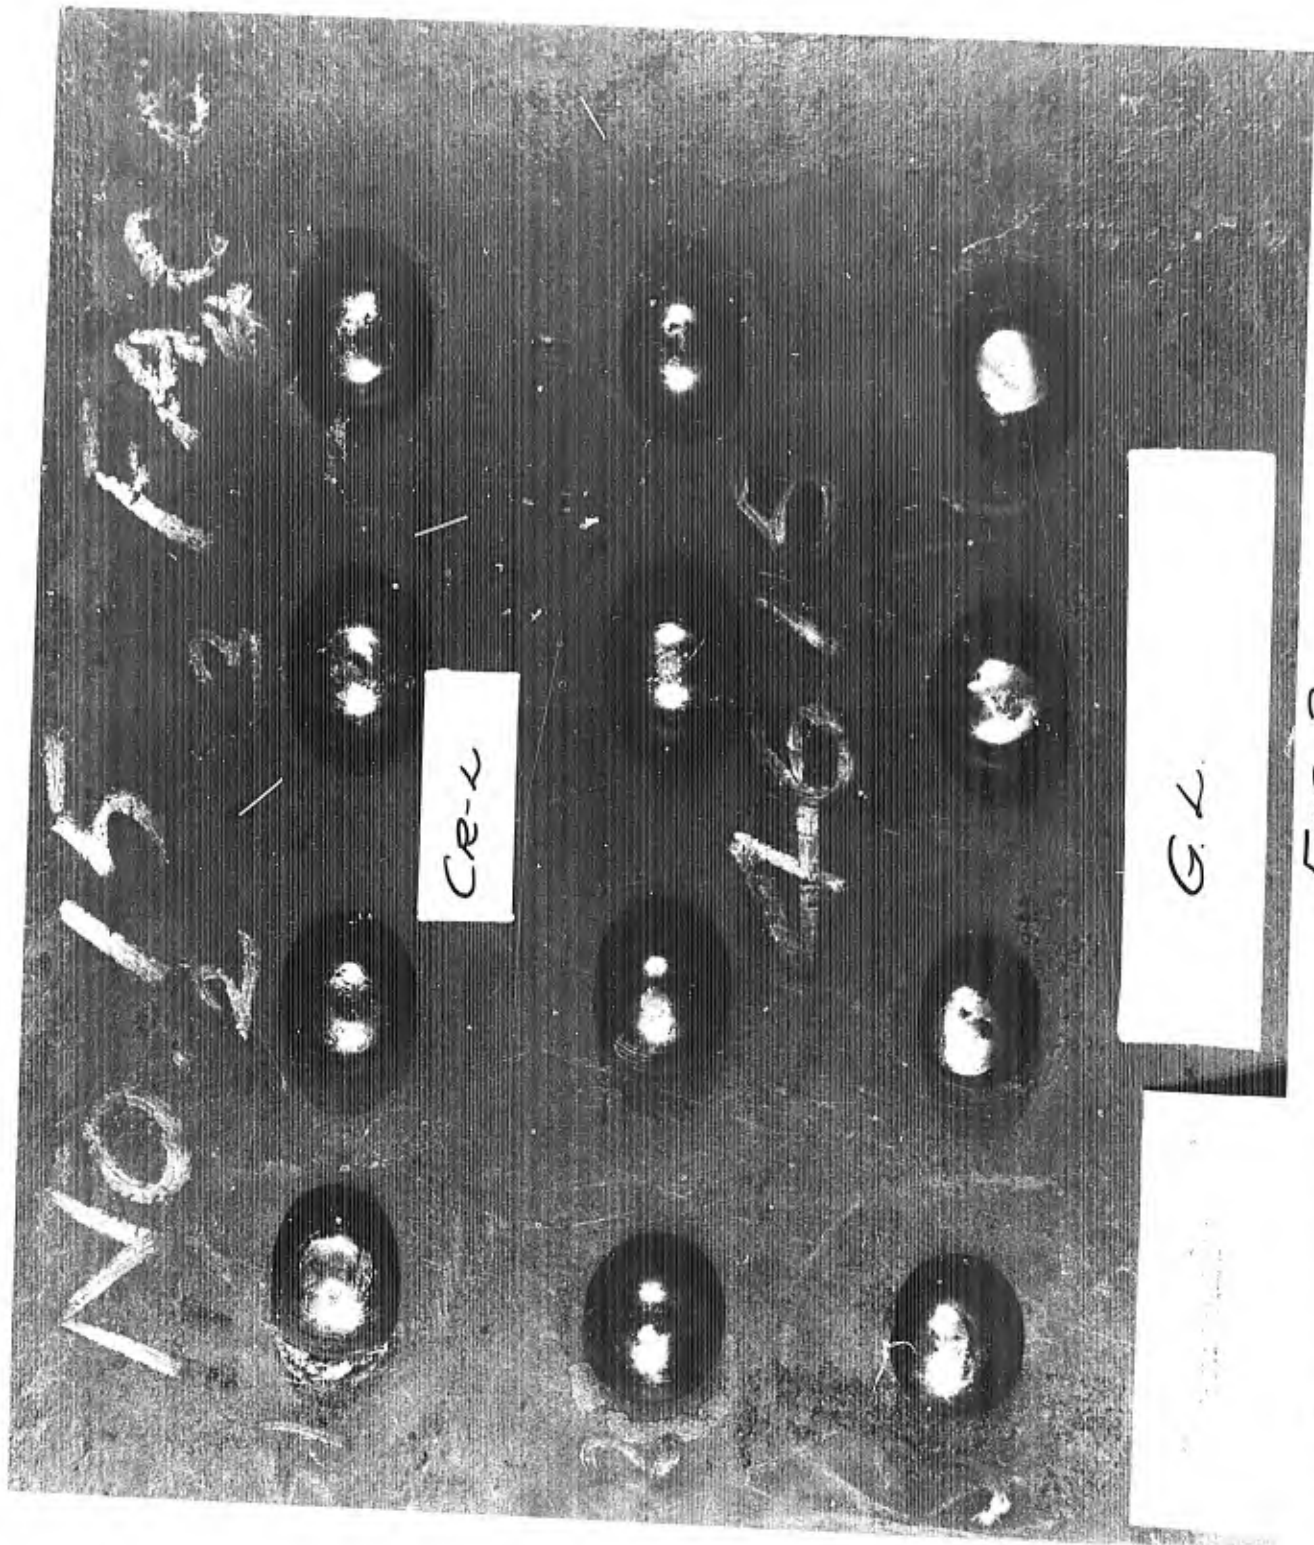
FIG. 3

4. Section No. 15, see Figures #3 and #4 attached, was made up of a 1/2" face hardened plate and a 1/4" structural steel backing plate. All rivet holes on this section were countersunk on the front and rear of the section with a 60° included angle tool to a depth of 1/16". All the rivets used in this section were also normalized from 1550°F.

Row 1	Rivets 1-4	Cromasil steel (manganese, silicon, chrome, vanadium) cold headed from the front.
Row 2	Rivets 1-4	SAE 4615, cold headed from the front.
Row 3	Rivets 1-4	N-A-X High Tensile steel, cold headed from the front.

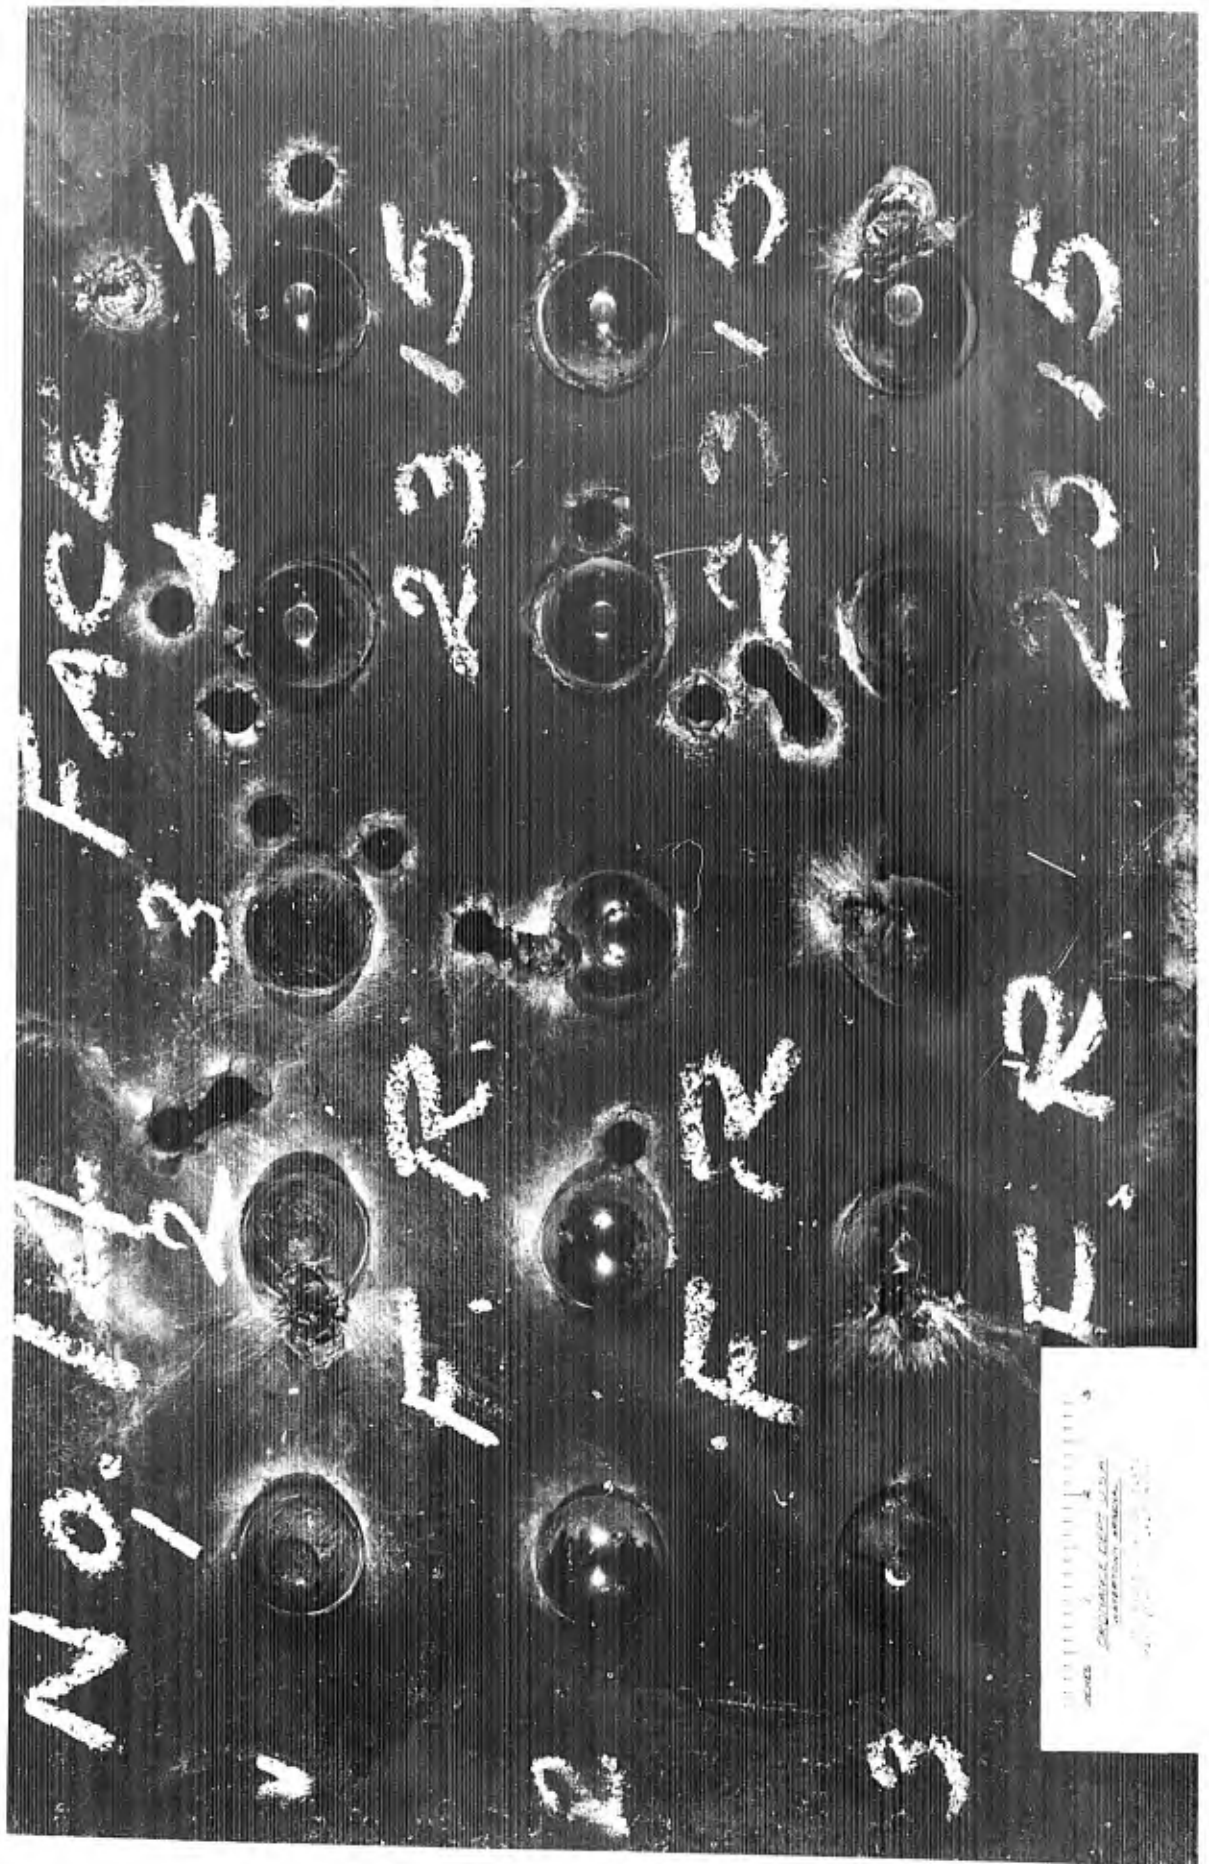
FIG. 5

5. Figures #5 and #6 attached show the front and rear of section No. 15 after ballistic testing. All shots fired were .50 caliber A.P. at a striking velocity of 2400 f/s. It will be noted that although many of the rivet heads were severely distorted by the impacts of projectiles, no heads were fractured from the section. In the case of the SAE 2315 rivets although no heads were fractured off, sectioning of several of these rivets revealed cracks propagating at the non-filleted original rivet heads. This condition resulted irregardless of whether the non-filleted head was on the front or the rear of the section. No cracks were found at the original filleted heads of the manganese steel rivets.

a. That the original heads should be filleted on all rivets used in the fabrication of armored structures subject to ballistic impact.

c. The manganese steel in the normalized condition appears very satisfactory if provided with at least a $3/32$ " (preferably $1/8$ ") fillet at the original head.

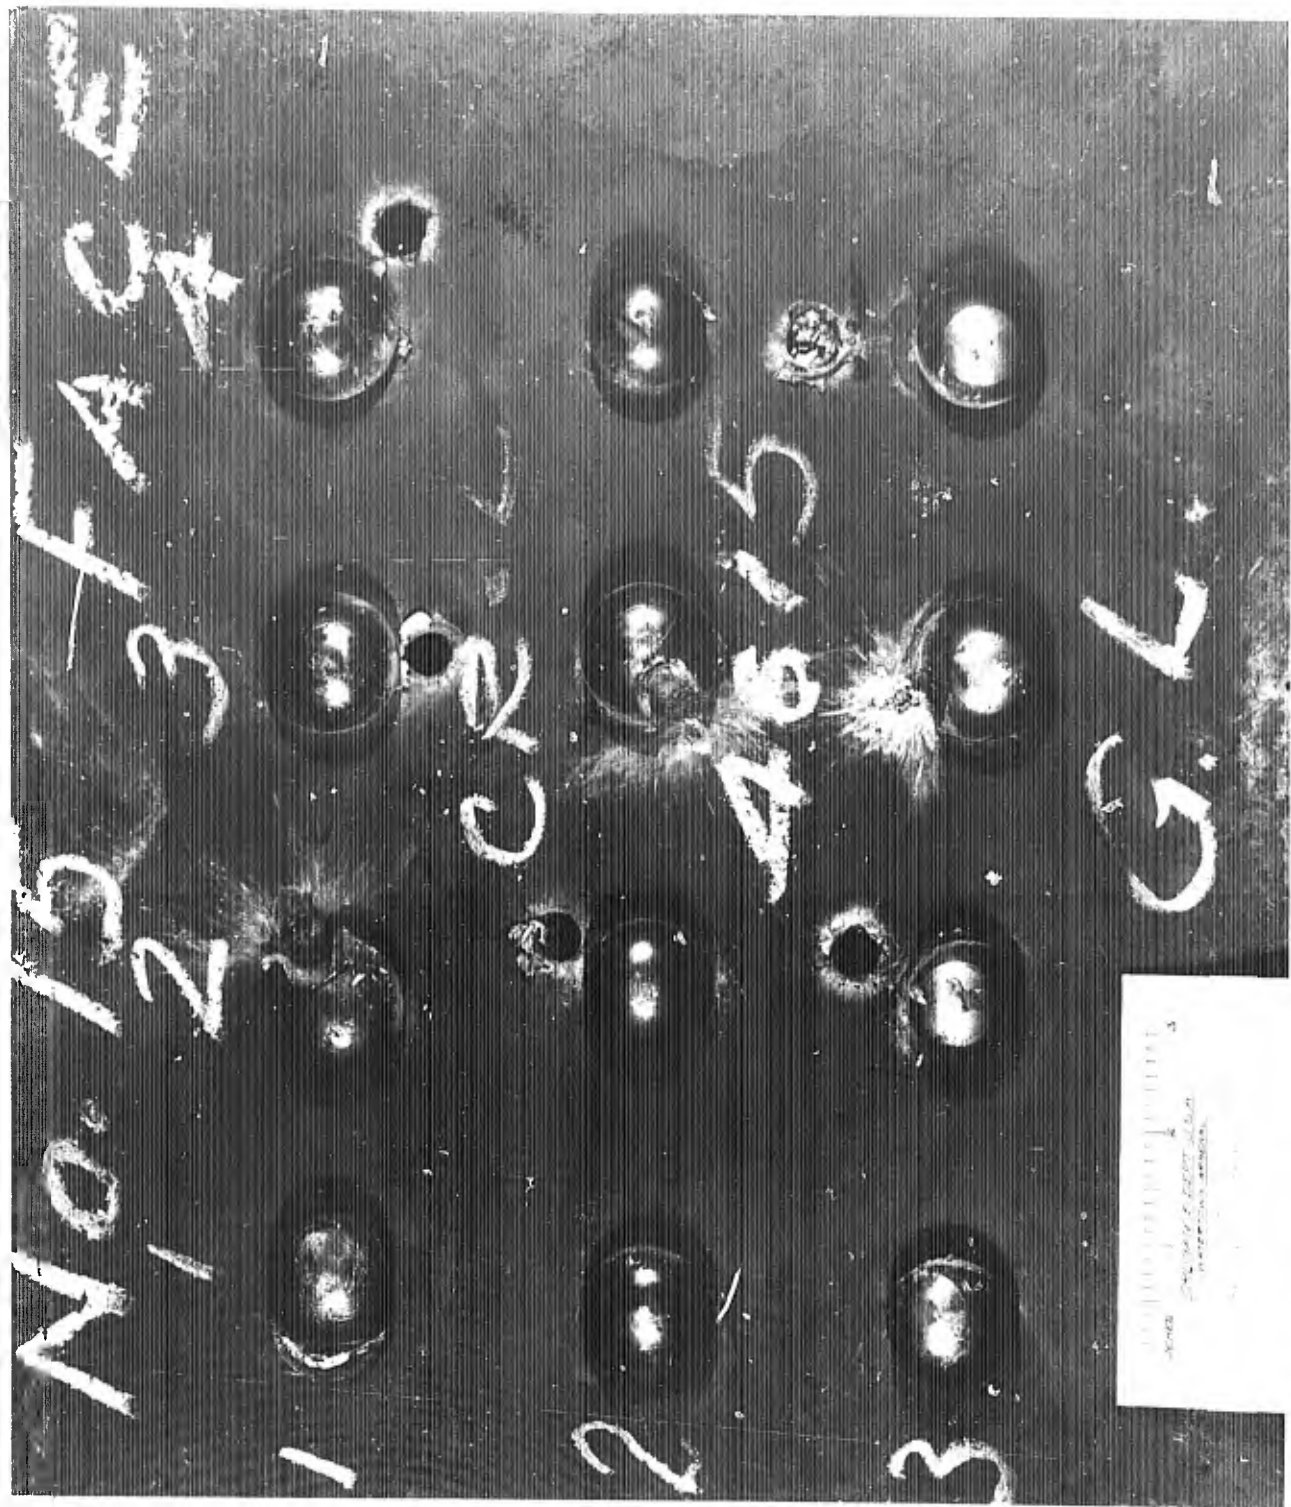
FIG. 7

e. Cold heading appears satisfactory if used in conjunction with a filleted rivet and properly radiused holes. But from the results on section 15, it should be noted that cold heading is dangerous unless proper fillets and radiused holes are provided.

6. Figures #7 and #8 attached show the front and rear of section No. 15 after similar ballistic tests. Although a greatly less number of shots were fired at this section, the original unfilleted heads

fractured off in the great majority of cases although in many cases impacts were up to two inches removed from the rivets.

d. Machining of a $1/8$ " radius on the faces of the drilled

holes should be provided on both the rear and front of the section to take full advantage of the filleted head and provide a fillet on the hot or cold formed head.
