IMPROVED WINDSHIELD AND CANOPY PROTECTION  
DEVELOPMENT PROGRAM

H. EDWARD LITTELL, JR.  
PPG INDUSTRIES, INC.  
PITTSBURGH, PA. 15238

TECHNICAL REPORT  
AFFDL-TR-74-75

JUNE 1974

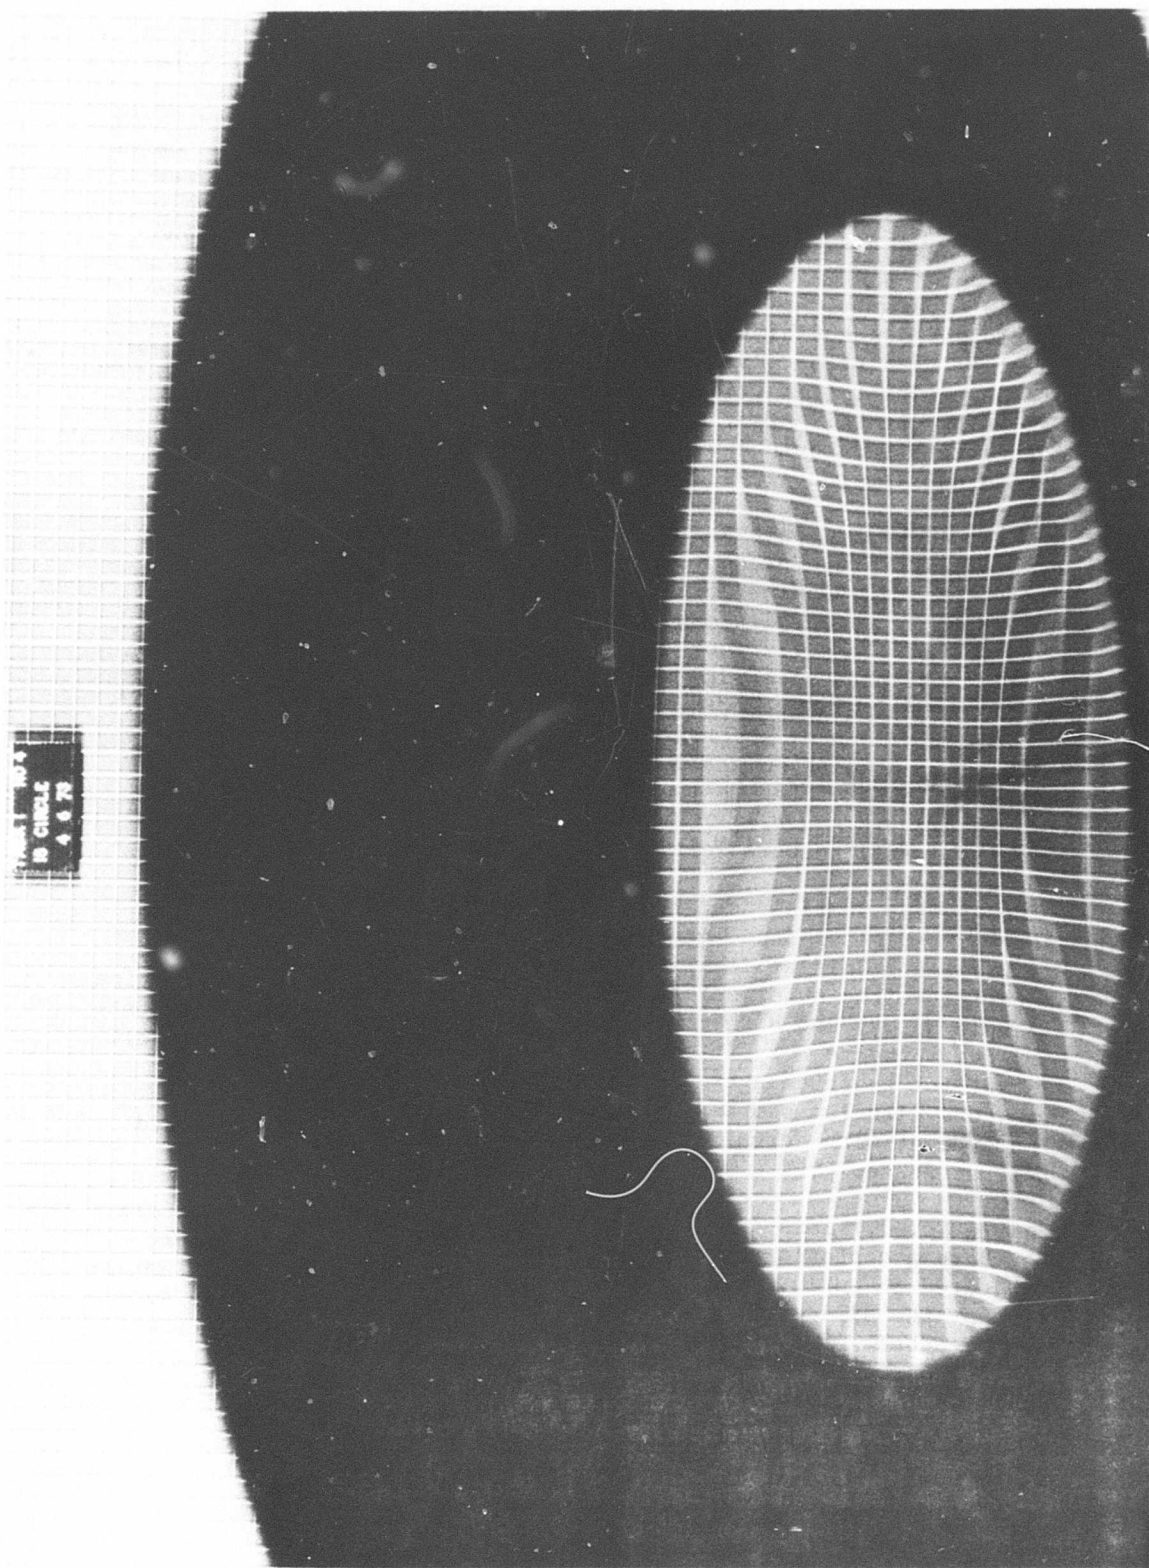
FIGURE 20(a). THERMAL SAMPLE NO. 5 BEFORE TEST

The acrylic-faced panels also showed interlayer bubbles at the higher temperature/pressure exposures comparable to the glass-faced design. Bubbles formed in the interlayer that subsequently helped to cause acrylic deformation. The photographs in Figure 20 show the optical effect of the damage caused by these tests. The photographs present a view of the standard 1" gridboard through panel No. 5 inclined at the F-111 windshield installation angle of 22°. Comparison of the Figure 20(b) photograph with the as-fabricated condition in Figure 20(a) graph illustrates the detrimental effects of the tests.

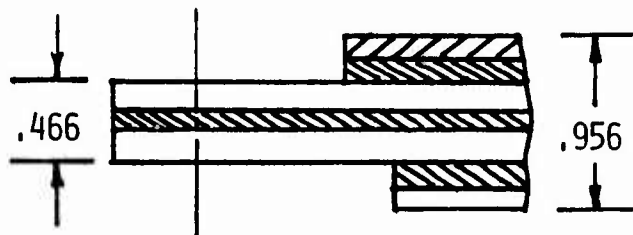
WT-18 7A OK 507 KT NO PC DAMAGE

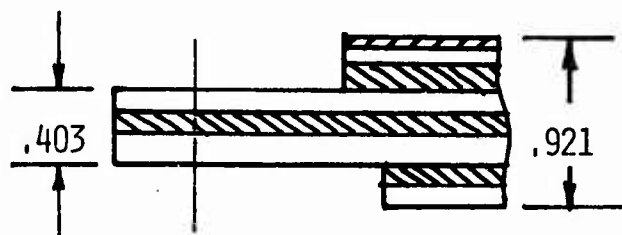
WT-9 13A OK 499 KT NO SERIOUS DAMAGE

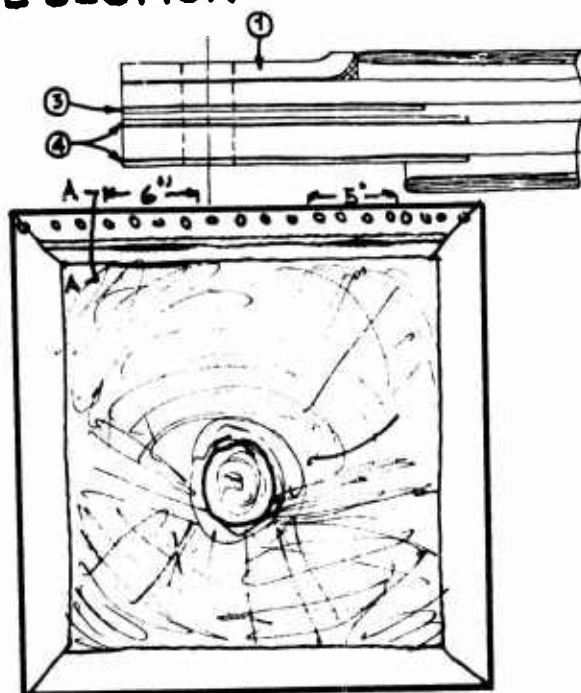
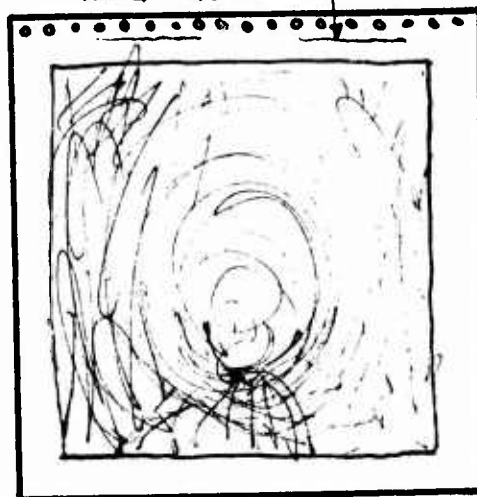
SHOT NO.: WT-29 (NO. 11) INTENDED: 850 FPS SPEED: PRELIM: 869 FPS BIRD WT.: 1814 gm; 4.00 LB. 507 KT = FINAL: 856 FPS K.E.: 45,470 FT-LBS

- ① SOFT ALUMINUM RETAINER
  - ② .030" x 2.25" NOMEX INSERT (TAPERED)
  - ③ .020" x 1.75" NOMEX JTRAP BONDED W/ ~90% .013 RTV 630
  - ④ .020" x 2.00" " " " " " " " "
  - ⑤ ALUMINUM BUSHING
- NOMEX CRACKED 7

BIRD DID NOT PENETRATE. PORTION  
OF TOP EDGE RETAINER REMOVED  
LEAVING MODIFIED 1" RETAINER SHOWN

NO RETAINER PEELING AND ONLY SLIGHT SEPARATION FROM RTV IN 2 PLACES. 8 BOLTS OFF ALONG TOP EDGE (SHEARED @ 1<sup>ST</sup> THREAD)

SPALL. INBOARD SPALL PERFORATED FOIL OVER FORM PLACED VERTICALLY BEHIND PANEL & HORIZONTALLY BELOW (40") PANEL. PARTICLES STUCK IN BOTH W/P'S. LARGEST PARTICLE: .060" x .188" x .750".

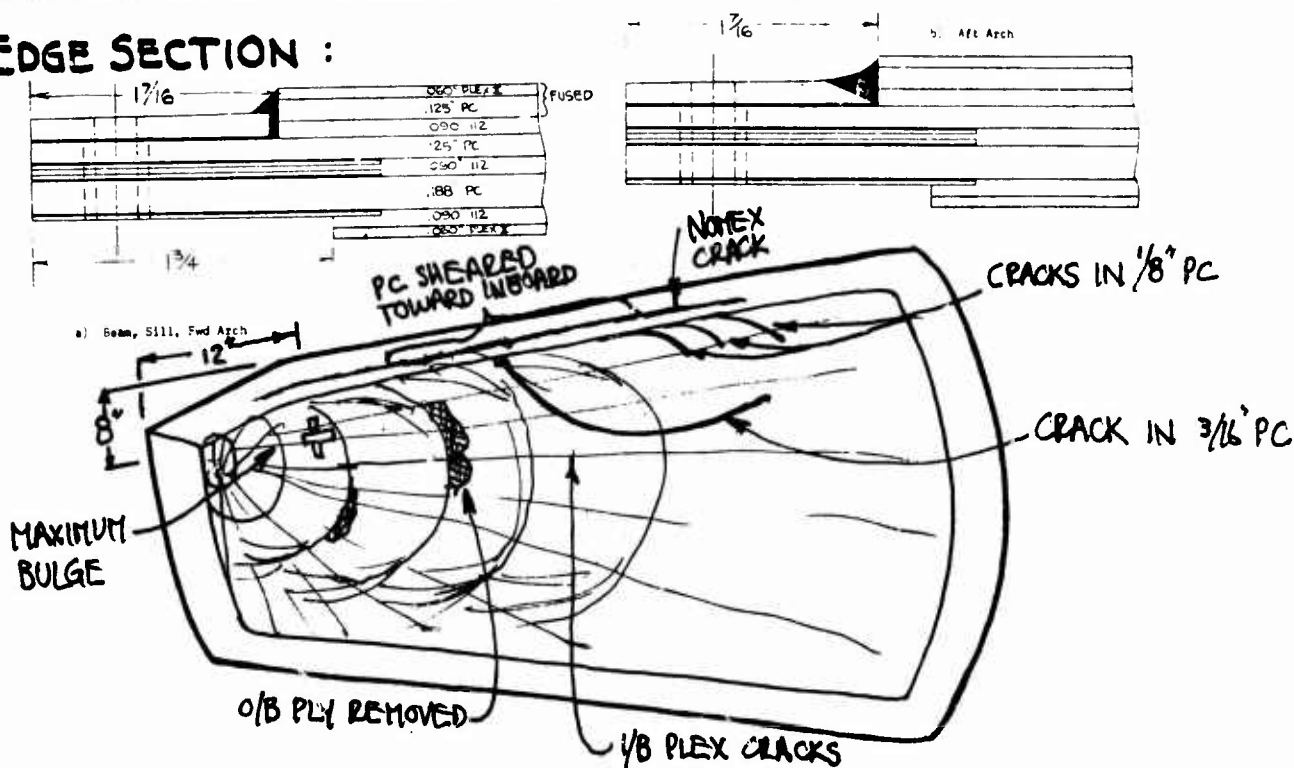
SHOT NO.: WT-41 SPEED: INTENDED - 1200 FPS BIRD WT. : 4.13 LB  
FINAL = 1189 FPS K.E. : 90,618 FT-LB.  
REMARKS : No. 2 FRAME, SPS BOLTS " = 704 KTS

BIRD DID NOT PENETRATE. LARGE RESIDUAL BULGE WITH ACRYLIC SPALLED IN MAX. BULGE AREA. CRACK IN BEAM EDGE ATTACHMENT AND PC WITH CRACKS FROM EDGE SHEAR LINE INTO VISION AREA IN BOTH  $\frac{1}{8}"$  &  $\frac{3}{16}"$ . OUTWARD PLY PULLED AWAY FROM RETAINER ALONG FORWARD HALF OF BEAM. APPROXIMATELY  $\frac{1}{4}"$  OUTWARD PERMANENT WARP IN FWD. HALF OF BEAM EDGE. CLOSE TO LIMIT.

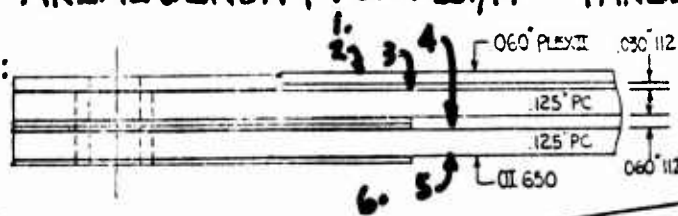
CRACKS THRU
