AFFDL-TR-79-3040

LARGE AREA COMPOSITE STRUCTURE REPAIR

J.D. Labor
S.H. Myhre

Final Report For Period January 1976 - February 1979

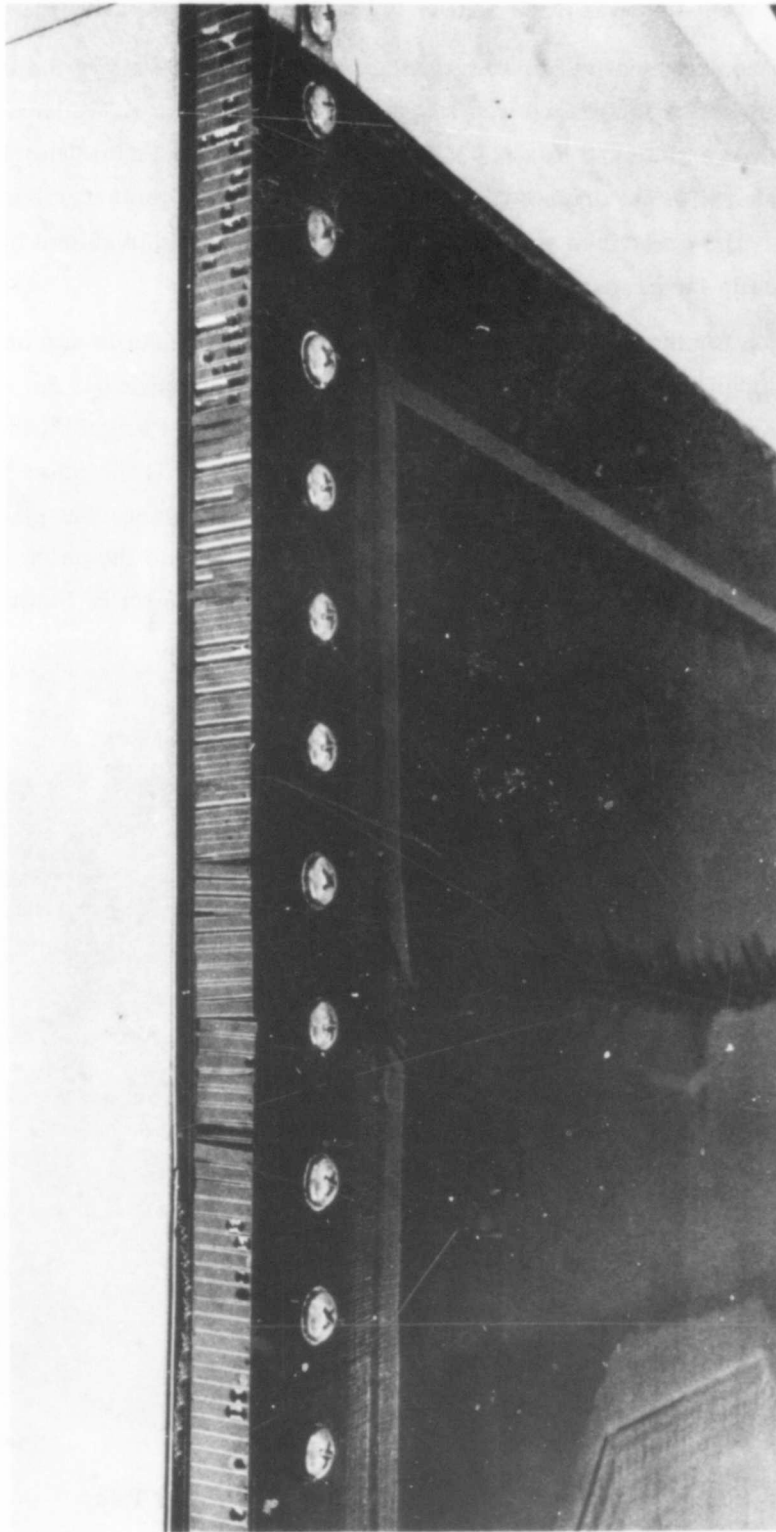
Bending was again applied to the box beam in load condition four, until tension failure of the panel. Failure loading in the 8-ply outer face was 2390 pounds per inch. The maximum axial strain at failure was $9670 \mu\text{in./in.}$ The results of all load conditions are shown in Figure 26 in terms of percent of allowable load and strain. The nonuniform strain distribution, shown in Figure 27, became an advantage in this particular case since it reduced strain along the panel edge where the attachment holes are located. The failure, shown in Figure 28, occurred remote from the patch.

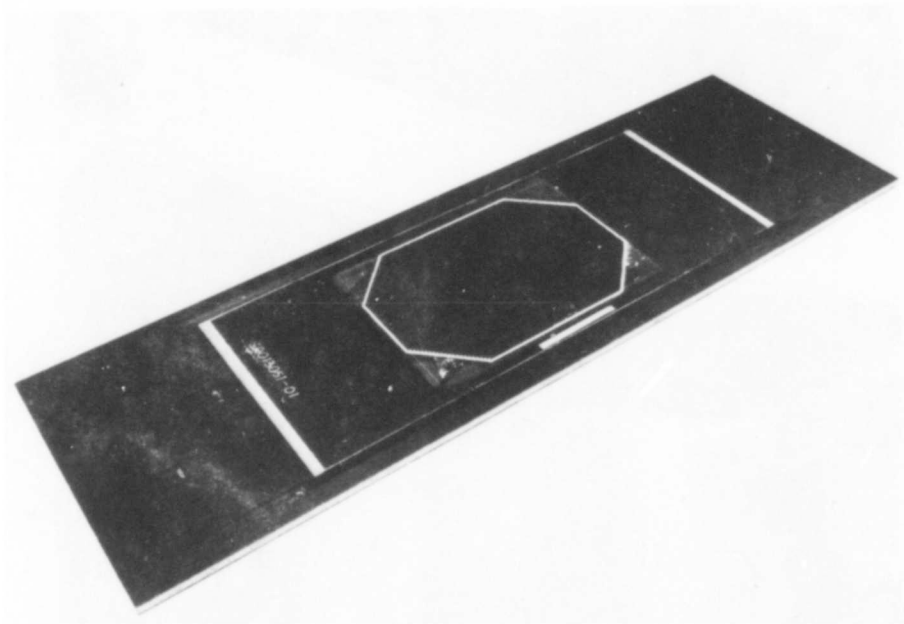
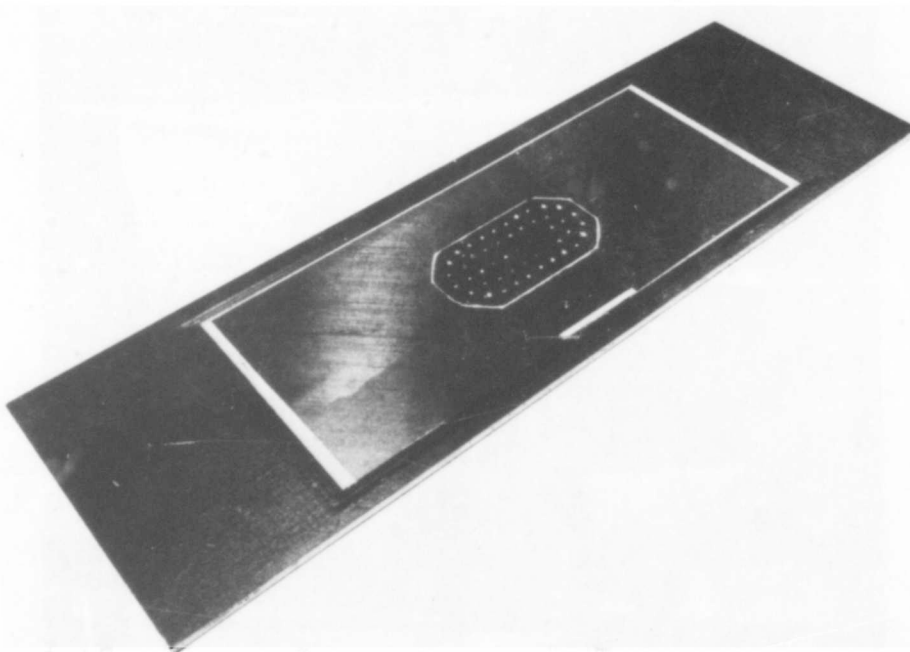
Figure 32. Panel Two Completed Blind Side Sandwich Repair

Panel Two was loaded to failure in tension resulting from positive bending on the box beam. The panel design ultimate allowable was defined in the same way as for Panel One, i. e. 1715 pounds per inch per face. Panel Two failed at 2095 pounds per inch in the outer face or 122 percent of design ultimate allowable. Maximum strain at failure was $8925 \mu\text{in./in.}$ on the parent laminate just off the end of the patch. Noises and strain gage readings during loading indicate some deterioration of the bond of the blind side patch. However, the failure occurred outside this area and the bond deterioration appears to have had no effect on the ultimate failure. Photos of the failure, viewed from the outside and inside are shown in Figure 33. The test results and the mode of failure demonstrate that even an imperfectly bonded repair, made simulating on-aircraft conditions with access from one side only, can restore strength well beyond ultimate design load requirements. By using a repair method which is capable of high strength restoration a considerable margin is available to allow for reduced quality standards.

The final operation consisted of cocuring the outer face patch plies with film adhesive over the core, the scarf and the outer surface. The completed repair is

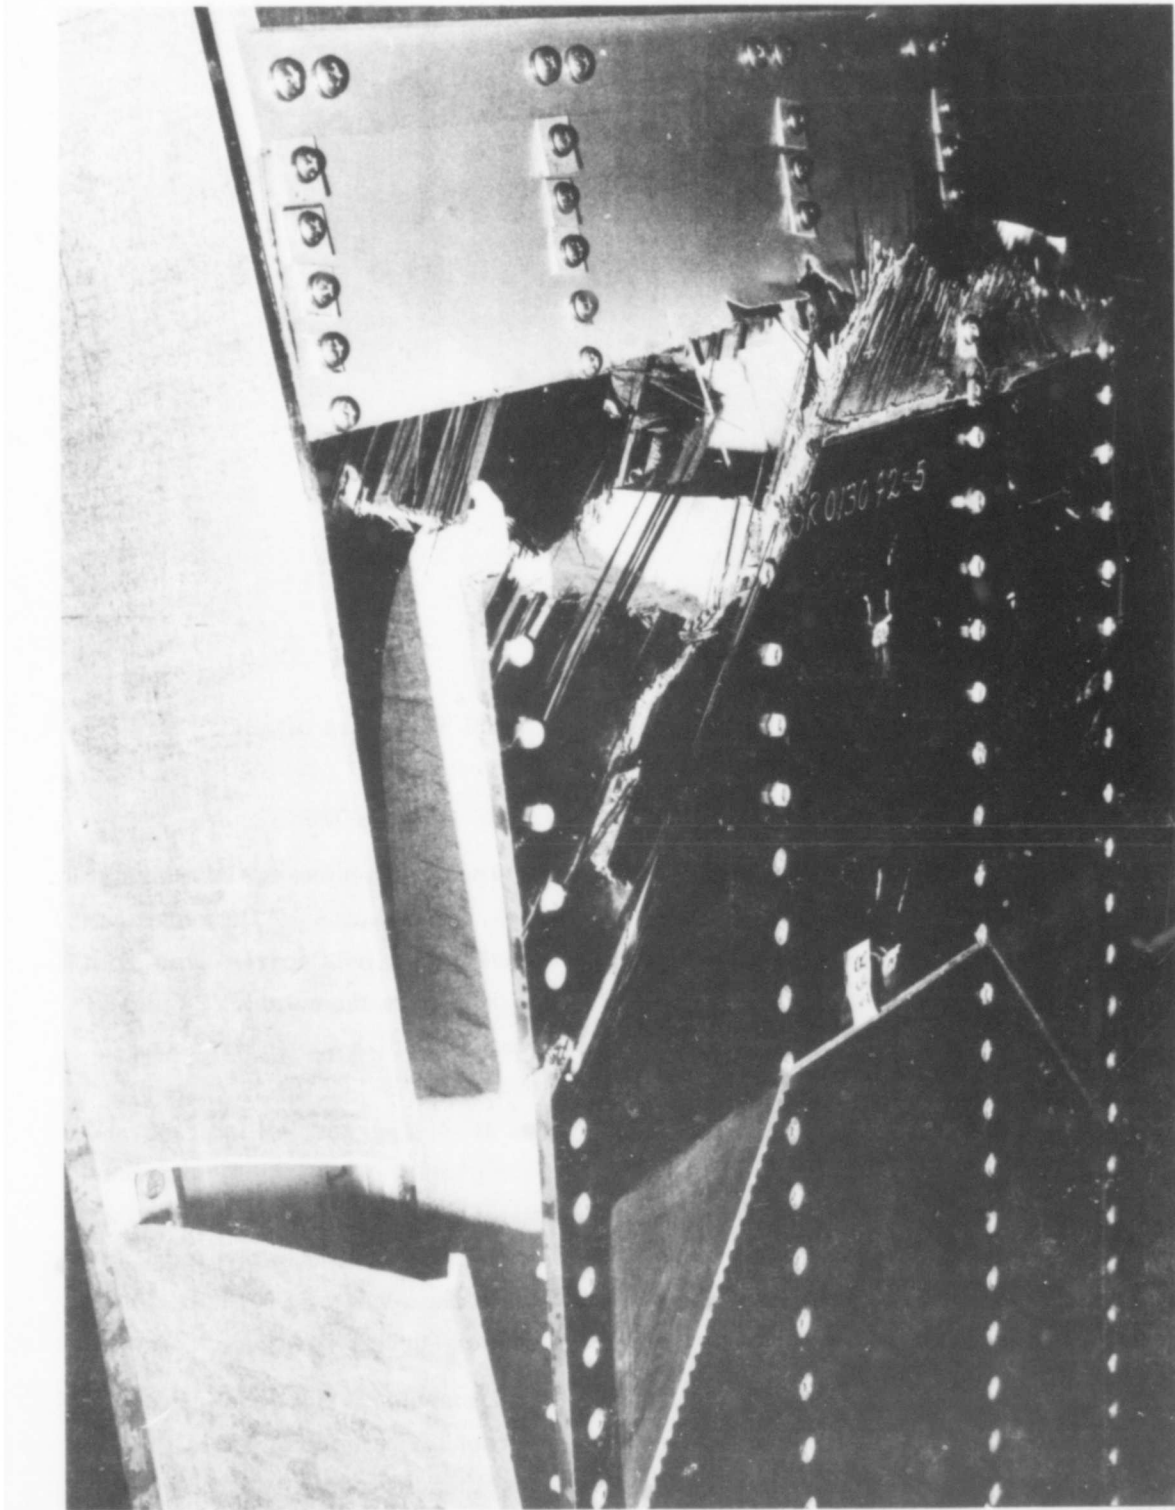
Figure 36. Panel Three Failure at 155% of Design Ultimate Allowable 78-04464-10

Testing of Panel Three proceeded first by applying the limit loads of Table 14 (neglecting N_y) with no indication of failure. Load condition four was positive bending to failure at an average tension panel loading of $N_x = 14,200$ pounds per inch. The maximum axial strain recorded in the panel and projected to failure was $7720 \mu\text{in./in.}$ Failure occurred remote from the repair, as shown in Figure 36. Again using the 50 percent strength reduction factor for the skin/spar attachment holes the panel ultimate allowable would be 9135 pounds per inch. Hence, the repair sustained 155 percent of the panel design ultimate allowable strength.

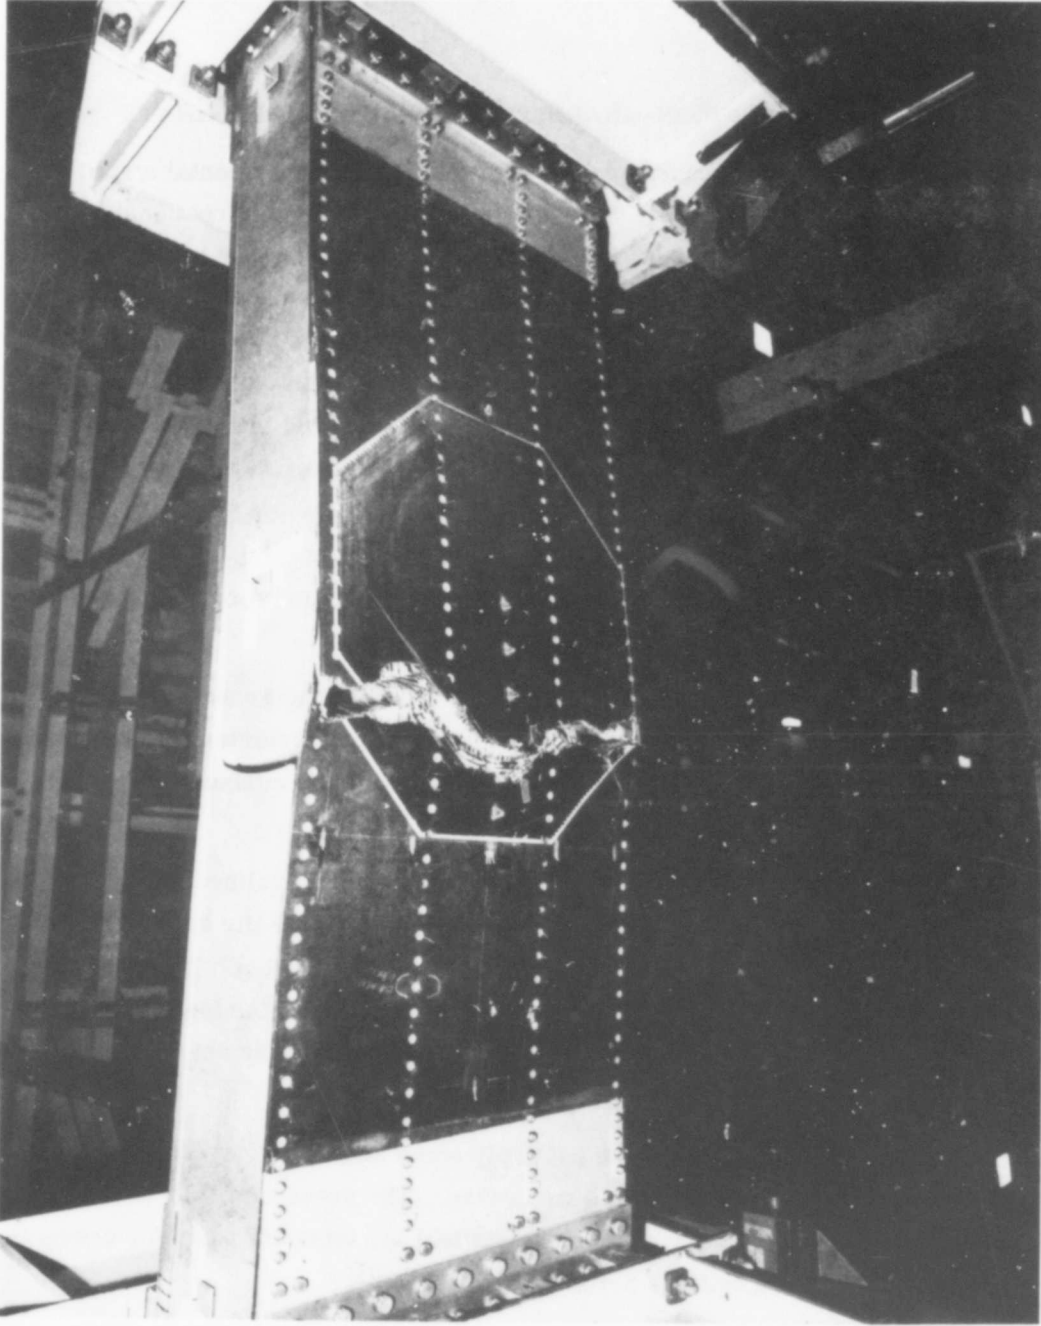
Figure 37. Panel Four Failure at 155% of Design Ultimate Allowable

The testing of Panel Four proceeded in the same manner as for Panel Three. No indication of failure was seen from the three limit load conditions of Table 14. Positive bending to failure resulted in an average panel loading of $N_x = 14,200$ pounds per inch, almost identical to the load required to fail Panel Three. The maximum

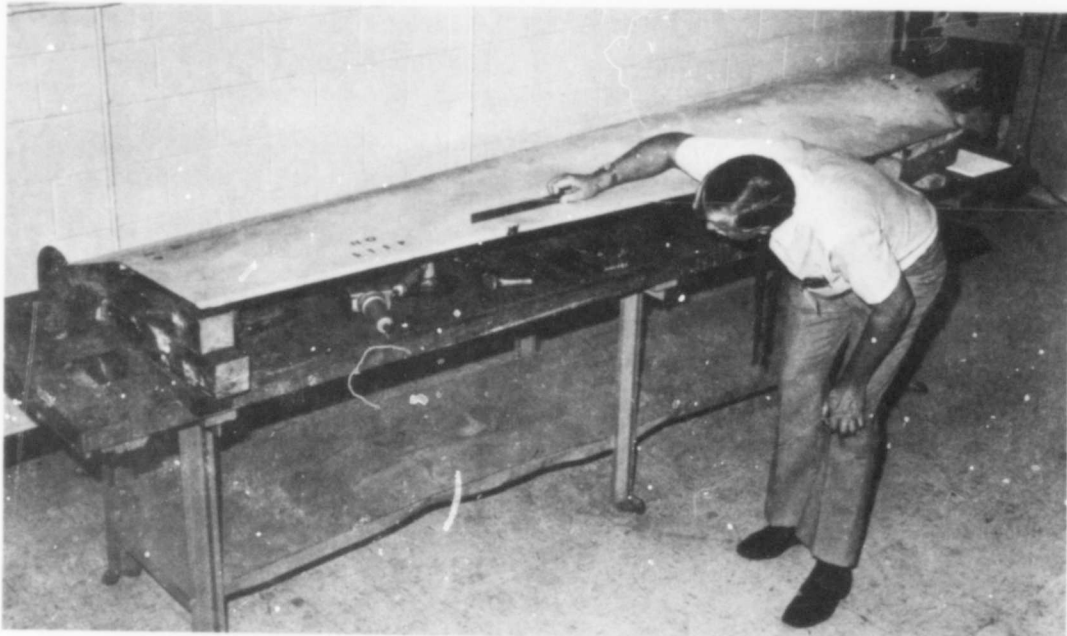
All removal of damaged material was done with hand tools and no special guides to demonstrate a simple technique which could be used for on-aircraft repairs. A hand held router was used to cut the 5 to 6 ply skin. The cut was made to a scribed line, the skin was peeled off the core and the core cut with a knife. The router was used to remove strips of core so that the remaining pieces were easily removed with a knife.
