ADC TECHNICAL REPORT 52-267

**INSTALLATION AND FLIGHT TEST OF DRAGLESS ANTENNAS FOR USE WITH  
VHF HOMING EQUIPMENT IN F-80, F-86, AND F-84 AIRCRAFT**

**SHERLA L. STUTZ  
COMMUNICATION AND NAVIGATION LABORATORY**

**AUGUST 1952**

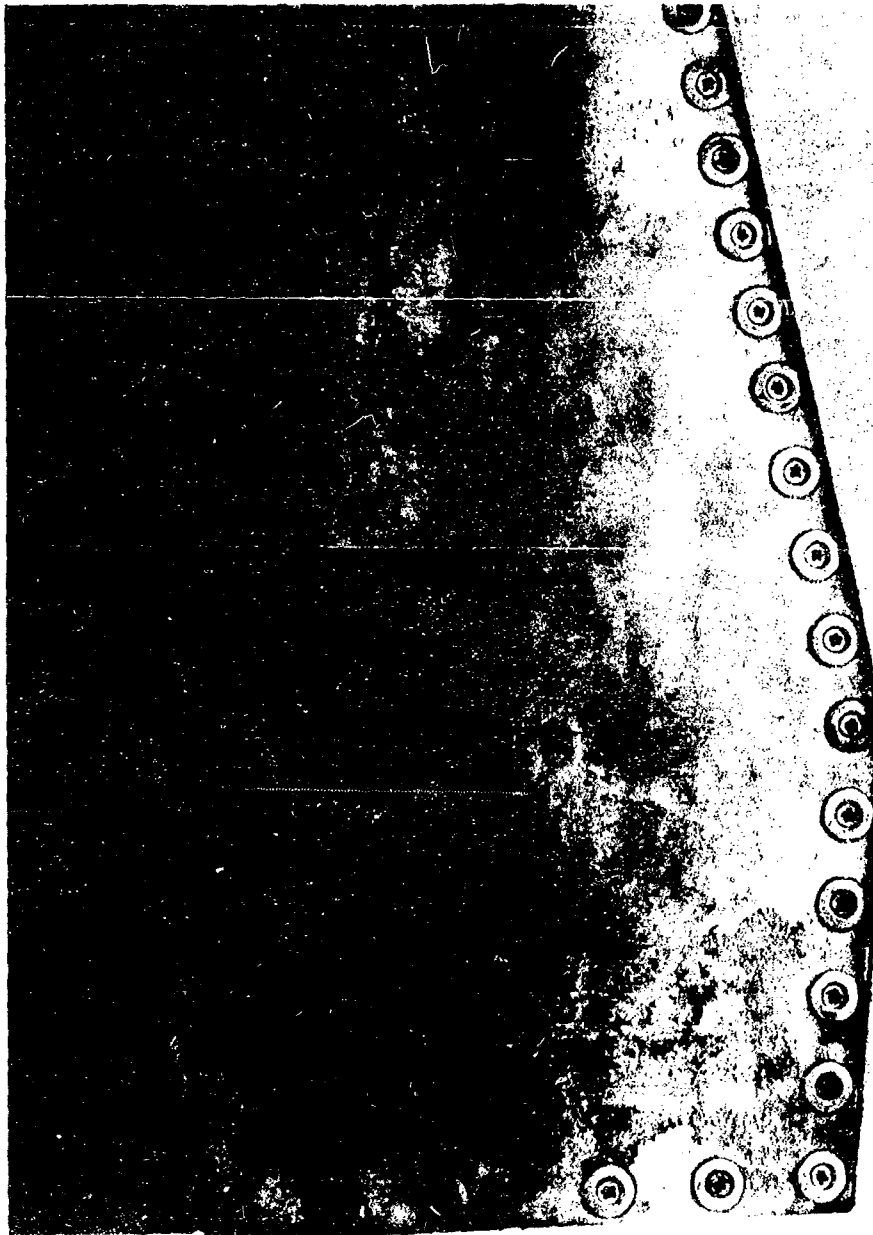
FLUSH-MOUNTED ANTENNA PANEL FOR HOMING ADAPTER AN/ARA-8.  
IN F-80 AIRPLANE, SERIAL NO.5337.

See Fig. 5 and 9. Fig. 5, pictures a good antenna panel structural design. Fig. 9 pictures results of exposure to a high speed and low temperature conditions on a make shift panel design. The surface impregnant cracked and blew away as a result of the rapid pressure changes that occurred while at the low temperature. The antenna should be designed for exposure to long periods (several minutes time) of bombardment from rain or ice pellets traveling at rates of speed in the order of 13 to 1400 feet per second. The antenna system is, wherever possible, designed to be placed in the aircraft skin in other than symmetrical locations (centerline of top and/or bottom of fuselage) to eliminate the necessity for cutting into any of the main longerons, formers or bulkheads. In the design of the antenna panel the physical shape and size is adjusted as nearly as possible to the configuration and dimensions of the section of the aircraft surface into which it is to be installed. The antenna panel is, wherever possible, placed in a section of the aircraft surface that is unpressurized and that has approximately equal normal pressures both inside and outside, while in flight. If the pattern studies of the particular aircraft will permit and the opportunity presents itself the panels are designed to replace existing access or inspection doors. This procedure permits ready fabrication, installation, replacement and/or modification, when and if the aircraft is already in production status. Such an antenna is pictured in Figures 10, 11, 12 and 13. To counteract forces and effects of low temperatures and rapidly changing pressures the antenna panel is designed of "void free" laminated, structural plastic incorporating reinforcing ribs, and impregnated with the proper and not excessive amount of low loss (electrical) binder plastic. The antenna panel is (in addition) coated with an outer skin of vinyl plastic or rubber which increases its resistance to rain and ice particle erosion. Due to the location and size of various other aircraft components that may be installed near the antenna panel it is sometimes necessary to use metallic backing thus forming a cavity behind the panel to reduce the mutual coupling between the panels and other aircraft equipment or stray (RF) fields. The resulting cavity should be an appreciable portion of a wavelength deep whenever possible so as not to result in an unfavorable antenna impedance and/or lowered "Q". The employment of a cavity behind the antenna panel makes it possible to achieve a balance between the elements of the antenna system more easily than without.

Fig. 9 pictures the results of a combination of high altitude (low temperature) and rapidly changing pressures on the inside and outside of the aircraft structure at the point where the antenna was installed. You will note from the photograph that a large portion of the surface coat of impregnant has broken loose and blown away. When the panels were fabricated, a surplus of impregnant remained on the surface, aggravating the condition. The breakdown of the surface could have been prevented for a much longer period of time by the increased reinforcement of the panel, a coating of vinyl plastic or rubber, and the proper amount of impregnant permitted to remain on the surface of the panels during manufacture.
