NACA RM E52116

INVESTIGATION OF BLADE FAILURES IN A J34, ELEVEN-STAGE  
AXIAL-FLOW COMPRESSOR

Lewis Flight Propulsion Laboratory  
Cleveland, Ohio

May 18, 1953

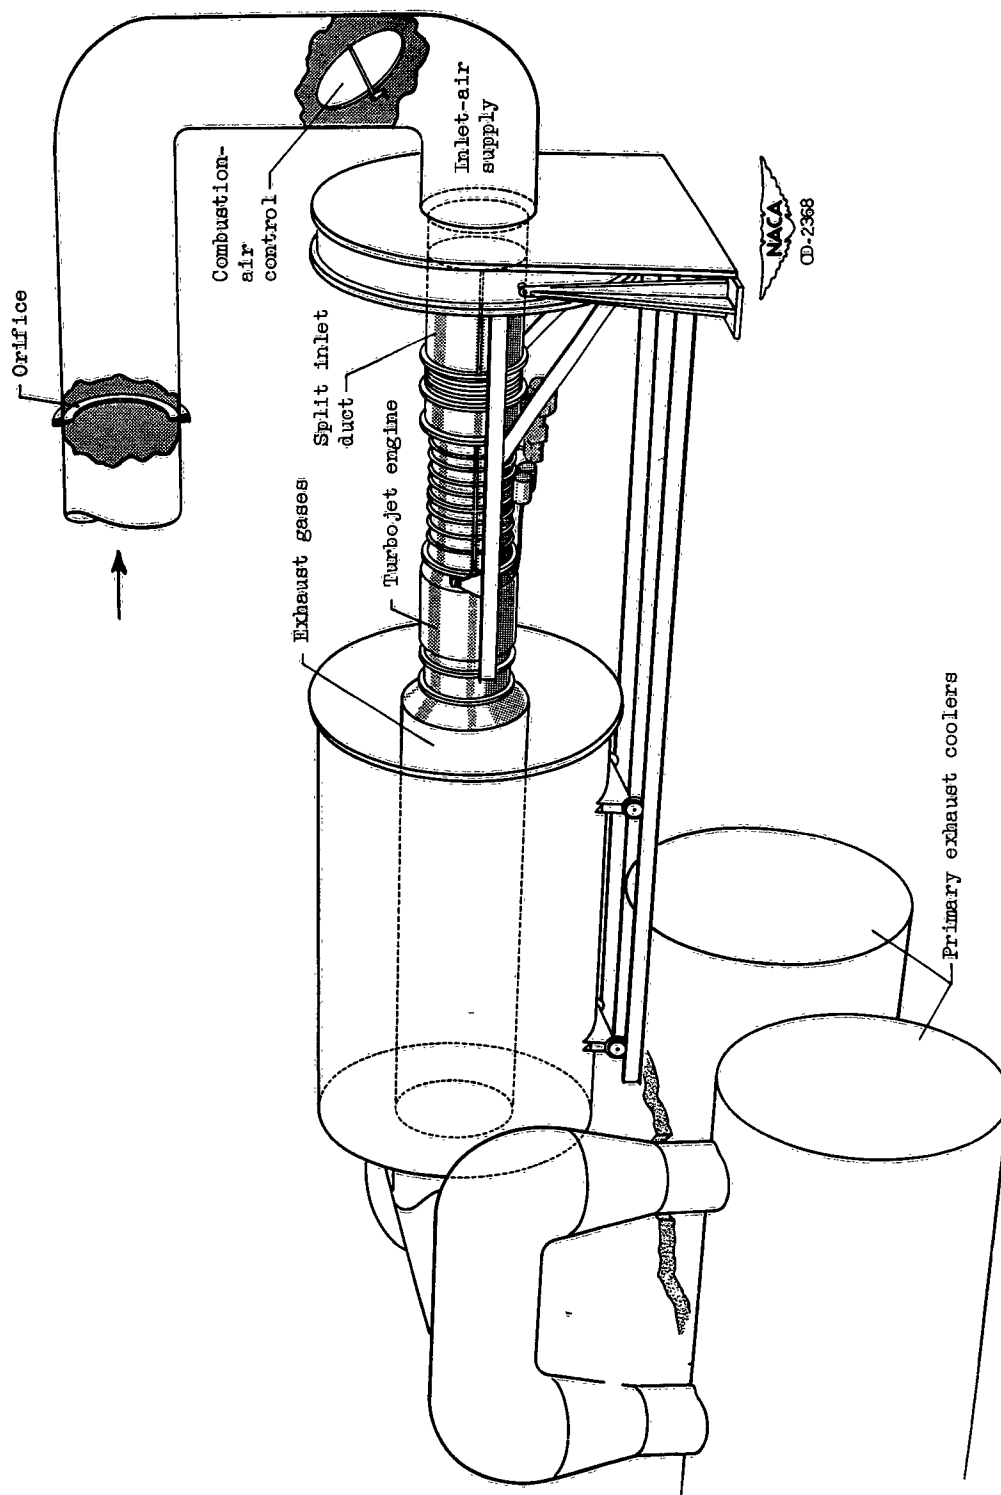
Figure 1. - Turbojet altitude chamber.

The engine was operated throughout the normal speed range of 5000 to 12,500 rpm in order to observe all blade vibrations present. The investigation was conducted with the turbojet engine operating in two different test cells. First, the engine was operated in a turbojet altitude chamber (fig. 1) where the air supply and exhaust were connected to the laboratory systems. Second, the engine was operated in a sea-level test stand where the air supply was taken from the surrounding atmosphere and exhausted through a muffler to the atmosphere. All engine parts were fabricated by the engine manufacturer and sent to the Lewis laboratory.

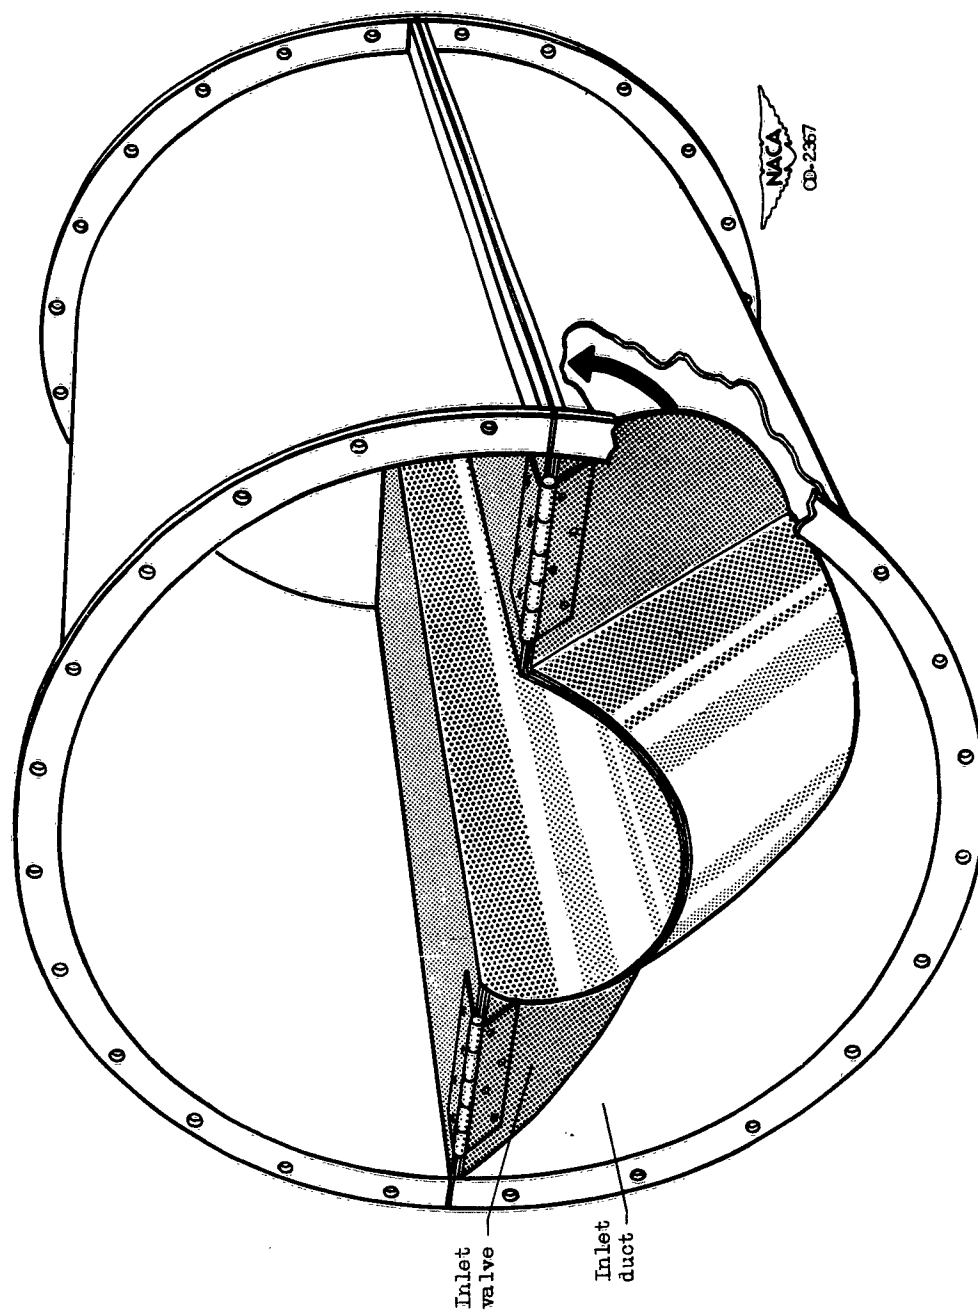
Inlet valve. - A special valve assembly (fig. 2) was fabricated to control the air flow to one-half of the compressor inlet from approximately zero to full flow. This valve simulated possible uneven air-flow conditions of the two-duct inlet-air supply system used in many aircraft and was used to determine the effect of flow pattern on vibration.

Inlet duct. - The section of inlet ducting containing the special valve was fabricated in two parts (fig. 2). The top half of the duct and the special valve were removed, and the engine was operated throughout the critical speed range. With the duct open the engine was receiving its air from the test cell. This procedure was carried out to determine the effect of the laboratory inlet piping on the vibration.

Figure 2. - Split inlet duct and inlet valve.

Inlet valve. - With the inlet valve at various positions from open to fully closed, the engine was accelerated and decelerated throughout the normal speed range. The strain-gage signals were closely observed, but the position of the inlet valve did not affect the third-stage-vibration amplitude nor introduce any new vibration.

Inlet duct. - When the engine was operated with the top half of the inlet duct removed, the critical third-stage vibration was completely eliminated. The top half of the inlet was again installed and the engine operated. Again the critical third-stage vibration was present. These results indicate that the inlet ducting system could be either causing or aggravating this vibration.

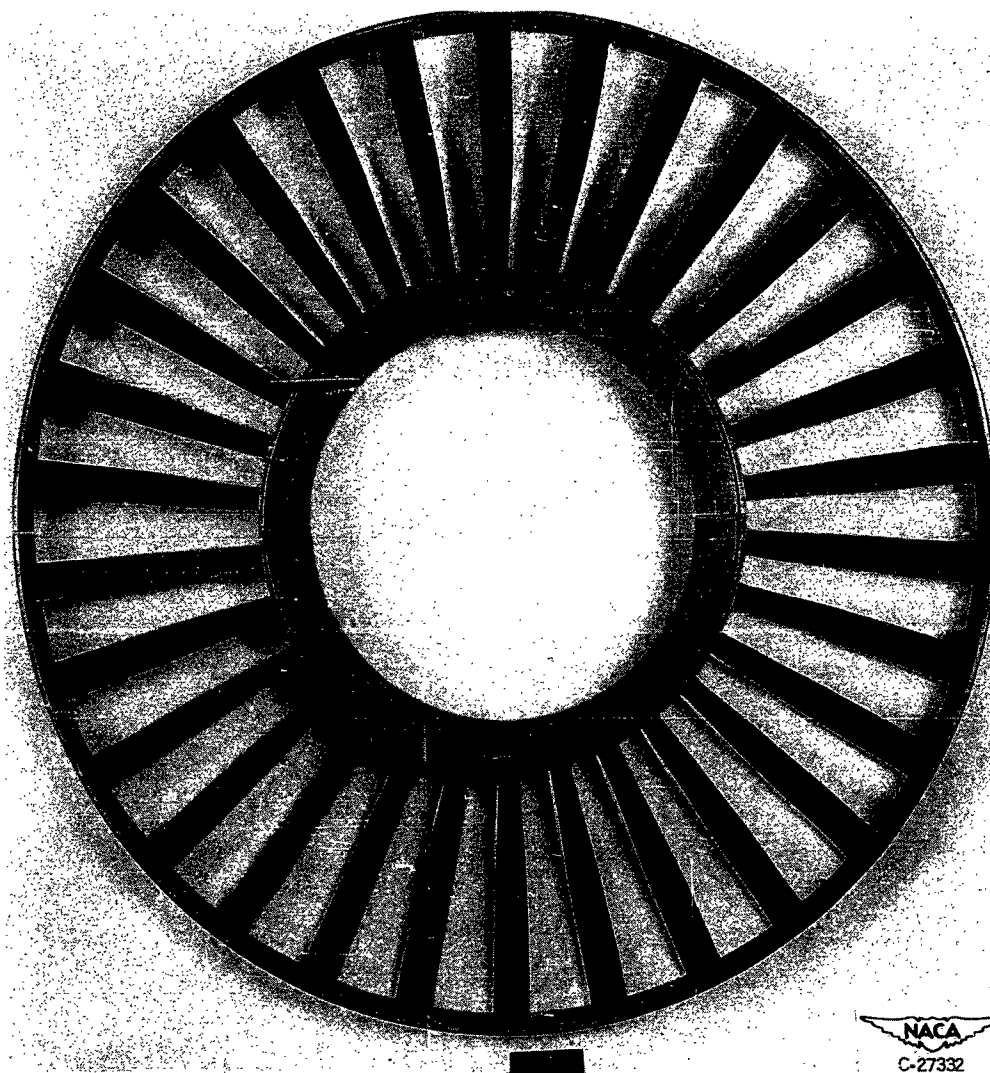
Stator blades. - Twisting or changing the angle of incidence of stator or rotor blades is a common standard means of attempting to solve such air-flow problems as compressor stall. A series of second-stage stators were fabricated by the engine manufacturer with various angles of incidence (fig. 3). These angles are shown in table I.

Figure 3. - Second-stage stator vane.

Stator blades. - An investigation of the effect of the angle of incidence of the stator vanes immediately preceding the third stage of the compressor was conducted in a sea-level test stand; the results are shown in figure 9. The vibratory stress levels noted on this plot are averages of numerous data points of the maximum amplitude obtainable in the critical speed range for each stator angle. The number of stator assemblies tested for each angle, the resulting average stress, and the percentage of the stress produced by the standard vanes are presented in table I.

Installation of the stator with vanes closed 3° reduced the vibratory stress to less than half and would possibly bring the vibration below the danger point. A change, however, to 9° greater angle of incidence would assuredly eliminate all third-stage vibration failure of this compressor design in the critical speed range. However, with the 9°-closed

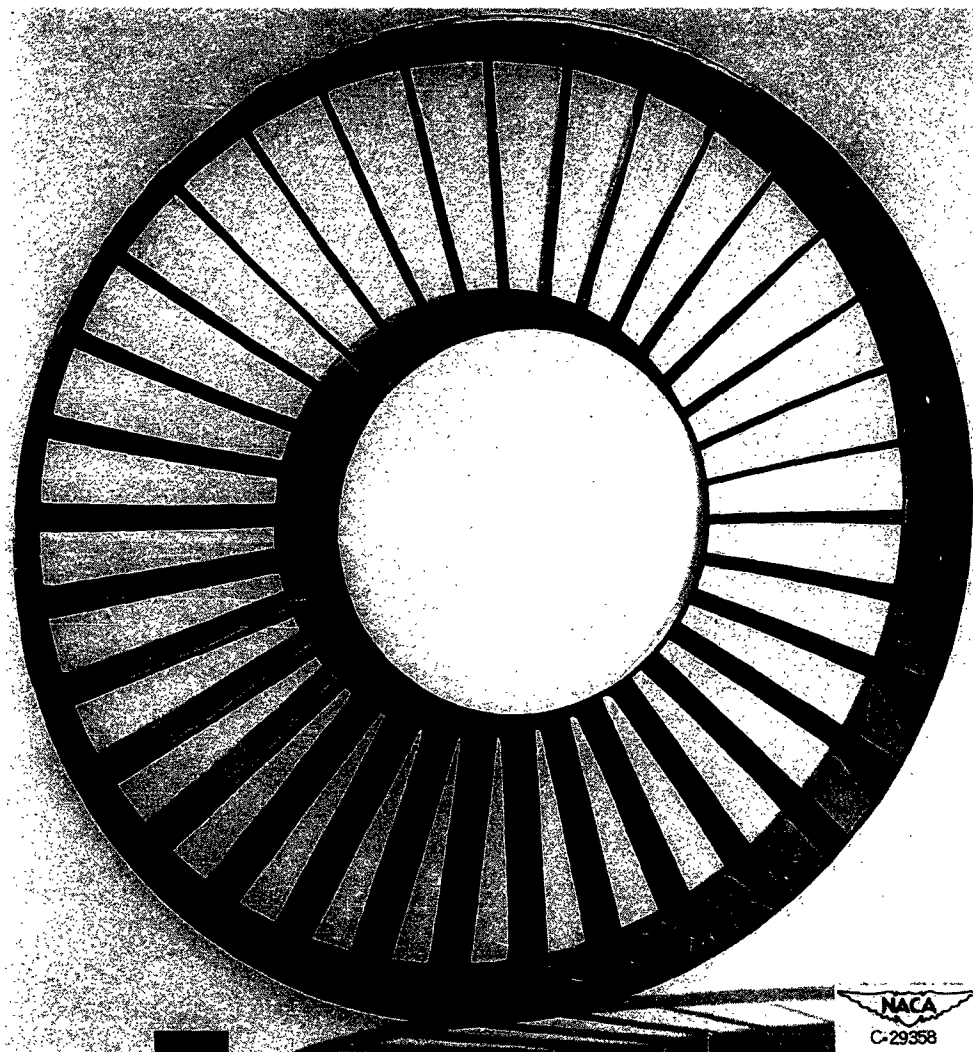
Inlet guide vanes. - A new inlet-guide-vane assembly (fig. 4) was fabricated by the manufacturer with a decreased angle of incidence of the vanes, which resulted in a 4-percent increase in the inlet flow area. This new inlet was operated with all the second-stage stators listed in table I.

Figure 4. - Inlet guide vane.

Inlet guide vanes. - It was decided to investigate the effect of opening the compressor-inlet flow area to increase the weight flow and engine thrust. The manufacturer supplied new inlet guide vanes (fig. 4) with an increase in flow area of approximately 4 percent. The vanes were installed in the engine and the engine operated throughout the complete speed range. The operation with the new inlet guide vanes and standard second-stage stators indicated that the serious third-stage vibrations had been eliminated and no new vibration introduced. A check of the engine thrust at military take-off showed that the change in inlet guide vanes had increased the thrust approximately 4 percent, or an increase of  $7\frac{1}{2}$  percent over the operation with the  $9^\circ$ -closed stators.

5. The inlet-guide-vane assembly with an increase of 4 percent in the inlet flow area eliminated the third-stage vibration and increased the thrust 4 percent.

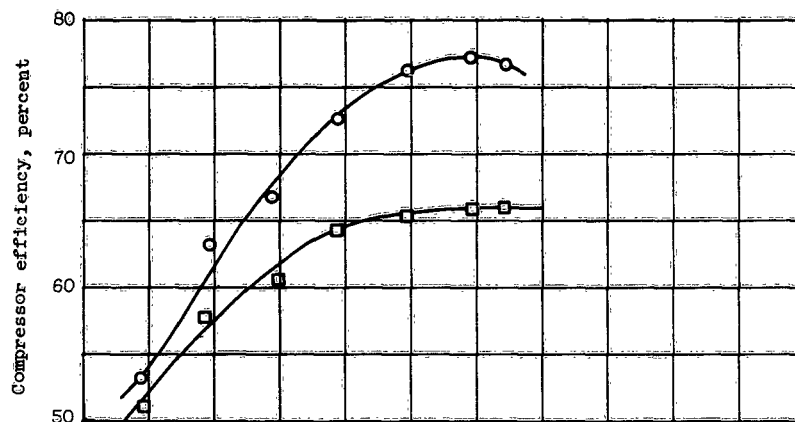
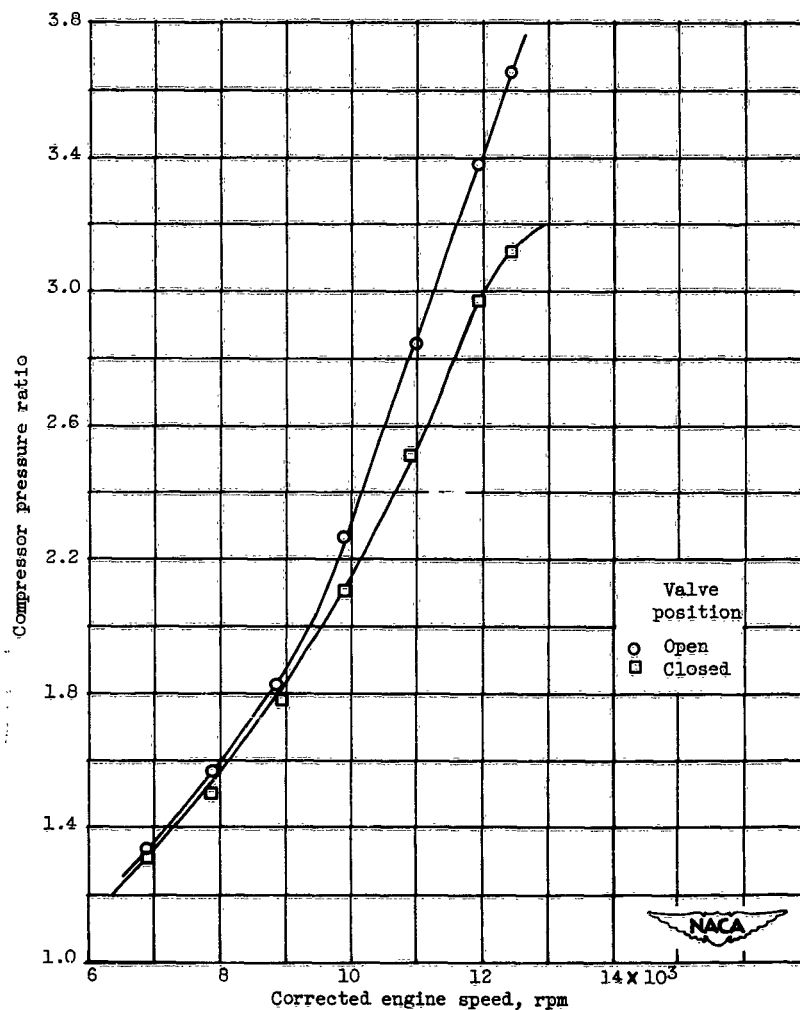
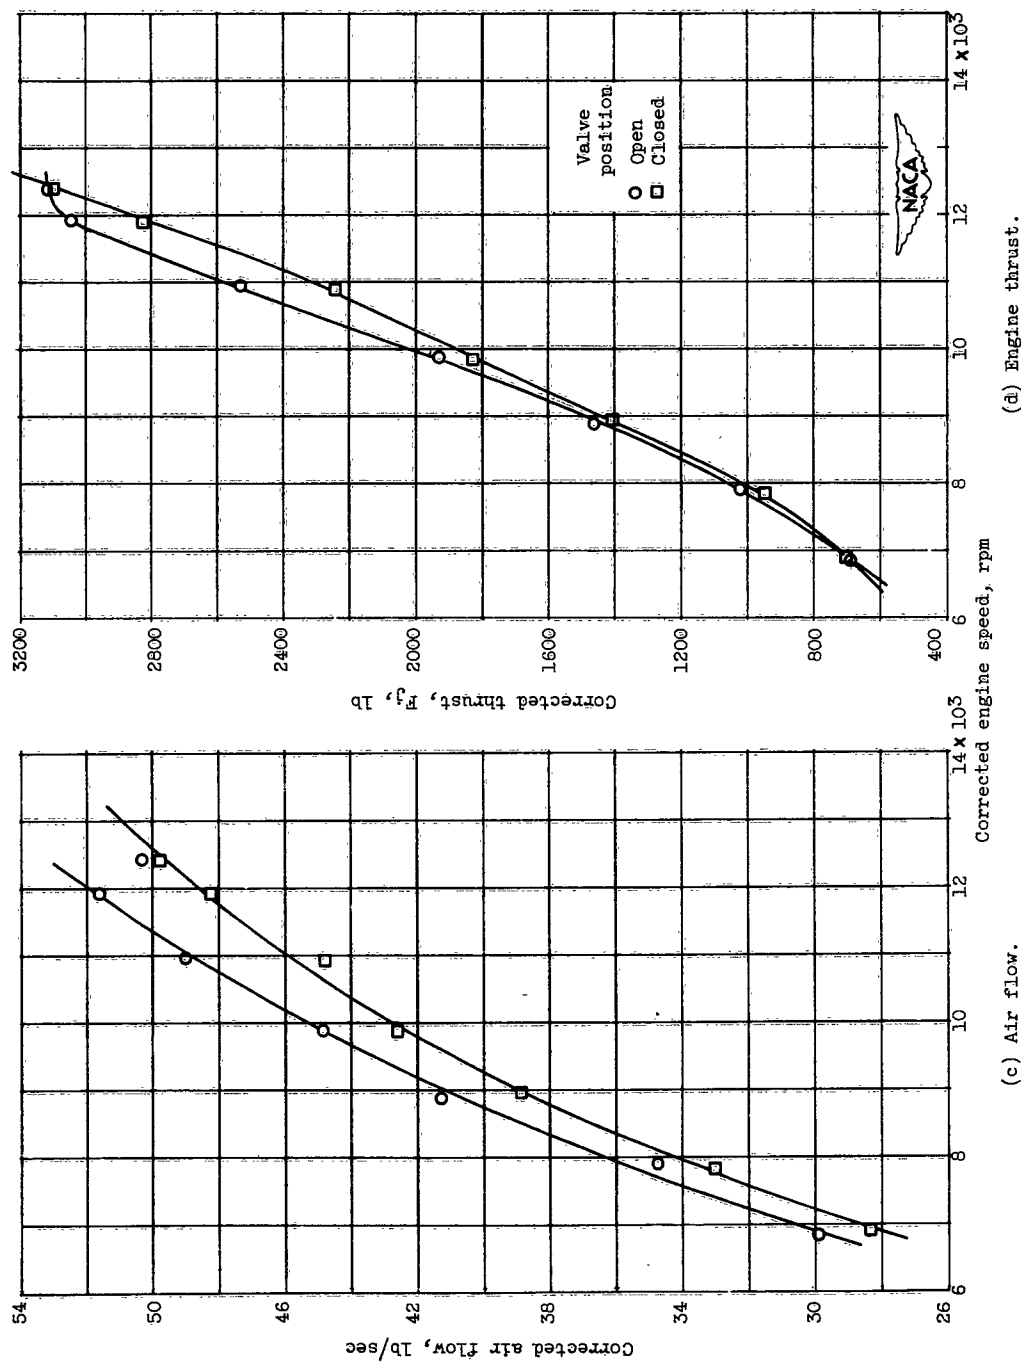
The valve position had a decided effect on engine performance. Figure 5 presents curves of the compressor efficiency, pressure ratio, and corrected air flow, and corrected engine thrust plotted against corrected engine speed. Operating with the closed valve reduced the corrected engine thrust approximately 9 percent. Such a loss in thrust would be serious; however, for the jet-engine installation with the twin-inlet-duct system the airplane could have one duct damaged or filled with foreign material during a flight with little or no effect on the ability of the airplane to return to its base.

(a) Compressor efficiency.

(b) Pressure ratio.

Figure 5. - Effect of inlet-valve position on engine performance.

Figure 5. - Concluded. Effect of inlet-valve position on engine performance.

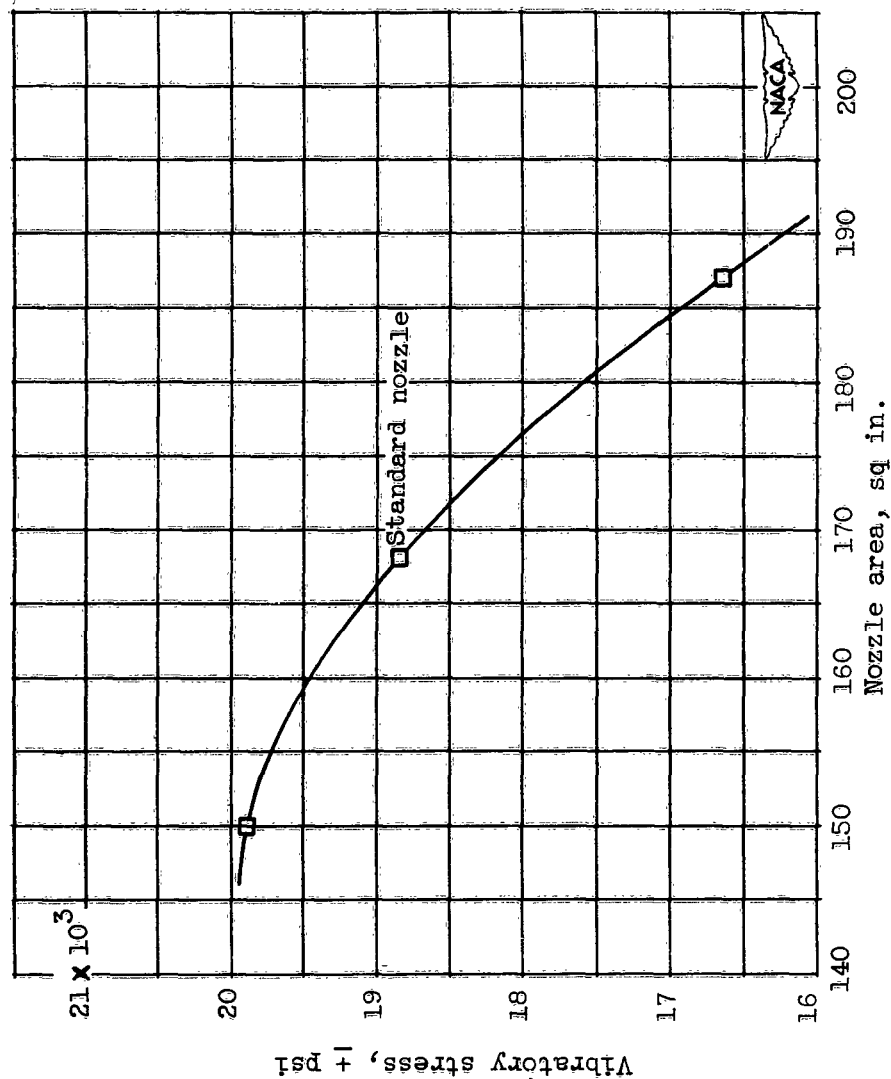
Various exhaust nozzles. - The effect of exhaust-nozzle area on the third-stage blade vibration is presented in figure 6. As the nozzle area was reduced and the pressure ratio increased, the vibratory stress increased. This same effect was observed and reported in reference 1. The 168-square-inch nozzle was the standard for the investigation.

Figure 6. - Effect of exhaust-nozzle area on vibratory stress of third-stage blade.

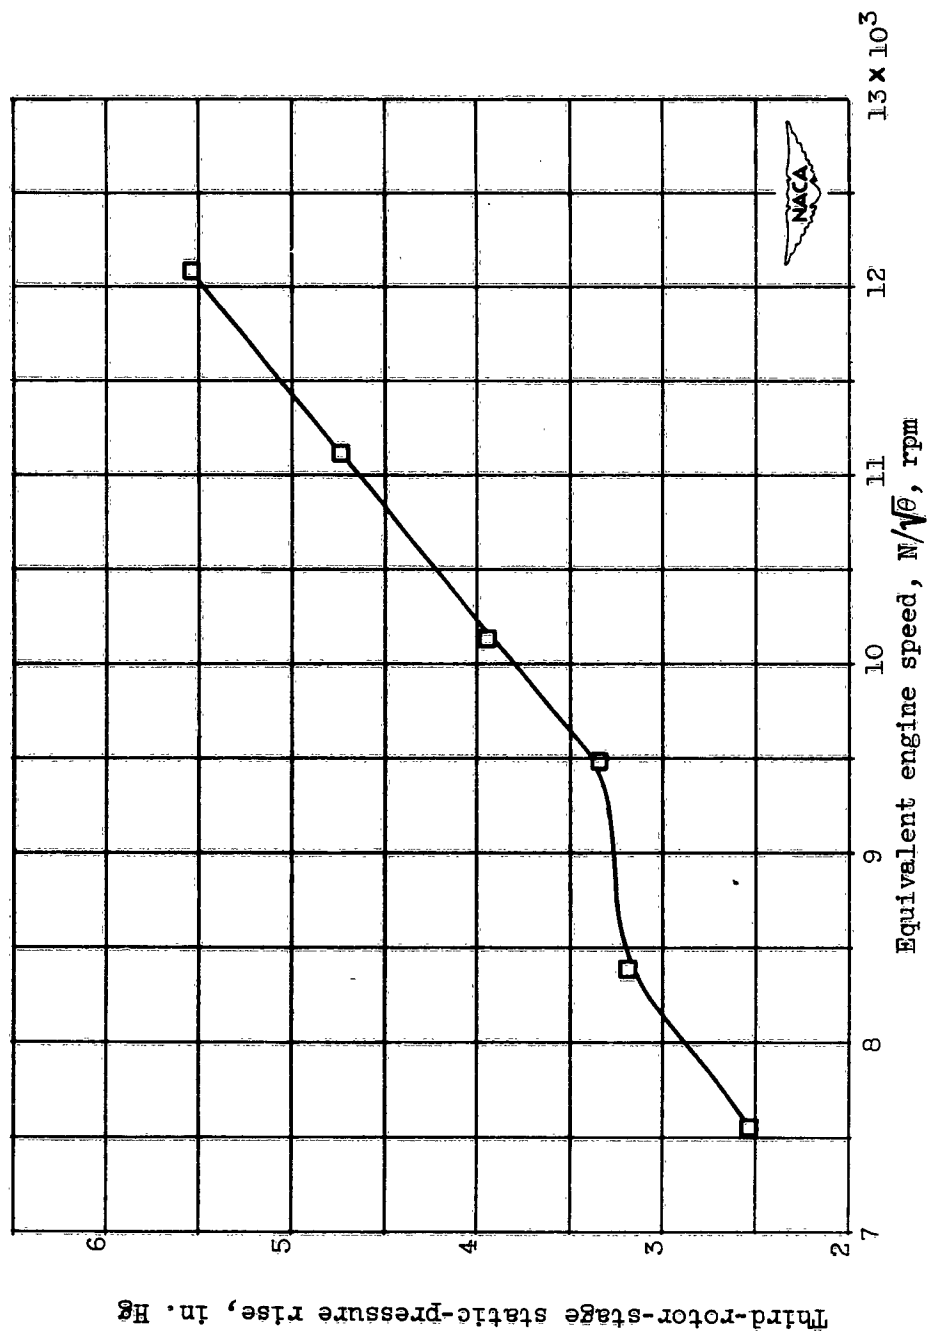
Pressure-rise test. - The third-stage static-pressure rise at equivalent engine speeds from 7500 to 12,000 rpm is shown in figure 7. A constant rate of pressure rise with engine speed was observed at all speeds except in the critical speed range from 8500 to 9500 rpm. Here the pressure remained approximately constant for about 1000 rpm, which indicated that the third stage was probably in a partially stalled condition.

Figure 7. - Third-stage static-pressure-rise survey.

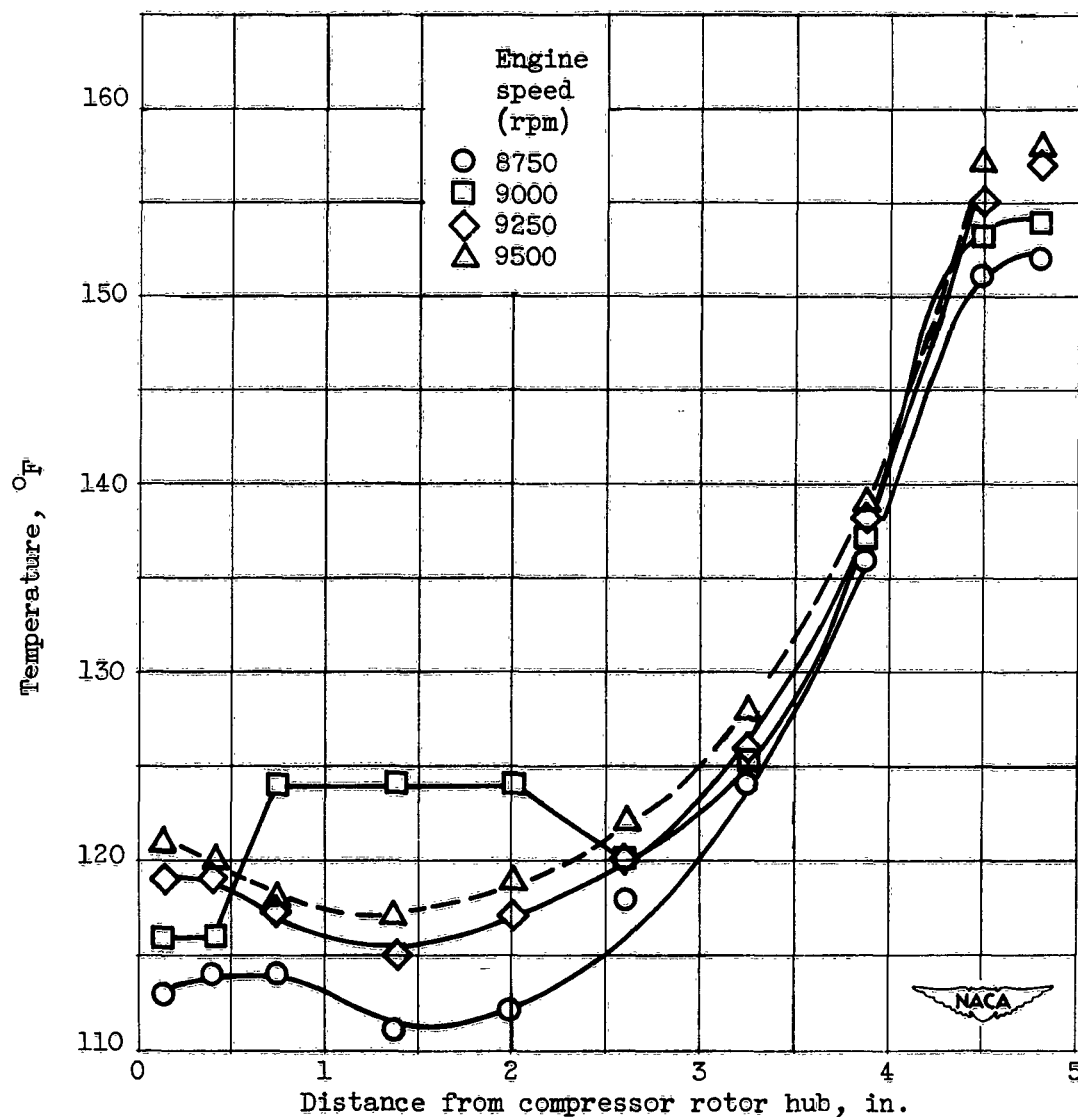
Temperature and hot-wire measuring probes. - Data from the temperature survey of the air out of the third stage are plotted in figure 8. At all speeds the temperature increased uniformly from the base to the tip of the blade except from 1 to 2 inches from the hub at 9000 rpm. This 10° rise and the consistently high temperature at the blade tip indicate that stalling possibly exists around the lower part of the blade at 9000 rpm and at the tip throughout the complete critical speed range.

Figure 8. - Third-stage radial temperature survey.

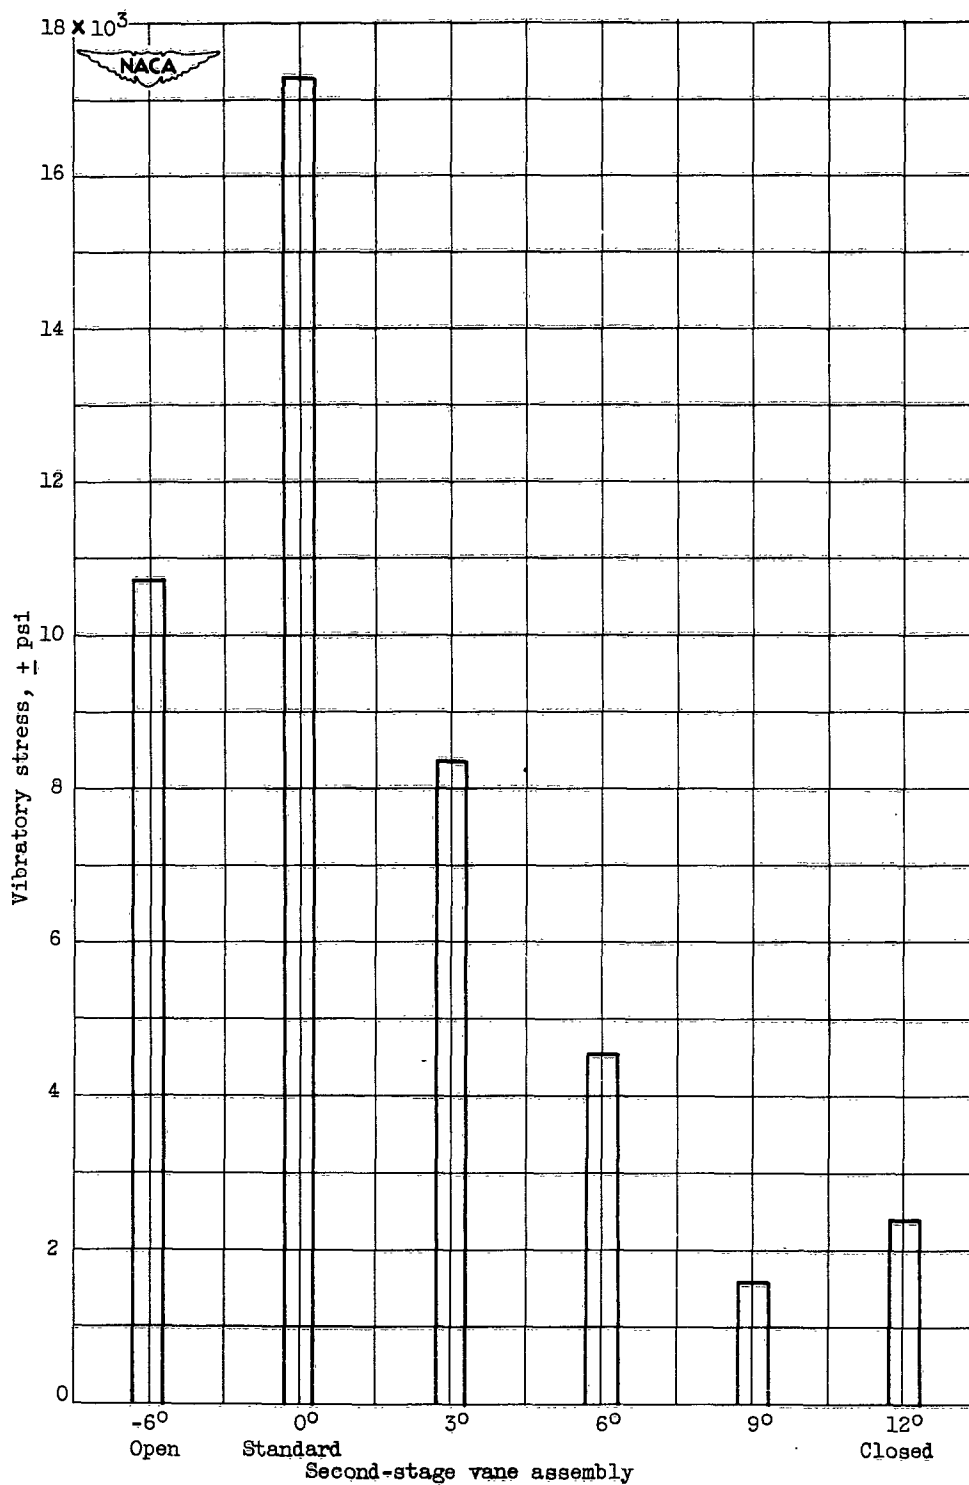
Figure 9. - Effect of second-stage vane-assembly angle of incidence on third-stage vibration.

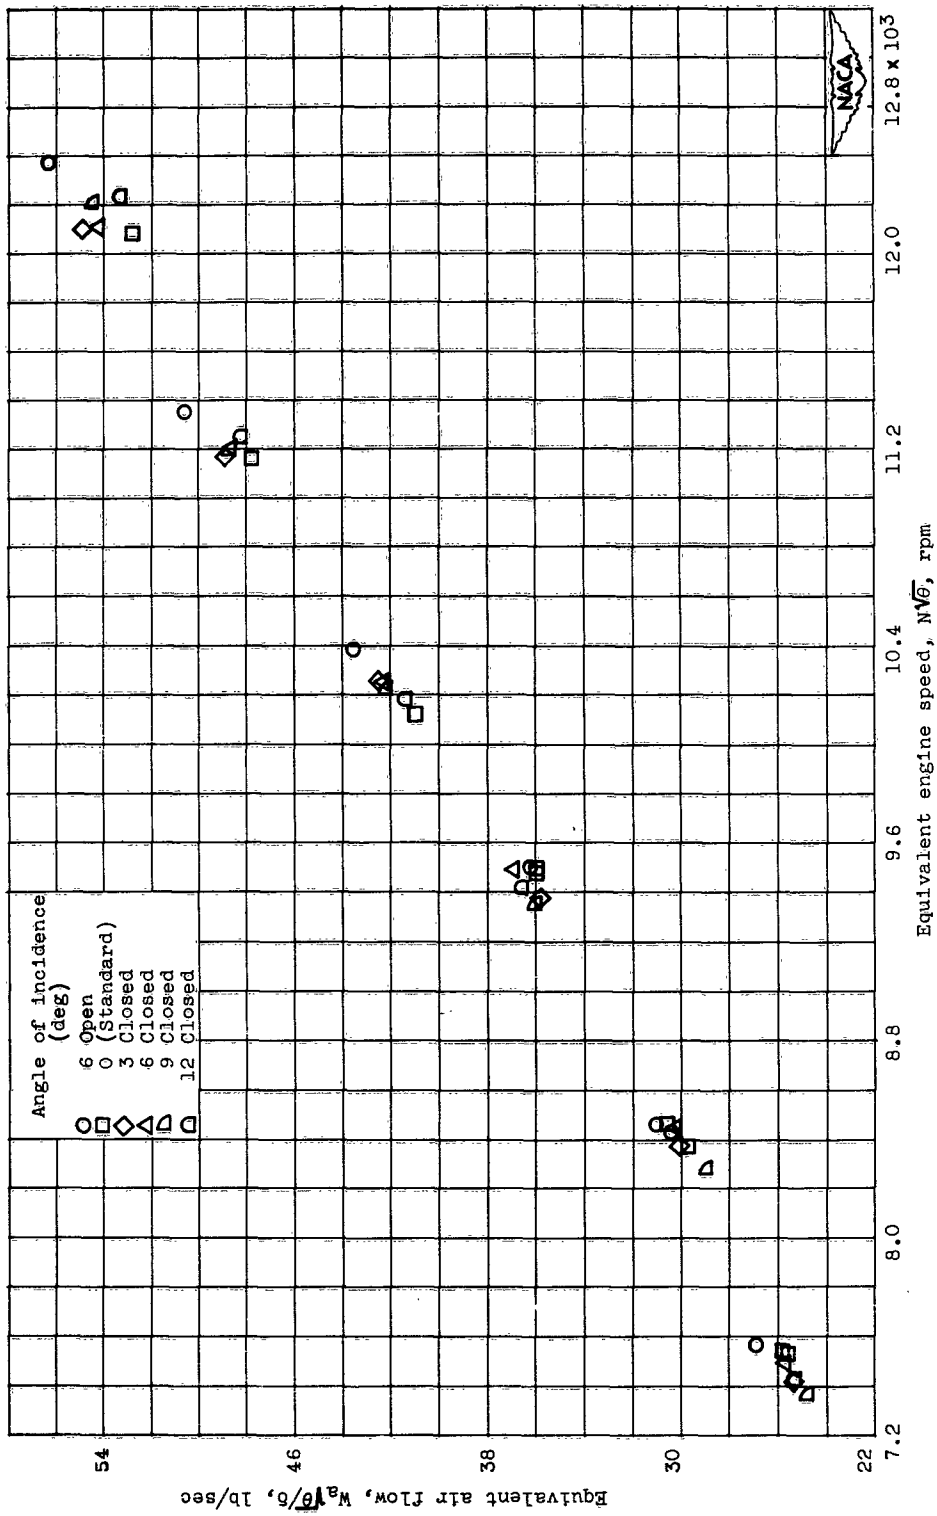
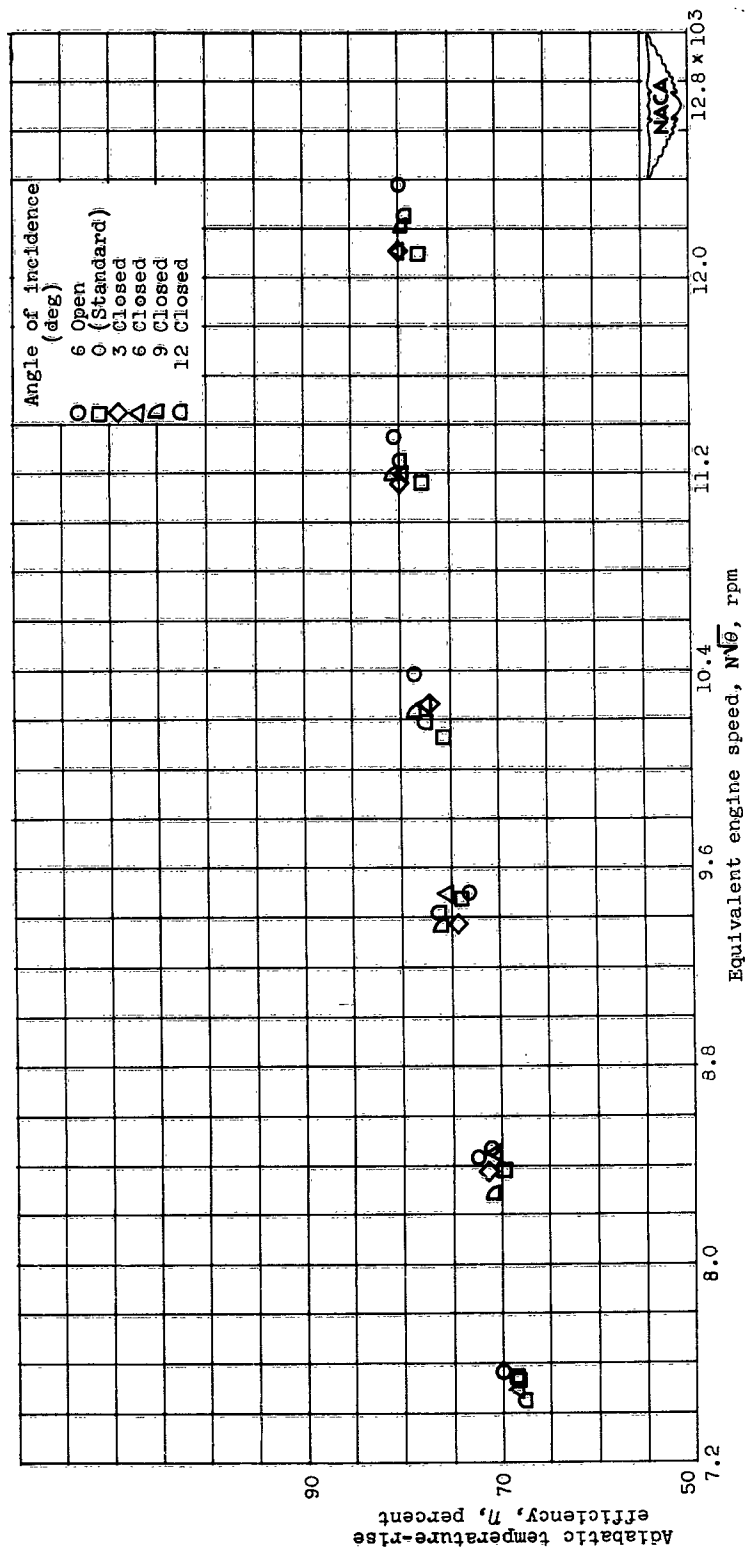
(a) Equivalent air flow.

Figure 10. - Performance characteristics of eleven-stage compressor with various second-stage vane-assembly angles of incidence.

Figure 10. - Concluded. Performance characteristics of eleven-stage compressor with various second-stage vane-assembly angles of incidence.

The complete speed range (to 12,500 rpm) was investigated with vanes of each angle to determine vibratory effects as well as engine performance. No new vibration of significant amplitude was introduced by any of the new angles. The effect on over-all engine performance is illustrated in figures 10 and 11. Although a total change of  $18^\circ$  ( $6^\circ$  open to  $12^\circ$  closed) was investigated, very little change in engine performance was detected.

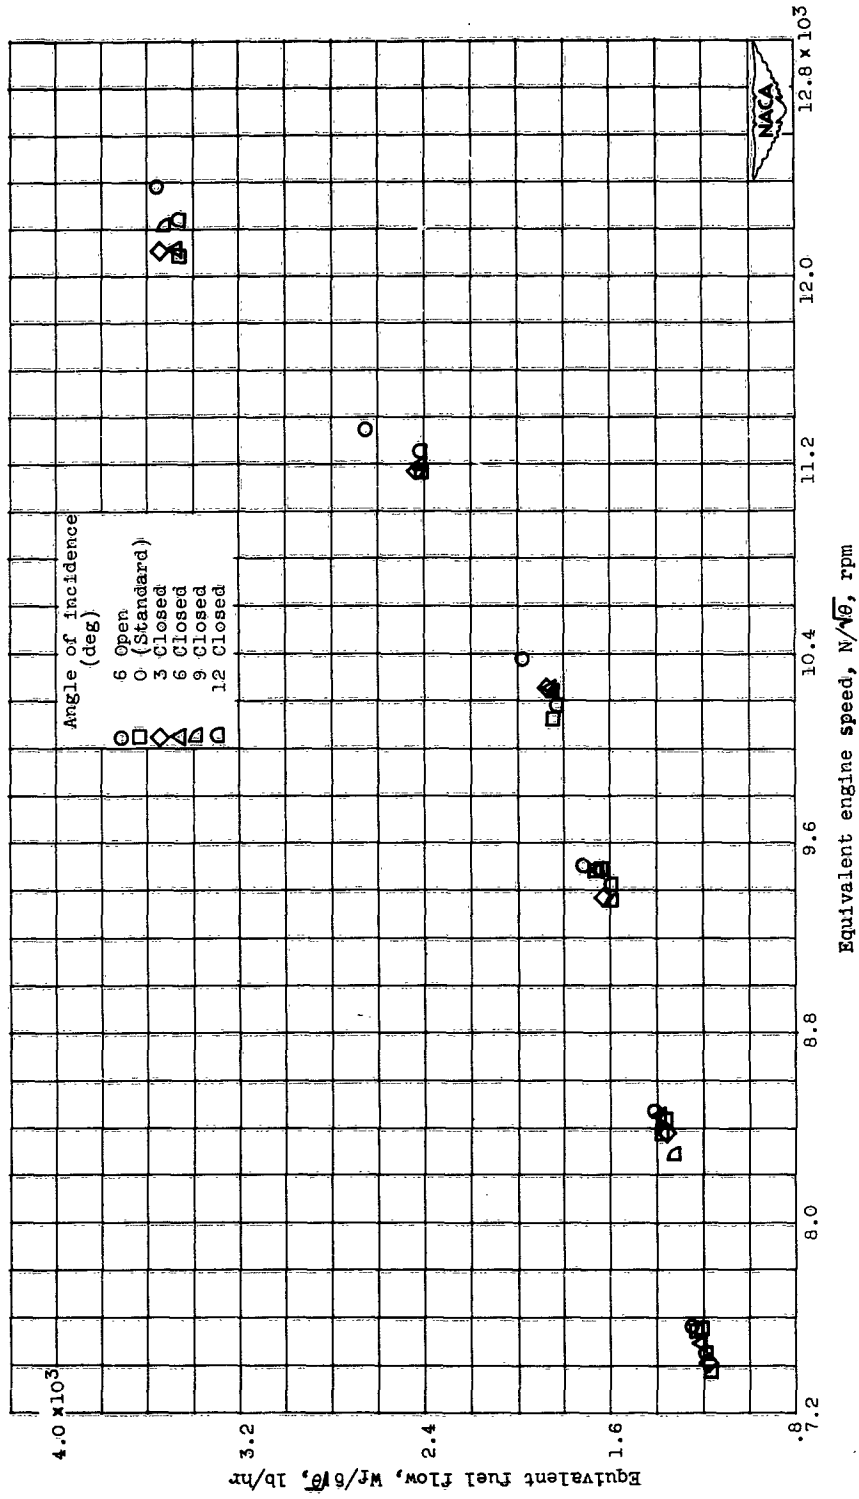
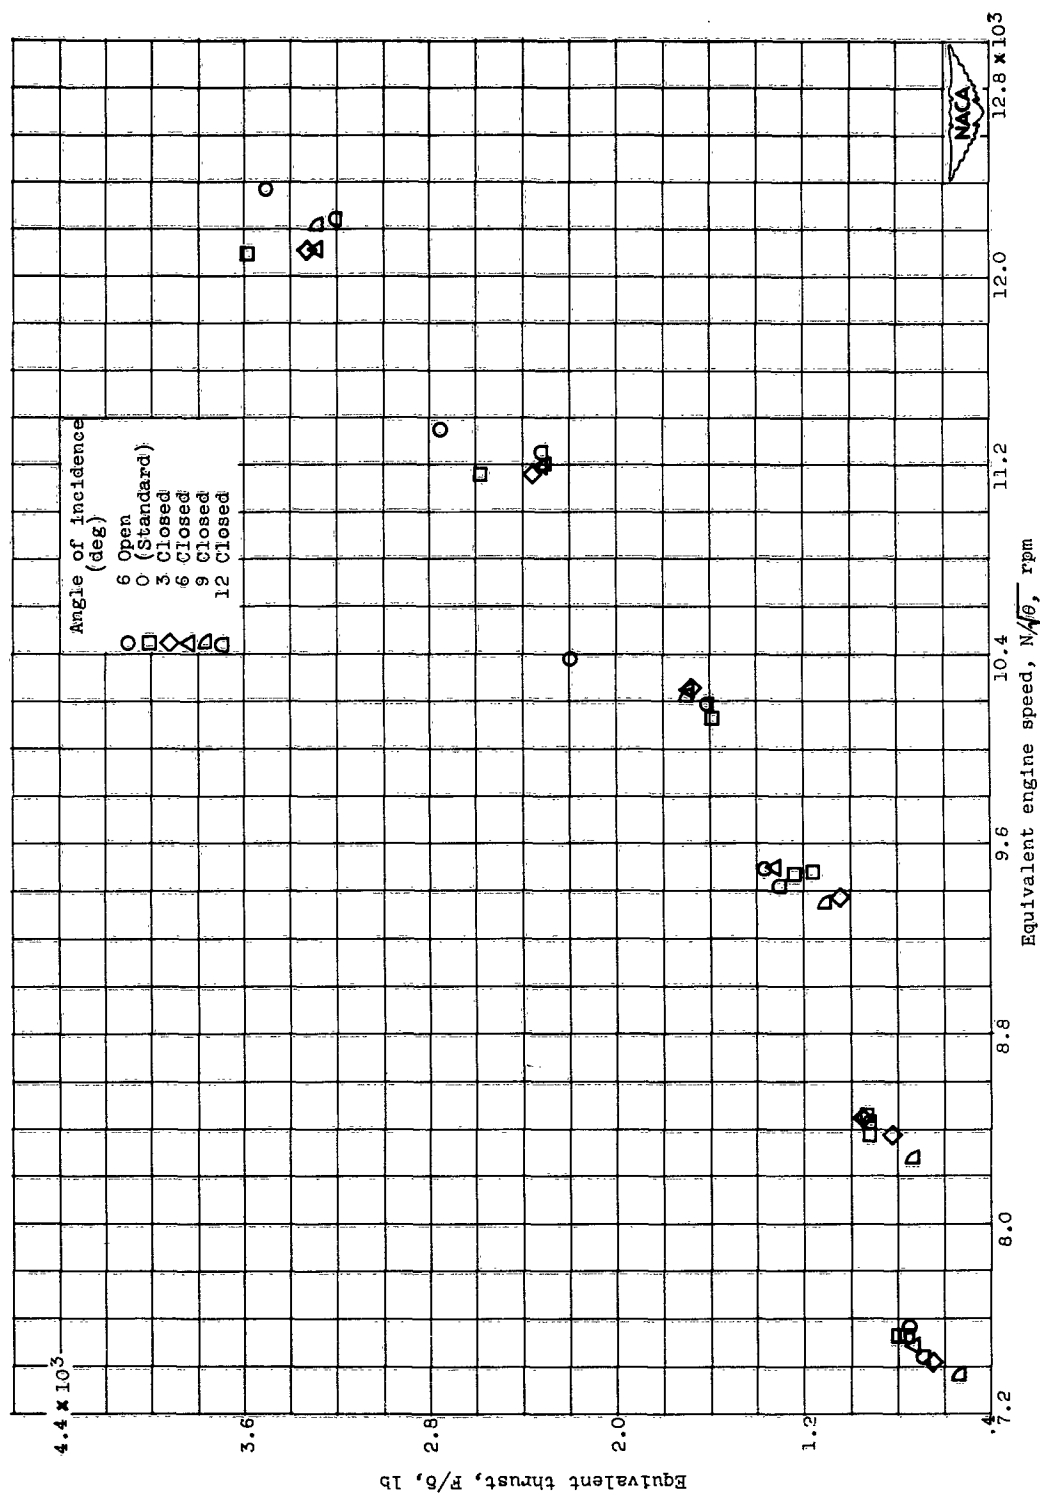
Figure 11. - Performance characteristics of turbojet engine with various second-stage vane-assembly angles of incidence.

Figure 11. - Concluded. Performance characteristics of turbojet engine with various second-stage vane-assembly angles of incidence.
