OBSERVATIONS OF PROPAGATING STALL  
IN AXIAL-FLOW COMPRESSORS

T. Iura and W. D. Rannie

Report No. 4

April 1953

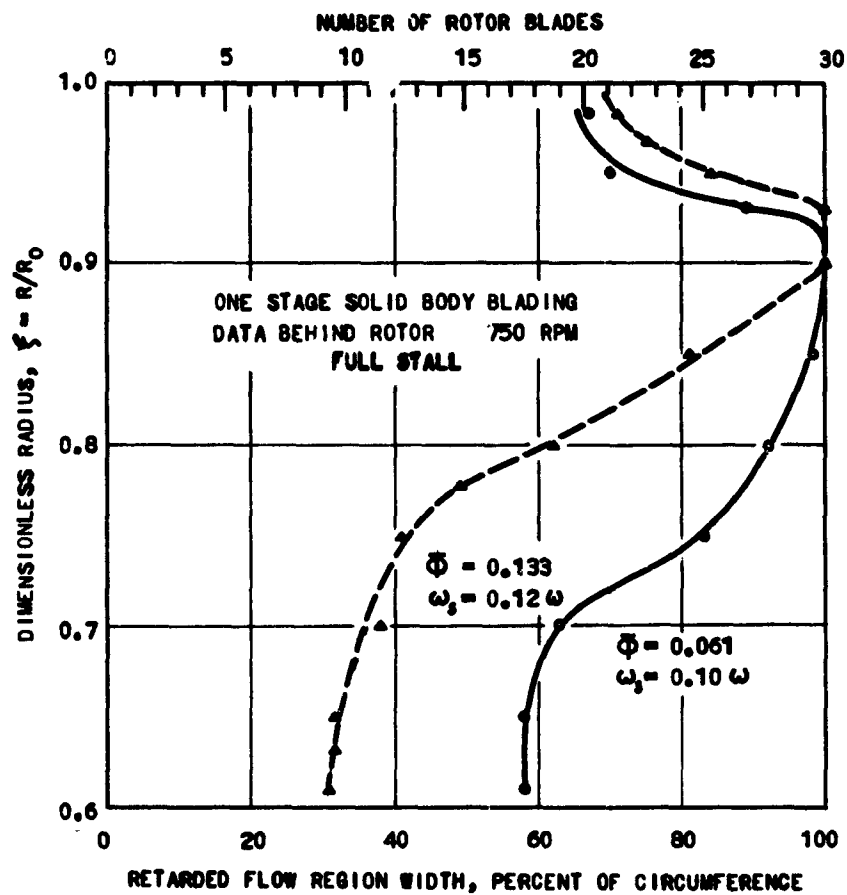
FIGURE 44  
RADIAL VARIATION OF RETARDED FLOW REGION WIDTH
