REPORT NO. 1137

-----  
FUZING SYSTEM FOR XSAM-N-4, GUIDED MISSILE DOVE;  
STEEL PLATE IMPACT TESTS

Fuzing System for XSAM-N-4, Guided Missile Dove;  
Steel Plate Impact Tests

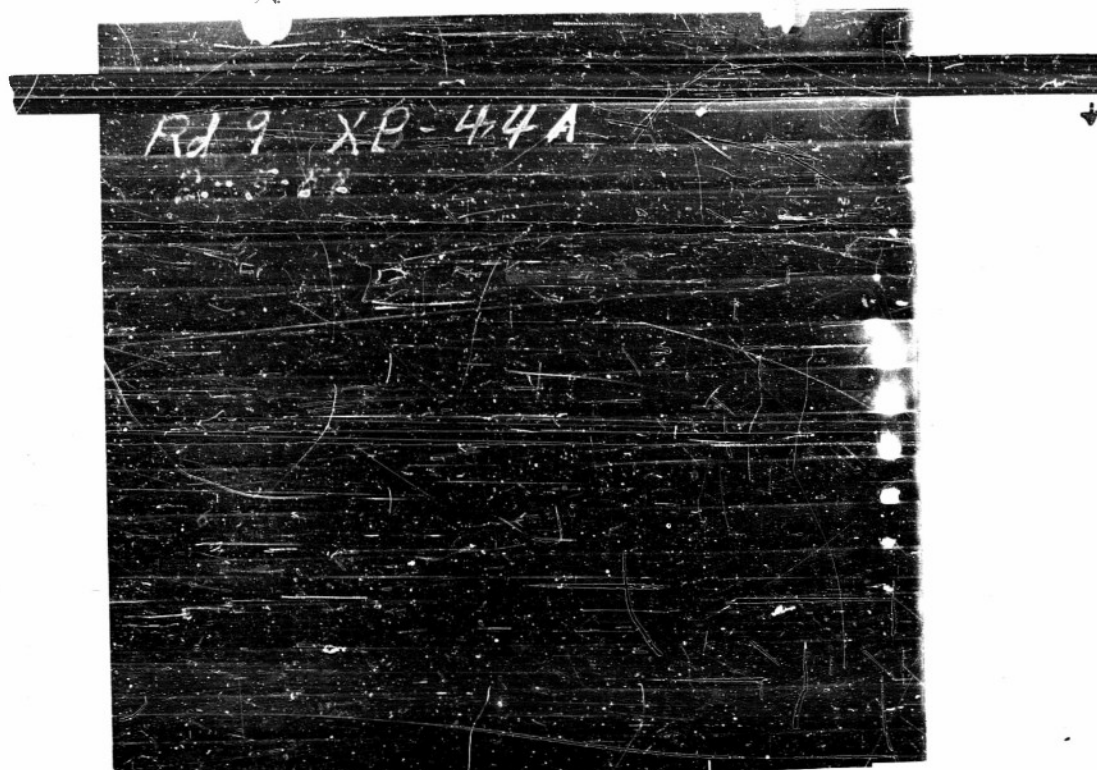
Functioning Test of XB-44A dove Fuze. View: Rd 9 - Fuze #160 fired from NPG 500 ft. launcher in 250# G.P. bomb vs 1-1/4" STS target at 0° obl. Impact velocity 881 ft/sec. Fuze functioned H0 with 215 ft. (0.39 sec.) delay after impact. Note fuze detonation at after end of sand pile. Figure 7
