WADC TECHNICAL REPORT 52-226  
PART 2

INVESTIGATION OF AXIAL LOADING FATIGUE  
PROPERTIES OF HEAT RESISTANT ALLOY N-155

Part 2. An Exploratory Investigation of the Effect of Temperature,  
Time, and Stress on Fracture Characteristics  
and Metallographic Structure of N-155  
and Hardness of N-155 and S-816

Fred W. DeMoney  
University of Minnesota

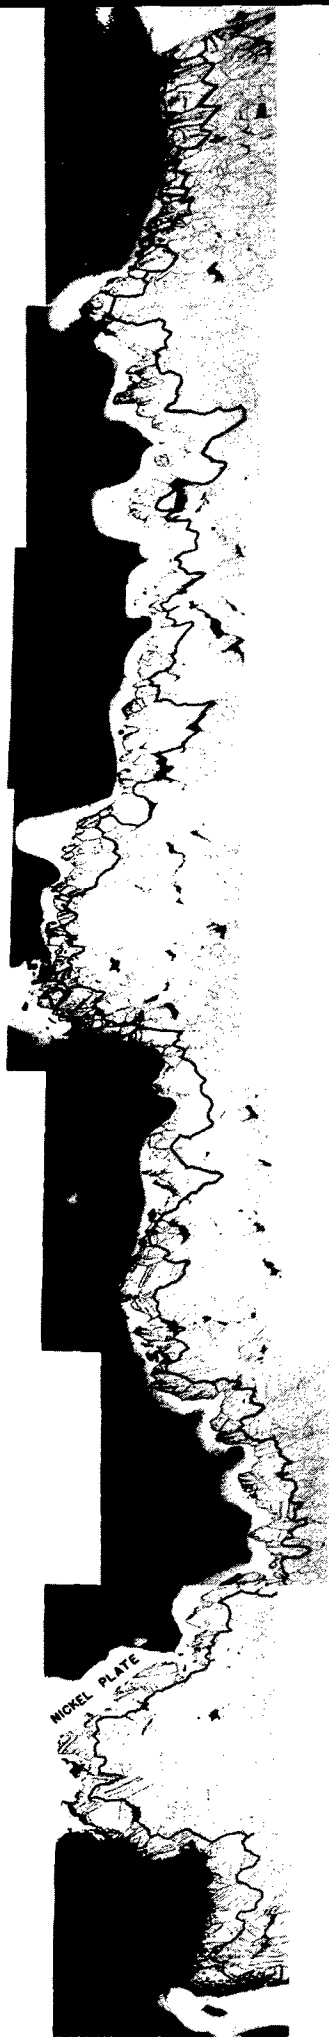
FIG.2 FRACTURE-PROFILES OF SPECIMENS TESTED AT 1500°F. ORIGINAL MAG. 150 X

A. JB-5: STRESS RATIO A=0: MAX. STRESS  $S_c=22.5$  KSI: HRS. TO FRACT.=20.7: INTERCRYST. FRACT.=96 %

B. JW-4: STRESS RATIO A=25: MAX. STRESS  $S_c=30.0$  KSI: HRS. TO FRACT.=8.0: INTERCRYST. FRACT.=54 %

C. JV-13: STRESS RATIO A=67: MAX. STRESS  $S_c=37.0$  KSI: HRS. TO FRACT.=10.9: INTERCRYST. FRACT.=41 %

A representative series of fracture-profiles are shown in Figures 2 and 3. The results obtained from this analysis are shown in Table I and are plotted in Figure 4. Data obtained from a previous investigation (1) are also shown. It is seen that the four test variables--time, temperature, stress, and stress ratio--influence the type of fracture and these effects will be discussed in the following sections.
