DEFECTS OF IMPORTANCE IN THE SPECIFICATION  
OF REINFORCED PLASTICS PRODUCTS

NAVORD Report 2797

23 March 1953

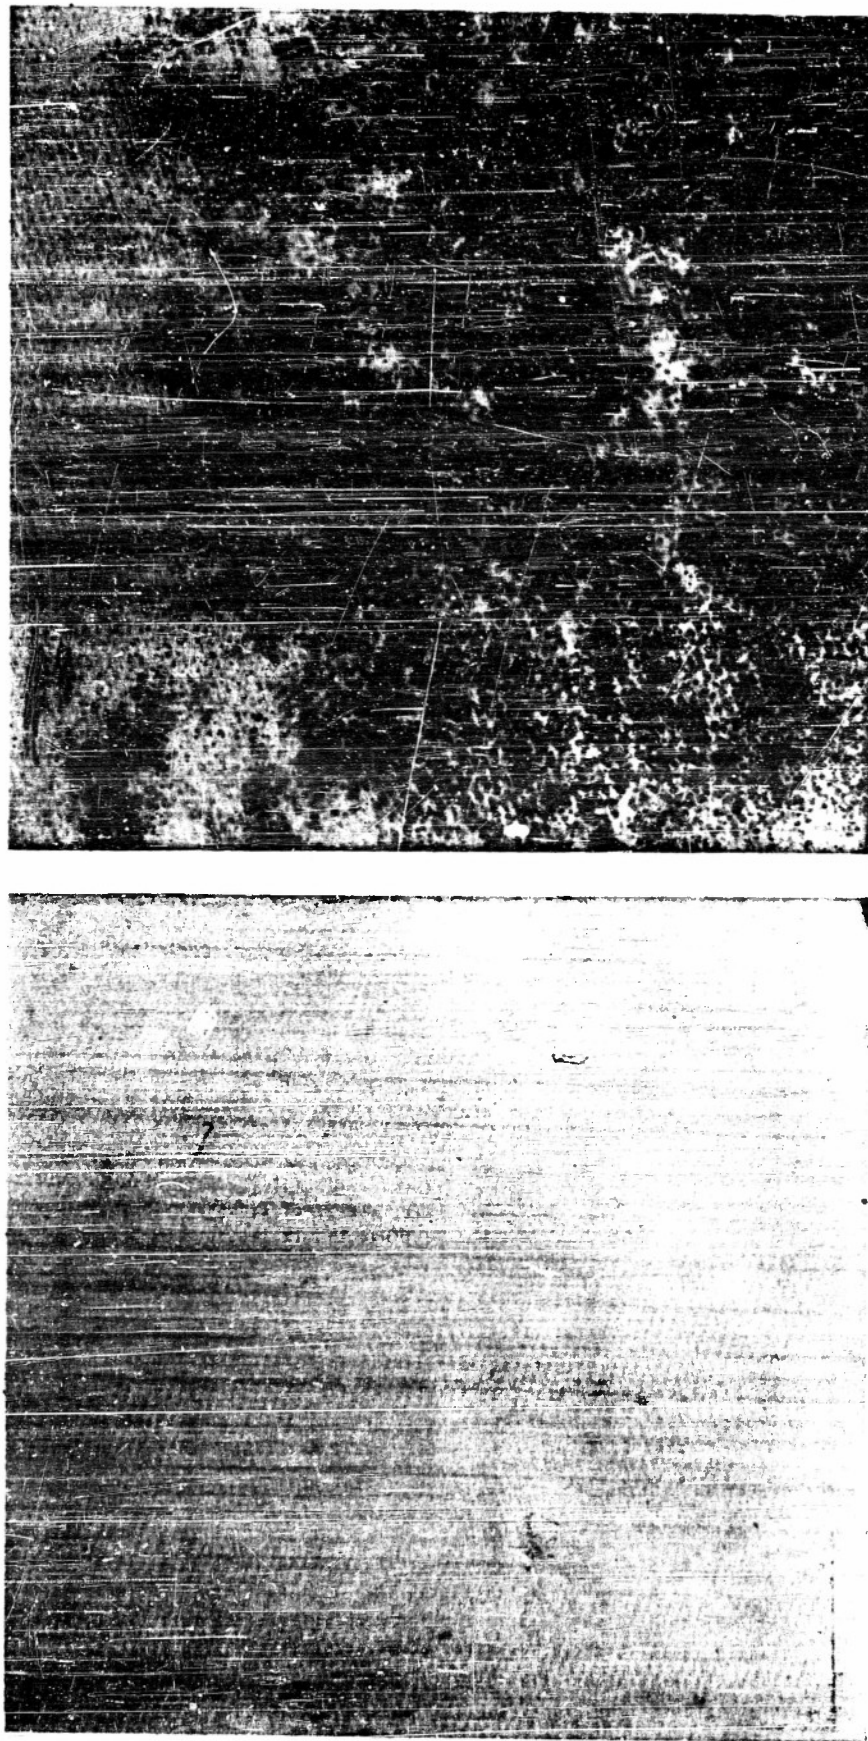
**FIG. 7 EXCESSIVE AMOUNTS OF AIR AND GAS BUBBLES**

*OPTIMUM QUALITY LAMINATE      EXCESSIVE AMOUNTS OF AIR AND GAS BUBBLES*

8. Air or gas bubbles in a laminate may constitute a very serious flaw for certain applications. Laminates with but very slight amounts or no visible bubbles are often termed "void free" and are the optimum quality laminates pictured in Figures 1 and 2 of this report. The primary question to be answered is how much air and gas bubbles can be tolerated considering the end use. If simple stress is the only factor involved then these bubbles are of importance only as a large or excessive amount of them indicate poor quality and workmanship on the part of the fabricator. Bubbles will appear on the surface as in Figures 5 and 6 or internally as in Figures 3 and 8. Surface bubbles are serious as their presence makes it difficult if not impossible to use many of the standard methods of gasket sealing to the laminate surface. Internal bubbles when numerous and bunched, Figures 4 - 8 indicate areas where the laminate will have a high rate of moisture or gas permeability. In fact they may form actual channels through which water can be forced under low pressures. Laminates with minor or slight amounts of bubbles, Figure 3 and 4, apparently suffer no decrease in their physical properties.

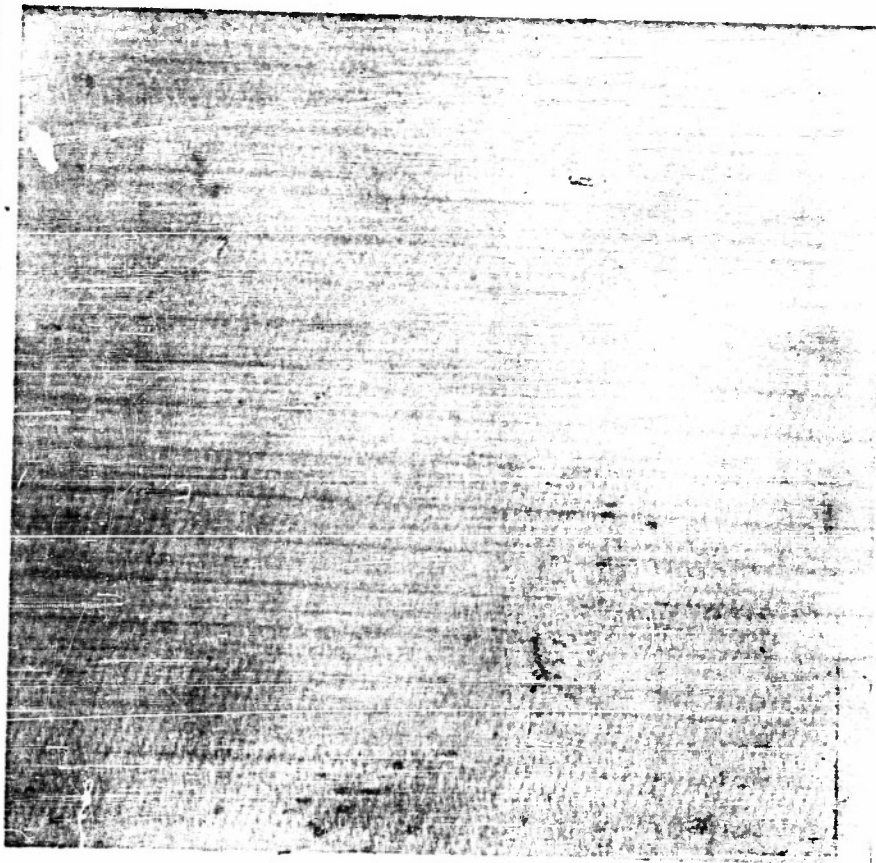
FIG. 10 SLIGHT CRAZING WITHIN LAMINATE

SLIGHT CRAZING WITHIN LAMINATE

10. Crazing, an indication of localized bond cleavage between resin and reinforcement is a very common occurrence in a laminate. In its minor conditions, it tends to give a hazy translucent appearance to the laminate, see Figures 10 and 11. Small white specks or dashes can be seen which occur at the points of maximum bend in the yarn of the reinforcement fabric. In a more severe condition crazing occurs rather heavily along a given ply following a defined pattern and appearing very much like a water mark,

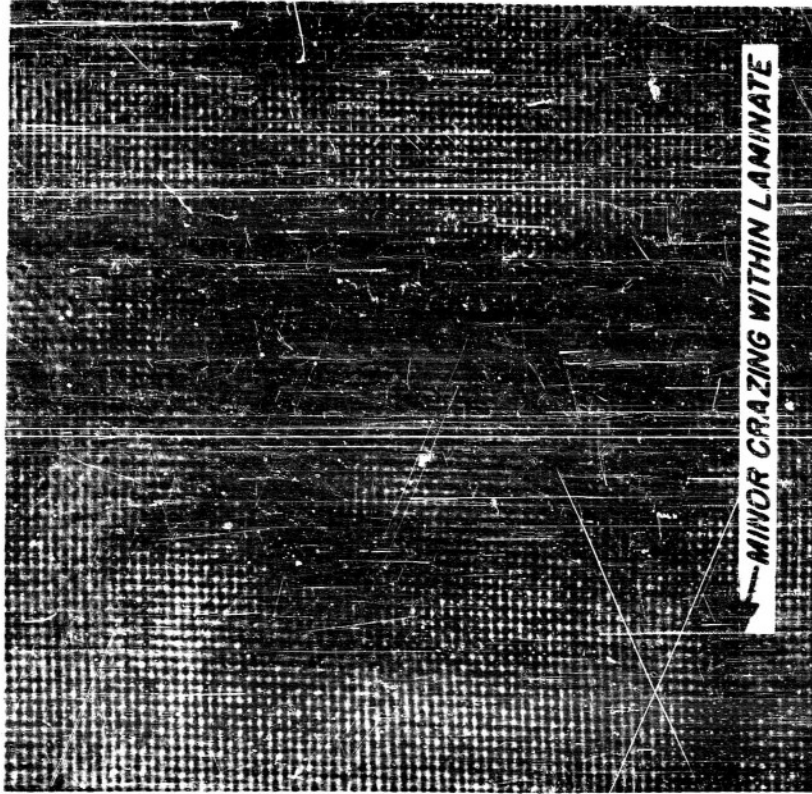
FIG. 12 MINOR CRAZING WITHIN LAMINATE

MINOR CRAZING WITHIN LAMINATE

Figures 12 - 15. This type of flaw in its severe condition indicates that something was wrong with the reinforcement and means a product with degraded properties having very poor resistance to outdoor weathering or any form of humidity cycling. Oil or grease on the fabric or a finish not evenly or effectively applied are factors which may cause the occurrence of this flaw. In one condition, crazing may cause the entire laminate structure to be "white" and lacking in translucency. See Figures 15 and 16. This same condition may be brought about by a high heat cure of a laminate which has not been properly wetted out prior to the cure or which was fabricated under excessive humidity conditions.

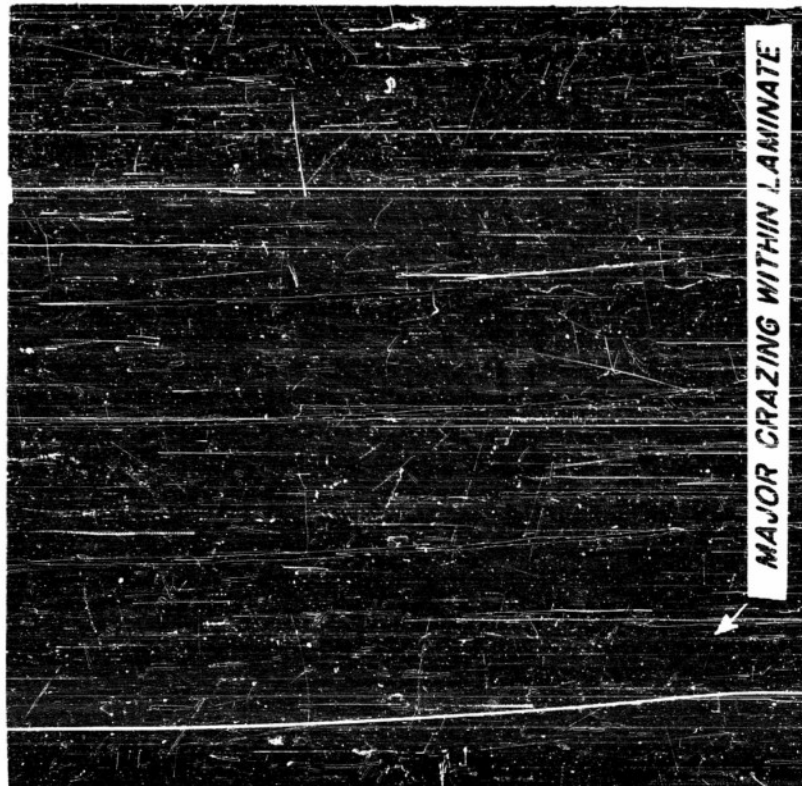
FIG. 15 MAJOR CRAZING WITHIN LAMINATE

MAJOR CRAZING WITHIN LAMINATE

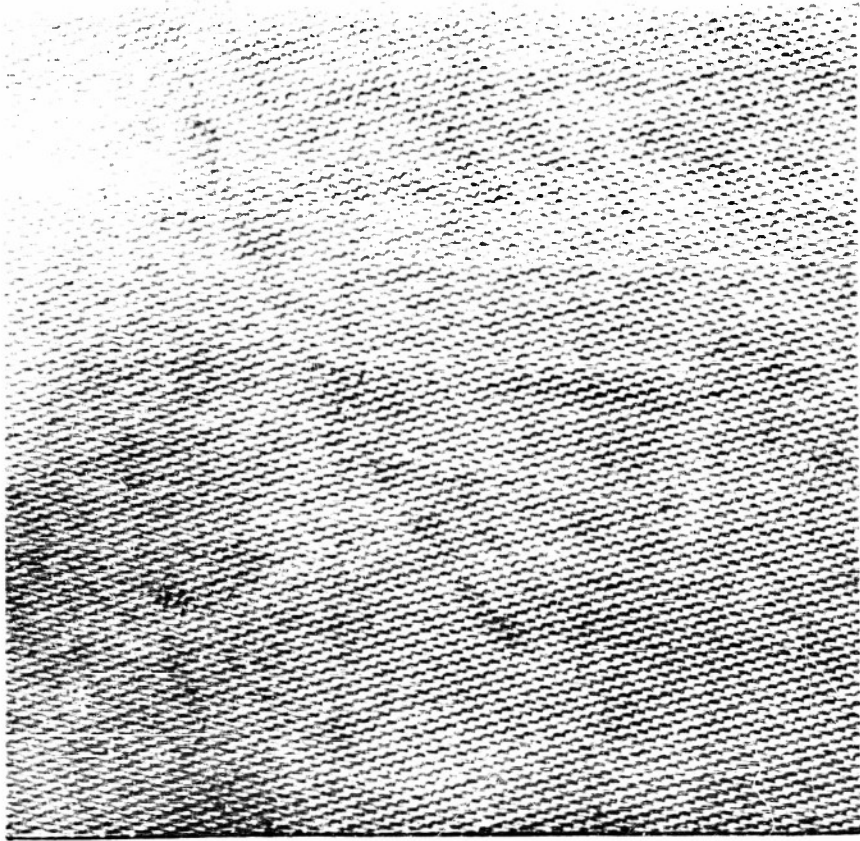
FIG. 17 "WHITE" LAMINATE

"WHITE" LAMINATE

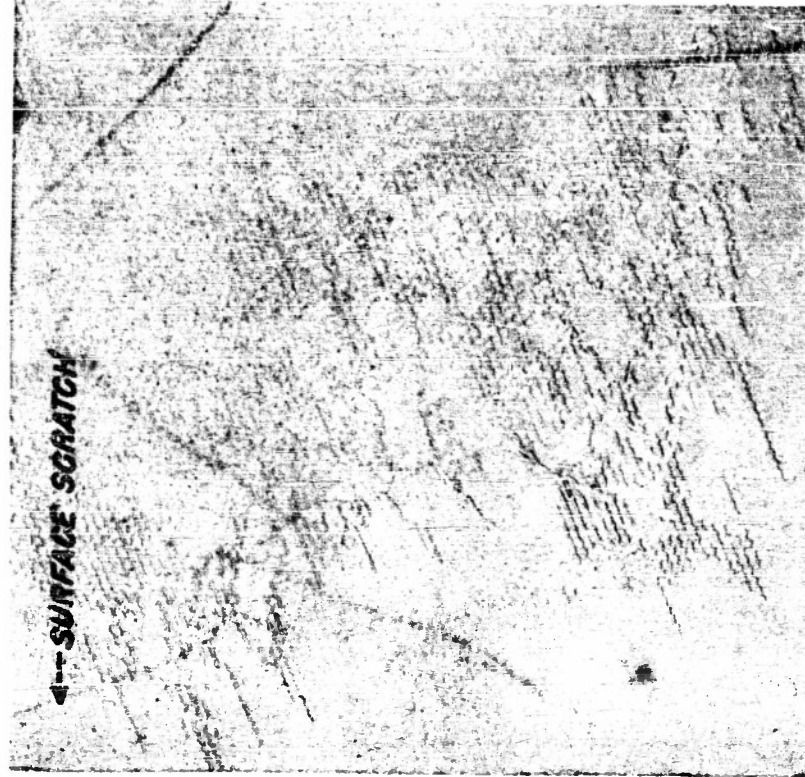
FIG.34 SURFACE UNEVENNESS

SURFACE UNEVENNESS

22. "Rough" surfaces may occur because the release coat on the mold was not properly cured before molding of the piece. Styrene in the molding resin then attacks the release coat and "lifts" it so that the surface of the molded piece becomes rough at these points. This flaw, Figure 34, has no effect on the properties of the piece as such, except where a seal may be required.

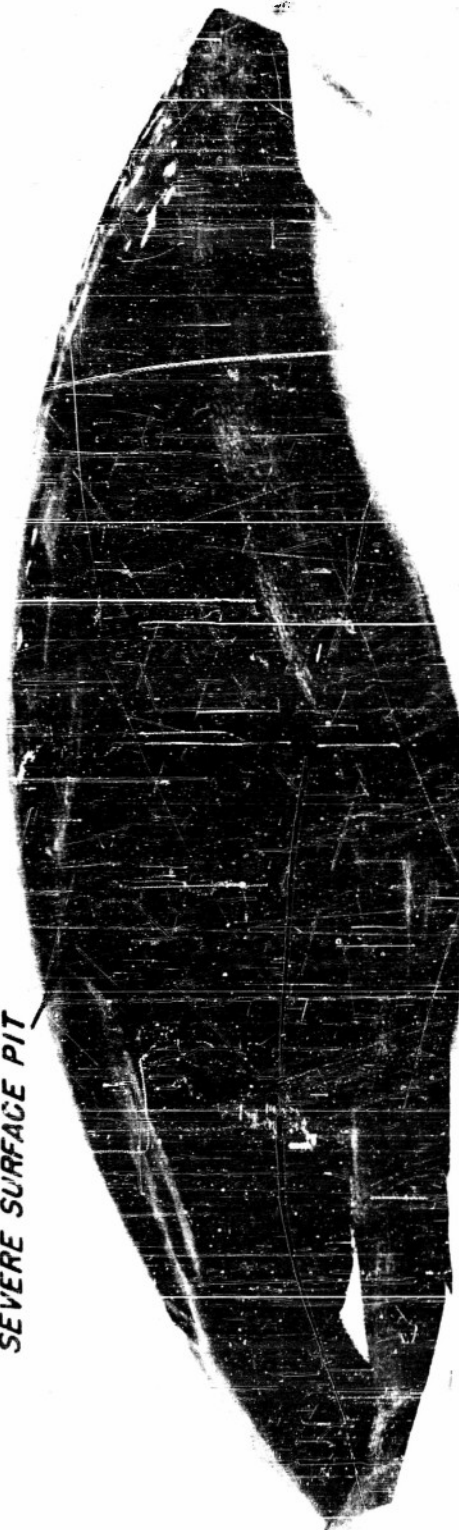
**FIG. 36 SURFACE PITS**

*SEVERE SURFACE PIT*

24. Pits may also occur in the surface of laminates. Small ones indicate a poor mold surface or the presence of foreign matter on the mold surface and may generally be considered as of no consequence. See Figure 35. Large pits, however, are indicative of improper molding conditions. See Figure 36. They develop as a result of not having enough material, in effect, at that point of the pit. This flaw is precluded in some moldings by incorporating a layer of glass mat between the glass fabric plies. The mat tends to be resilient and adjusts to variations in the cavity space in a mold and between differences in the quantity of fabric at any point in a lay-up.

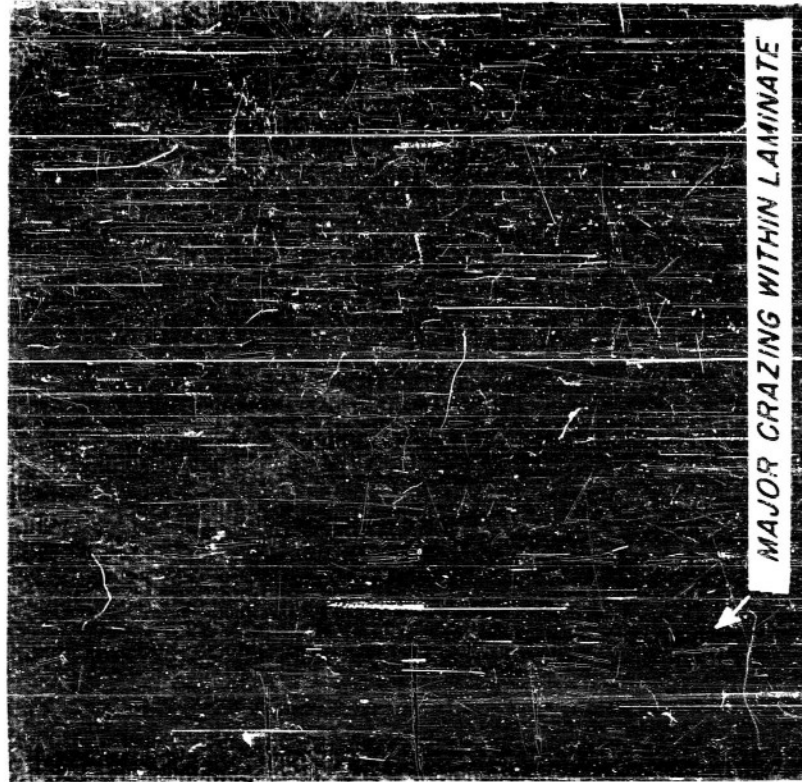
FIG. 14 MAJOR CRAZING WITHIN LAMINATE

MAJOR CRAZING WITHIN LAMINATE

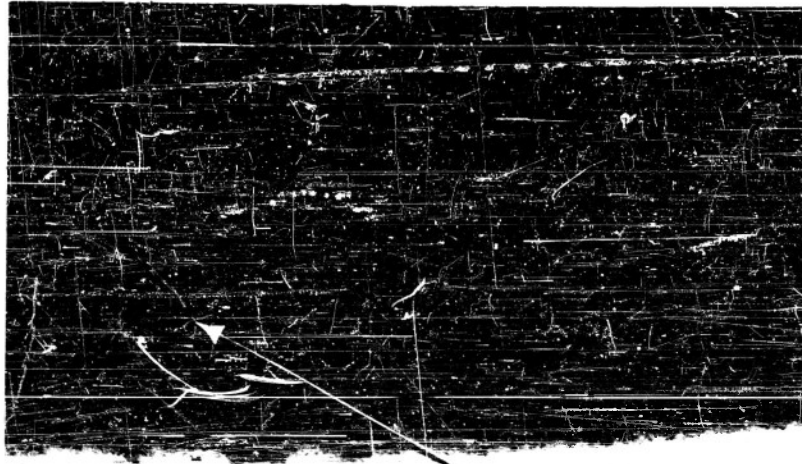
FIG.26 POORLY WETTED UNDER-PLIES IN LAMINATE

POORLY WETTED  
GLASS MAT  
UNDER - PLY

16. A common practice with reinforced plastics is to use plies of glass mat in conjunction with glass cloth. With such a technique it is very possible to develop the condition in which the cloth wets out but the wetting of the mat is very spotty. Figures 26 - 28 are examples of this flaw. Here again large areas of poor wetting indicate poor molding practices and the product will be inferior for many applications.

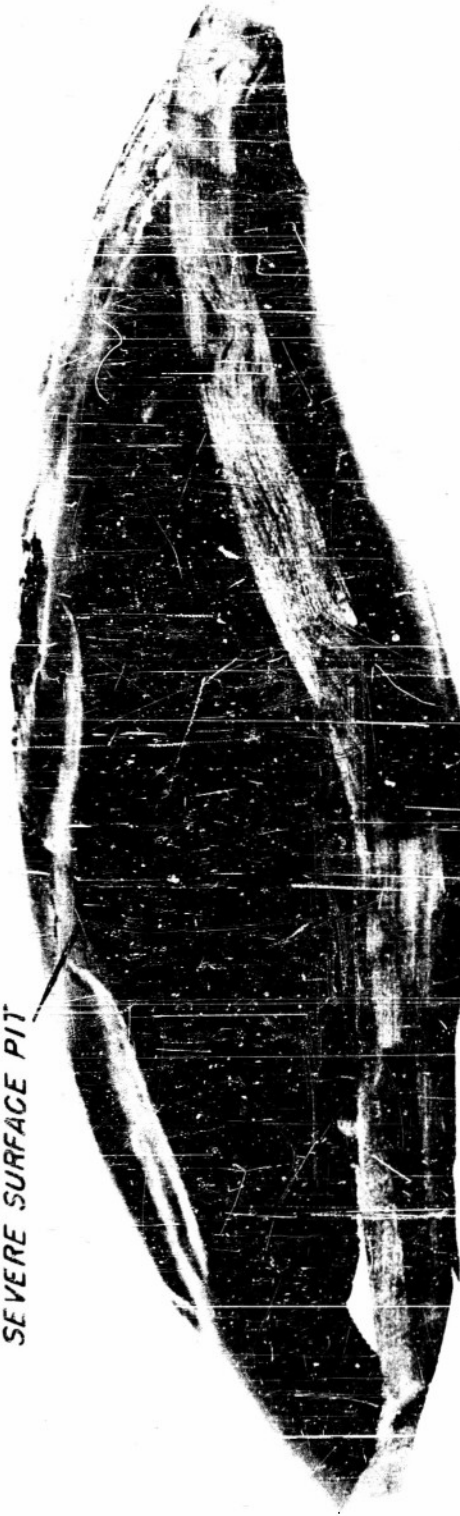
FIG. 36 SURFACE PITS

SEVERE SURFACE PIT
