TRANSITION TEMPERATURES OF STRUCTURAL  
STEEL BEAMS WITH BUTT WELDED SPLICES.

WILLIAM J. KREFFELD and GEORGE B. ANDERSON

Technical Report to Office of Naval Research and  
Welding Research Council of the Engineering Foundation  
Office of Naval Research Contract No-onr-271 - T.O. 7,  
CU-1-53-ONR - 271-CE.

OCTOBER — 1955

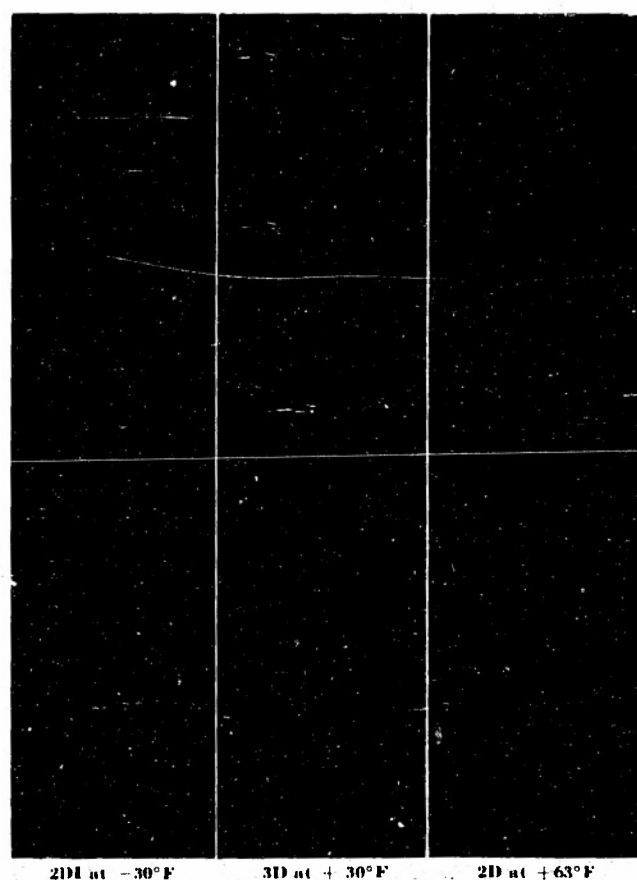
Plate 19 Fractures in unwelded and notched Beams, FK series
