Welded Continuous Frames & Their Components

Progress Report U

THE COLLAPSE STRENGTH OF A WELDED  
SINGLE BAY FRAME

Fritz Laboratory Report No. 205D.5

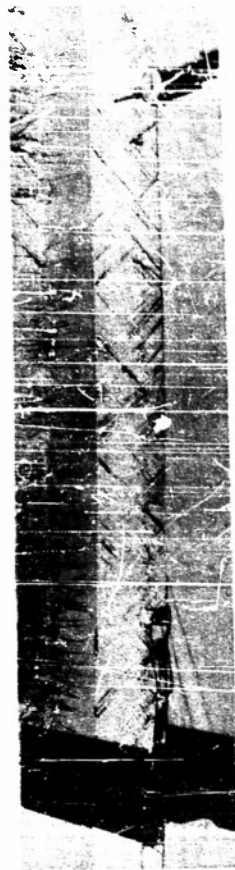
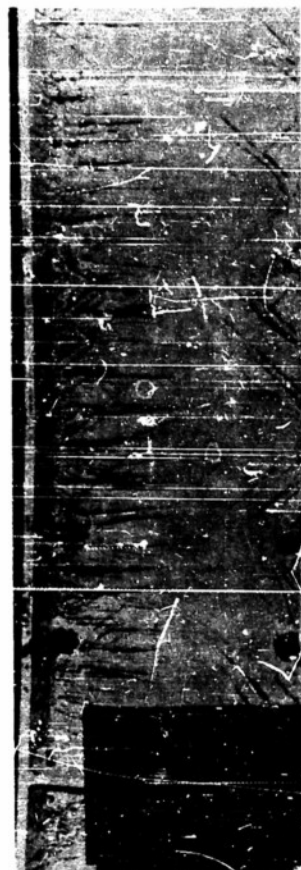
FIG. 13 REGION OF SECOND PLASTIC HINGE  
AT FINAL LOAD

a. VIEW LOOKING UP

b. SIDE VIEW

The first evidence of instability was observed by eye after the ultimate load had been reached and took the form of a lateral displacement of the compression flange of the beam near the second plastic hinge. The effect of this lateral buckle has already been discussed with regard to the drop in moment capacity of the beam in the region where the buckle occurred. This buckle took the form of a wave about 3 ft. long, but its displacement was prevented from increasing by the lateral supports which were attached to the beam at the intersection of web and flange.
