NACA RM E54A08

RESEARCH MEMORANDUM

EXPERIMENTAL INVESTIGATION OF ROTATING STALL AND
BLADE VIBRATION IN THE AXIAL-FLOW COMPRESSOR
OF A TURBOJET ENGINE

Lewis Flight Propulsion Laboratory
Cleveland, Ohio

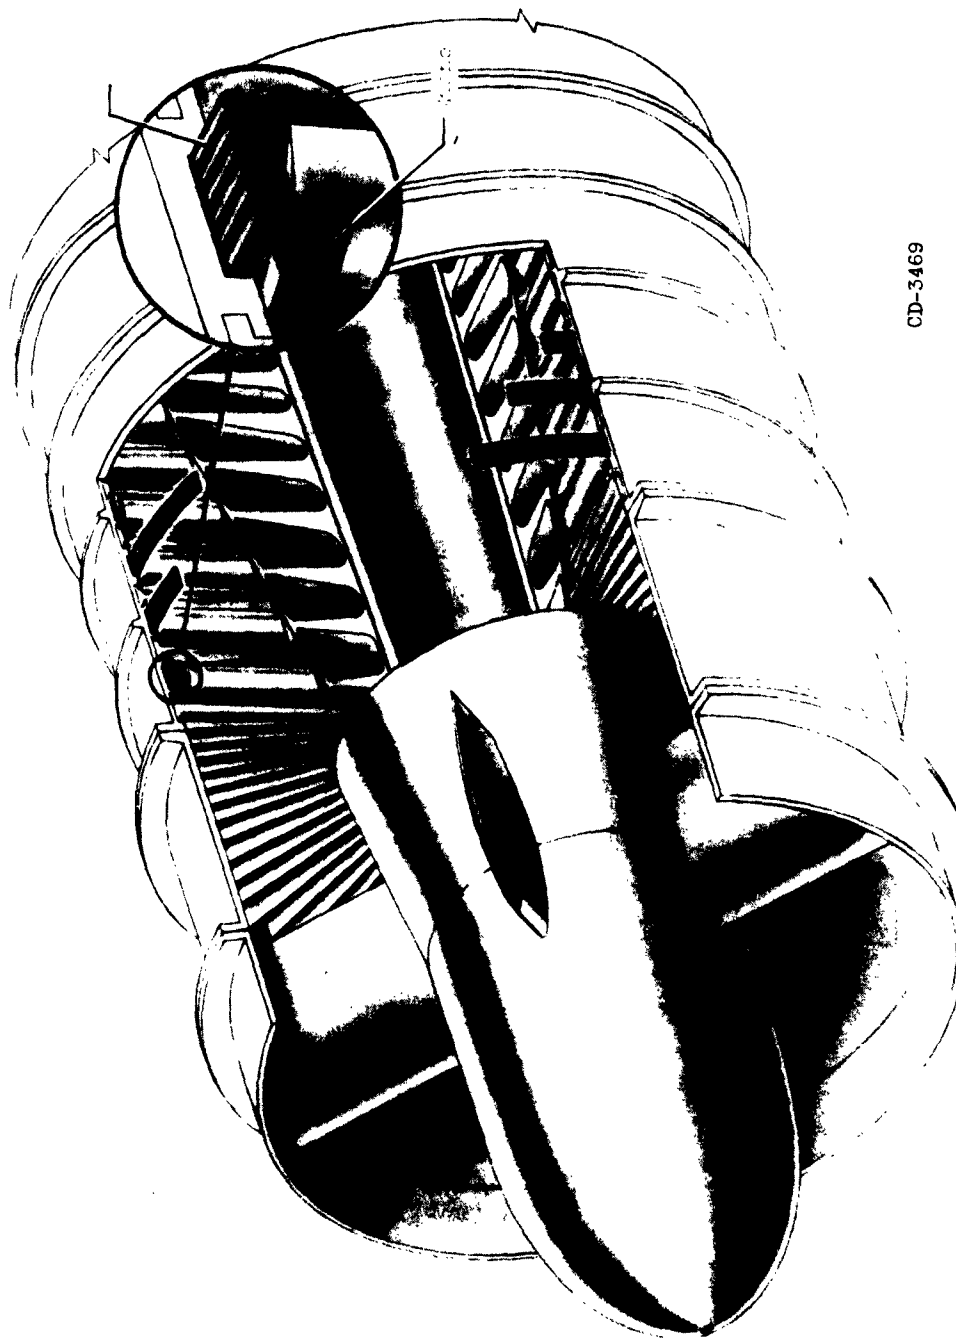
Figure 2. - Magnetic blade vibration indicator.

In addition, a permanent magnet was mounted in the tip of one blade each in the first-, second-, and third-stage rotors. Circumferential slots were machined on the inside of the compressor case with their center lines over the center line of each of the first three rotors. A wire coil was installed in each slot with the wires placed circumferentially in the casing of the compressor as shown in figure 2. Inasmuch as the rotor blades are set at an angle with respect to the compressor axis of rotation, any blade vibration would cause the magnetic field due to the magnets in the blades to cut the coils, resulting in an electromotive force generated in the coil. The voltage output is proportional to the rate of cutting flux or to the blade velocity normal to the coil wires, and is consequently a measure of the amplitude of the blade motion in and out of the plane of rotation due to vibration. This device will hereinafter be referred to as a magnetic vibration indicator.
