Report 989

**LYCOMING**  
**DIVISION - THE AVIATION CORPORATION**  
**WILLIAMSPORT, PENNA.**

**INITIAL OPERATION OF A SINGLE REED VALVE  
COMBUSTION CHAMBER**

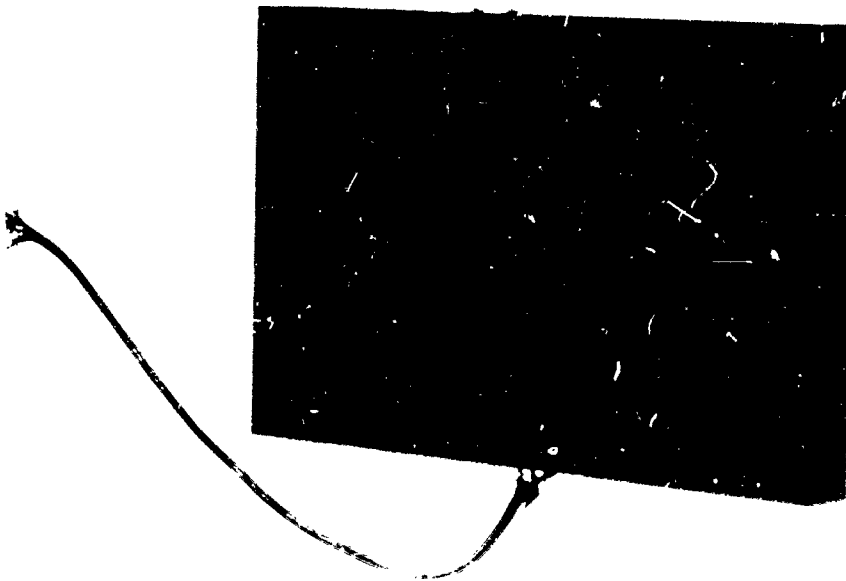
27 Pages, Page 19  
Report No. 989  
Photo No. E-4038

8. Photo No. E-4038 on page 19 shows the reed on the seat with the cover plate at the side.

| | <u>Page No.</u> |
|---|---|
| Photo No. E-4038 - Valve Parts with Reed on the Seat ..... | 19 |

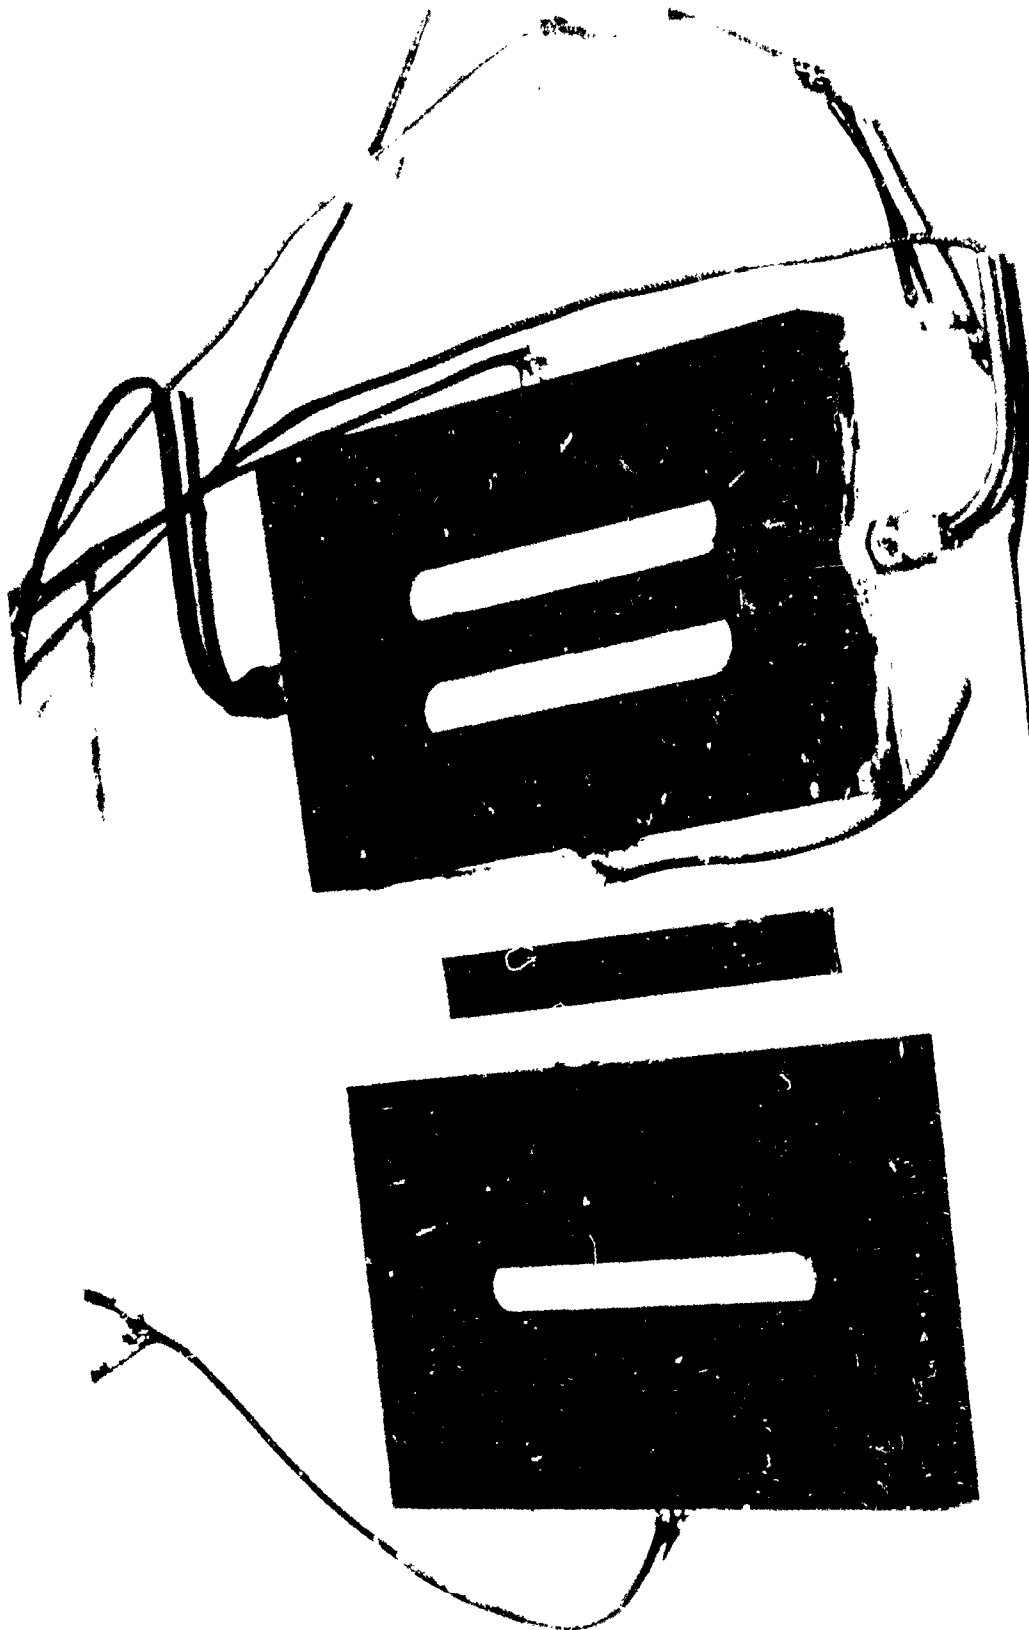
27 Pages, Page 20  
Report No. 989  
Photo No. E-4039

9. Photo No. E-4039 on page 20 shows the reed between the seat plate and cover plate.

| | <u>Page No.</u> |
|---|---|
| Photo No. E-4039 - Valve Parts with Reed off the Seat ..... | 20 |
