a. This is an interim report on the accelerated phase of the "Operational Suitability Test of the RB-57A Aircraft," Project No. APG/TAT/122-A. The test was initiated in accordance with APGC Letter Directive, dated 28 October 1953.

**RB-57A Aircraft**

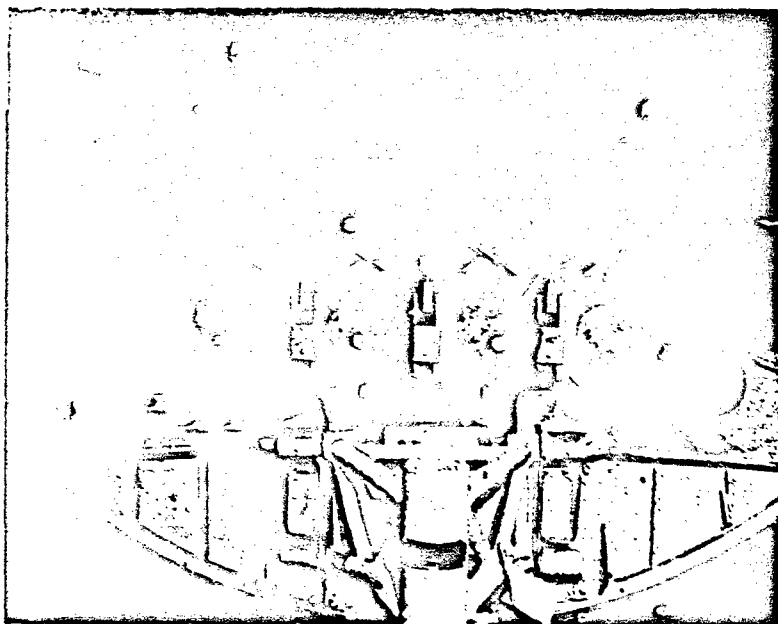
**PHOTO 6**

Front view of bottom four M-120 Bombs with sway braces fully tightened.
