WADC TECHNICAL REPORT 55-56  
PART II

**PROTECTIVE SHOT PEENING OF PROPELLERS**

**Part II. Fatigue Tests**

*LESSELLS AND ASSOCIATES, INC.*

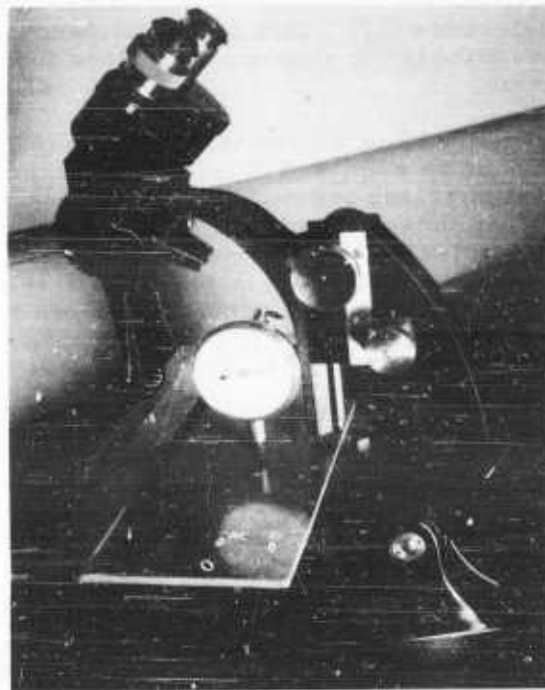
Figure 3. Apparatus for Gouge Depth Measurement

After testing, the failures were examined. In the cases where failure originated at a simulated gouge, the gouge depth was measured optically by means of a microscope with a dial gage mounted between the barrel and the stage. This arrangement is shown in Figure 3. In the case of shallow gouges a metallurgical microscope with a 6 mm objective and micrometer screw was used for increased accuracy. Accuracy of gouge depth measurement decreased with increasing peening intensity because of the rough surface. It was impossible to observe gouges on many of the heavily peened specimens, much less measure their depths. Photographs of the cracks were taken in many cases. Where necessary, specimens were bent to a small permanent set in order to delineate the cracks.

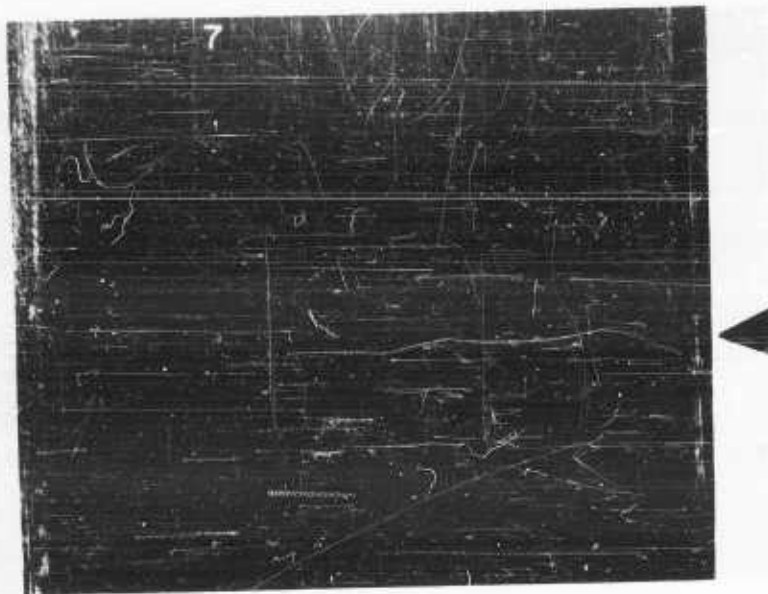
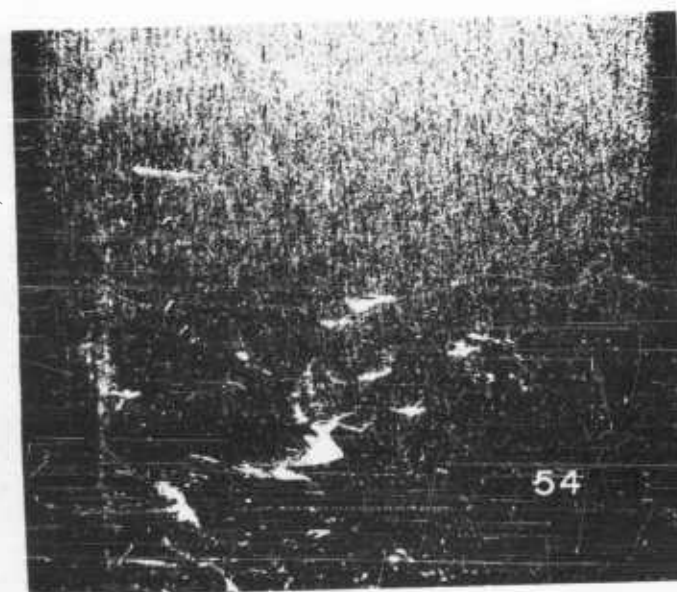
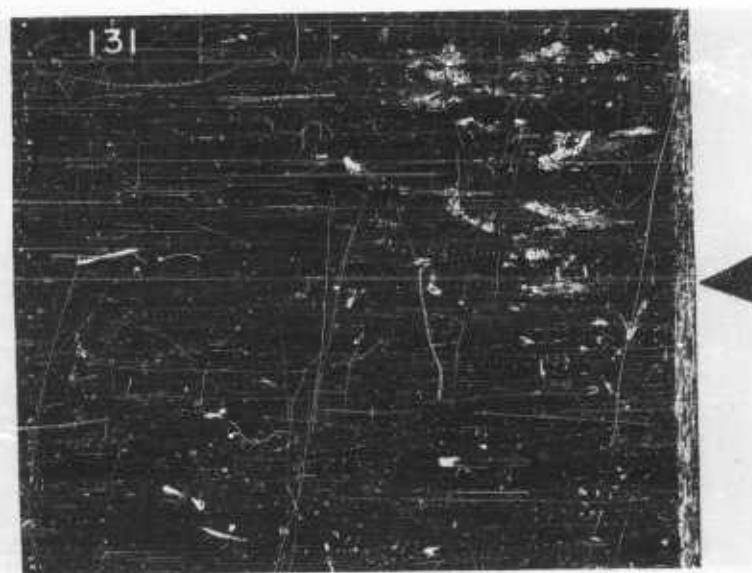
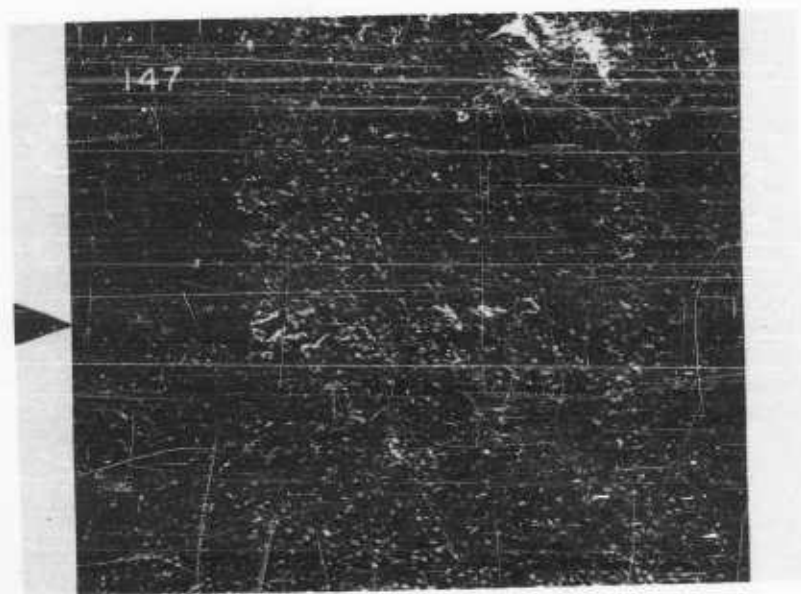
Figures 20 through 45 are photographs of failed test specimens, showing several typical failures. Many of the cracks run to at least one edge of the specimen. This is usually a result of crack growth from a nucleus nearer the midpoint of the specimen, although some cracks did start at the chamfered edge. The stress at this edge is calculated to be less than one percent greater (due to anticlastic curvature) than the stress along the center line of the bar. In cases where there was doubt as to the origin of failure, the bars were broken in two and examined for beach marks pointing to the origin. In a few cases, two or more cracks were formed.

Figures 20 through 45 are included to show the general appearance of the shot peened surfaces, the artificial damage and the failures. The triangular pointer at the side of each photograph indicates the location of the failure. In case of multiple failures, multiple photographs are included. Photographs are approximately 4X magnification.
