# AFTER OPERATIONS REPORT

1<sup>ST</sup> ENGINEER  
ARCTIC TASK FORCE

This report discusses briefly the scope, objectives, and significant accomplishments of the 1955 program and enumerates the problems encountered and the solutions applied or recommended for future years.

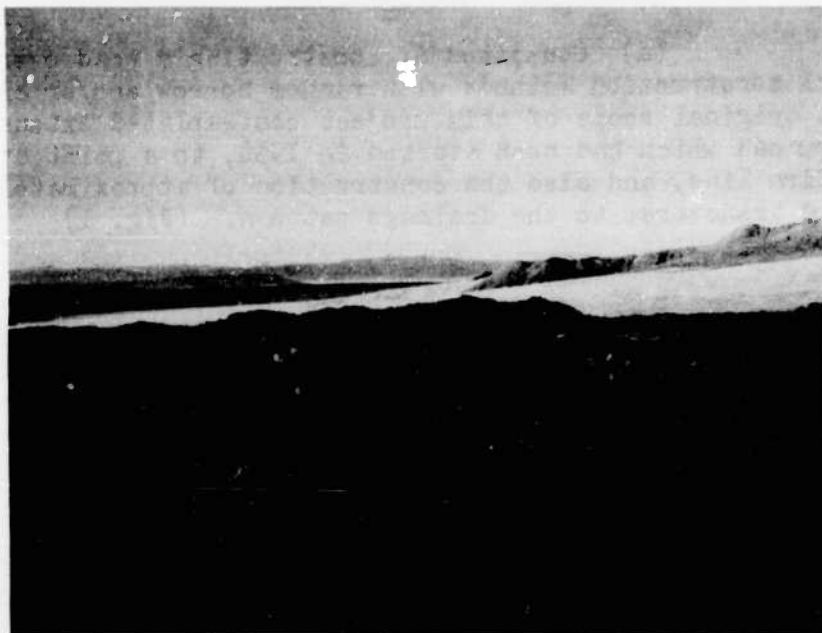
**Fig. 2 Fill Material Used in Rebuilding Washed Out Section of 1954 Constructed Ramp Road**

(b) Approximately one mile of the 1954 construction had to be removed and reconstructed since the material which had been used contained too much fine silt which absorbed free moisture during the early melt season and as a result turned the road into a river of mud. (Fig. 2)

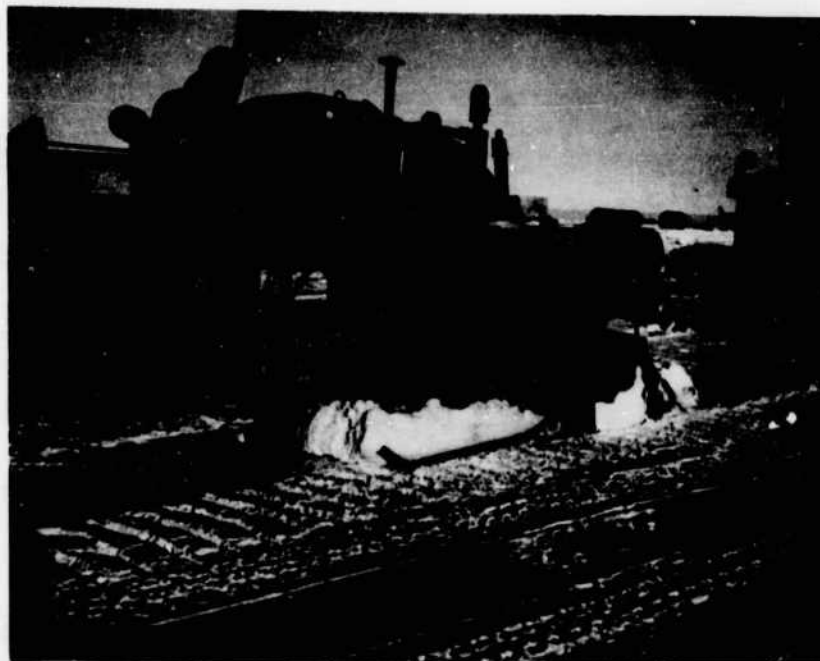
Fig. 3 Pulvimixer and Operator

(c) Considerable difficulties were experienced in maintaining pulvimixers and low ground pressure D-8 tractors due to a lack of sufficient spare parts and an acute shortage of qualified maintenance personnel. This situation was further aggravated by a lack of sufficient low ground pressure tractors to permit snow compaction equipment to be used in the most efficient manner. (Fig. 3)

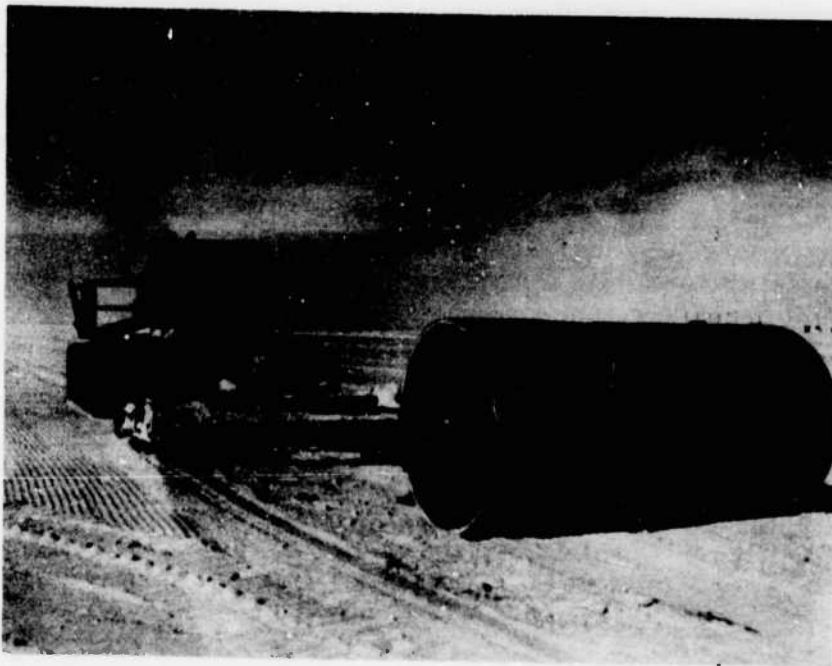
**Fig. 4 Rear View of D-7, LGP, pulling Drag Unit and Corrugated Steel Roller**

(d) Despite maintenance difficulties, shortage of personnel and equipment, compaction of the first strip was completed on or about the 20th of September, and although densities and hardness achieved were not uniform throughout the entire 10,000 foot length of the strip, the project engineer considered it ready for operational testing of wheel-type aircraft. (Figs. 4 and 5)

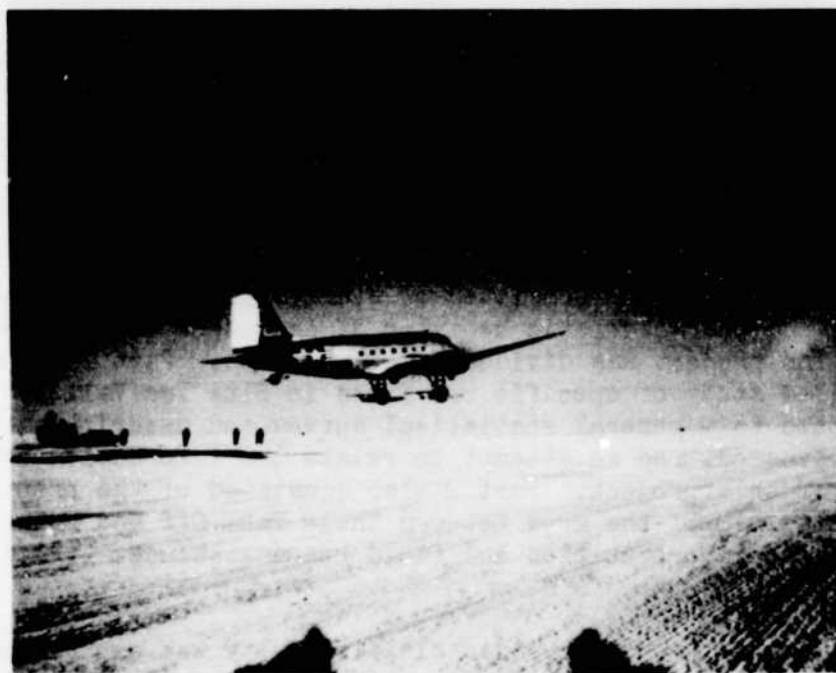
Fig. 6 C-47 Making Wheeled Landing on Compacted Runway

(f) The C-124 landings were made with increasingly heavier loads until indications of failure occurred. The last two landings were made with an initial gross load of 168,000 pounds. Considerable rutting occurred during all of the C-124 tests, but this was due primarily to a surface layer of unprocessed snow which had fallen after the next processing had been completed. On the last day of the test landings, failures occurred in two places. In each case these failures consisted of complete disaggregation of the processed layer. Both failures are considered to have resulted from two factors, the reversing of the C-124 propellers, and the method which was used to compact the strip. The strip was compacted in segments of 2500 feet each. The failure in each case coincided with the equipment turn-around areas at the ends of the segments. (Figs. 6 and 7)

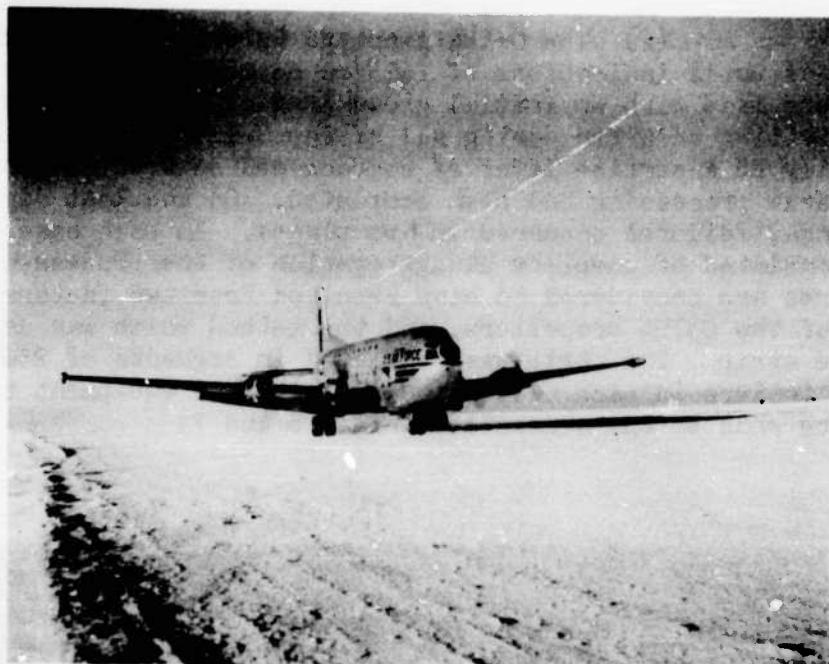
Fig. 7 C-124 Taking Off From Snow Compacted Air Strip

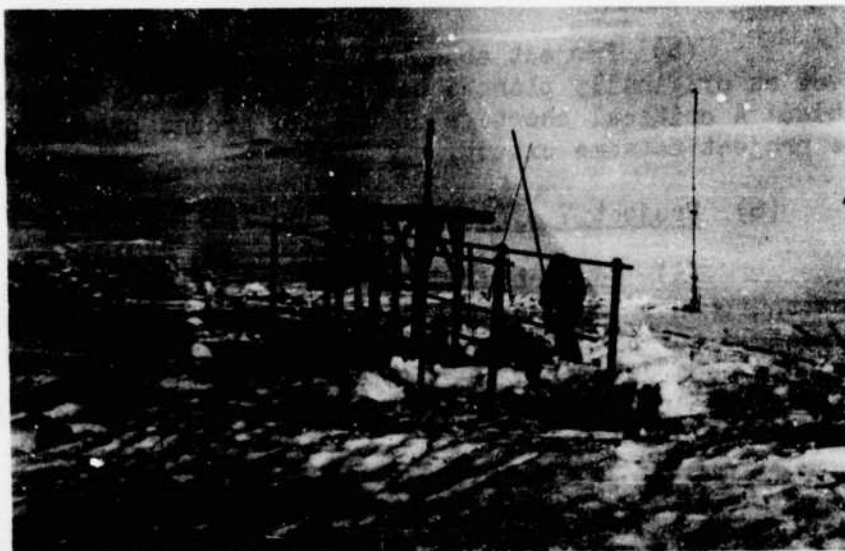
**Fig. 8** Bridgework Erected Across Crevasse to Facilitate Entrance and Exit

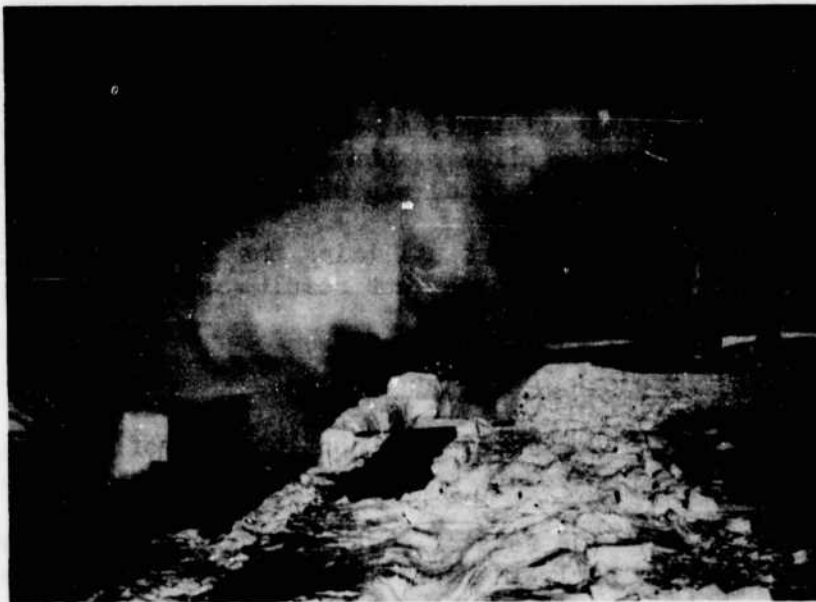
**Fig. 11 Peter Senior Blowing Snow on Plywood Arches**

(c) The tunnel and pit constructed and instrumented in 1954 were observed to measure deformation, loads and stresses. (Figs. 11, 12 and 13)

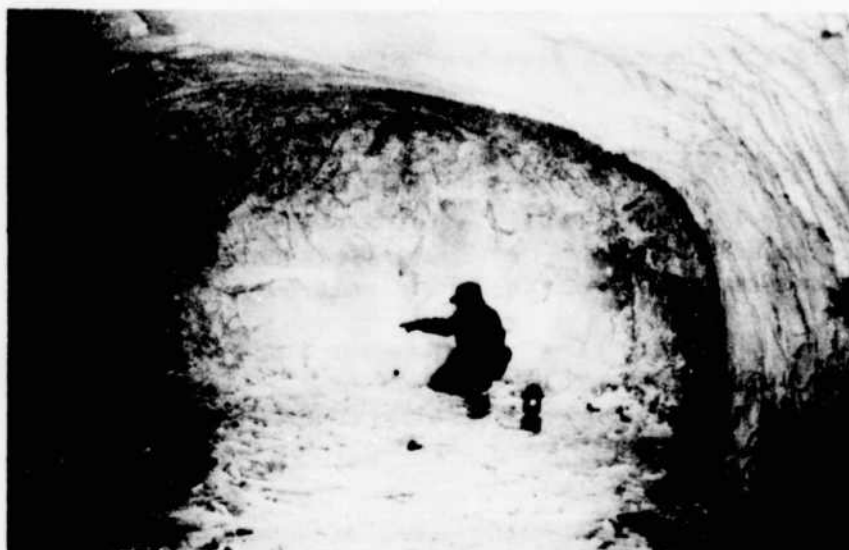
Fig. 17 Rear Wall of Jamesway Size Room Cut for NEAC

(a) Consisted of the excavation of a 500 foot tunnel in glacial ice to study tunneling techniques and the characteristic behavior of unsupported ice arches, corners, and fillets. (Fig. 17)

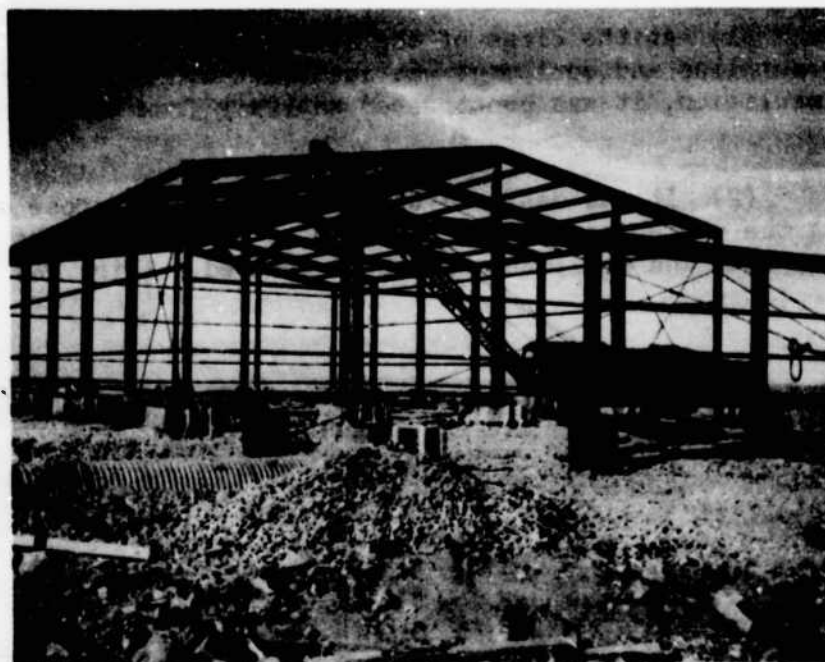
Fig. 22 Frame of Modular Building Erected for Mess Hall and Kitchen

(2) The Transportation Arctic Group provided the unskilled labor required for the project. Supervision, equipment, building materials, and skilled workmen were provided by the Corps of Engineers. Construction of the camp was completed on 20 September. (Figs. 22 and 23)

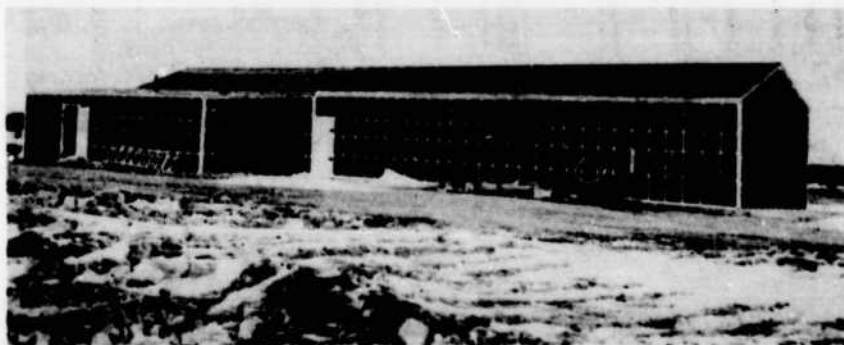
Fig. 24 Completed Kitchen-Warehouse at Engineer Camp TUTO

(2) It was designed to serve the dual purpose of a warehouse during the winter and a kitchen and mess hall during the summer after the supplies and equipment have been removed. (Fig. 24)
