WADC TECHNICAL REPORT 52-63  
ASTIA DOCUMENT NR AD 142103

EJECTION SEAT TESTS CONDUCTED  
ON THE 10,000 FOOT AERODYNAMIC  
RESEARCH TRACK AT EDWARDS AIR FORCE BASE

NOVEMBER 1957

WRIGHT AIR DEVELOPMENT CENTER

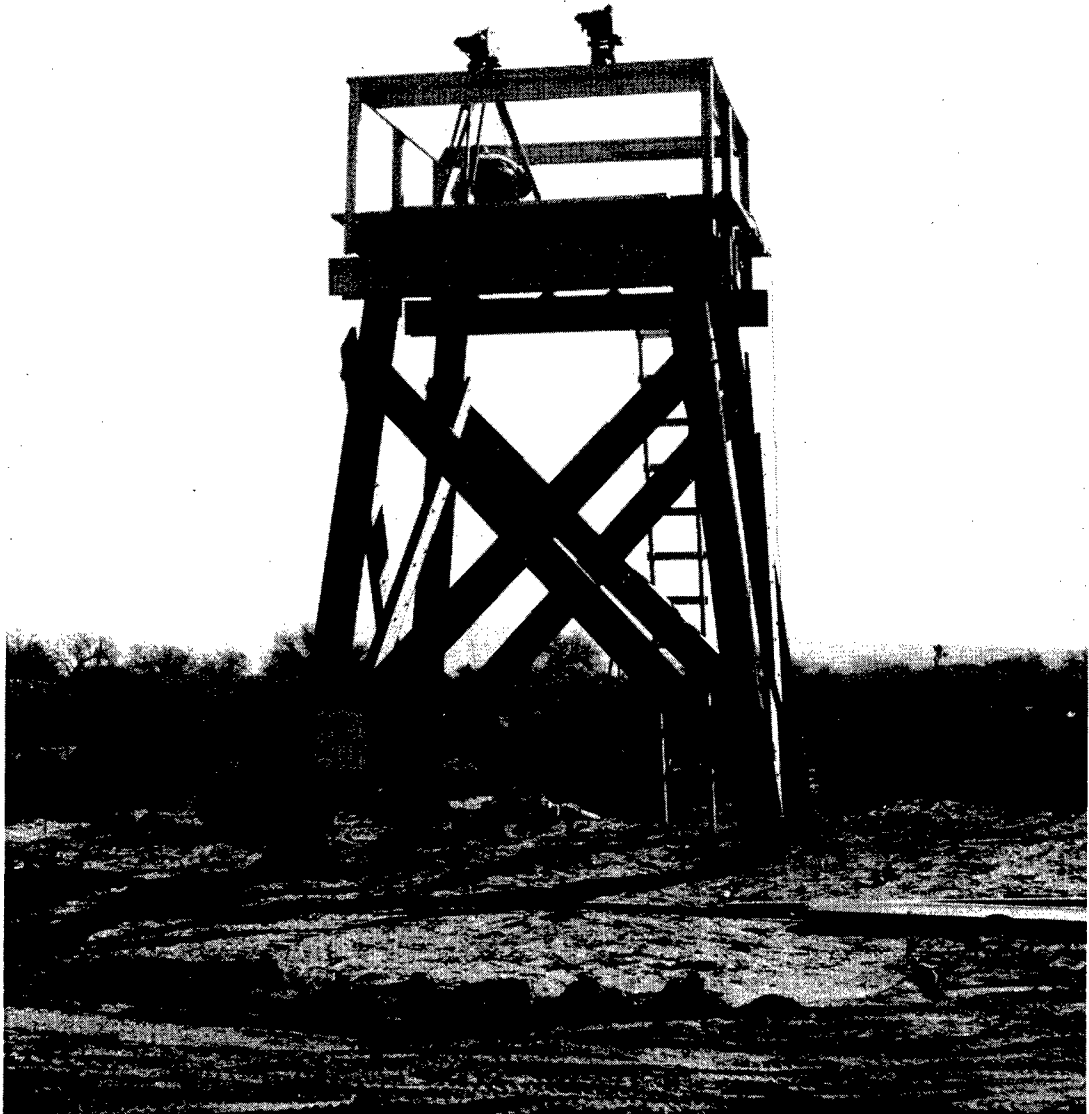
**FIGURE 21. 15 FOOT PHOTOGRAPHIC TOWER; 375 FEET SOUTH AND 50 FEET WEST OF EJECTION STATION.**

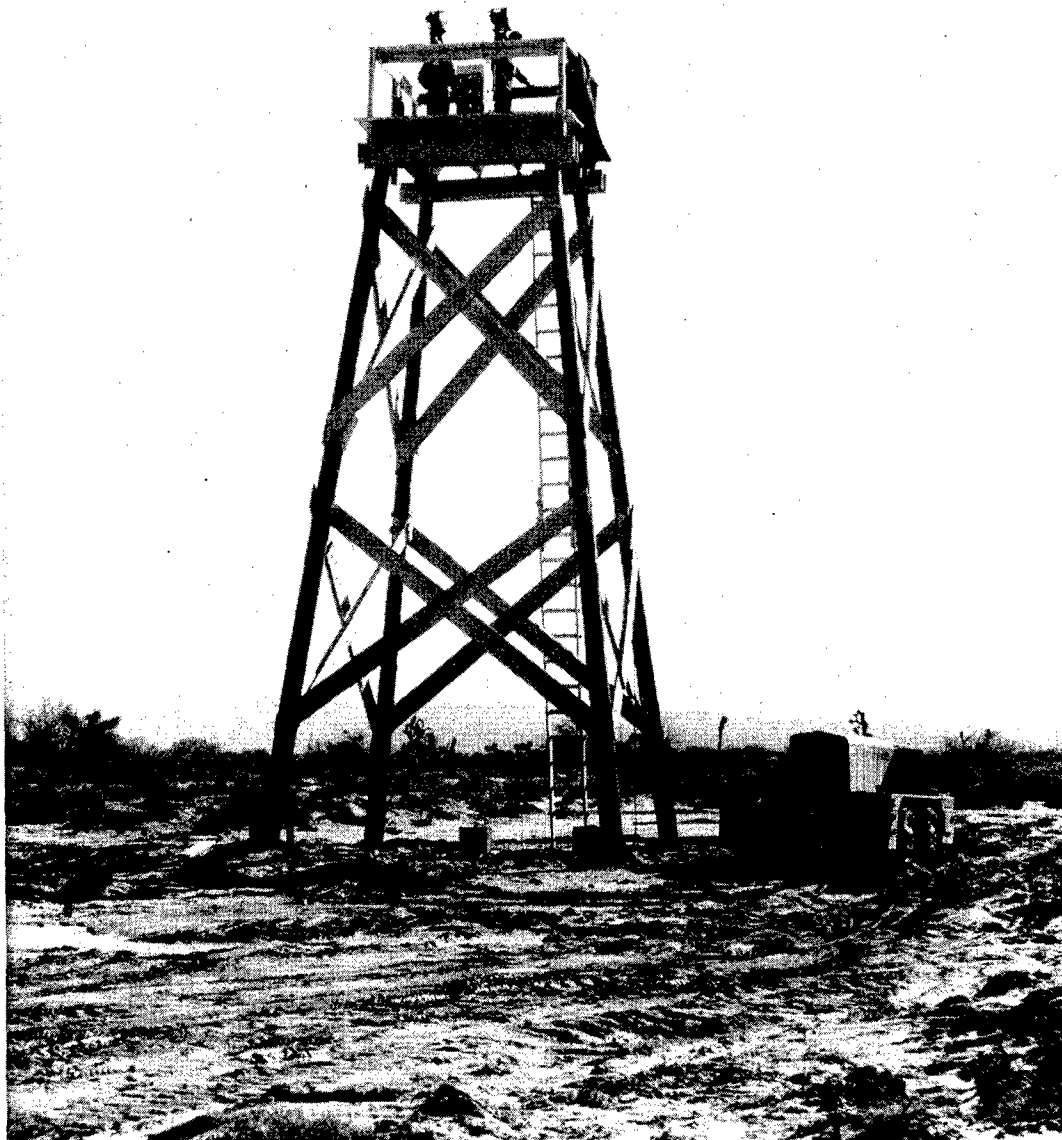
**FIGURE 22. 30 FOOT PHOTOGRAPHIC TOWER; 750 FEET SOUTH AND 550 FEET WEST OF EJECTION STATION.**

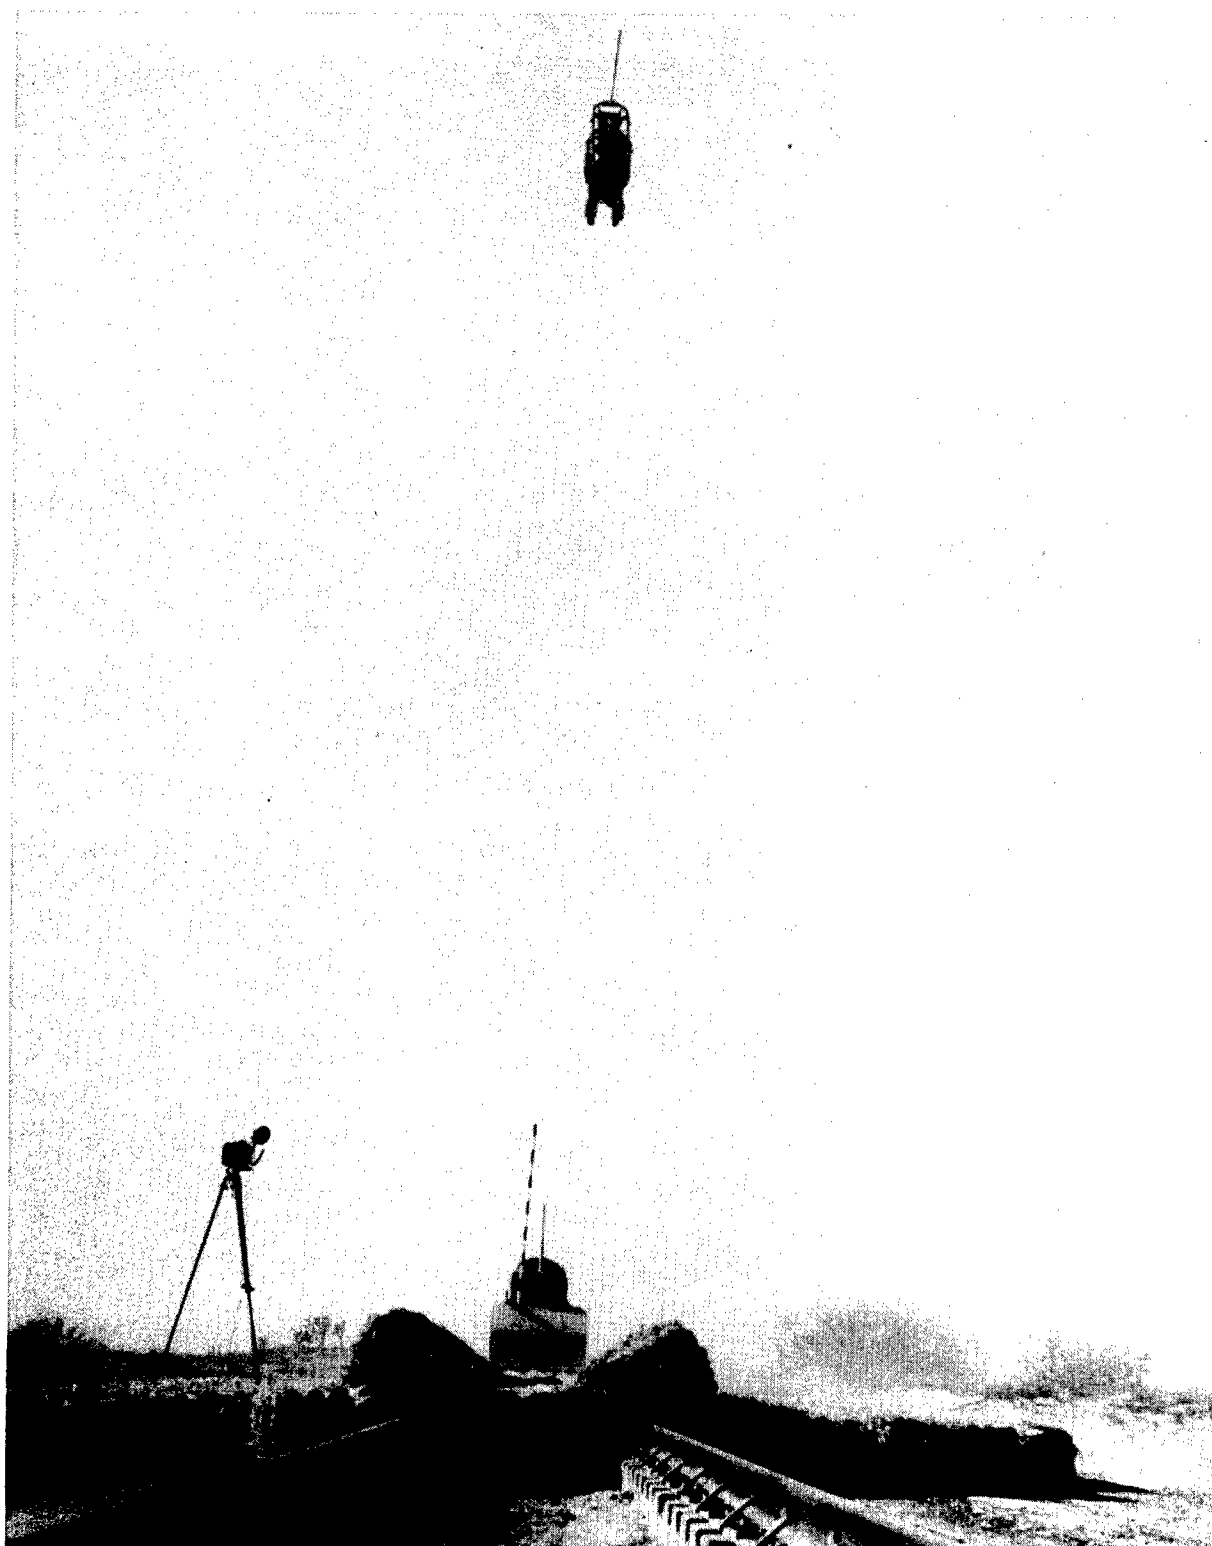
FIGURE 23. EJECTION TEST ; STATIC , NO. 2, PEAK HEIGHT  
REACHED BY DUMMY.

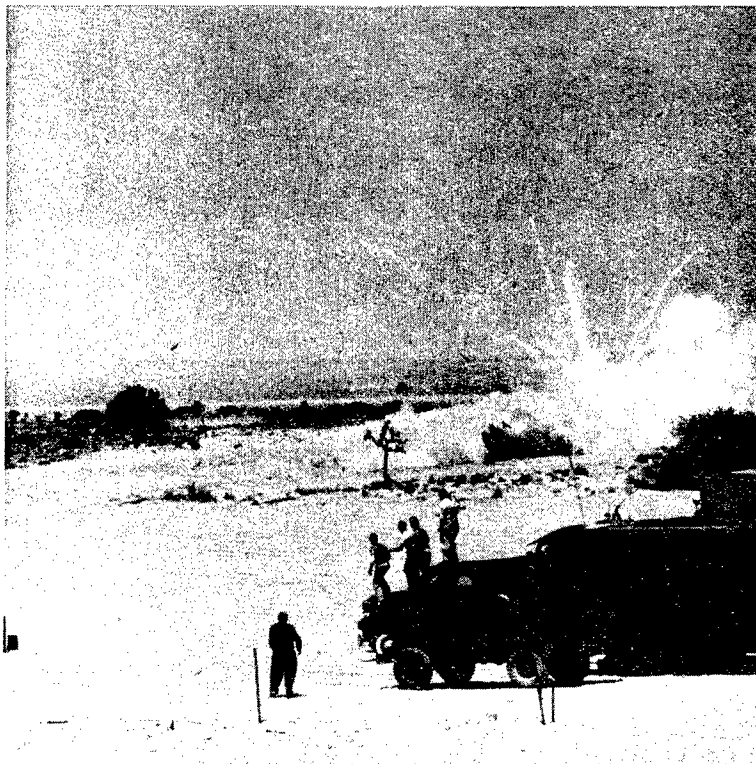
FIGURE 38. TEST 4 RESULT.

This run was unsuccessful due to the explosion of propulsion rockets upon ignition. The test carriage was destroyed and of course no data was obtained. See Test Nr 4, Appendix I. Figure 38 shows the explosion and its damage.

Approximately 0.30 seconds after ignition, T10E1 rocket units numbers 810 and 852 exploded. It is believed that unit 810 exploded first and in turn caused unit 785 to rupture and explode. Shortly after unit 810 exploded, it was followed by unit 852. The explosion of these three units broke up the rocket carriage. When this occurred, unit 796 propelled itself through the air and landed approximately 475 feet along the left hand side of the track. Unit 793 (in the center tube) propelled the center tube holding the 2.2KS rocket approximately 600 feet up the center of the rails. The left hand HVAR was driven forward, end over end, along the track approximately 1200 feet (blew out the aft end). The right hand HVAR and mount propelled itself approximately one mile along the track to the rear of the starting point. The 2.2KS rocket did not ignite. Contributing causes of T10E1 failure: 1. long exposure to sun; 2. border line acceptances.

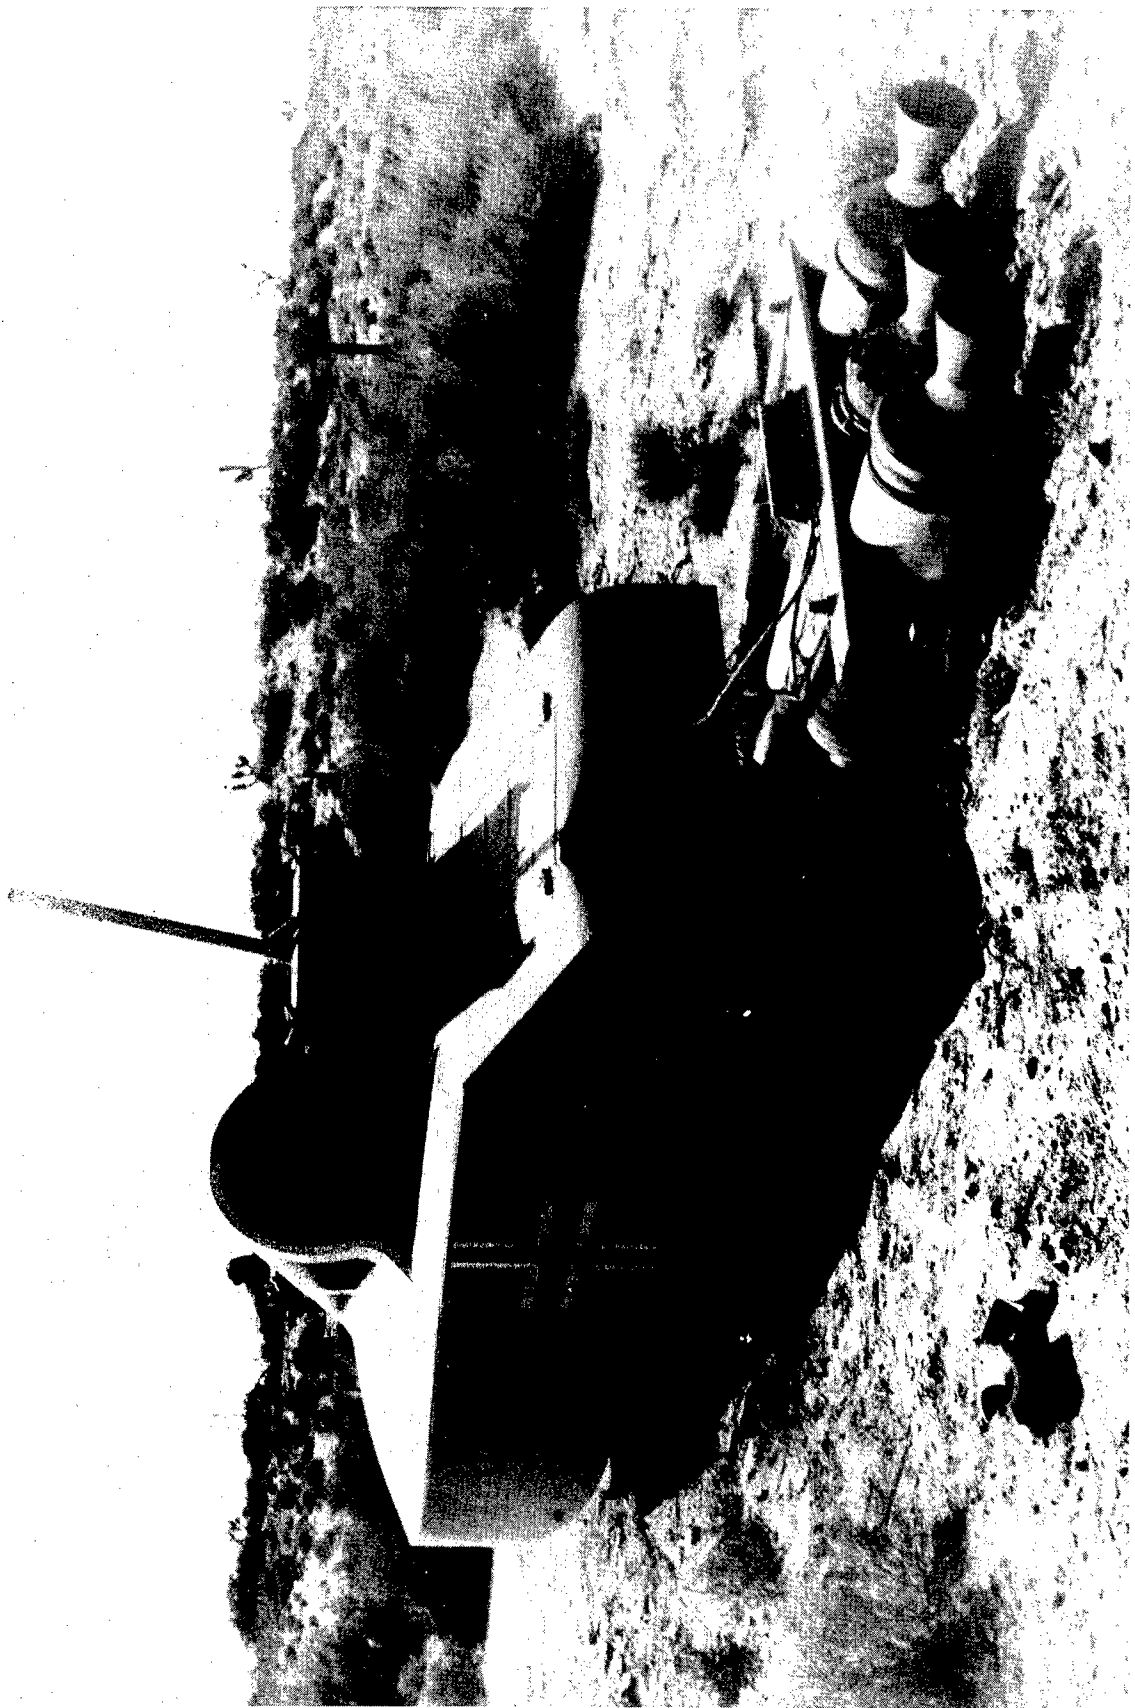
FIGURE 42. TEST 6, TEST CARRIAGE AFTER HAVING LEFT TRACKS.
