RF Project 682  
Technical Report No. 2

MECHANISM OF STRESS CORROSION OF  
AUSTENITIC STAINLESS STEELS IN HIGH-  
TEMPERATURE CHLORIDE WATERS

R. W. Staehle\*, F. H. Peck\*\* and M. G. Fontana\*\*\*  
Department of Metallurgical Engineering

Date: April 1958

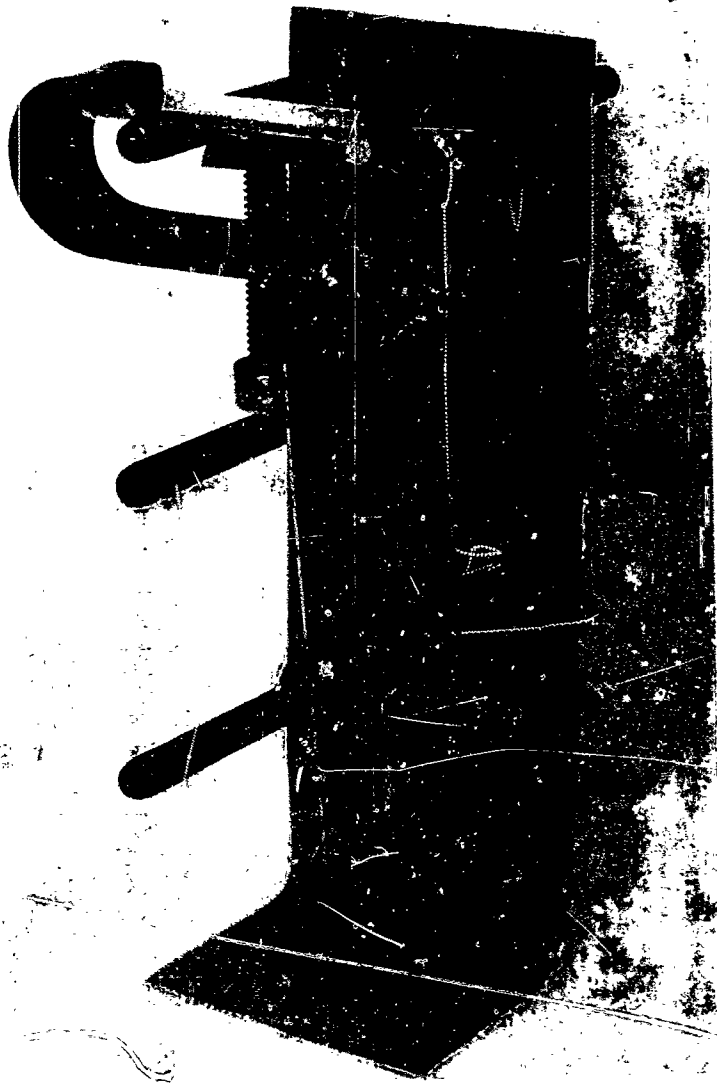
Fig. 4 Specimen support rack

After the specimen is stressed, it is placed on a rack as illustrated in Fig. 4. Teflon strips placed on the supports are used to insulate the specimen from any galvanic effect of the rack and the autoclave. After the rack is loaded, the entire unit is placed in an autoclave and is ready for testing. For testing in the water phase, the specimens are suspended, tension side down, on the lower part of the rack. For testing under conditions of intermittent wetting and drying, vapor phase, or vapor condensation, the specimens are suspended, tension side up, at the top of the

rack. As many as three specimens can be placed on any one level. The rack shown in Fig. 4 enables testing to be conducted in the water and vapor phases simultaneously if the autoclave is only partially filled. When the rack is filled, the entire unit is placed in an autoclave as shown in Fig. 5 and is ready for testing.
