NAVAL RESEARCH LABORATORY  
Washington, D. C.

RADIO DIVISION II - RECEIVER SECTION

EXPERIMENTAL VLF RECEPTION  
A STUDY OF VARIOUS LOOP  
COUPLING METHODS

- Report R-2872

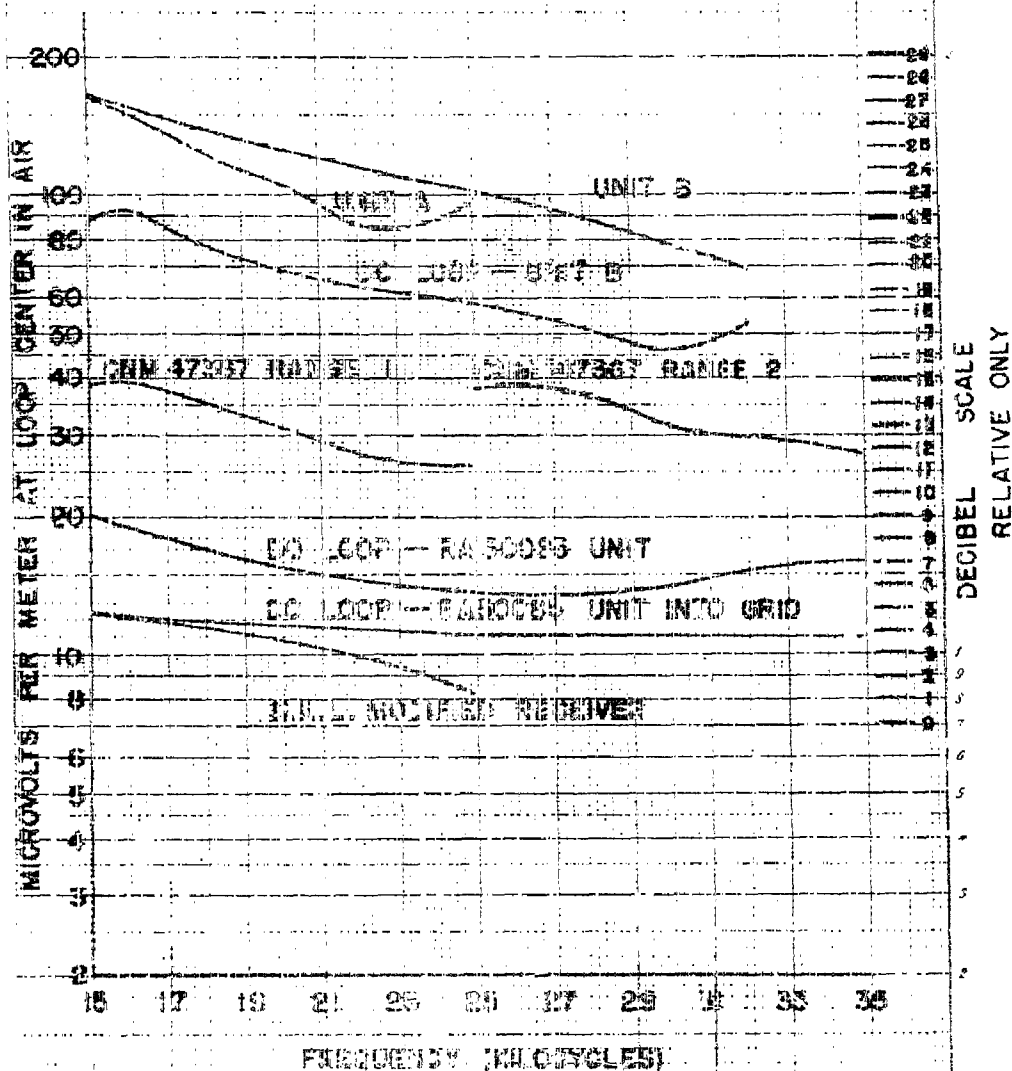
OVERALL SENSITIVITY CHARACTERISTICS  
OF  
COUPLING UNIT SYSTEMS  
MICROVOLTS PER METER AT LOOP CENTER  
IN AIR VS. FREQUENCY

5. The sensitivity of the overall system (GNM 66097 Loop, Mare Island Coupling Unit B, and RAK Receiver) varied from 163 microvolts per meter at 15 Kilocycles to 79 microvolts per meter at 30 Kilocycles. At 25 Kilocycles the sensitivity value was 102 microvolts per meter (Reference Plate 1). The overall sensitivity using the GNM-47367 Coupling Unit varied from 38 microvolts per meter at 15 Kilocycles to 31 microvolts per meter at 30 Kilocycles. The overall sensitivity using the modified Model RAK Receiver (incorporating NRL transformer design, Reference 3), varied from 12.2 microvolts per meter at 15 Kilocycles to 8.2 microvolts per meter at 25 Kilocycles. These data indicate that the present standard GNM 66097 system, using the GNM-47367 Coupling Unit, is about 13 decibels at 15 Kilocycles and about 6 decibels at 30 Kilocycles better than the system using the Mare Island Coupling Units. When the comparison is carried further, it is found that the NRL proposed system using the modified Model RAK Receiver and GNM 66097 Loop is about 23 decibels at 15 Kilocycles and about 21 decibels at 25 Kilocycles better than the system using the Mare Island Coupling Units. Proposed in reference (3), this system modification is understood to be in process of adoption.

6. For purposes of further comparison, a rewound Model DQ Loop, of higher Q value than a standard DQ Loop, was used with the Mare Island Coupling Unit B and the RA-50085 Coupling Unit (Reference 5). The use of the DQ Loop improved the overall performance of the Mare Island Coupling Unit B by approximately five decibels. Using the DQ Loop with the RA-50085 Coupling Unit, the overall performance was about three decibels short of being as good as the NRL modified RAK Receiver. The output of the RA-50085 Coupling Unit was then introduced directly into the first radio frequency amplifier grid of the RAK Receiver. The result obtained in overall performance was nearly as good as the NRL Modified RAK Receiver with the GNM 66097 loop (Reference Plate 1). However, this rewound DQ loop, while essentially matching the inductance of a DQ loop, is believed to have a definitely superior Q. Unfortunately, no Model DQ loop was available for comparison. The use of a DQ loop might very possibly have raised the DQ Loop curves of Plate I by a factor of two, or 6 decibels.

8. The curves shown on Plate 1 indicate that neither Mare Island Coupling Unit has a frequency range of 15 to 35 Kilocycles. Unit A frequency coverage lies between 15 and 25 Kilocycles. Unit B between 15 and 33 Kilocycles.

20. From the results of the data shown on Plate 1, it is concluded that the Navy had a good system of coupling loop antennas to RAX Receivers (Reference Paragraph 6). However, the NRL Modified RAX Receiver (Reference 3) has advantages over this system. These are simplicity, elimination of cost for a coupling unit, and the reduction in the number of controls for the radio operator. Aside from these the NRL modified design conserves needed space in the radio room of a submarine.

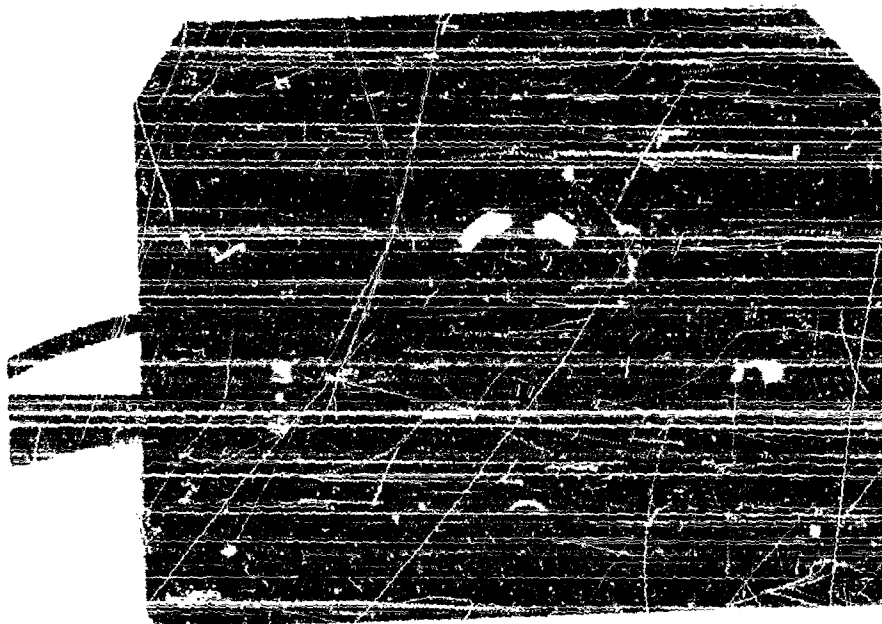
**PLATE 3**

TOP PERSPECTIVE VIEW  
HARP ISLAND COUPLING UNIT  
UNIT A

13. Upon inspection of this unit, it was observed that there were numerous undesirable features in the design that did not conform with the standards expected in naval equipment. For example, the dial plate of the variable capacitor should have been provided with a clamp to prevent accidental change of setting (Reference Plates 3 to 5 inclusive); the controls should have been labeled to properly identify them as to their function; it would have been desirable to include mounting brackets to facilitate installation and maintenance; knurled captive thumb screws to secure chassis to cabinet would have been superior to the use of self tapping screws; cable connections to the unit should have been made through proper jacks and plugs, and a tube clamp assembled to the chassis for the 6C6-Gt. tube. Further, the electrical wiring should have been such that all components would have been placed on approved fungus proof terminal boards and properly number designated for immediate identification with no more than three connections made at a terminal. The wiring lead lengths should have been long enough so that no lead would have been excessively long permitting a possible source of added coupling, or too short, allowing stress to exist in the lead. The method of grounding components and circuit points should have been made directly to the chassis in the shortest practicable distance, and the soldering of all components and all electrical circuit leads to terminals should have been such as to insure the electrical connection by making at least two turns around the terminal before the application of the solder. Further, the transformer should have incorporated a rust proof shield to safe guard against physical injury and stray field coupling.

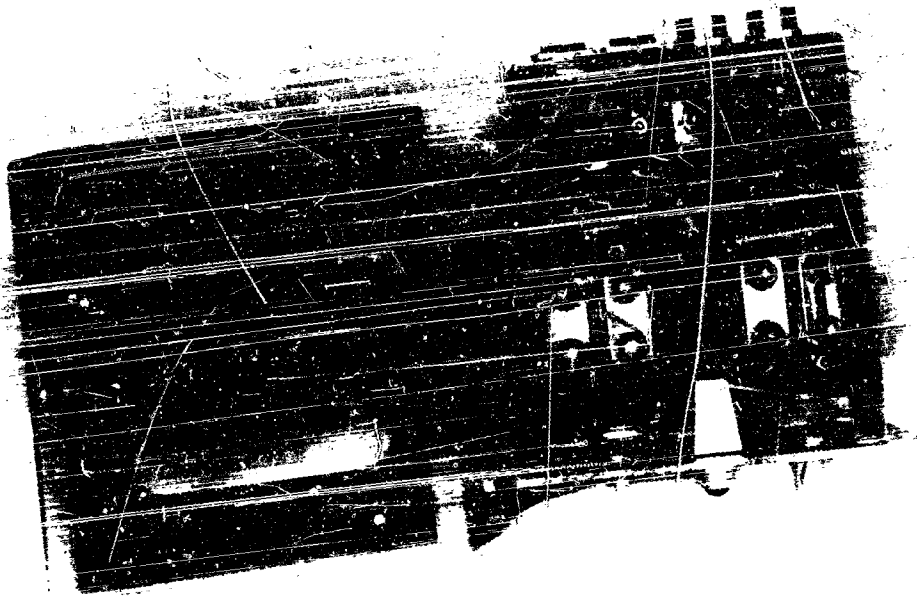
PLATE 7

FRONT VIEW  
MARE ISLAND COUPLING UNIT  
UNIT B

14. Upon inspection of this unit, it was discovered that there were undesirable features in the design of a nature similar to Unit A, but less numerous, that did not conform with the standards expected in naval equipment. These are, briefly, the methods of grounding circuit points and components, the use of self tapping screws to secure chassis to cabinet, the undesignated components, not mounted on approved terminal boards for immediate circuit identification, the absence of a tube clamp for the 6J7 tube and the omission of suitable brackets attached to the cabinet to facilitate installation and maintenance. Further, it would have been desirable if the design of the resonating capacitor was such as to minimize the possible physical damage to the rotor plates that could occur when the dial is set on 100 divisions and the chassis is removed from the cabinet.
