MEMORANDUM REPORT

NO. WAL 710/576

Watertown Arsenal Laboratory  
Memorandum Report WAL 710/576  
Final Report on Problem B-2.8

Effect of Directional Properties on  
Rolled Homogeneous Armor

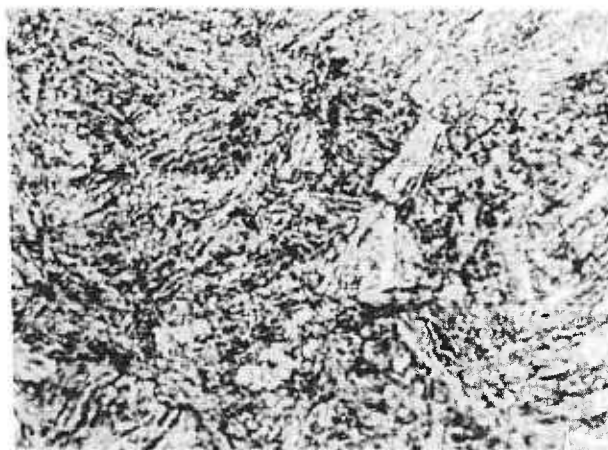
No. 2C

Sorbite and trace of ferrite.

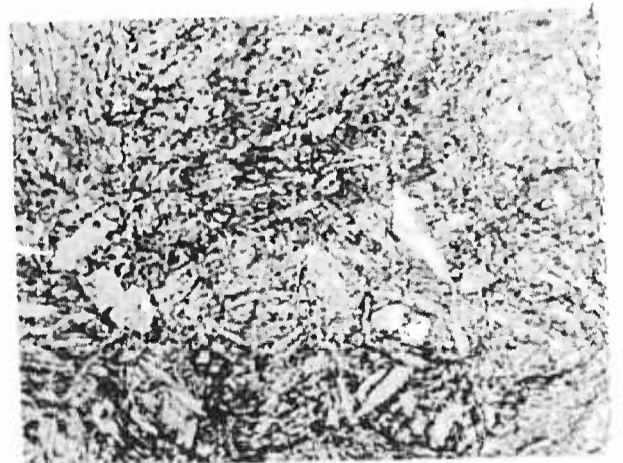
No. 6C  
Sorbite and trace of ferrite.

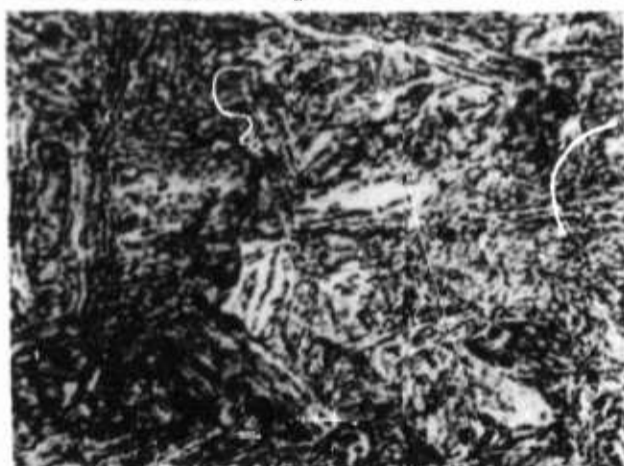
Intermediate temperature transformation products.

Figures 4-6 inclusive illustrate the typical microstructure of the samples. With the exception of plate numbers 1 and 1D all plates exhibited a tempered martensitic structure, consisting of sorbite and some traces of ferrite. The microstructure of plate No. 1 consisted of considerable amounts of ferrite and sorbite while plate No. 1D showed evidence of intermediate temperature transformation products.
