# AIR FORCE MISSILE DEVELOPMENT CENTER TECHNICAL REPORT

MANHIGH 1

WINZEN RESEARCH, INC.

HOLLOMAN AIR FORCE BASE  
NEW MEXICO

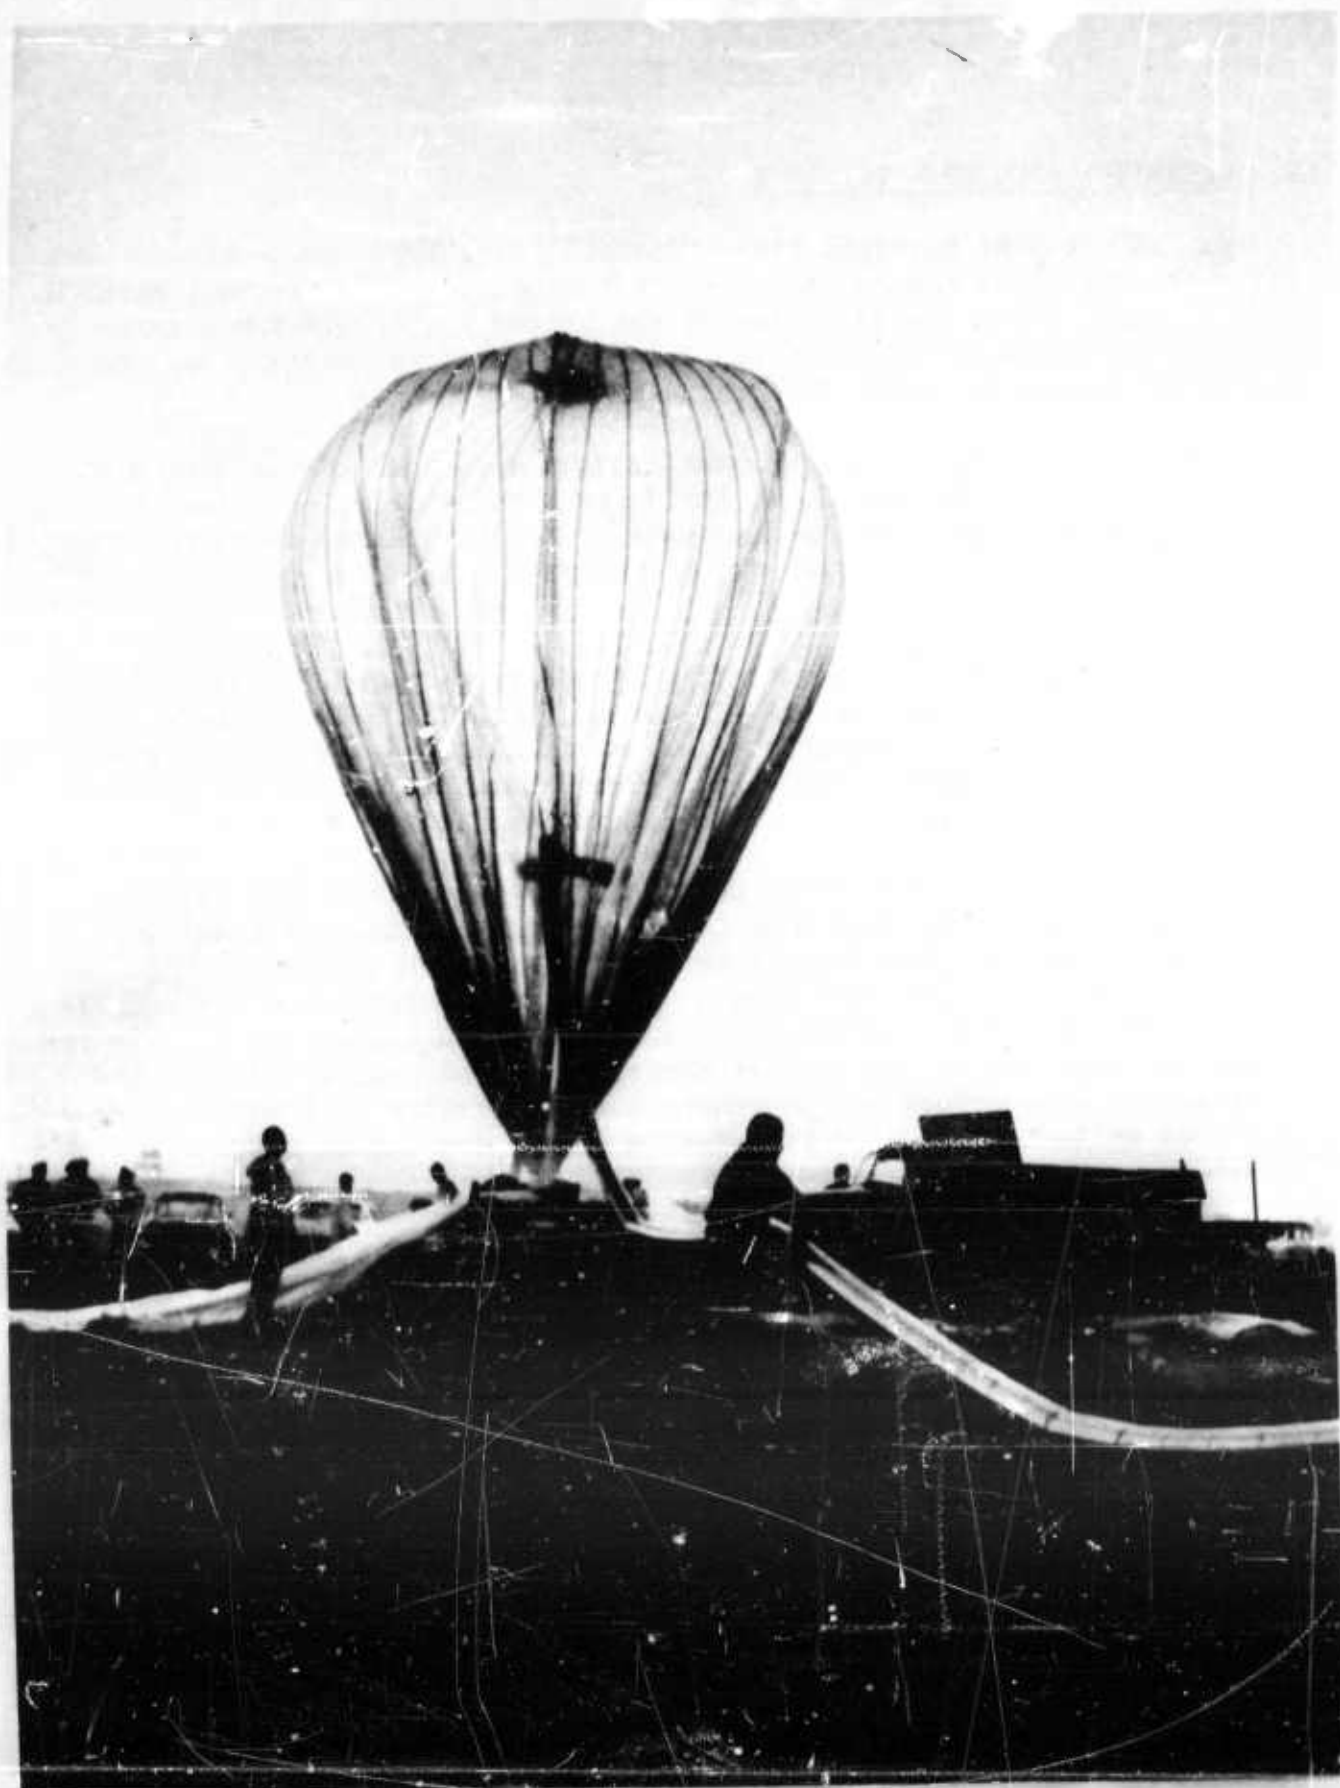
FIGURE 1

The pre-launch activities proceeded according to plan. The balloon was inflated and all flight equipment was installed. (See fig. 1).

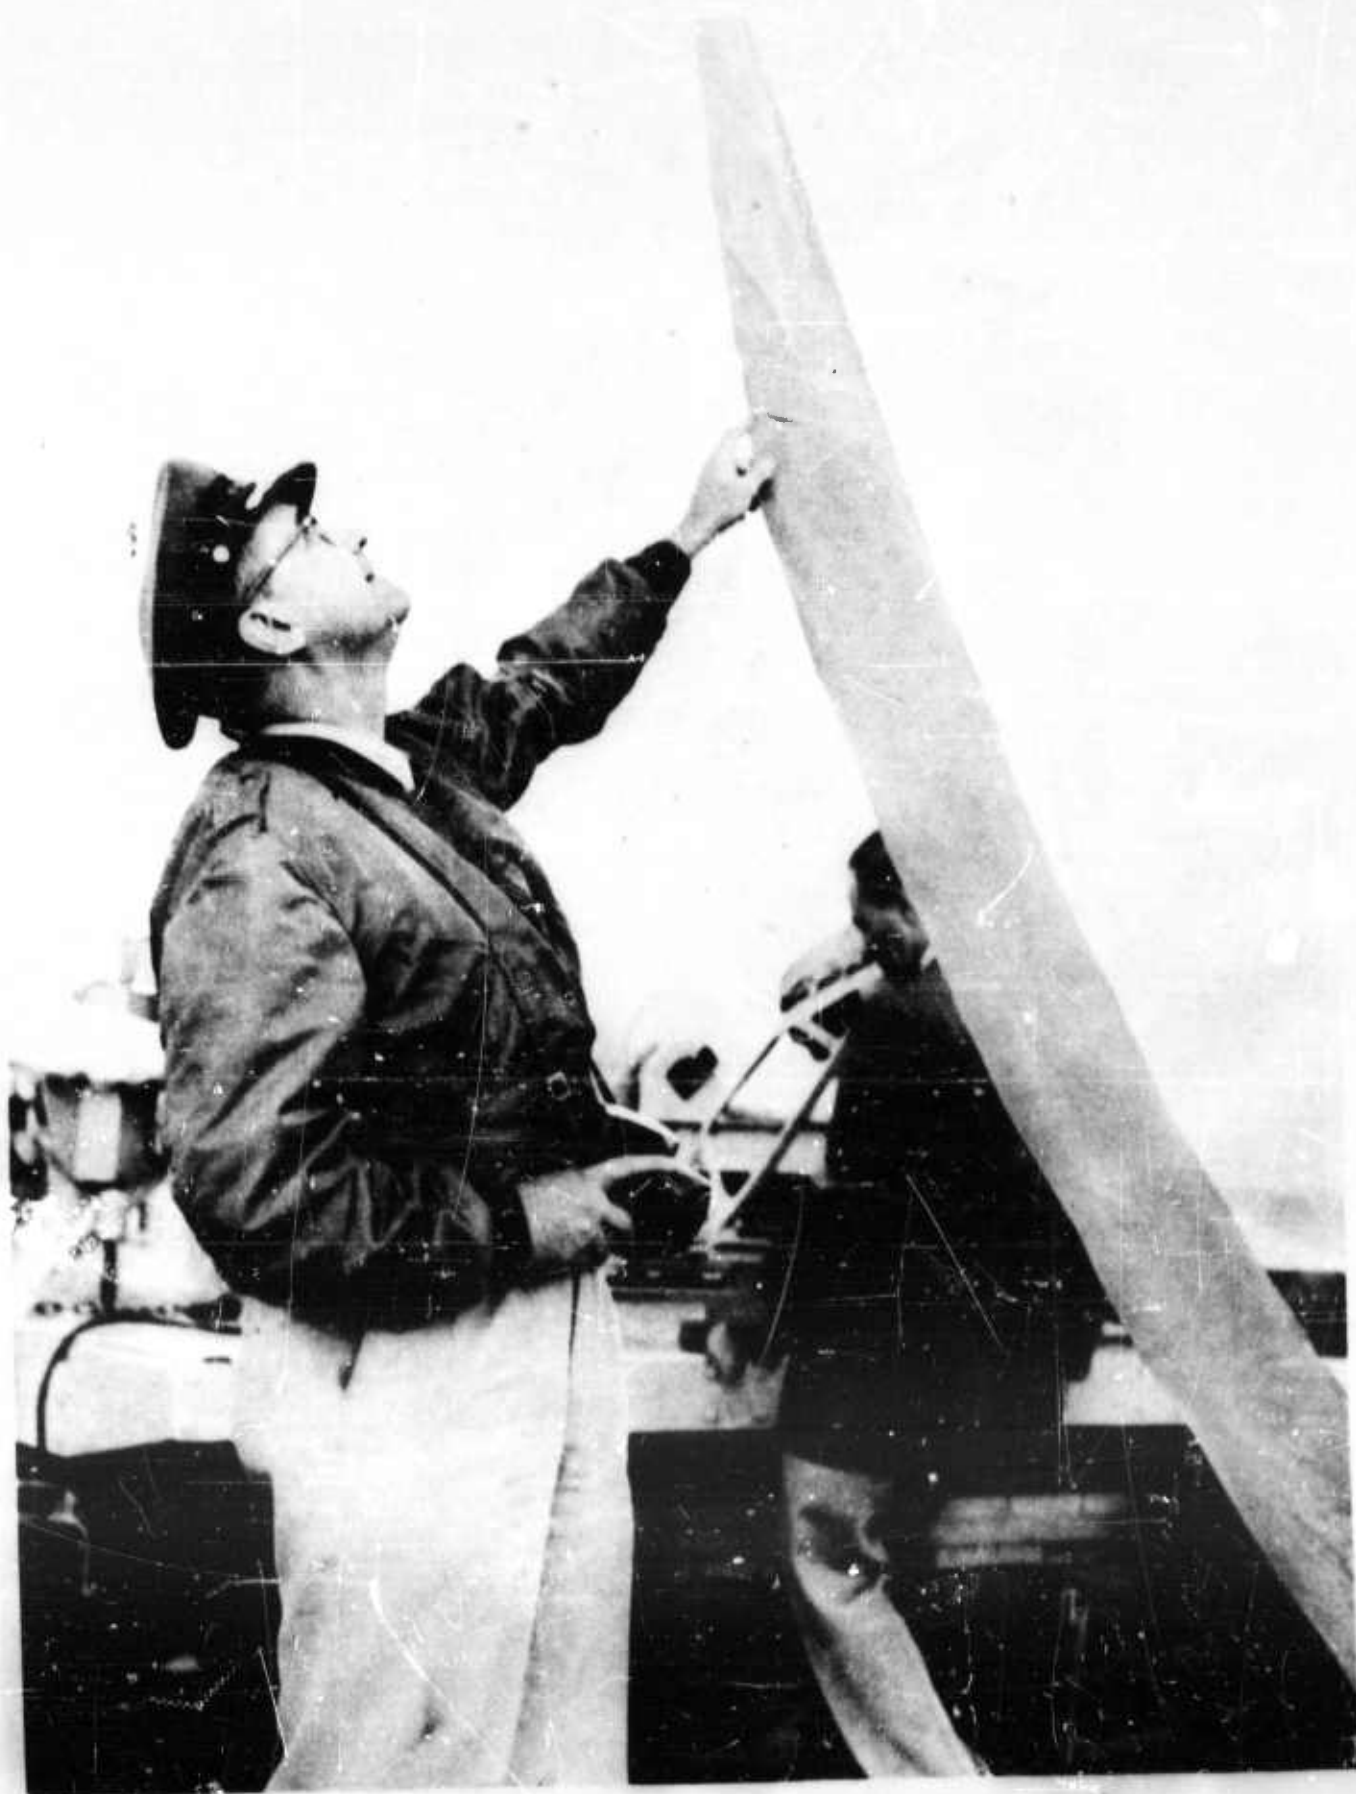
FIGURE 2

At 0620 CDT all preparations were complete, the surface winds were peaking at approximately two knots, and synoptic meteorological conditions were ideal for the anticipated flight. At 0623 CDT the balloon was released from the restraining rollers of the launching platform, and as the balloon ascended slowly, the capsule was lifted into the air (fig. 2, 3, and 4).

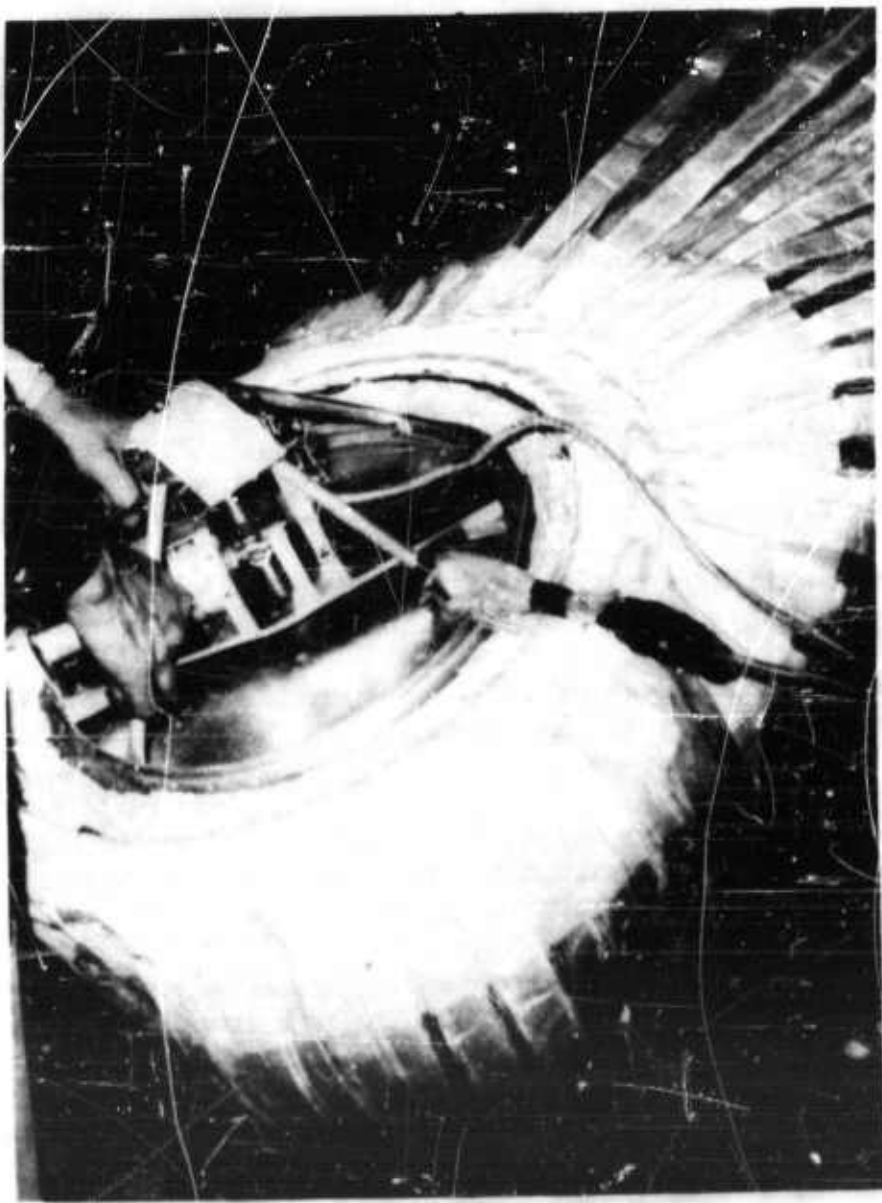
FIGURE 12

Installed at the apex of the balloon was an electrically driven 14-inch diameter fail-safe gas valve. (See fig. 12.) This valve was controlled from the electrical panel inside the capsule. The actuation of this valve permitted Captain Kittinger to release the helium gas from the balloon in order to decrease the rate of ascent, initiate descent, or to increase the rate of descent.
