**IGLOO AND REVETMENT**

**TESTS**

**NAVAL PROVING GROUND, ARCO, IDAHO**

**OCTOBER, 1946**

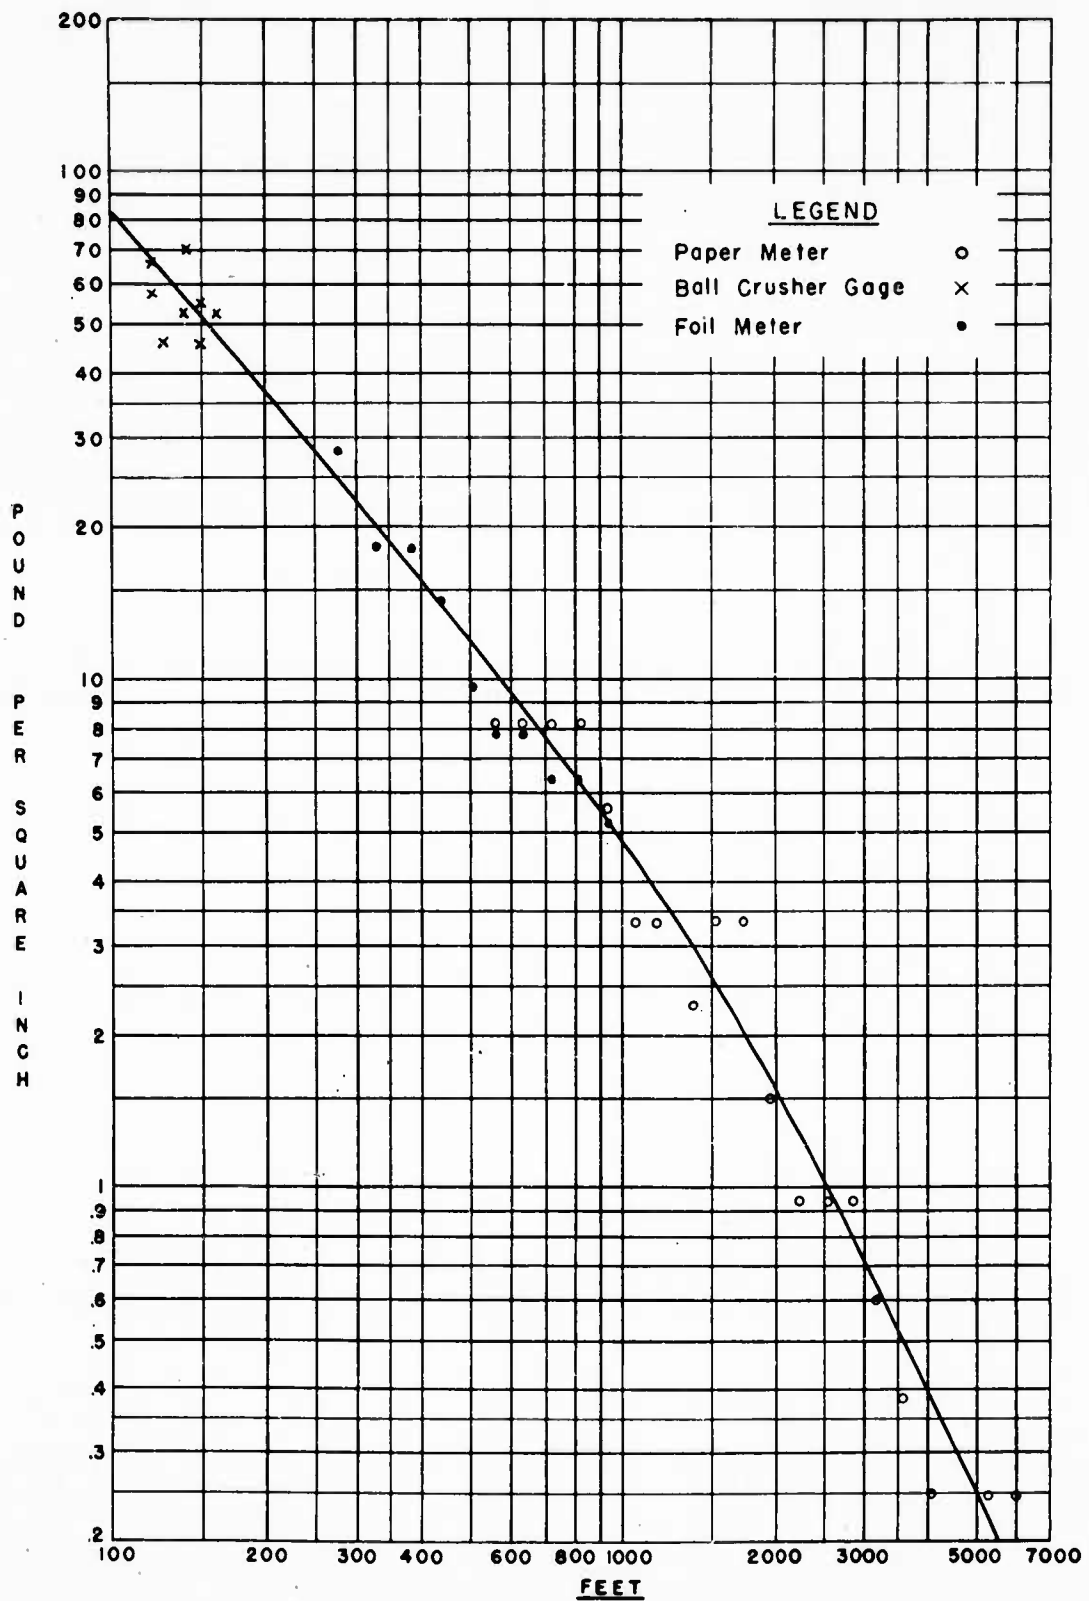
FIGURE 33. Peak Blast Pressure vs Distance from Charge, Test 1, Line 2 (Off Side)

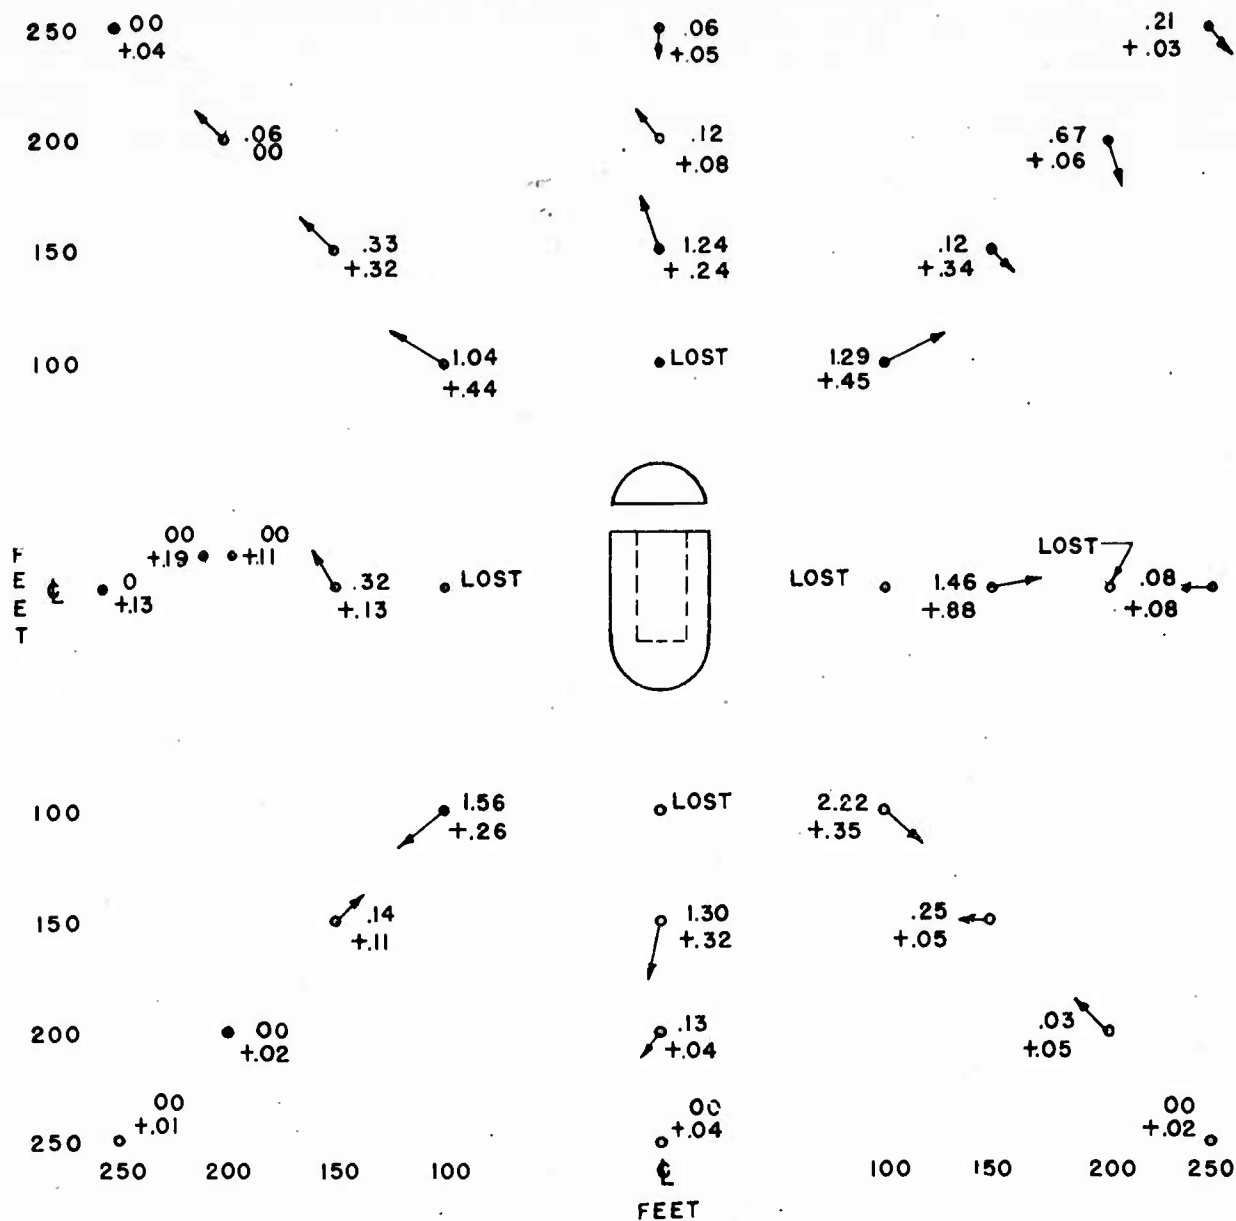
FIGURE 39. Permanent Horizontal and Vertical Earth Displacement, Igloo D, Test No. 1

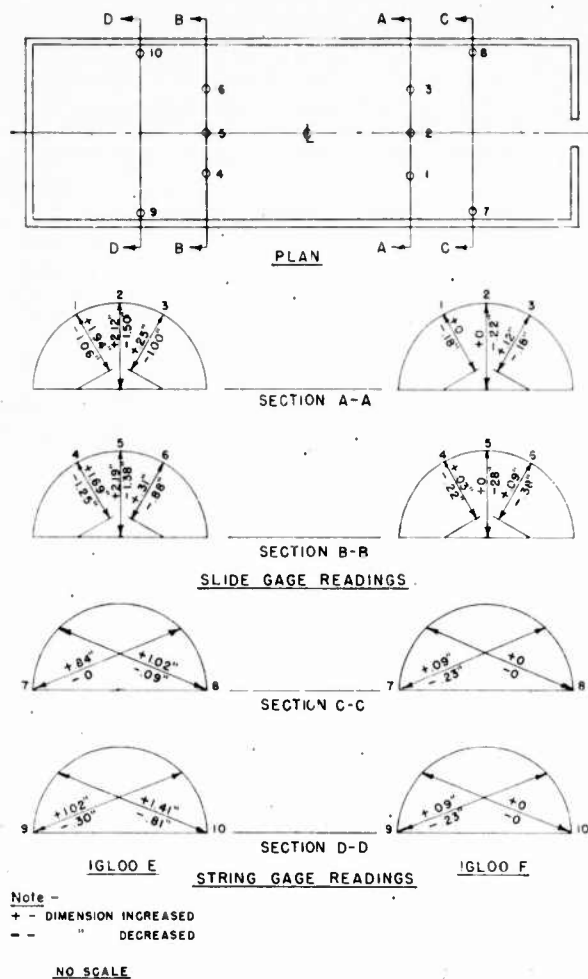
FIGURE 42. Transient Distortions of Internal Dimensions of Igloos E and F as Measured by Deflection Gages, Test 1

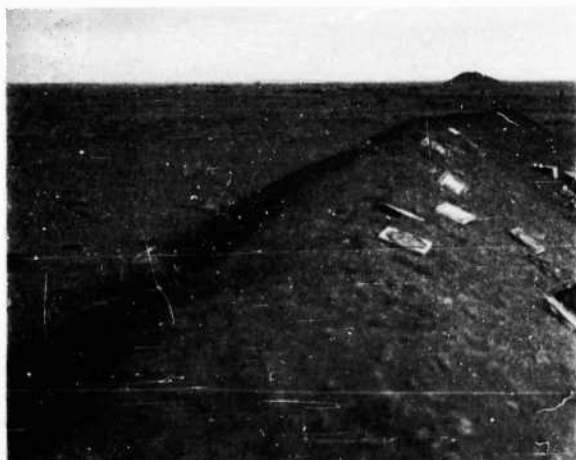
FIGURE 52. Revetment 1 after Test 1. Looking north along top of west windrow

figures 49 through 52. Apparently the suction phase of the blast was responsible for the toppling over of the middle third of the first tier of mines on the near side of the pile, the collapse of the corners of the stack and the wide scattering of individual mines. Twenty-one mines were counted on the ground on the near side of the revetment, the farthest lying about 40 feet from the edge of the stack, and 32 mines lay on the upper part of the windrow.

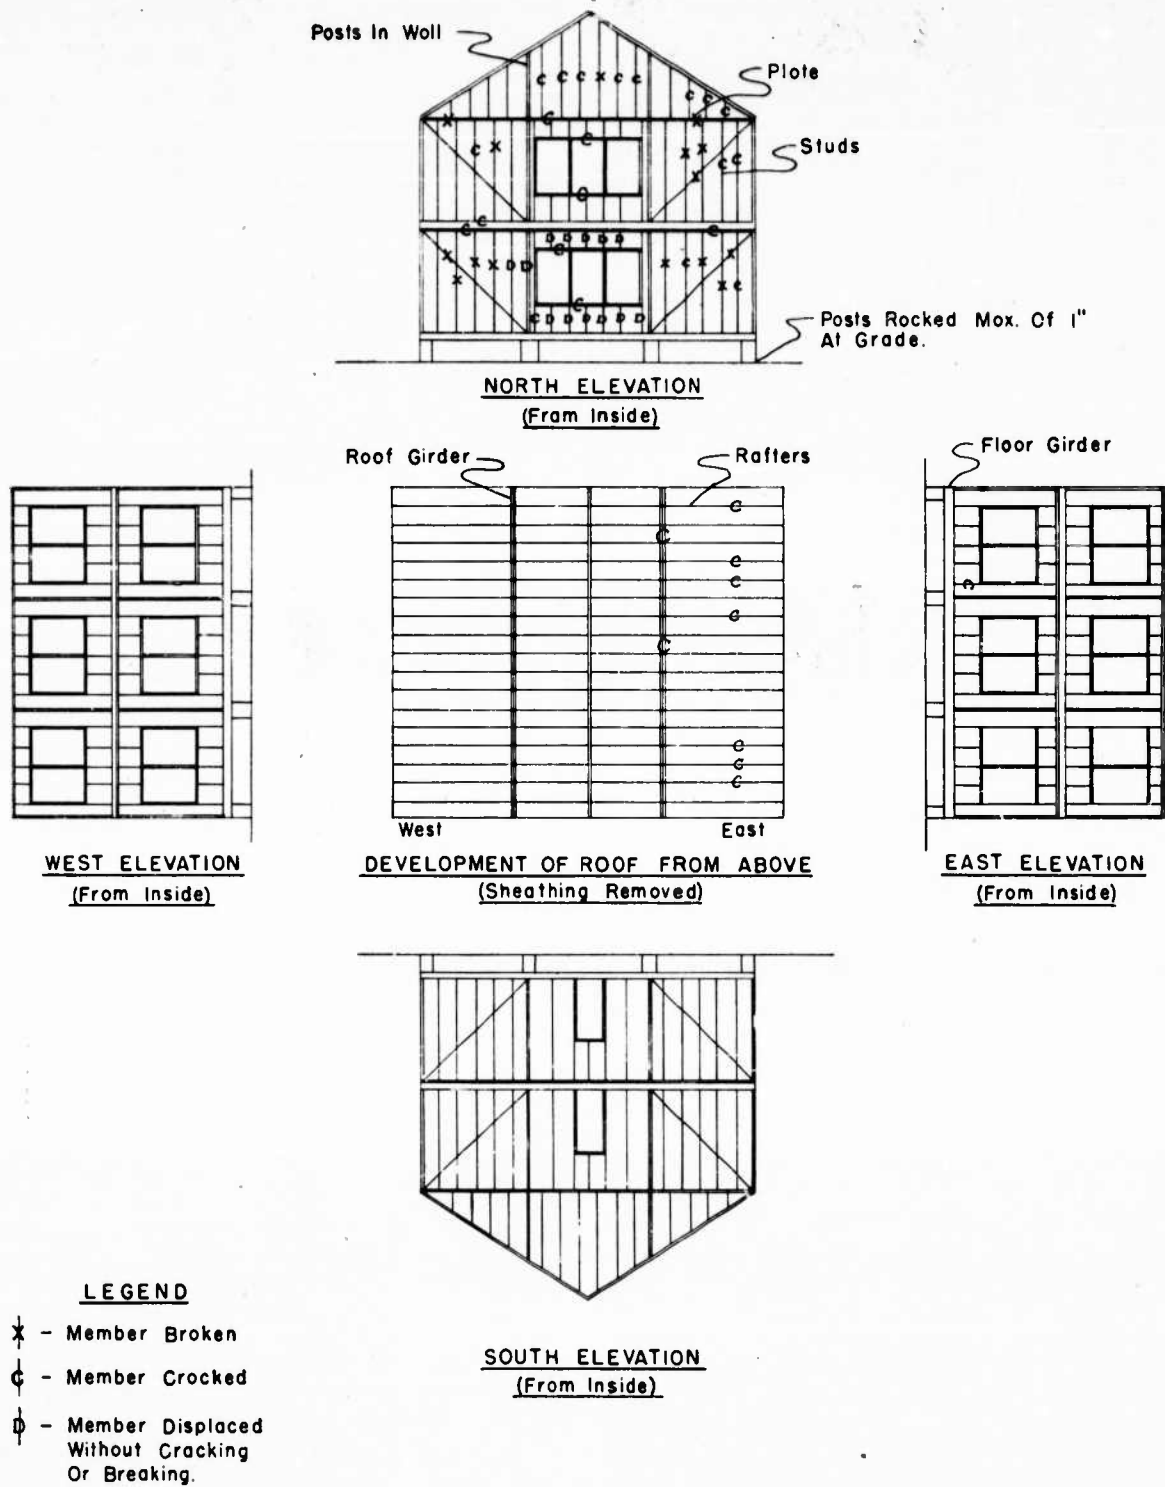
FIGURE 68. Damage to Barracks, Barracks 1. Test 1

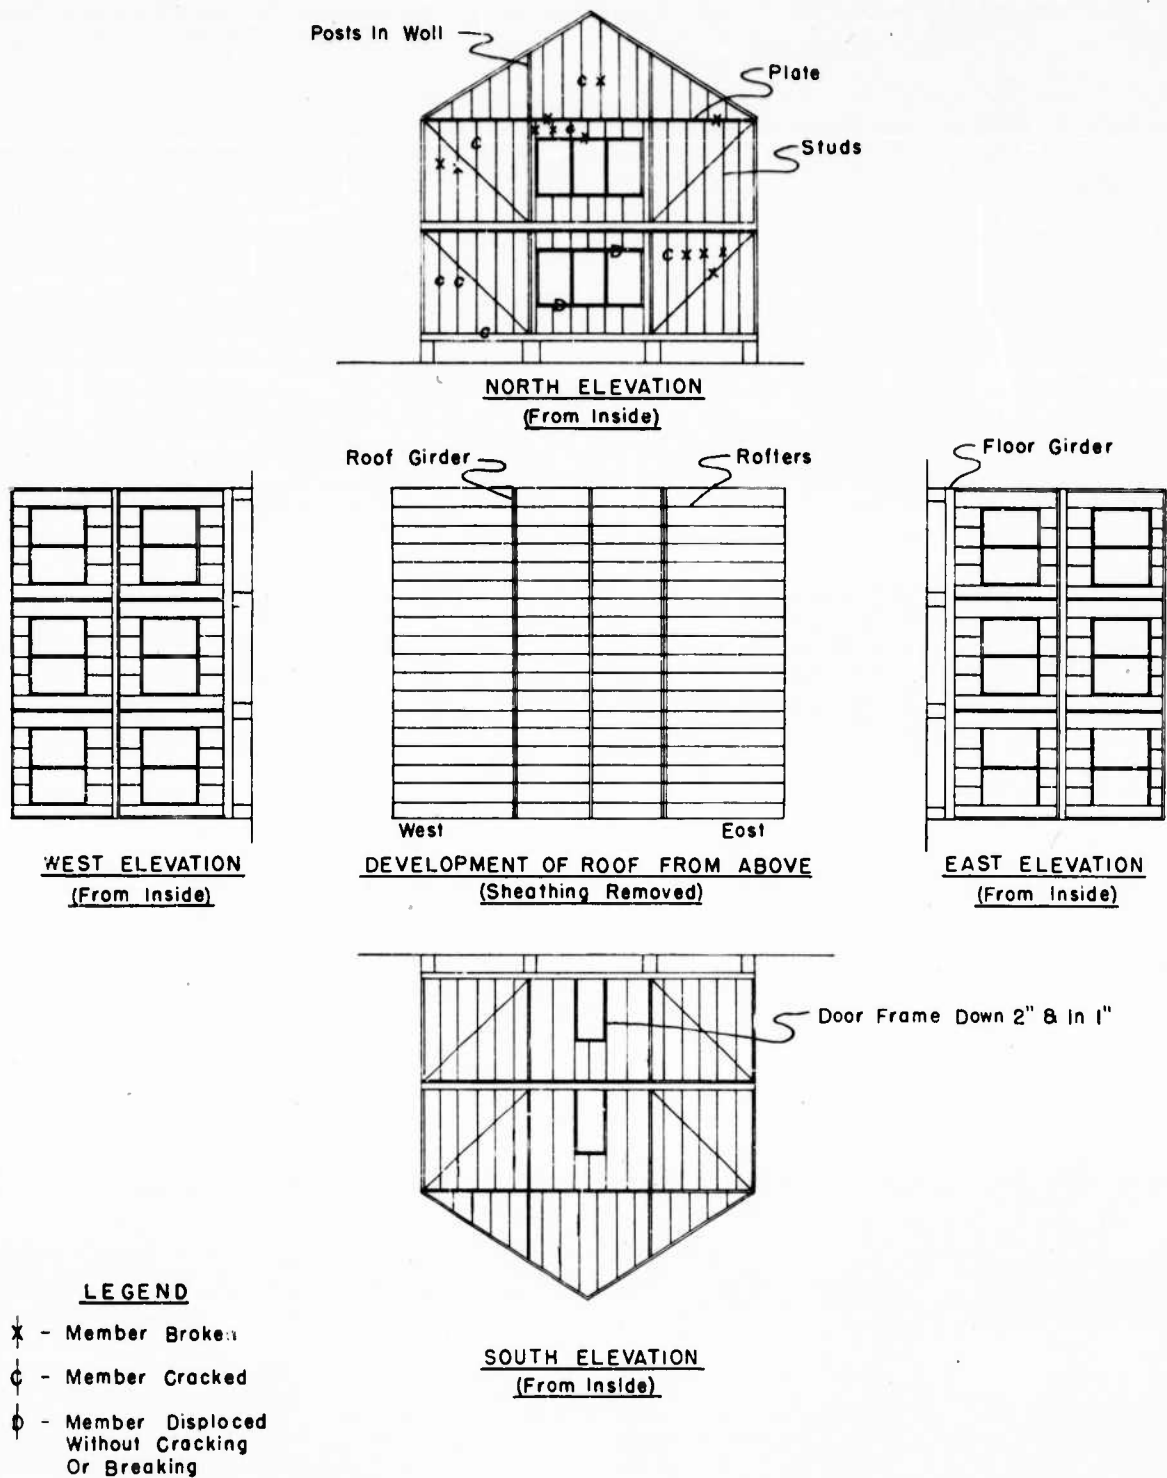
FIGURE 74. Damage to Barracks, Barracks 2, Test 1

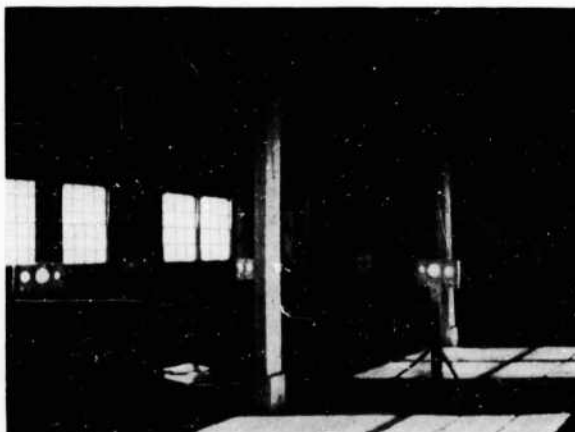
FIGURE 77. Interior, Barracks 3 after Test 1. Looking southeast on second floor

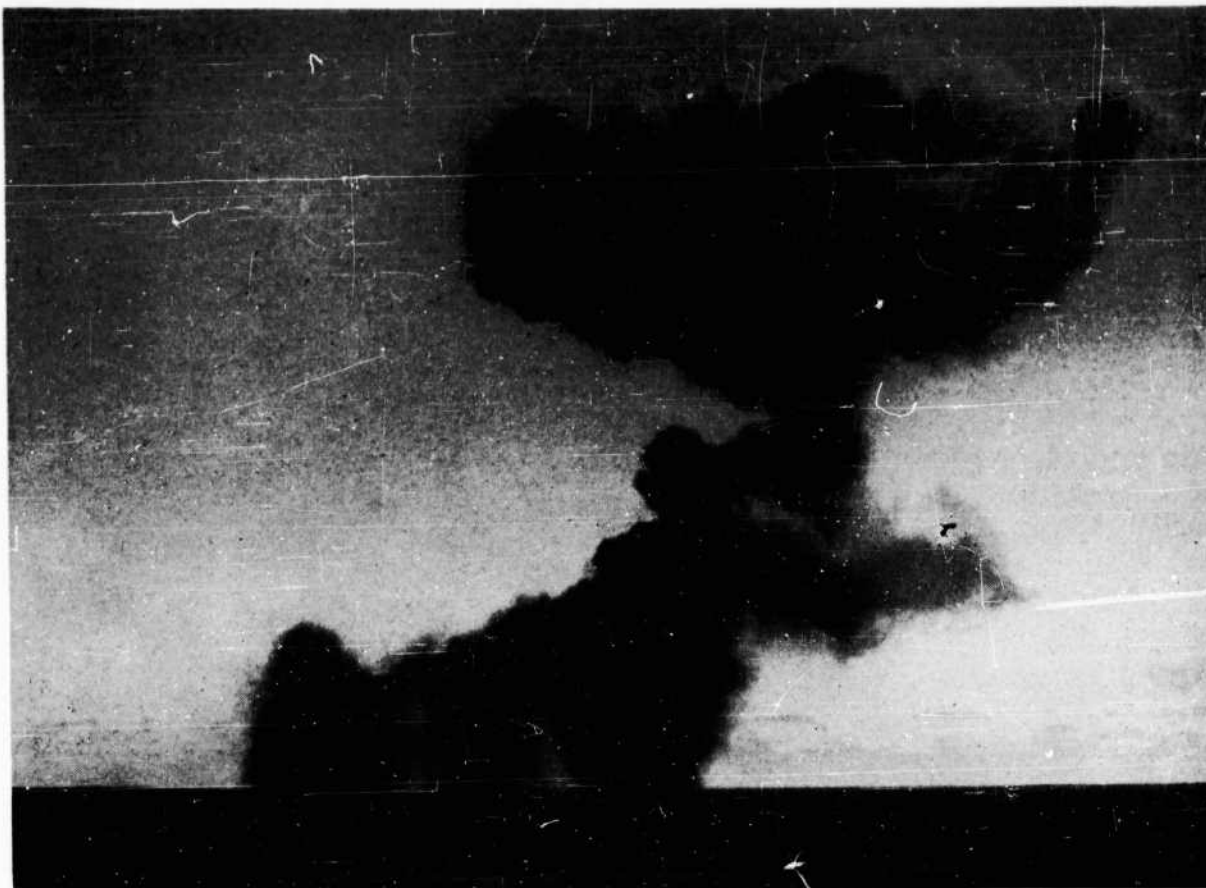
FIGURE 84. Explosion of Igloo E—4th stage

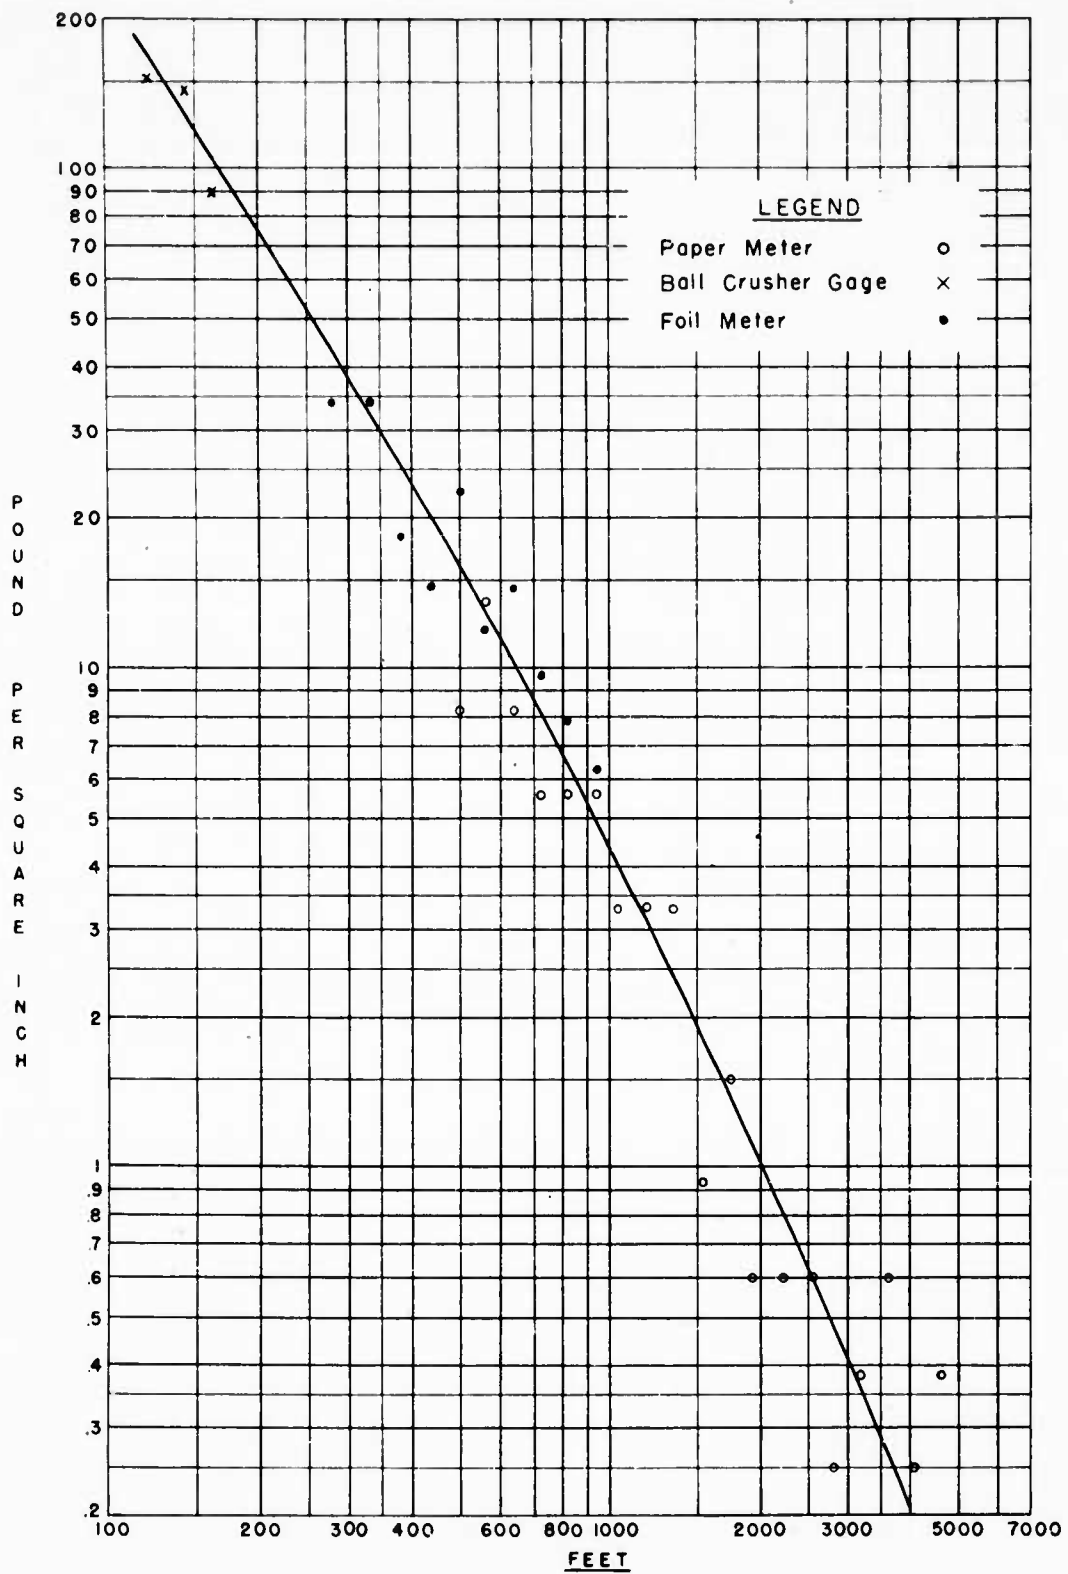
FIGURE 87. Peak Blast Pressure vs Distance from Charge, Test 2, Line 1 (Off Front)

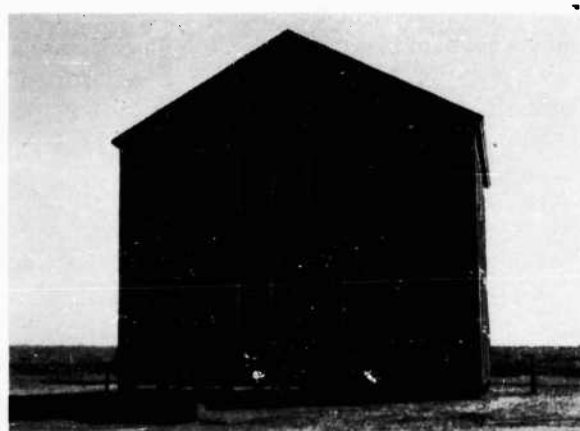
FIGURE 110. North elevation of Barracks 2 after Test 2

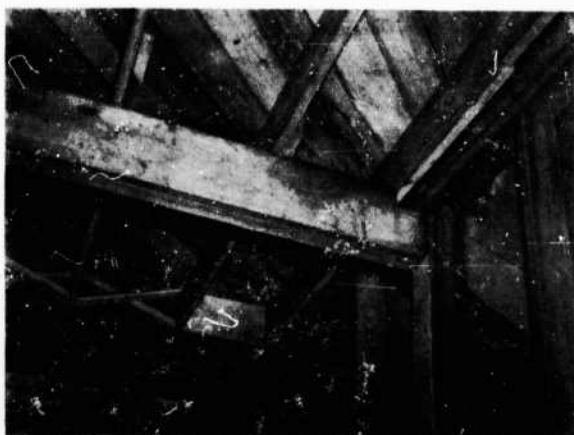
FIGURE 120. Displacement of south wall and column supporting 2nd floor, ground floor, Barracks 1 after Test 2

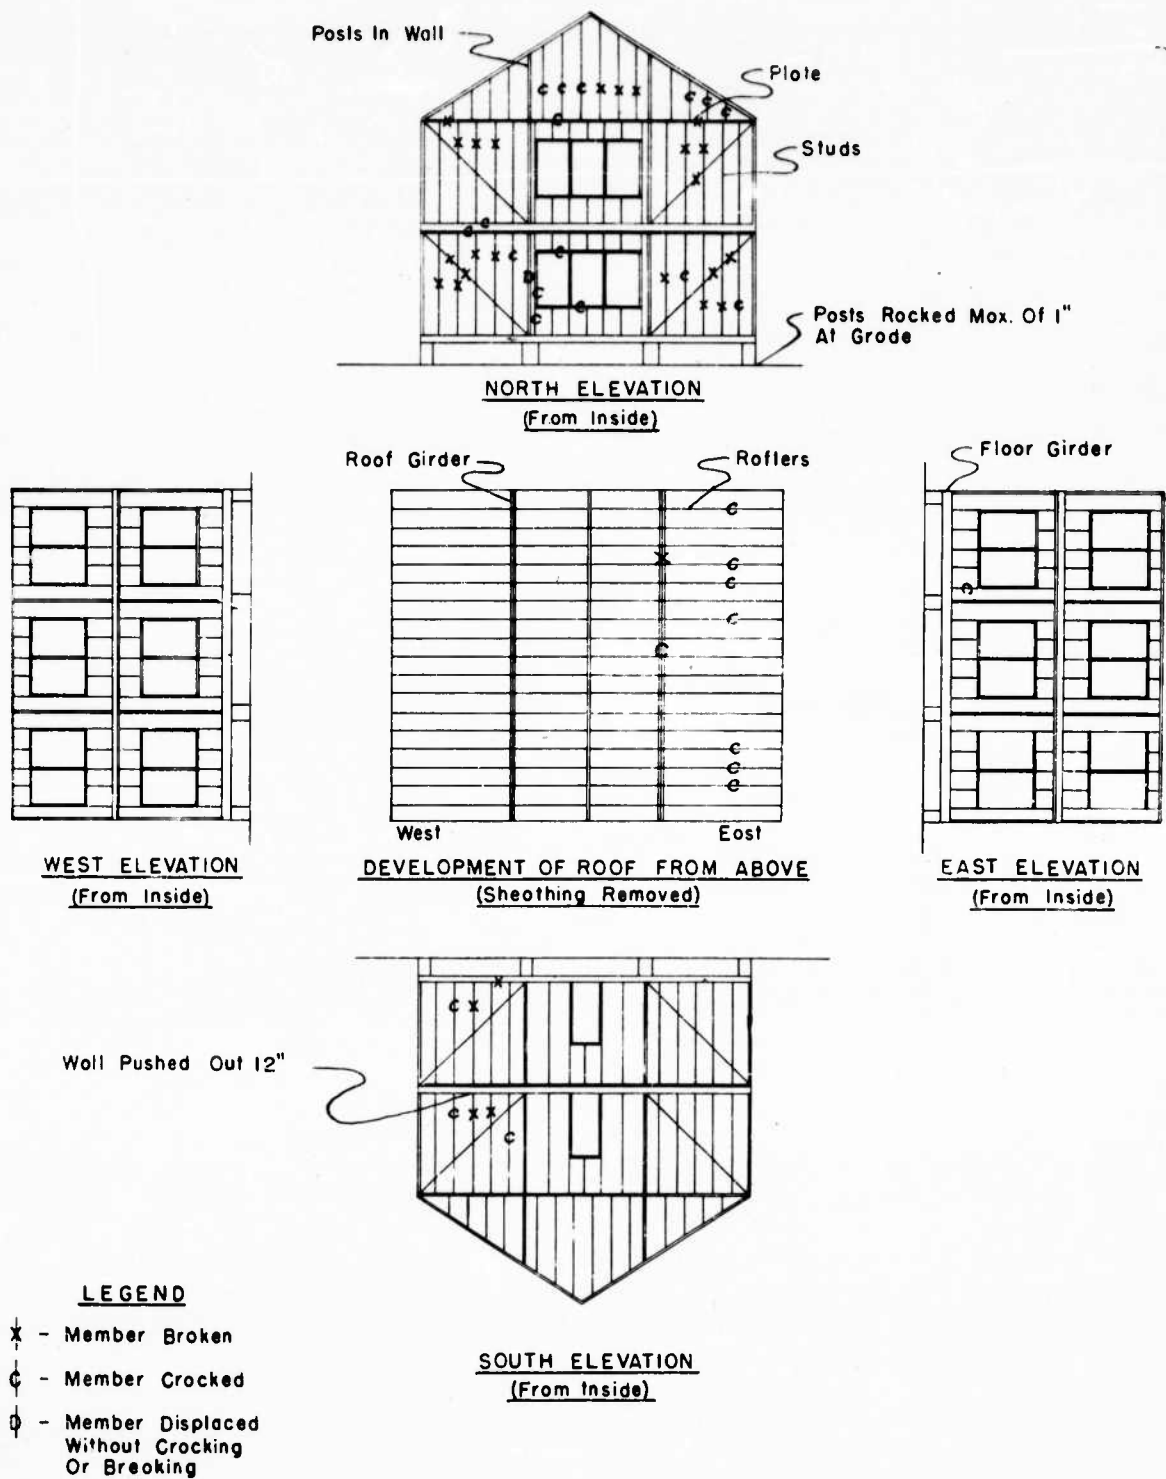
FIGURE 122. Damage to Barracks, Barracks 1, Test 2

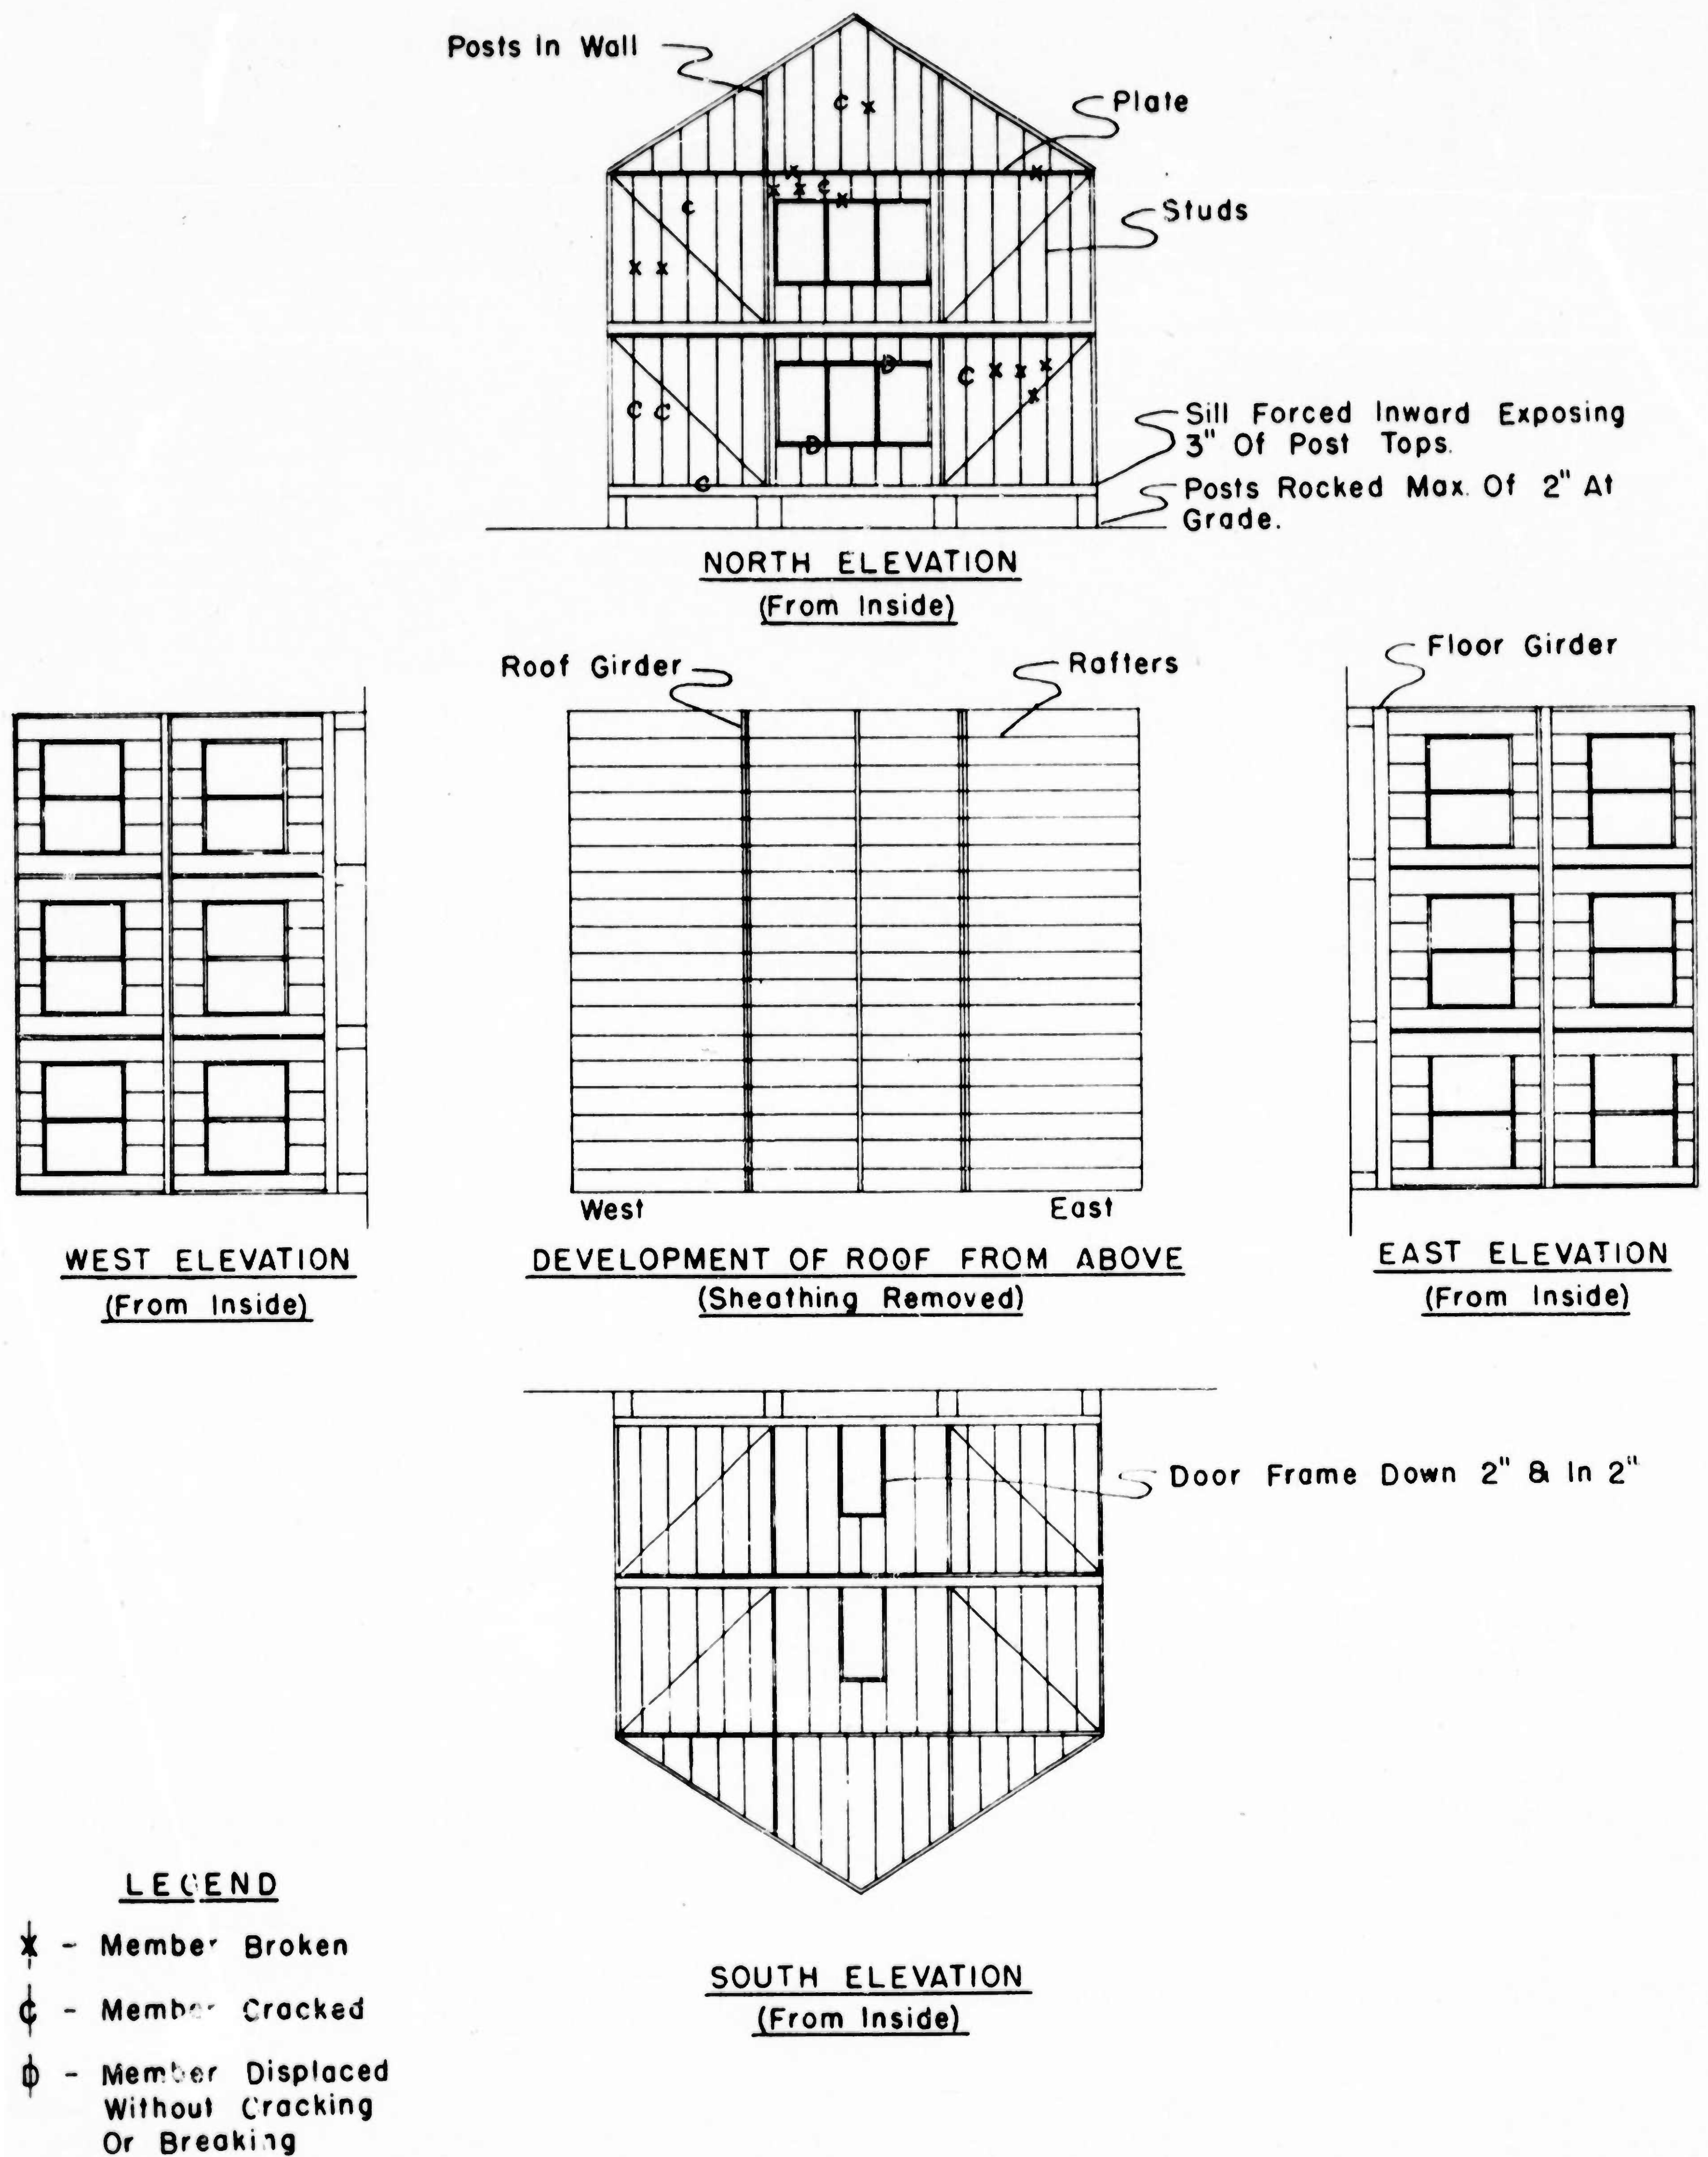
FIGURE 128. Damage to Barracks, Barracks 2, Test 2

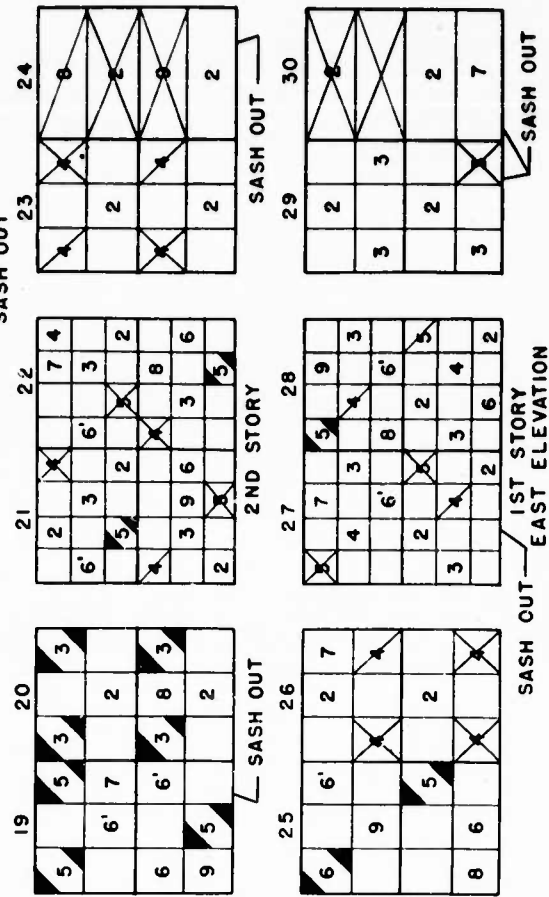
FIGURE 132. Glass Damage, Barracks 2, Test 2

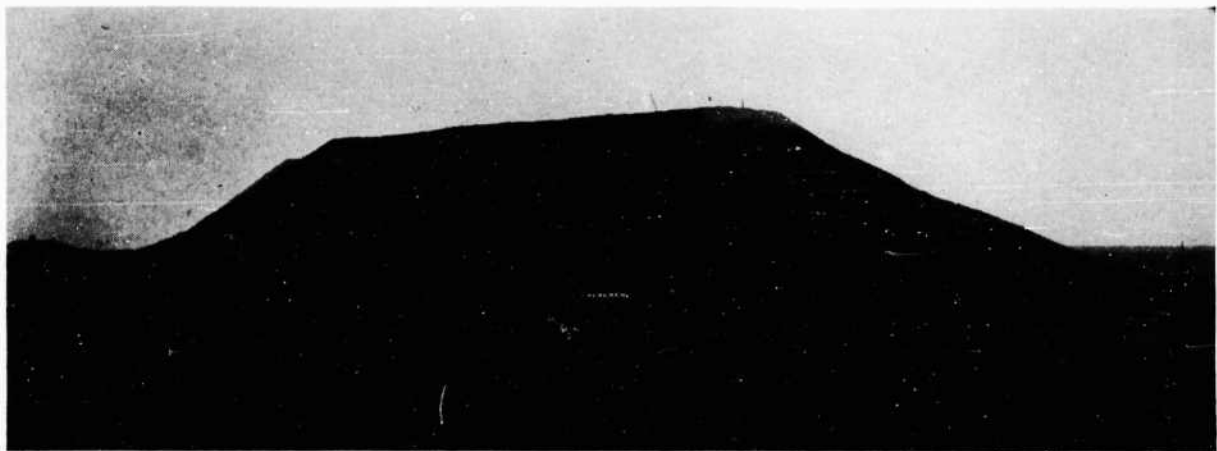
FIGURE 135. Three-quarter rear view of Igloo F prior to Test 3

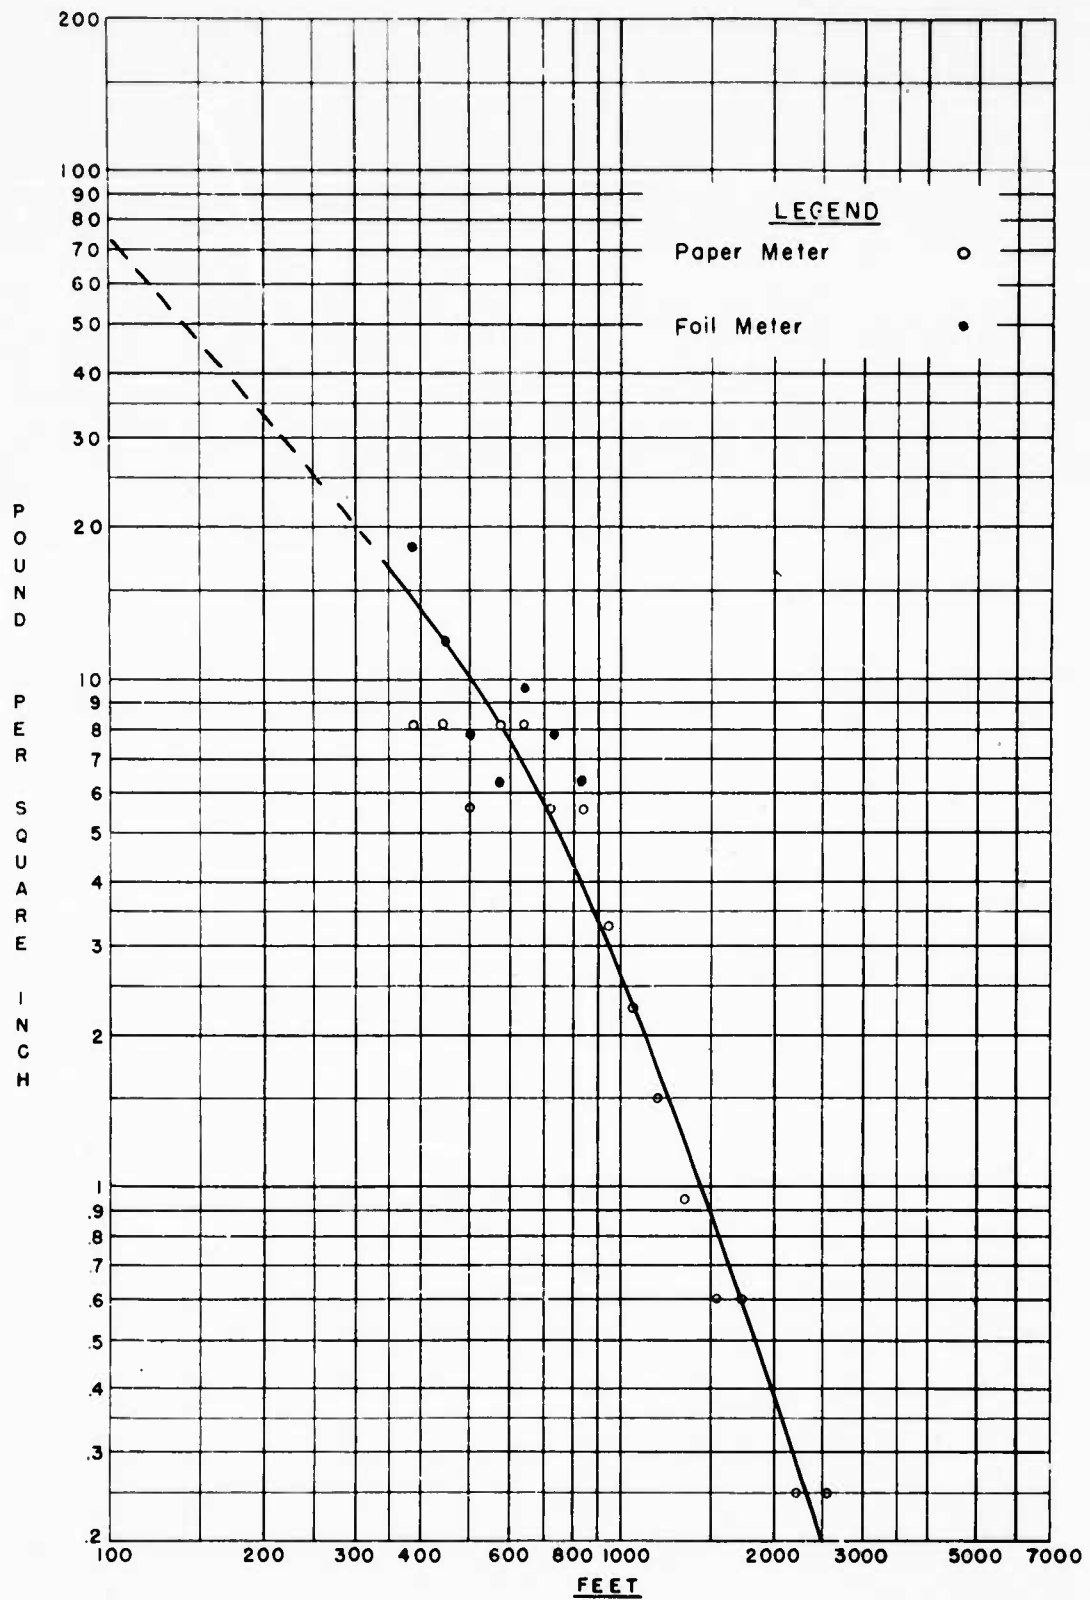
FIGURE 142. Peak Blast Pressure vs Distance from Charge, Test 3, Line 1 (Off Front)

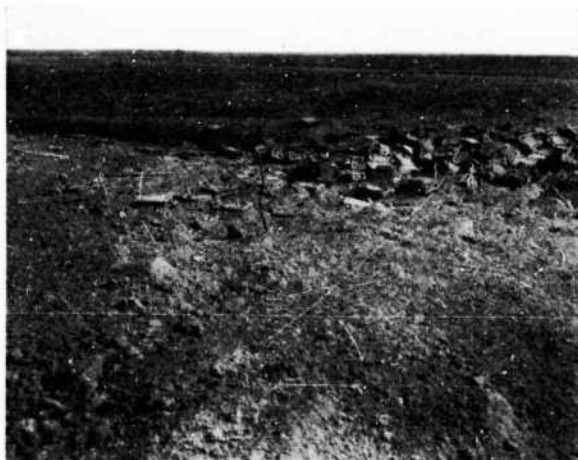
FIGURE 149. Revetment 2 after Test 3, looking east from west side

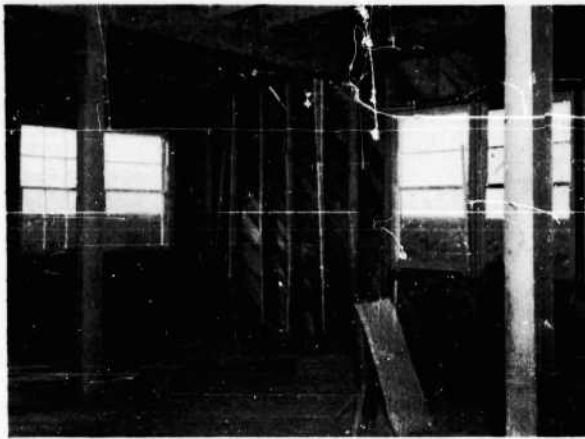
FIGURE 163. Interior, Barracks 1 after Test 3, showing broken studding, northwest corner, ground floor

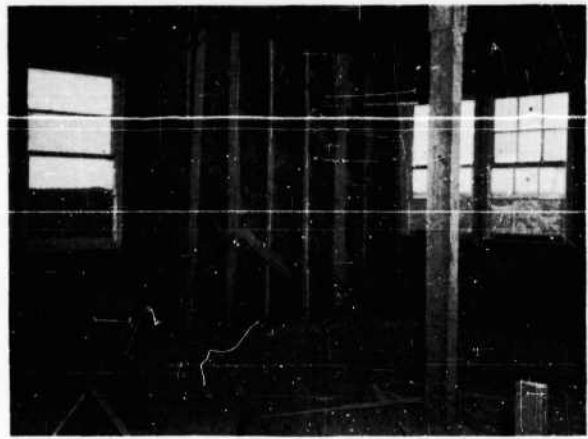
FIGURE 164. Interior, Barracks 1 after Test 3, showing broken studding, northeast corner, ground floor

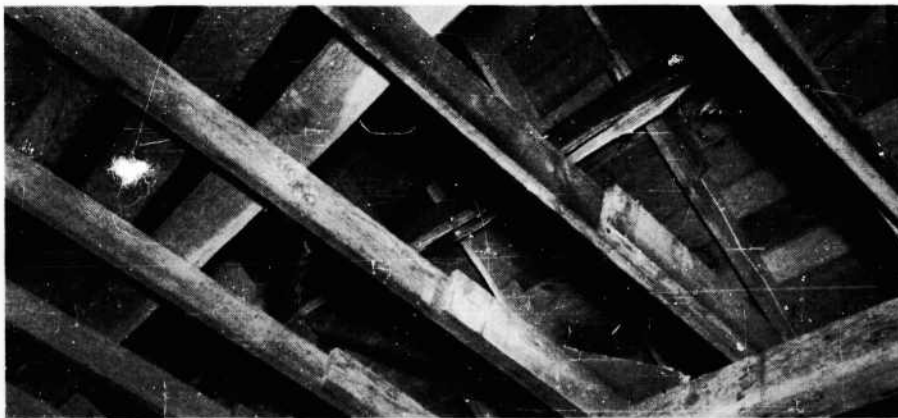
FIGURE 167. East section of roof framing, Barracks 1 after Test 3, showing broken purlin

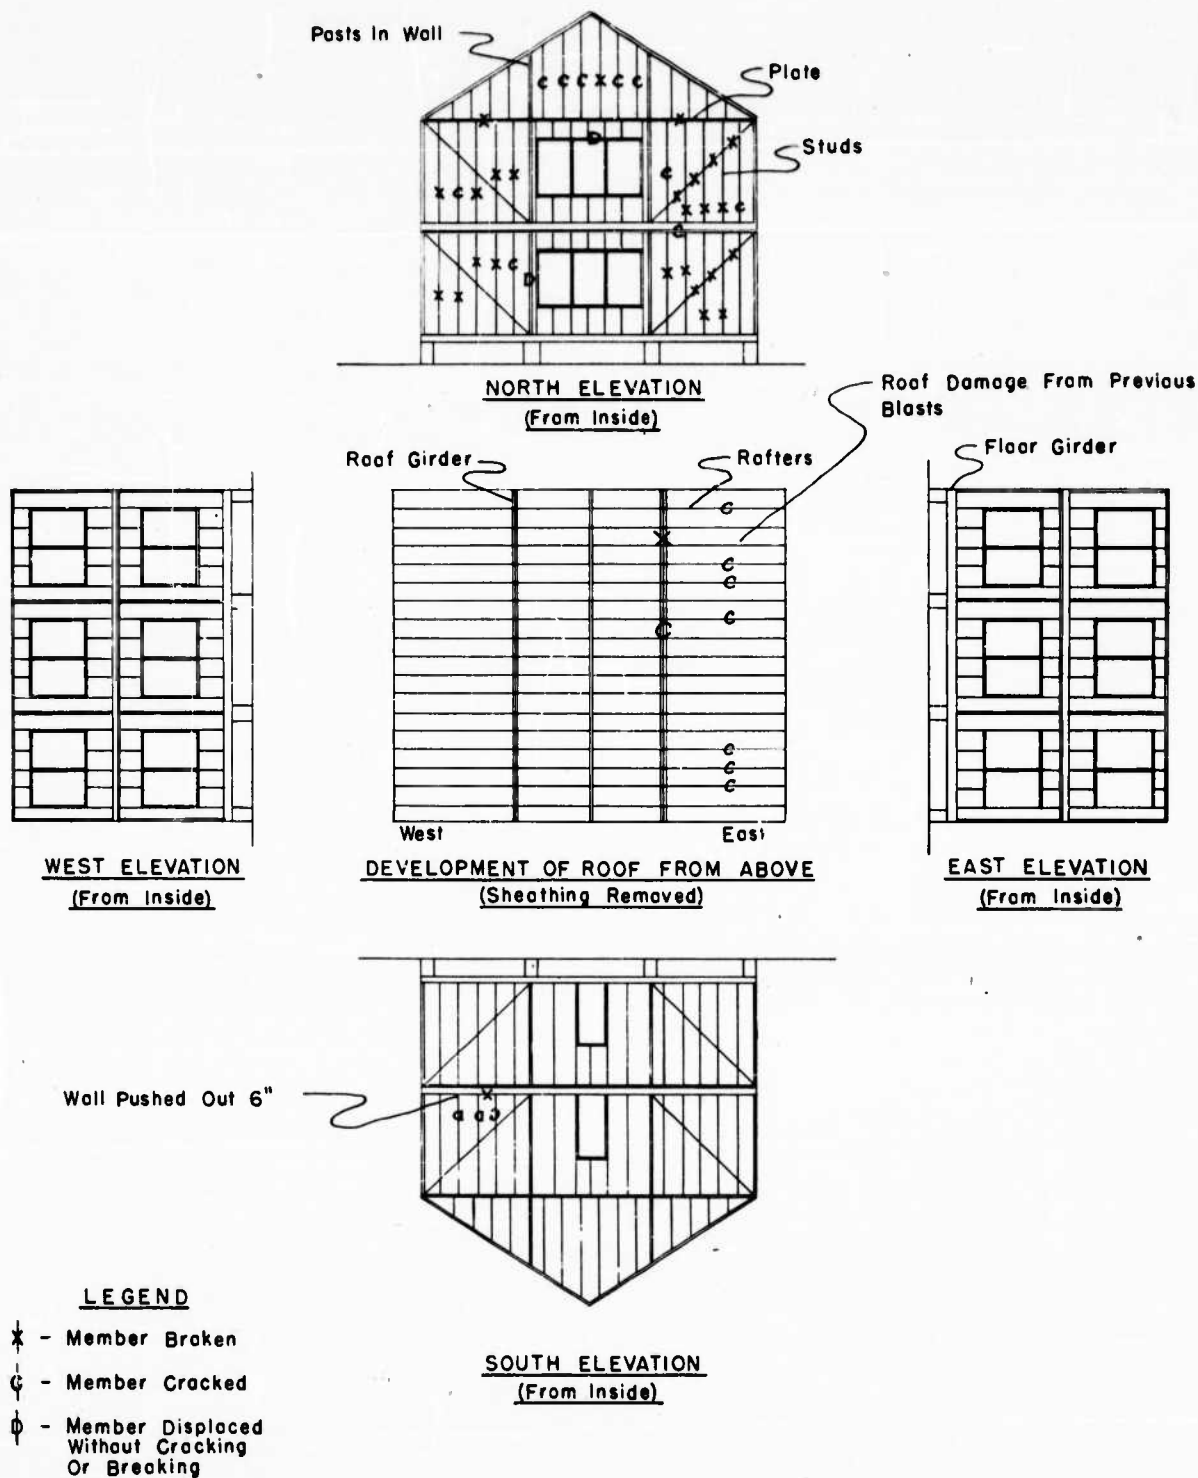
FIGURE 168. Damage to Barracks, Barracks 1, Test 3
