**IGLOO AND REVETMENT**

**TESTS**

**NAVAL PROVING GROUND, ARCO, IDAHO**

**OCTOBER, 1946**

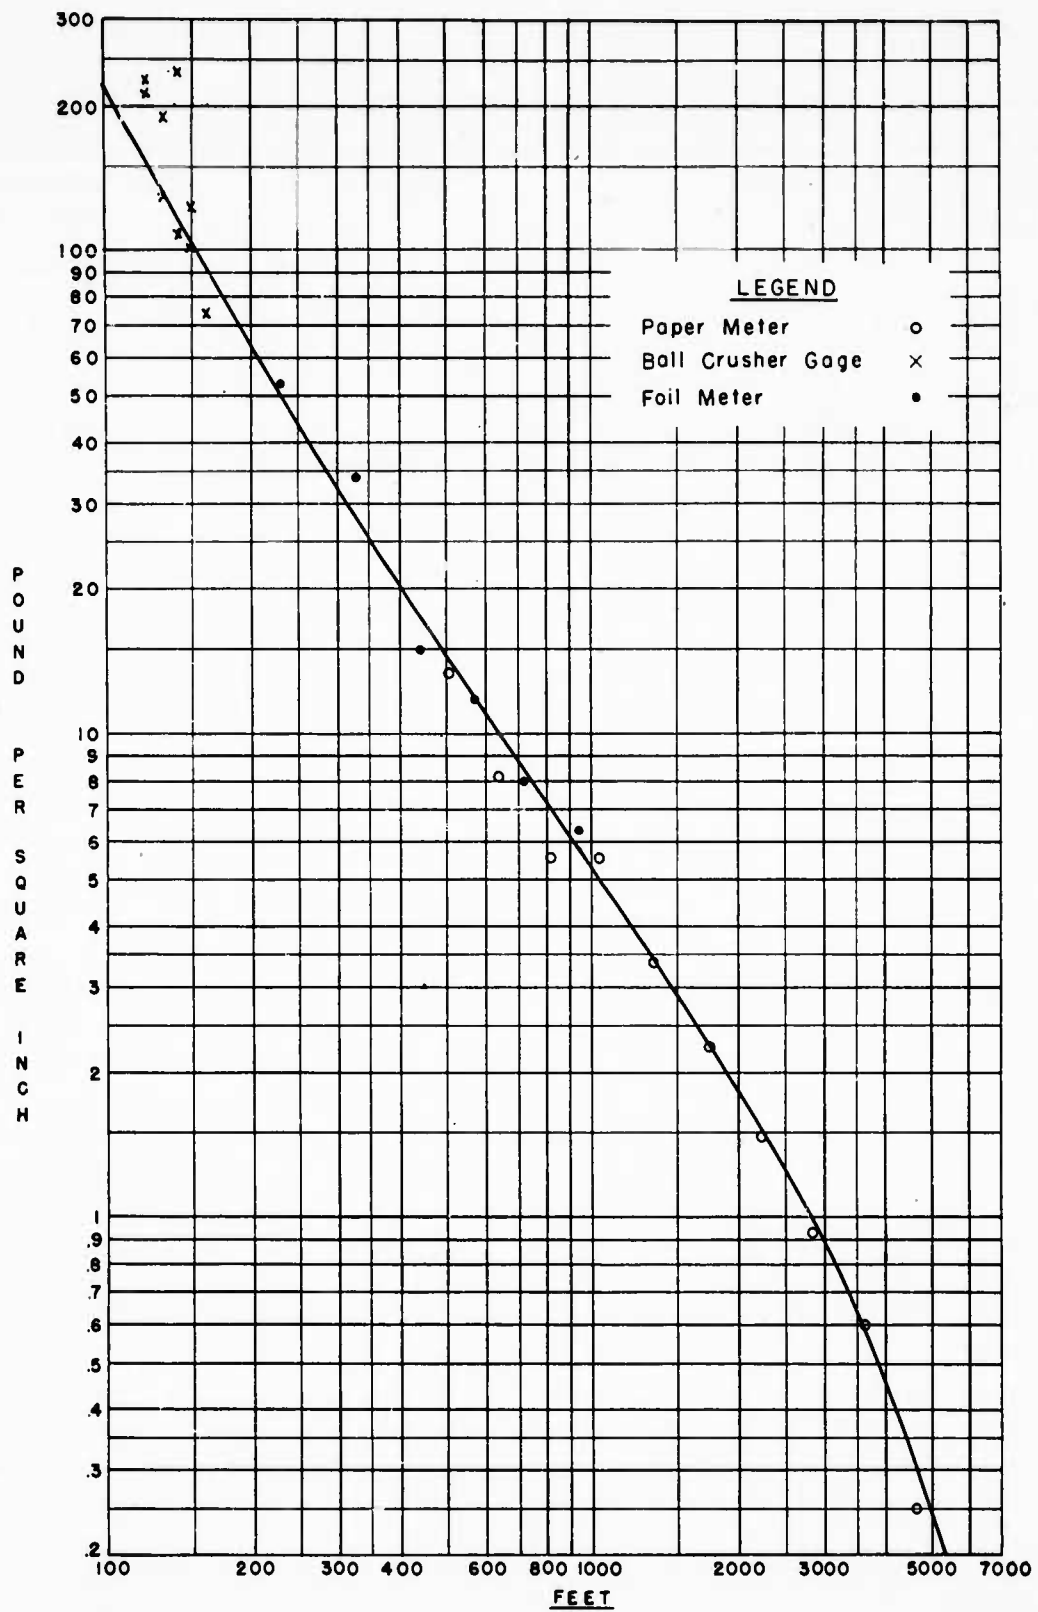
FIGURE 175. Peak Blast Pressure vs Distance from Charge, Test 4, Line 1 (Off Front)

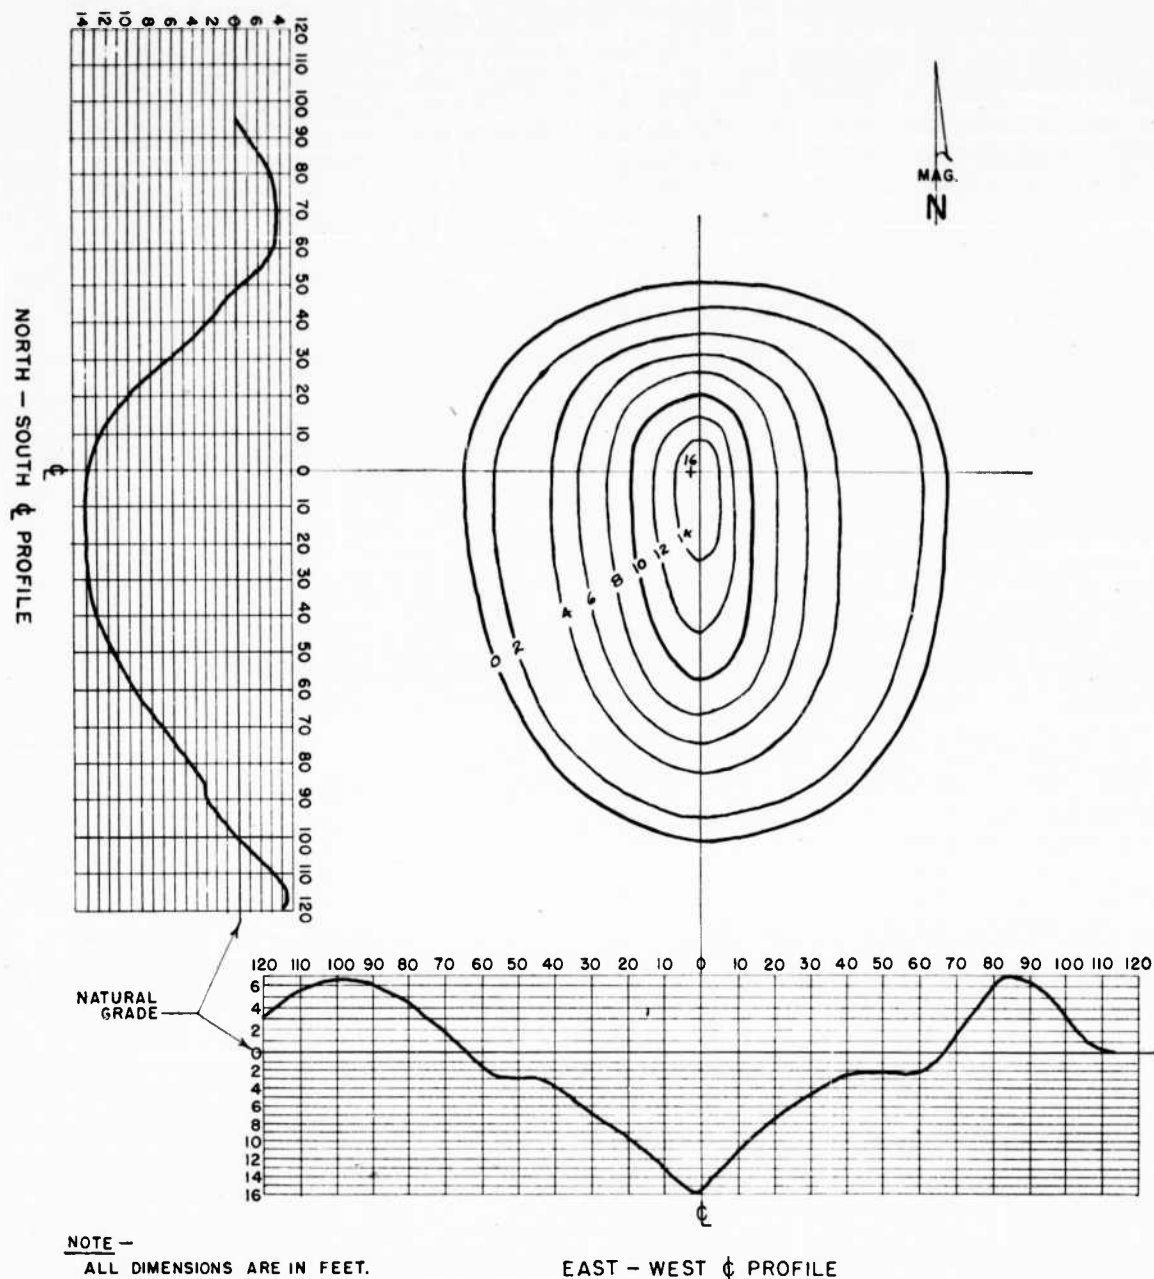
FIGURE 178. Crater Plan and Profiles, Test 4

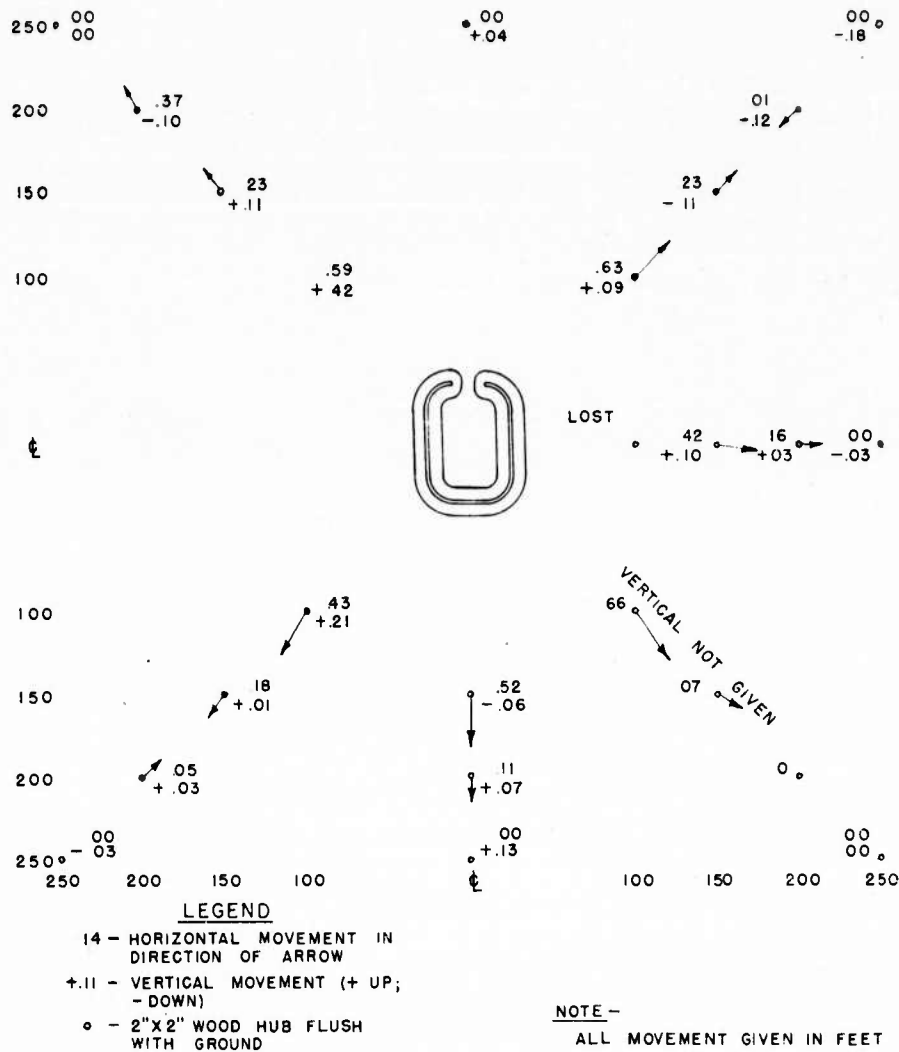
FIGURE 180. Permanent Horizontal and Vertical Earth Displacement, Revetment No. 1, Test No. 4

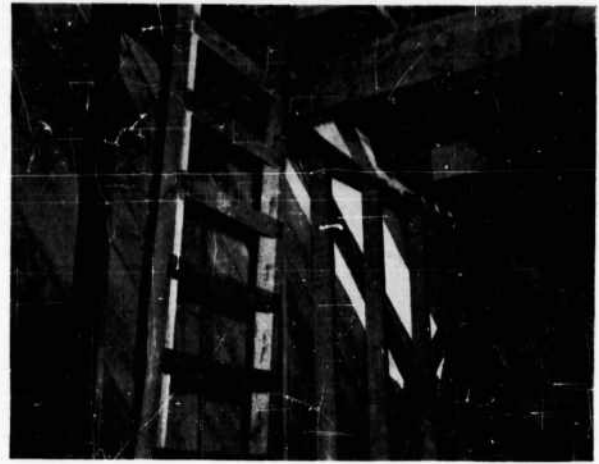
FIGURE 196. Interior of Barracks 1 after Test 4, showing separation of south wall from second floor, and missing sheathing

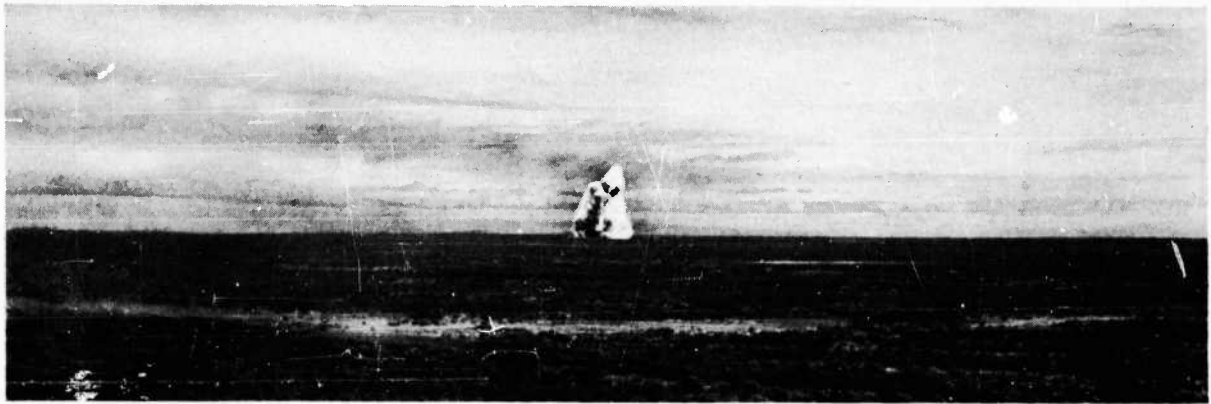
FIGURE 197. Explosion of Revetment 2, 1st stage

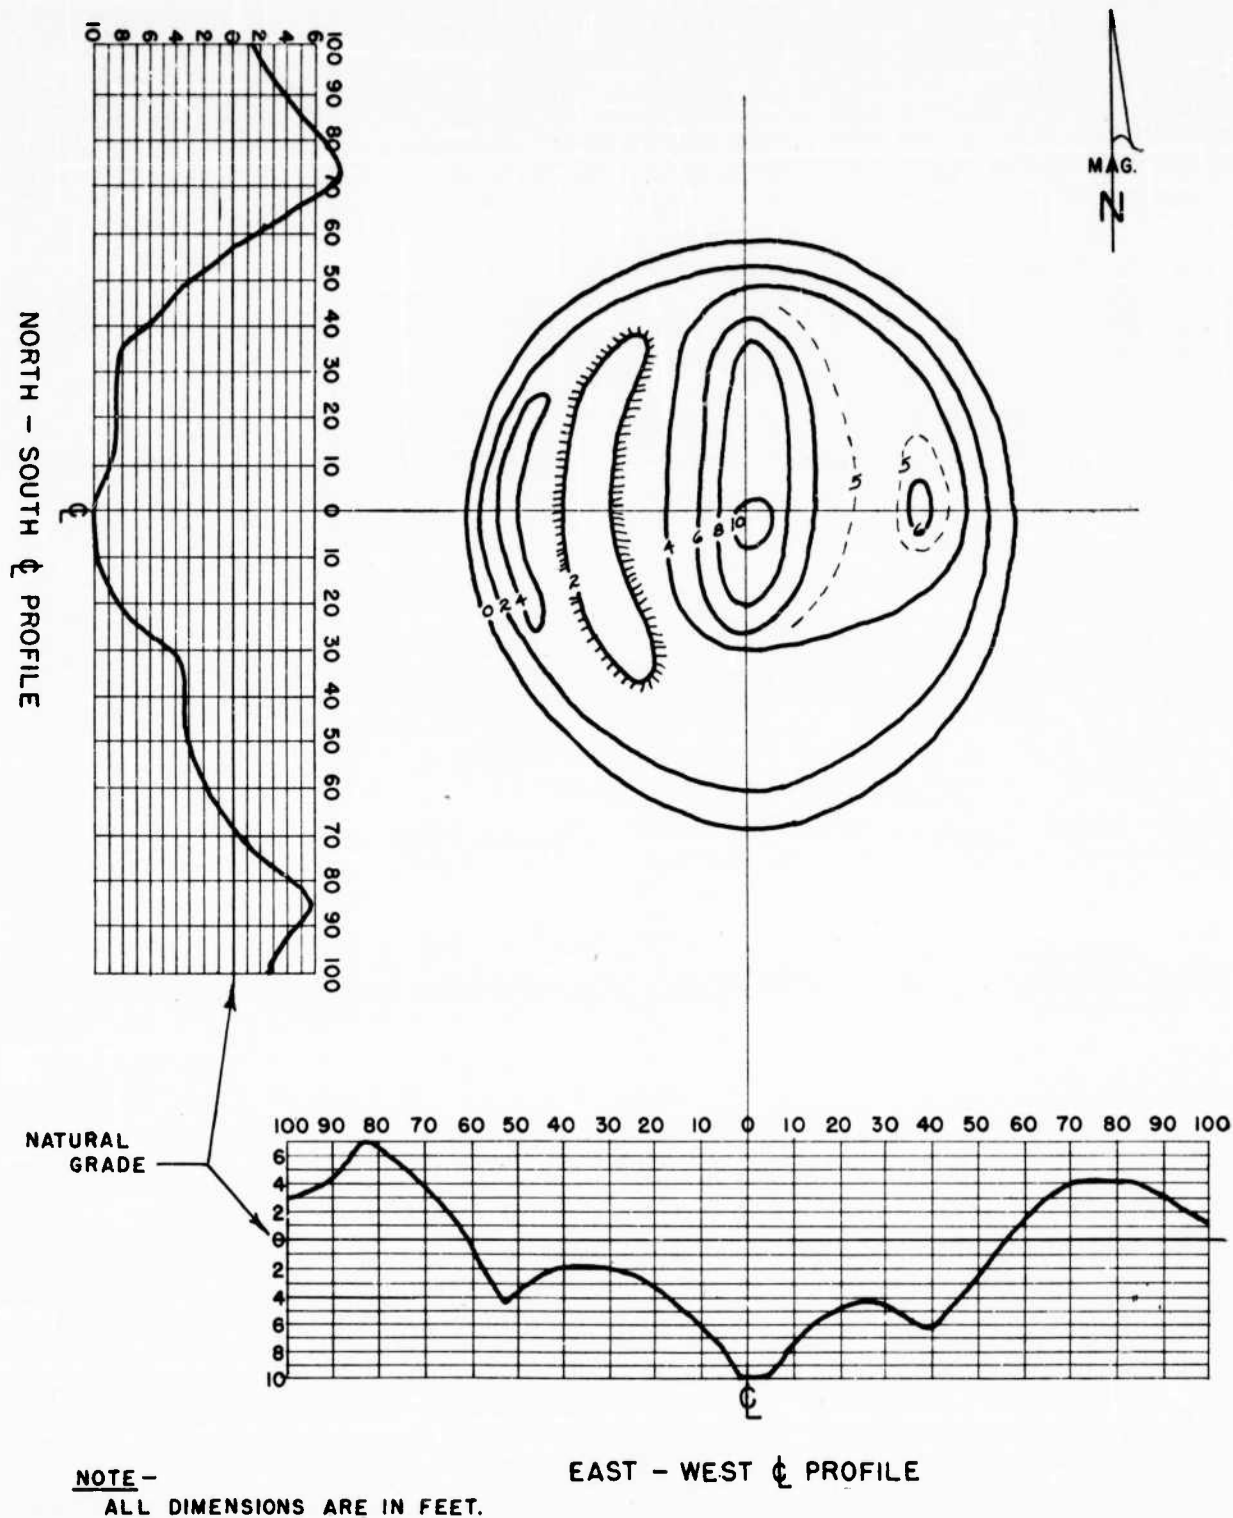
FIGURE 202. Crater Plan and Profiles, Test 5

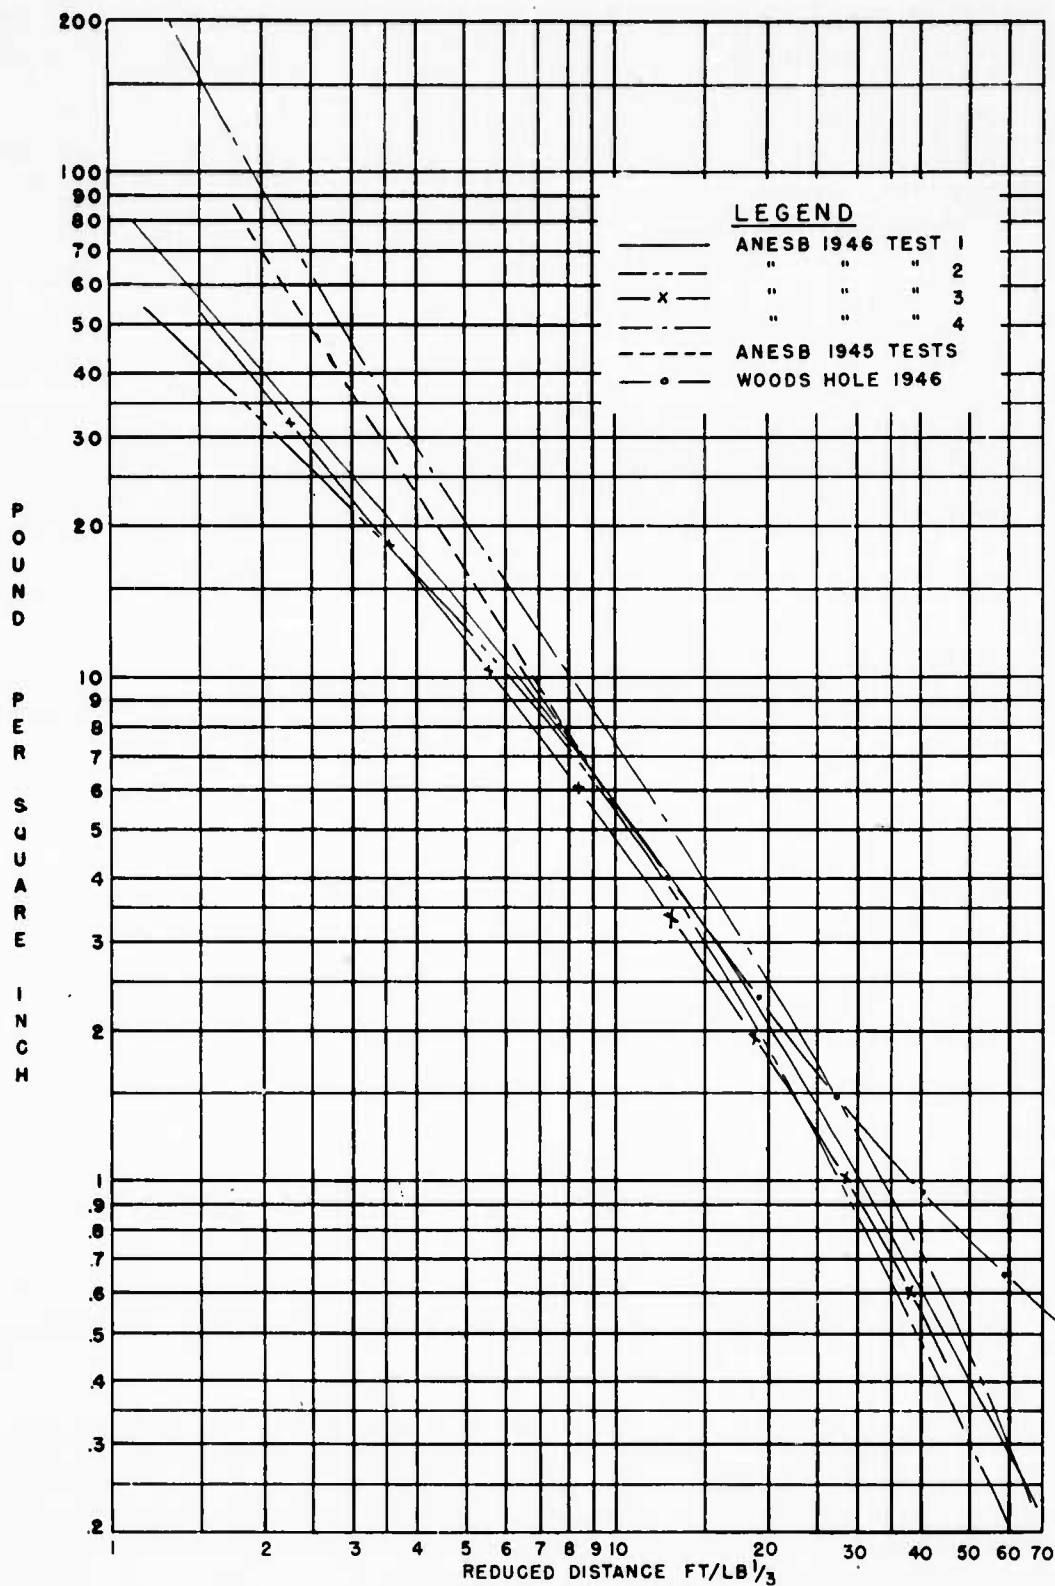
FIGURE 225C. Pressure-Reduced Distance Curves for Tests 1-4 incl. (Off Rear)

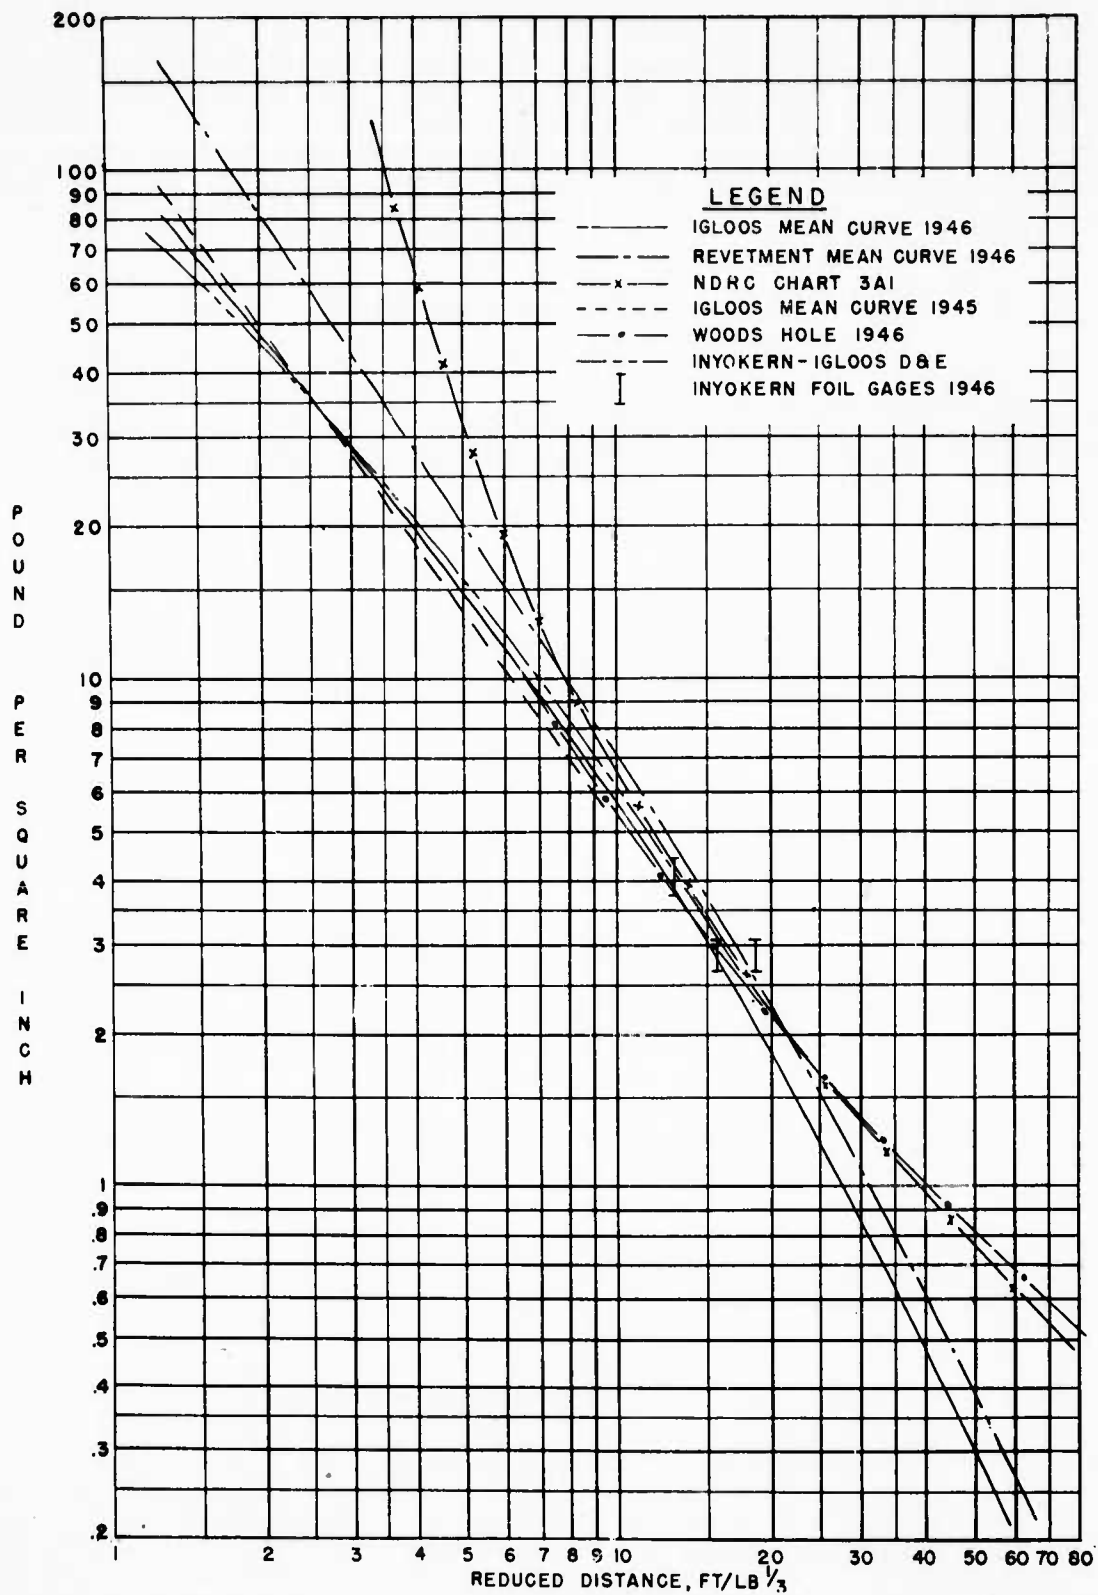
FIGURE 226. Comparison of Pressure-Distance Curves from Igloos and Rev. 1 with Curves from other Sources
