AFMDC-TR-60-7

AIR FORCE MISSILE DEVELOPMENT CENTER

TECHNICAL REPORT

WEAR, SOLID LUBRICATION, AND BEARING MATERIAL
INVESTIGATION FOR HIGH-SPEED TRACK APPLICATIONS

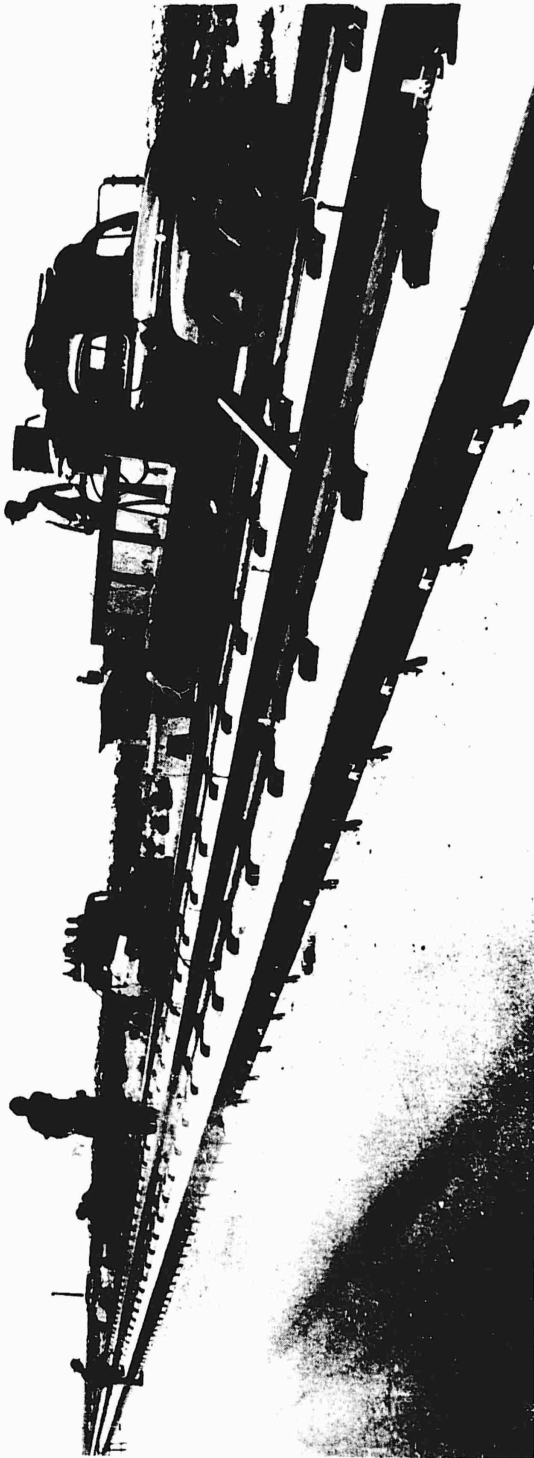
FIGURE 5. Rail Preparation and Metallizing Operations. Left Foreground, Sandblasting; Left Background: Lead Metallizing (right), and Aluminum Metallizing (left)

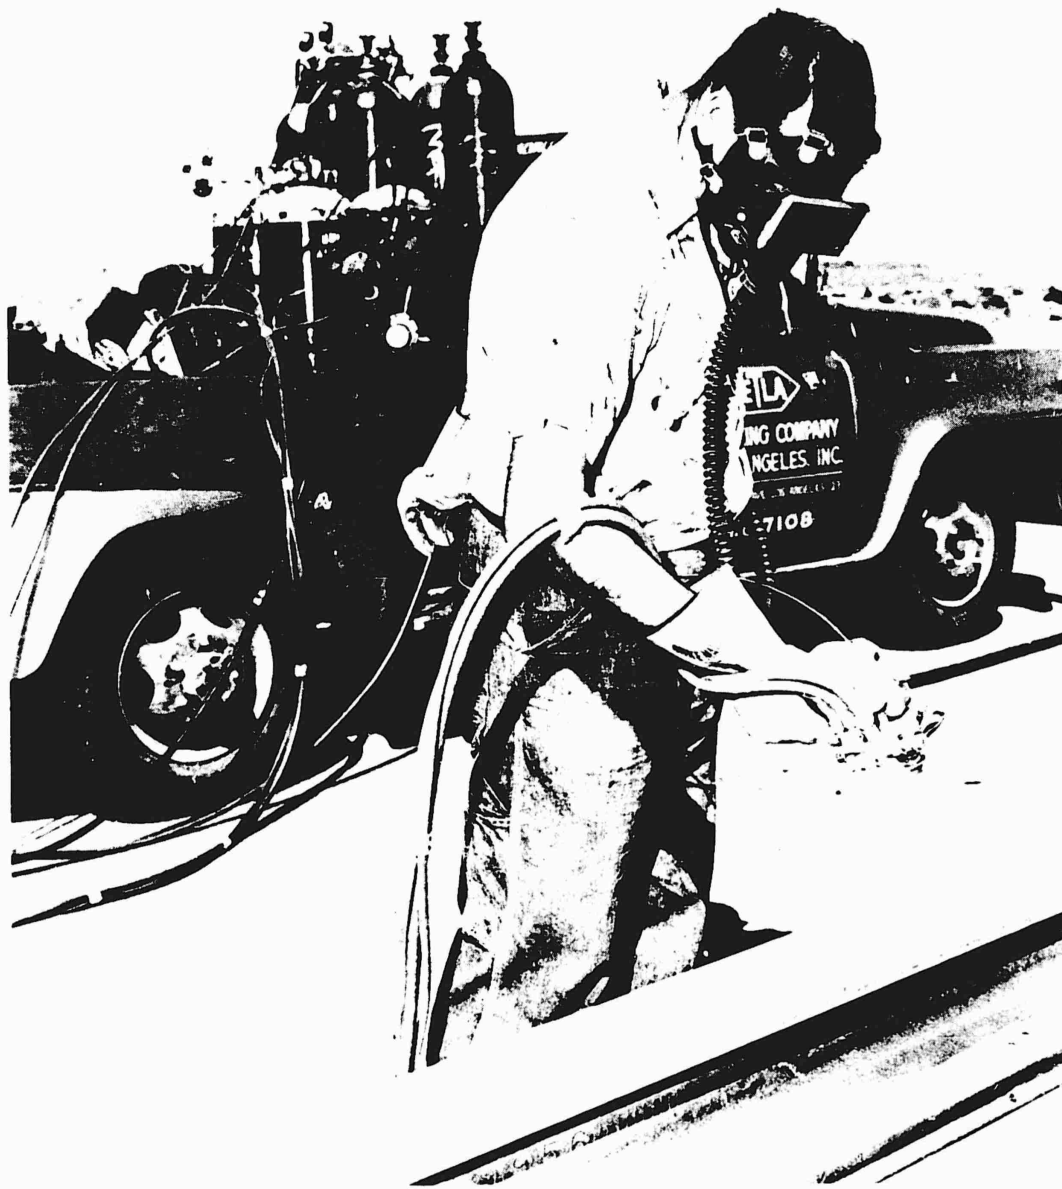
FIGURE 8. Six Percent Antimonial Lead Metallizing Operation

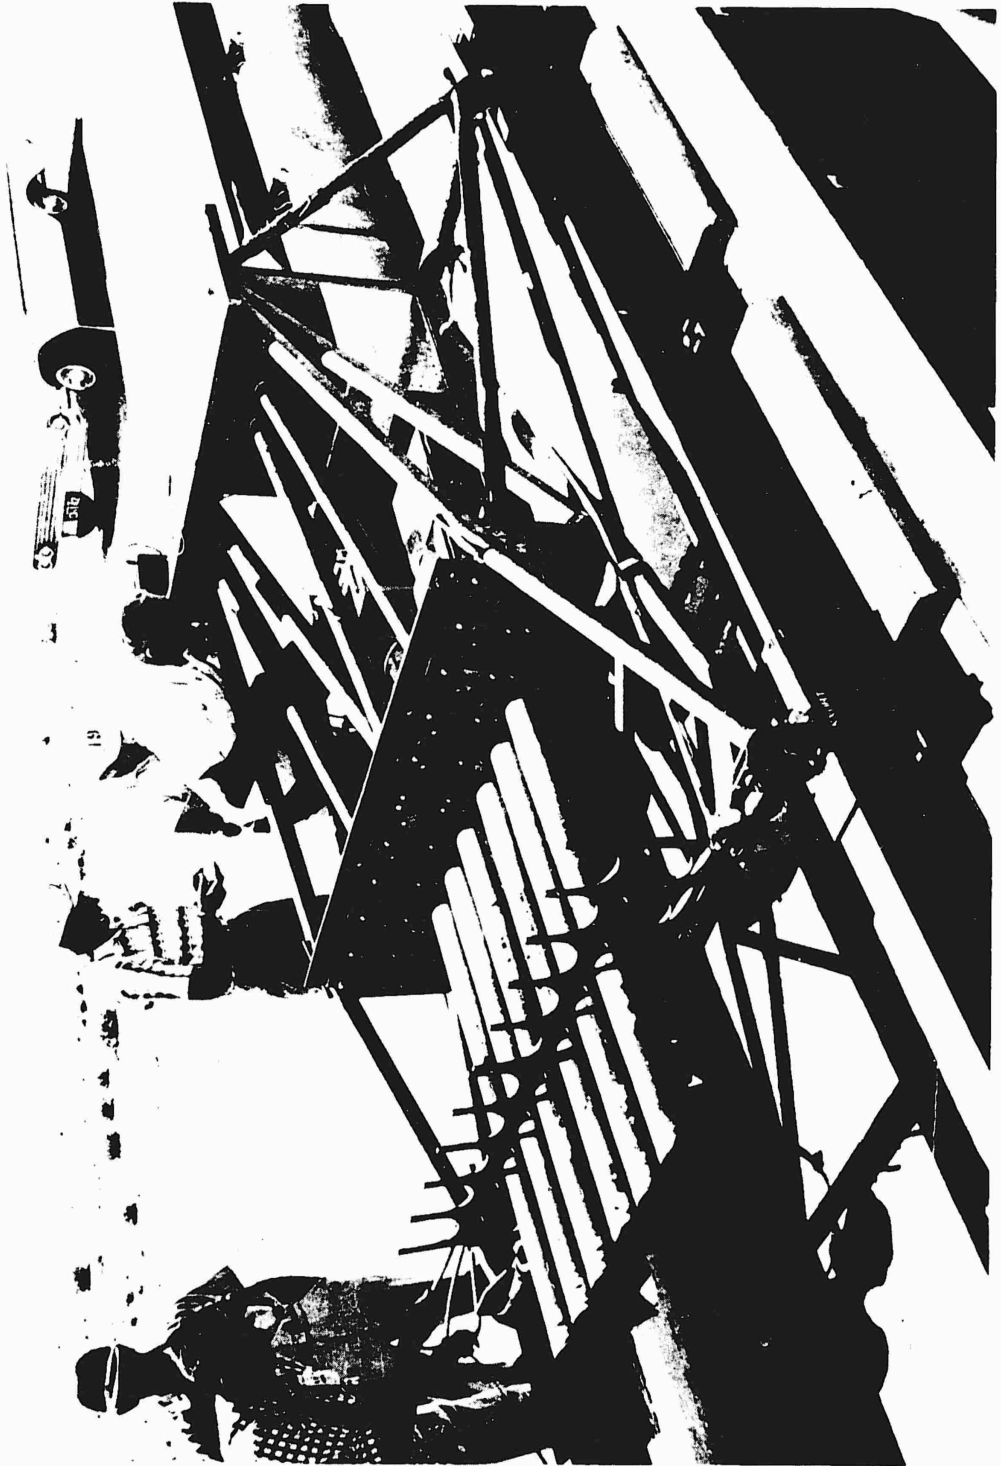
FIGURE 12. Rear Three-quarter View of GAM-67 Sled, Partially Unloaded.
Post-fire Condition

Note linkage above right front slipper for connection with
SRI test slipper.

Track Test Plan Number 59 was accomplished in April 1958. A modified GAM-67 (AF 5803) sled (Fig. 11, 12, and 13) was used to push two SRI test slippers (one on each rail) at a fairly constant velocity of 825 ft/sec for the 2,000-foot load application distance. Stainless steel and molybdenum test samples were used on bare, unprepared rail. A total of three runs was made.

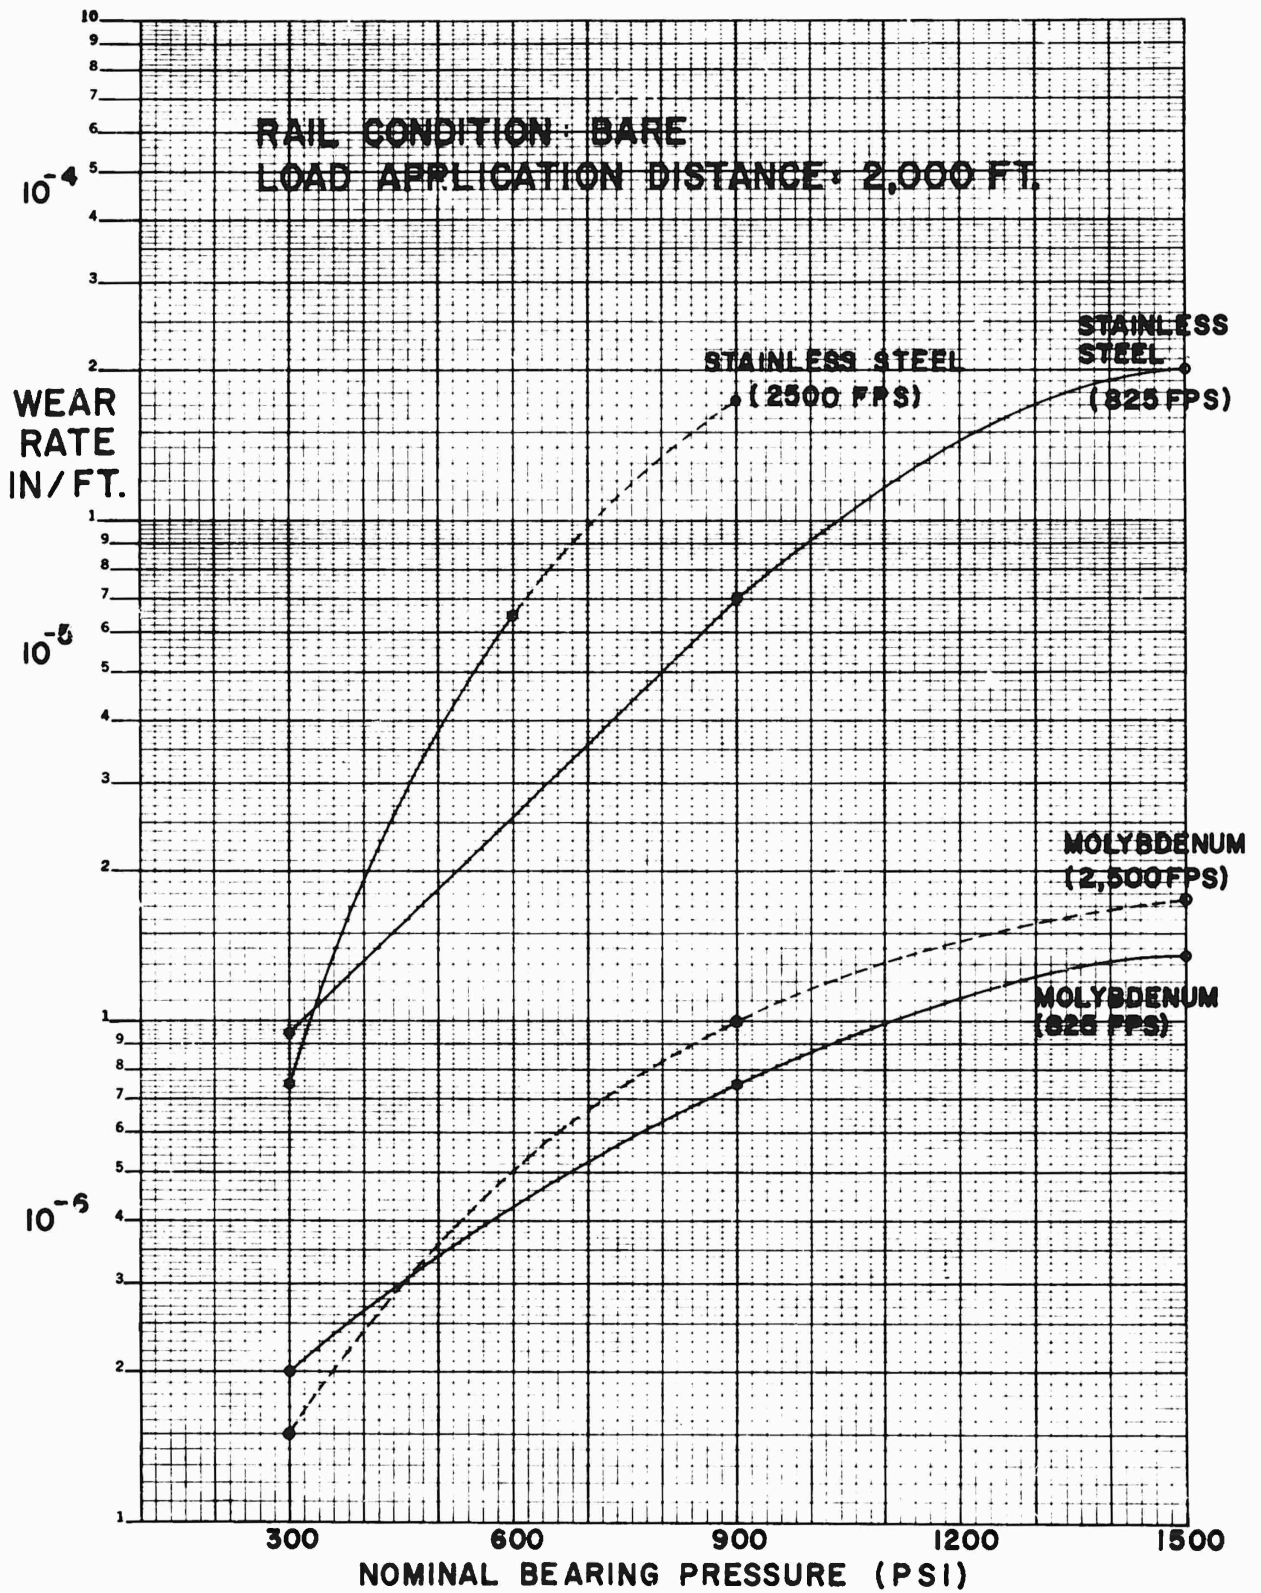
FIGURE 20

Wear rate versus nominal bearing pressure curves have been plotted for bare rail conditions (Fig. 20). The four curves represent six tests with Type 304 stainless steel and six tests with commercially pure molybdenum. The data for two of the curves were obtained at a fairly constant velocity of 825 ft/sec, and for the remaining two curves at 2,400 ft/sec \pm 150. The 900 psi data point on the high-speed stainless steel plot is a minimum wear rate because the entire gauge length of the test sample was worn through.

The two stainless steel curves (Fig. 20) indicate the wear rate of stainless steel increases with velocity at nominal bearing pressures above 300 psi. This observation is qualitatively substantiated by visual inspection of the bearing inserts of the SRI test slippers. They also wear more during high-speed runs than during low-speed runs. The difference in wear rate of the two molybdenum base alloy curves is not marked; therefore, at this time it is concluded that the wear rate of molybdenum is independent of velocity between 825 and 2,500 ft/sec within 300 to 1500 psi nominal bearing pressure. It appears that the increased heat flux at higher velocity is not sufficient to establish the steady state wear condition in molybdenum (Ref. 2).
