AUTOMOTIVE ENGINEERING LABORATORY

TX-200 TRANSMISSION

OIL COMPATIBILITY PROGRAM

Report No. DPS-235

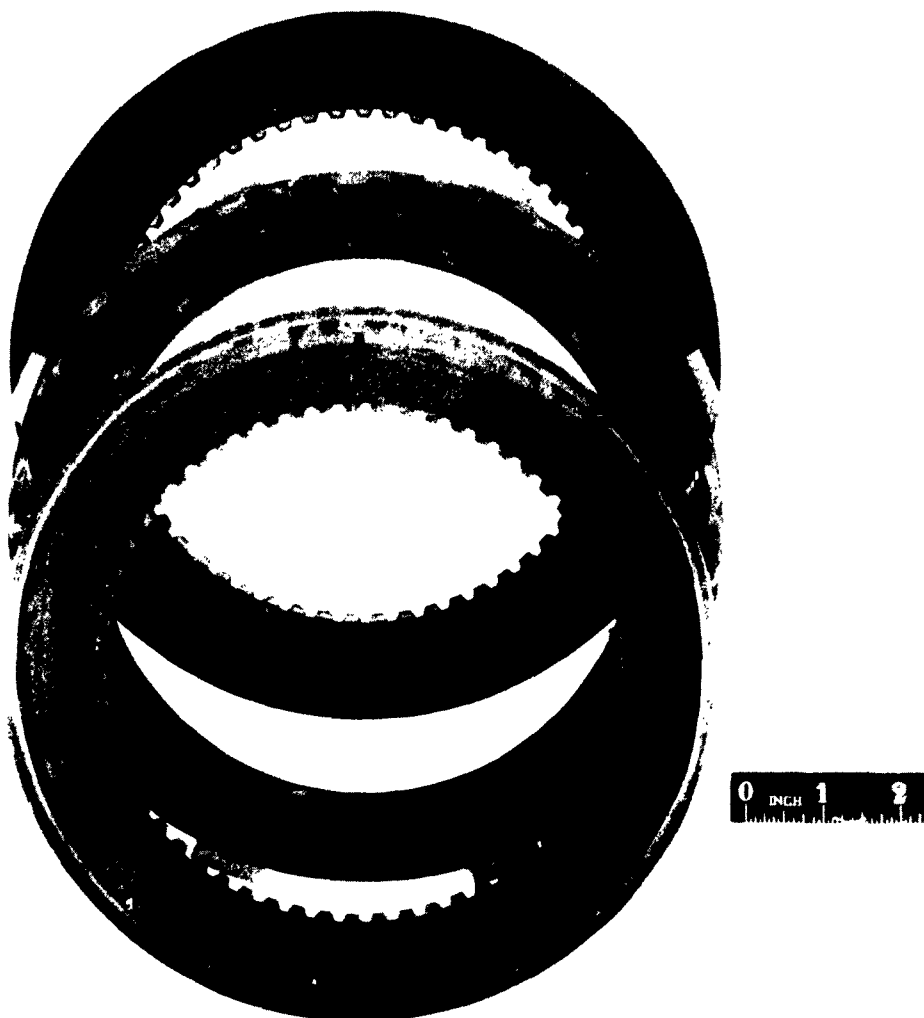
3.2.3 M35E8, 2-1/2 Ton Truck, TX-200-3X Transmission Serial Number 30821; MIL-L-2104A, OE-10, M-14500, REO-148-61 Oil. There were a number of interruptions during the 5000 miles of cross-country operation, but none of them were caused by the transmission. Considering the operation to which the transmission was subjected, its over-all appearance was good. In contradiction to the laboratory tests, the clutch plates were the most distressed areas. Figure 6 shows the worst area of wear and heating, which occurred on the intermediate-range clutch plates.

Figure 6: M35E8, 2-1/2 Ton Truck, TX-200-3X Transmission, Serial Number 30821; MIL-L-2104A, OE-10, M14500, REO-148-61 Oil. Intermediate-Range Clutch Plates.

All of the laboratory tests showed very little clutch-plate distress compared with the severe wear which occurred within the intermediate-range clutch-pack during test-course operation. This was undoubtedly due to the differences in shift-cycle severity. Check runs on the Churchville test course indicated that with no trailer and on a dry course there would be a total of 85,000 shifts for 5000 miles of operation, and that with the trailer and a muddy course there would be 91,250 shifts. Averaging the data for both conditions there would be a total of 47,250 splitter shifts during the 5000-mile test. During each test in the laboratory the transmissions were shifted 2850 times, of which 2730 were full-power splitter shifts. This is only 5.8% the total number of splitter shifts experienced at Churchville.
