INTERIM PROJECT REPORT  
NO. MS PR 61-45

CONTRACT NO. DA-04-200-507-ORD-333  
UNDER ARMY PROJECT NOS. 593-32-003 AND 593-32-005  
PHASE REPORT NO. 9  
EFFECT OF CONTROLLED WELD DEFECTS ON THE BALLISTIC  
PERFORMANCE OF 5083 ALUMINUM ALLOY WELDMENTS

M. B. Kasen

DEPARTMENT OF METALLURGICAL RESEARCH

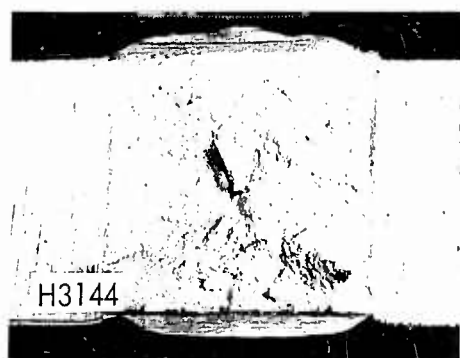
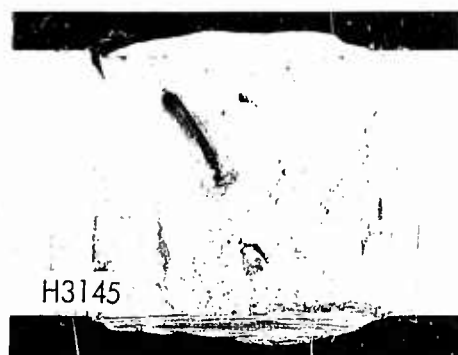
Figure 11

(a) Control Weld (No Defects)

(b) Moderate Dross Films

(c) Severe Dross Films

A correlation was also found between the severity of the cross film defect and the ultrasonic indication of this defect (Figure 11).

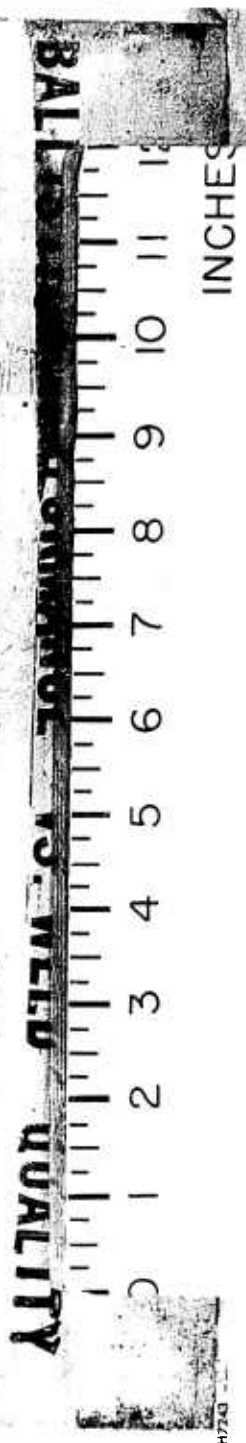
Figure 18

BACK SURFACE OF WELDMENT L220 AFTER BALLISTIC SHOCK TEST  
This weldment contained severe lack of fusion
