**BUREAU OF SHIPS  
CONFERENCE**

**HY-80 STEEL FABRICATION IN  
SUBMARINE CONSTRUCTION**

**AT BUREAU OF SHIPS  
21-22 MARCH 1960**

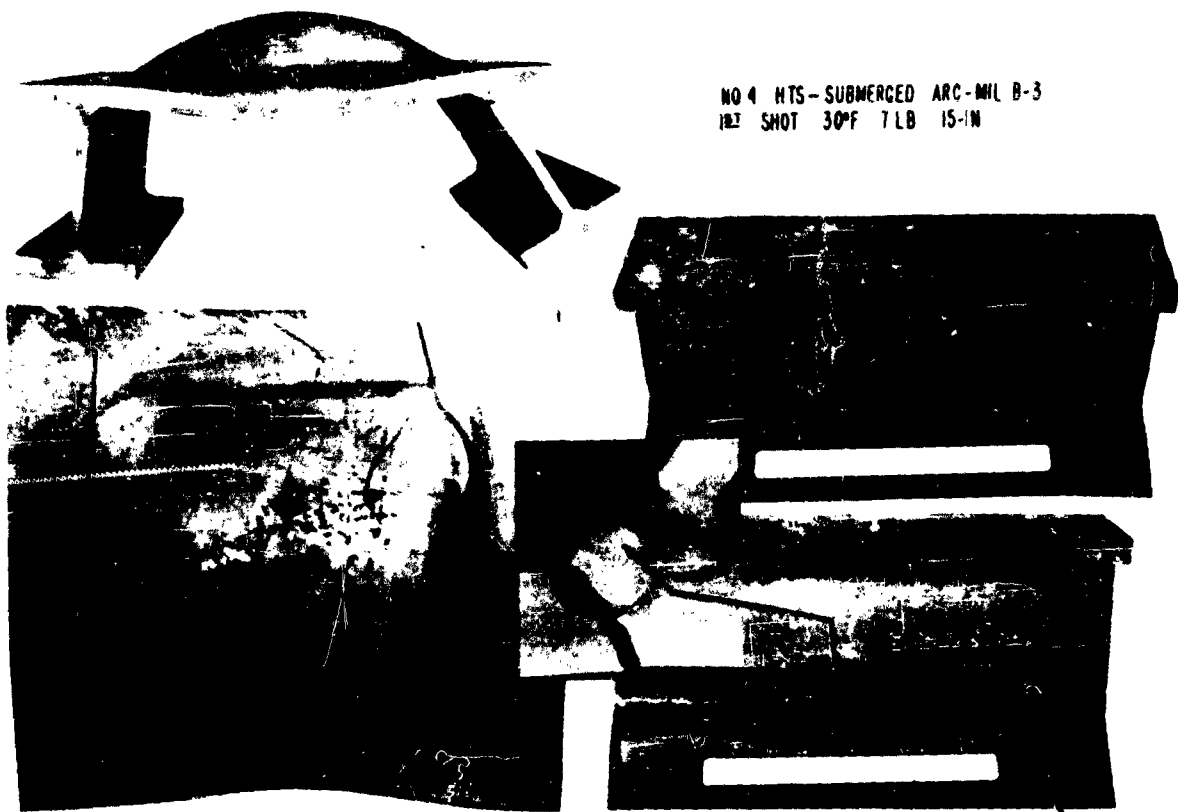
Figure 5 - Test specimen No. 4 after one explosive shot. Arrows indicate extent of ruptures.  
Insert shows submerged-arc weld failure.
