**INGERSOLL KALAMAZOO DIVISION**

Project Report SPDIR-25  
Contract NOrd 15719 Problem 4

High Strength MBMC #1 Steel Hydrotest  
Case Evaluation, Metallurgical Properties  
and Machinability

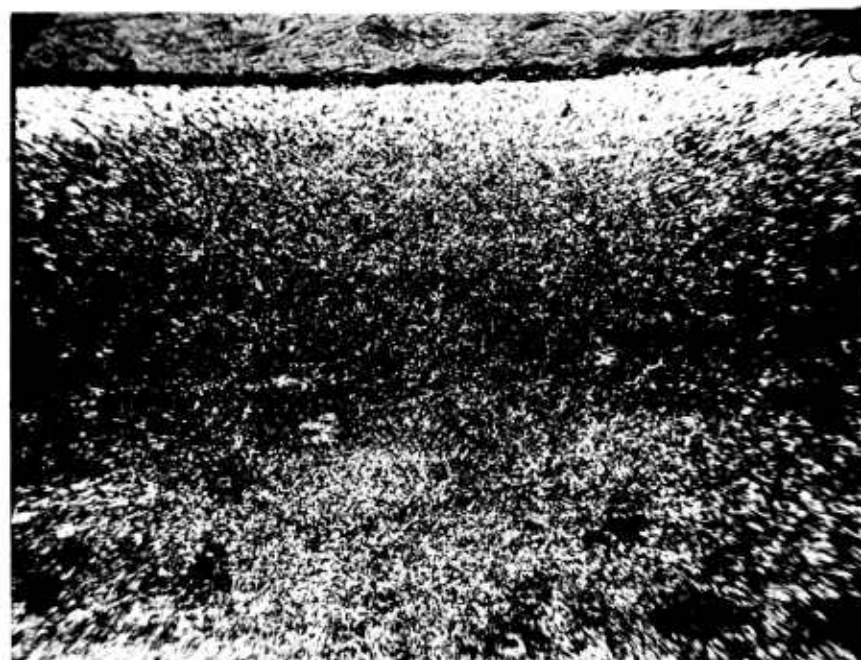
Figure 10. Photomicrographs Illustrating Visual Decarburization  
on Forged and Spun Cases

Condition III cases were heat treated in a decarburizing atmosphere and the tempering temperatures were varied to determine an optimum tempering temperature for the final evaluation cases. The decarburizing atmosphere was also varied to obtain one case with heavy decarburization and one with medium decarburization for the purpose of selecting a furnace setting for the evaluation cases. Figure 10 shows a photomicrograph illustrating the visual decarburization on cases F-102 (heavy decarb) and F-106 (medium decarb).

Case F-102. Medium Decarburization.  
Magnified 100 Times

Case F-106. Heavy Decarburization.  
Magnified 100 Times

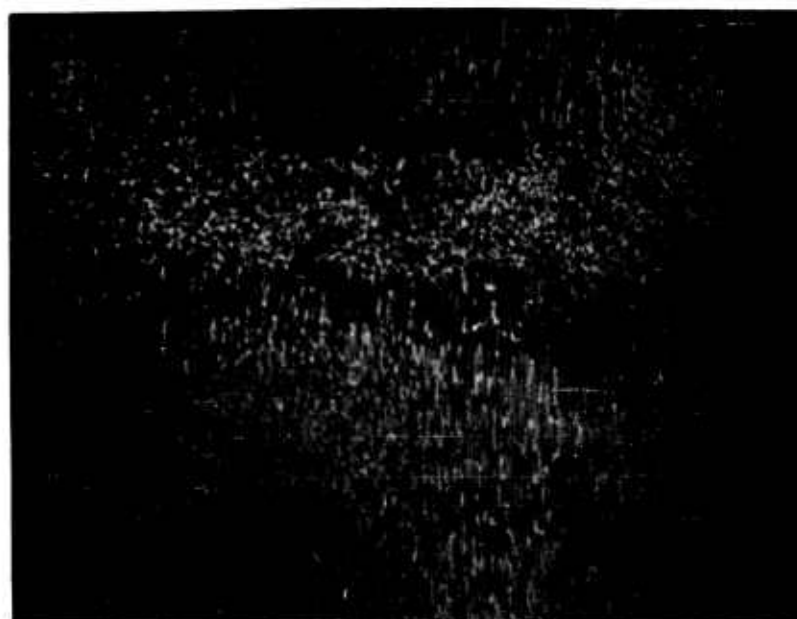
Stress Cracks at 98,000 psi Hoop Stress at Girth  
Weld. X 2

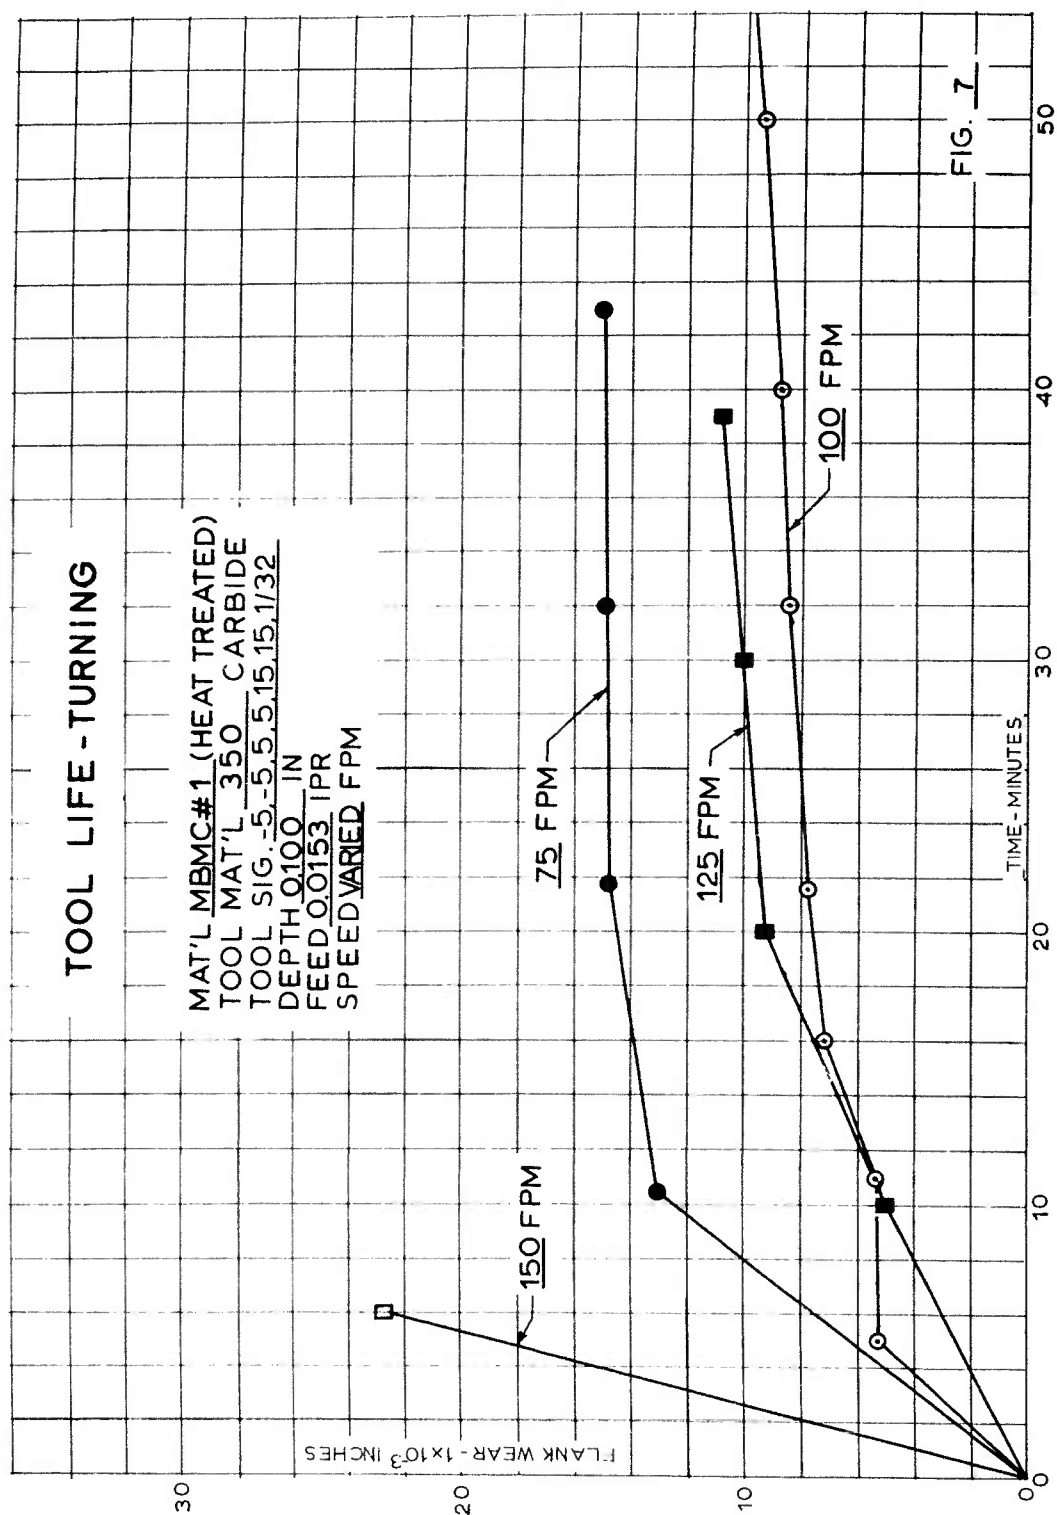
Test results for the heat-treated condition are summarized in Figs. 7 to 13 inclusive, Figs. 7 to 10 for roughing cuts and Figs. 11 to 13 for finishing cuts. Once more Carboloy-350 was the best grade of carbide as indicated in Figs. 8 and 9. Combining this experience with the variable speed tests of Fig. 7 led to the comparison plotted in Fig. 10 which shows that cutting speed for
