# MELLON INSTITUTE

## Annual Scientific Progress Report

## STRESS CORROSION OF HIGH STRENGTH STEELS AND ALLOYS: ARTIFICIAL ENVIRONMENT

Research Project No. 389-1

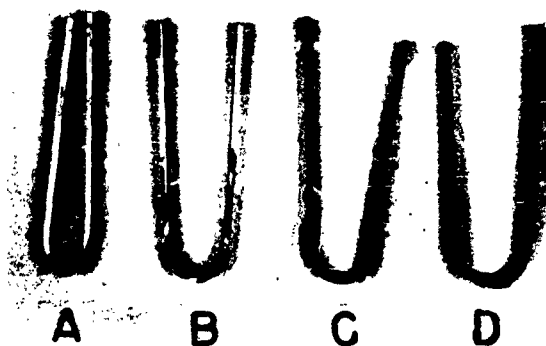
FIG. 13 U-BEND FRACTURE

Typical fracture types for the U-bent specimens are illustrated in Figure 13. Types

is close to the Y.S. and where the highest applied surface tensile stress

In addition to the probable existence of a threshold strength value, below which catastrophic stress corrosion failure may be non-existent (as discussed in the previous section of this report), observation of the U-bend specimens, in general, has shown that there is a definite incubation and a crack propagation time interval associated with failure of the samples. These effects were noted specifically for both the AM355 and the 4137 Co U-bend samples.

Immersion of the test samples for a period varying from a few hours to a number of days was followed by an audible "click" or "snap", which was, in turn, followed by audible failure of the specimen after a period of seconds to hours.

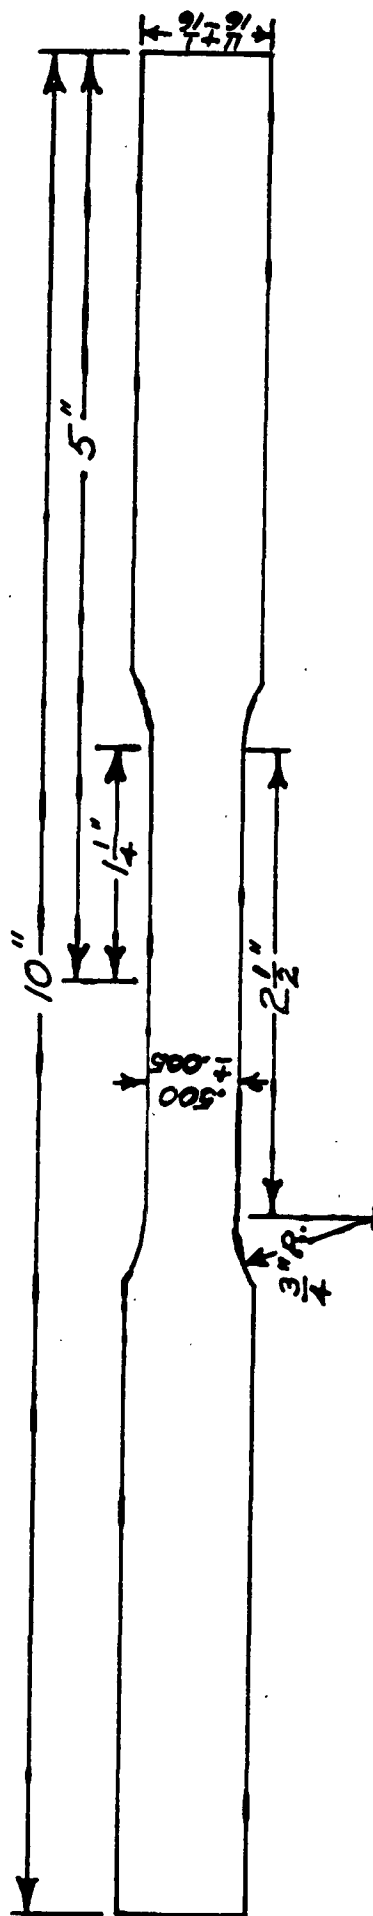
FIG. 1 FLAT TENSILE SPECIMEN

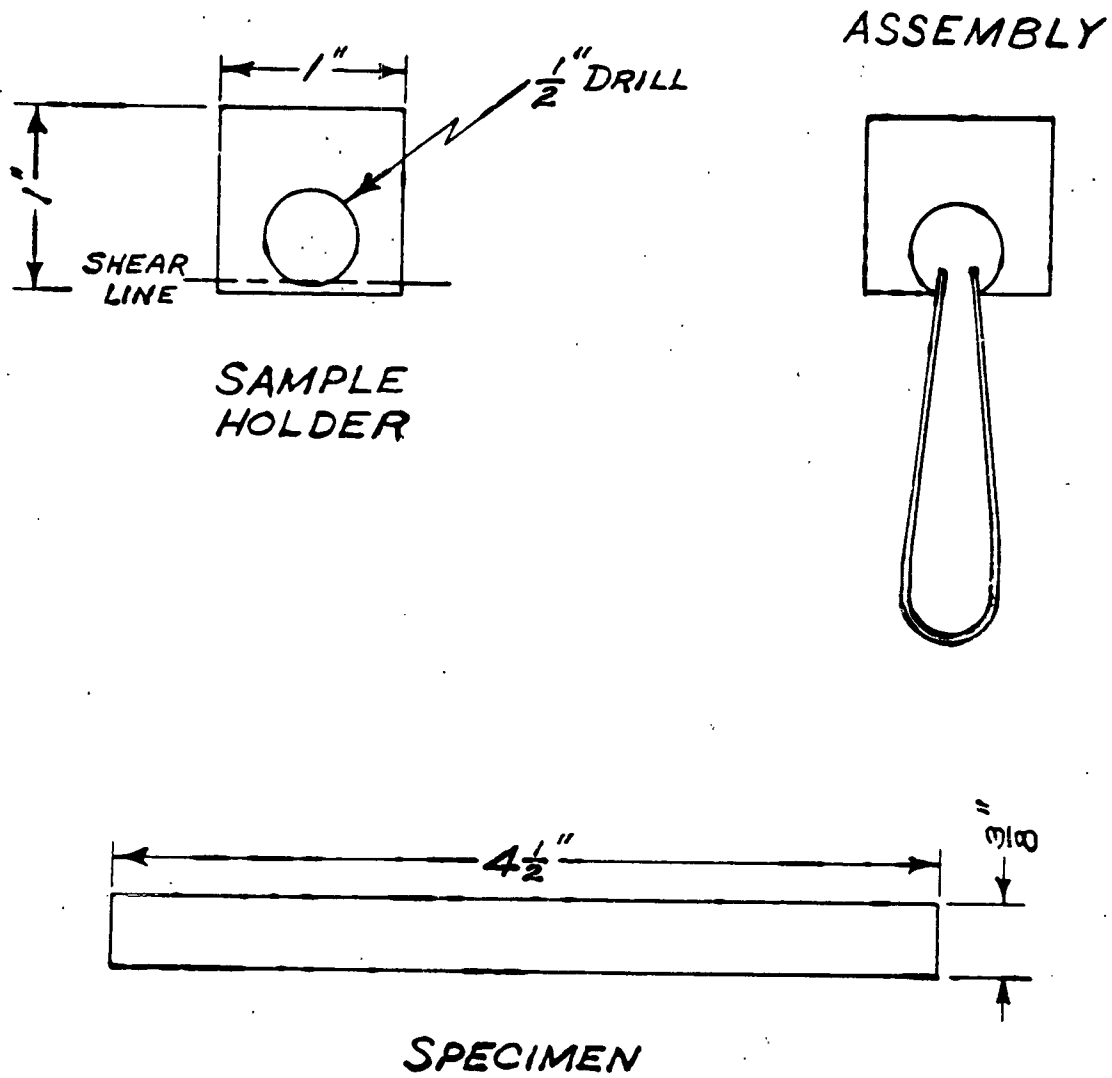
FIG. 2 THE U-BEND STRESS CORROSION SPECIMEN AND HOLDER

a. The U-Bend Test - The U-bend stress corrosion test utilizes a specimen and holder as illustrated in Figure 2. The test specimen is bent into a V-shape in a bending device and is sprung into a U-shape in a holder (of PVC material or the same material as the specimen). The bottom of the U is bent beyond the yield point and the area of greatest applied stress is that outer surface area immediately adjacent (on either side) to this.

This test method, known as the "quick-and-dirty" stress corrosion test, is capable of producing short term results that are not too consistently reproducible. It is not necessarily comparable with the bent beam test. However, the U-bend test will provide a general indication of a trend among steels, all other variables being equal.

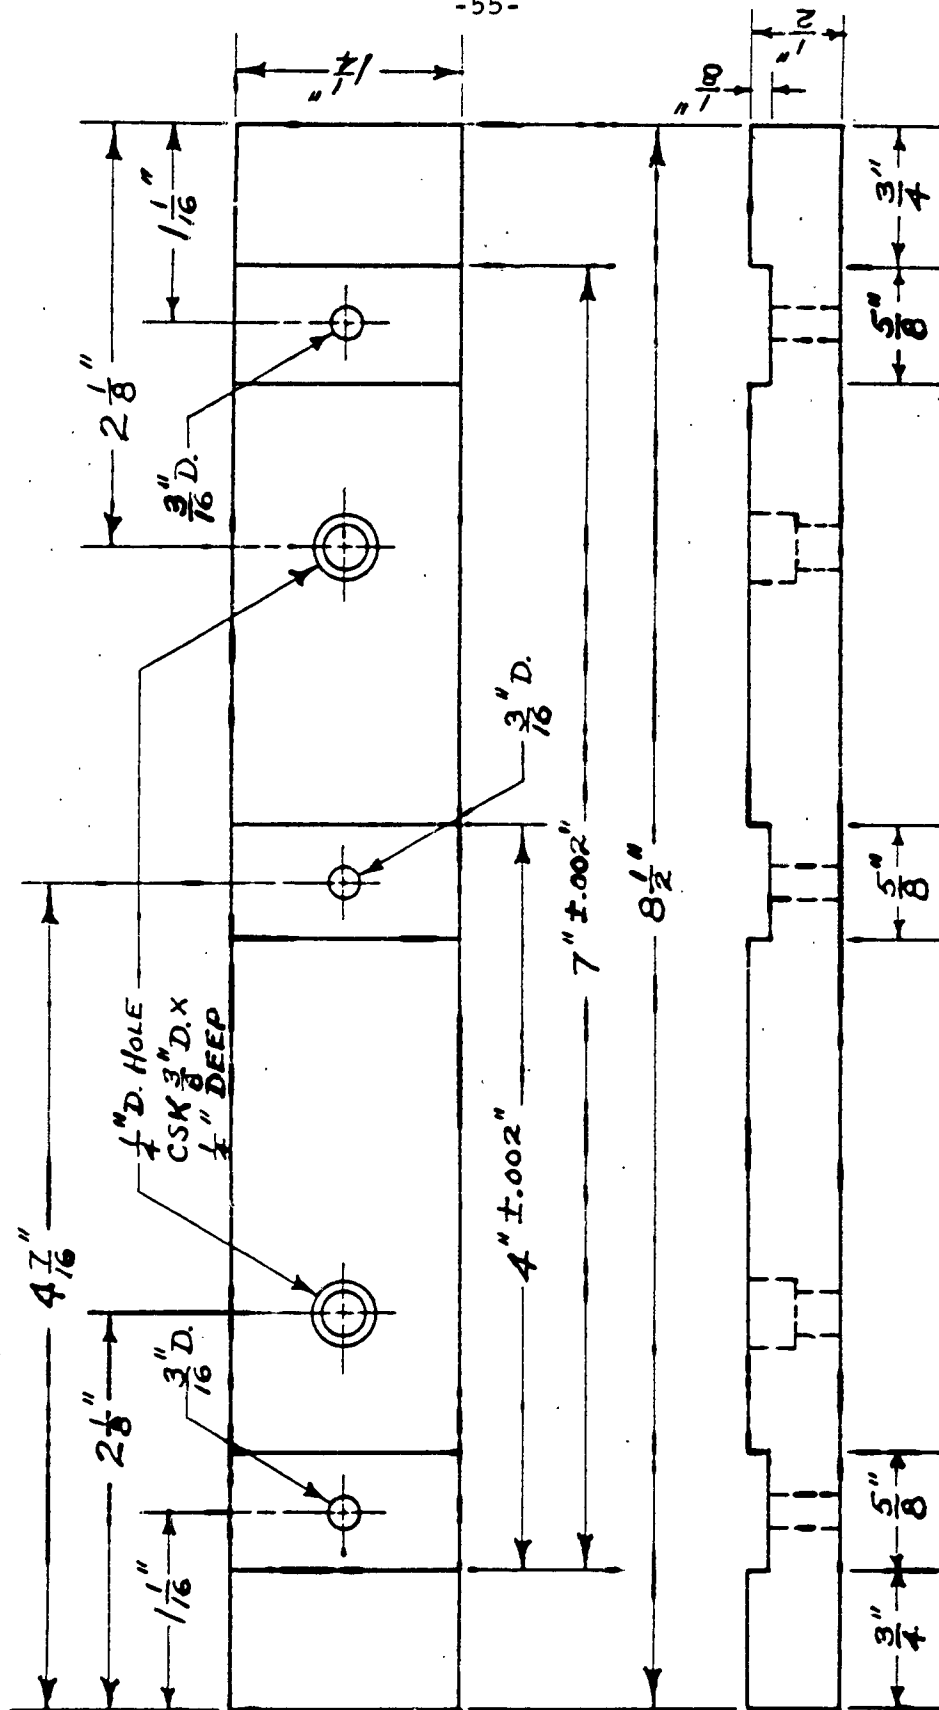
FIG. 3 SPECIMEN HOLDER FOR BENT BEAM SPECIMENS

b. The Bent Beam Test - The bent beam stress corrosion test utilizes a non-corrodable holder of the type illustrated in Figure 3. The material selected for this holder, polyvinylchloride (PVC), may be immersed in the test solution without introducing such variables as electrolytic or galvanic corrosion between sample and holder or chemical attack upon the holder by the test solution.

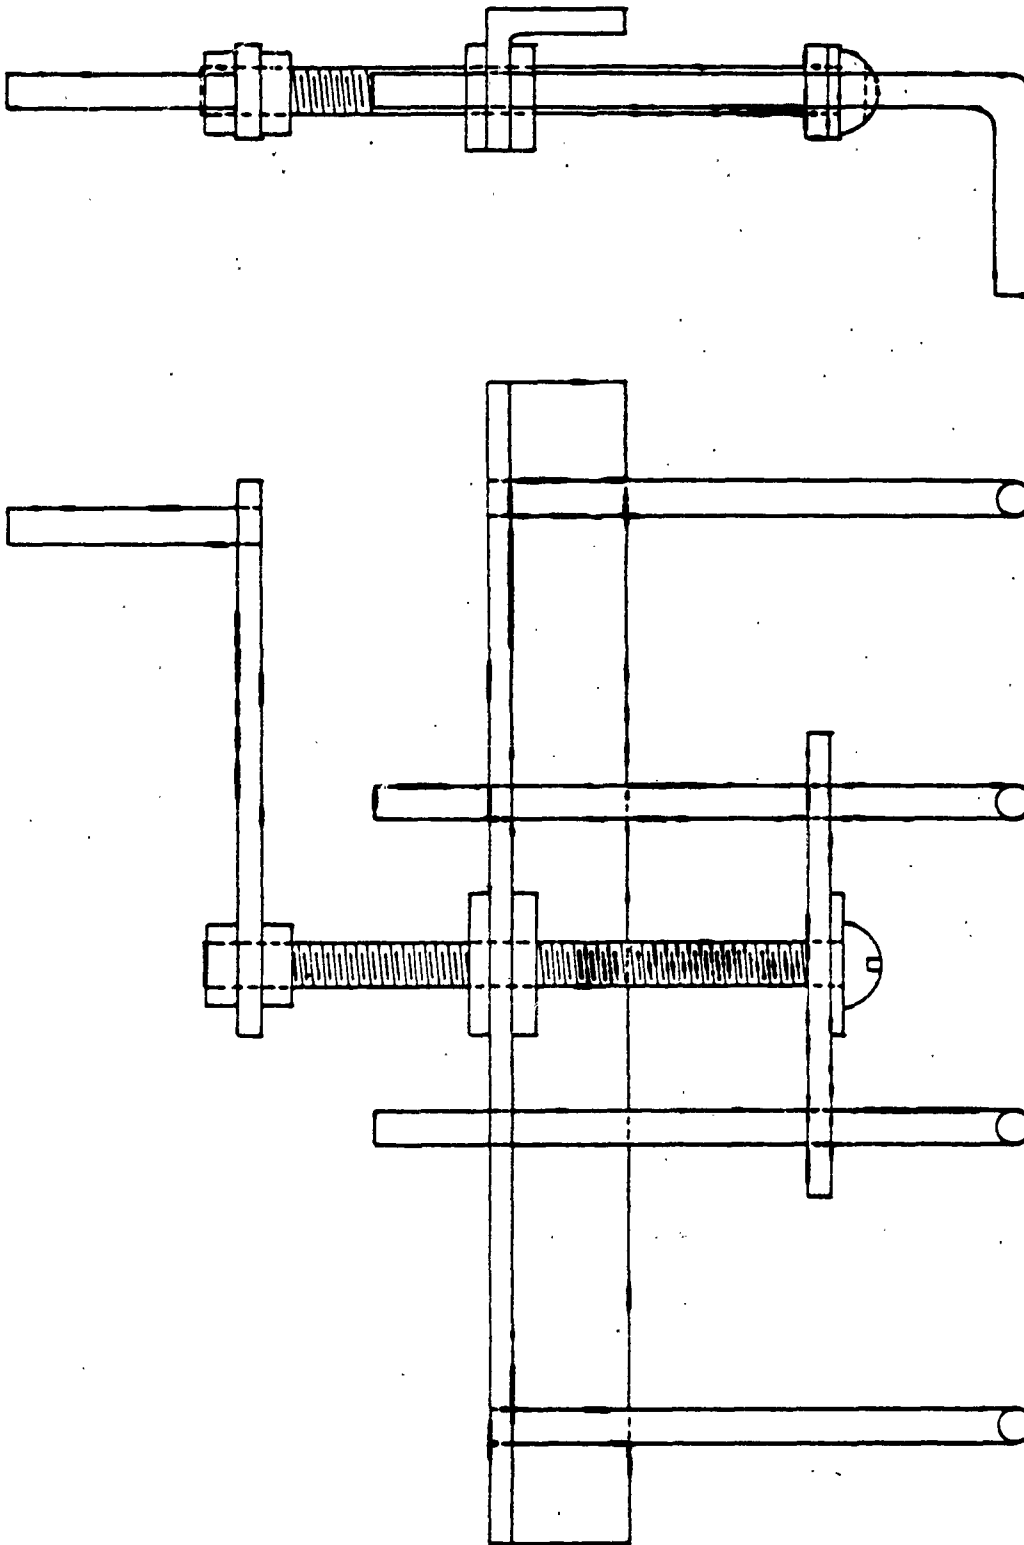
FIG. 4 SAMPLE BENDING DEVICE FOR BENT-BEAM STRESS CORROSION SPECIMENS

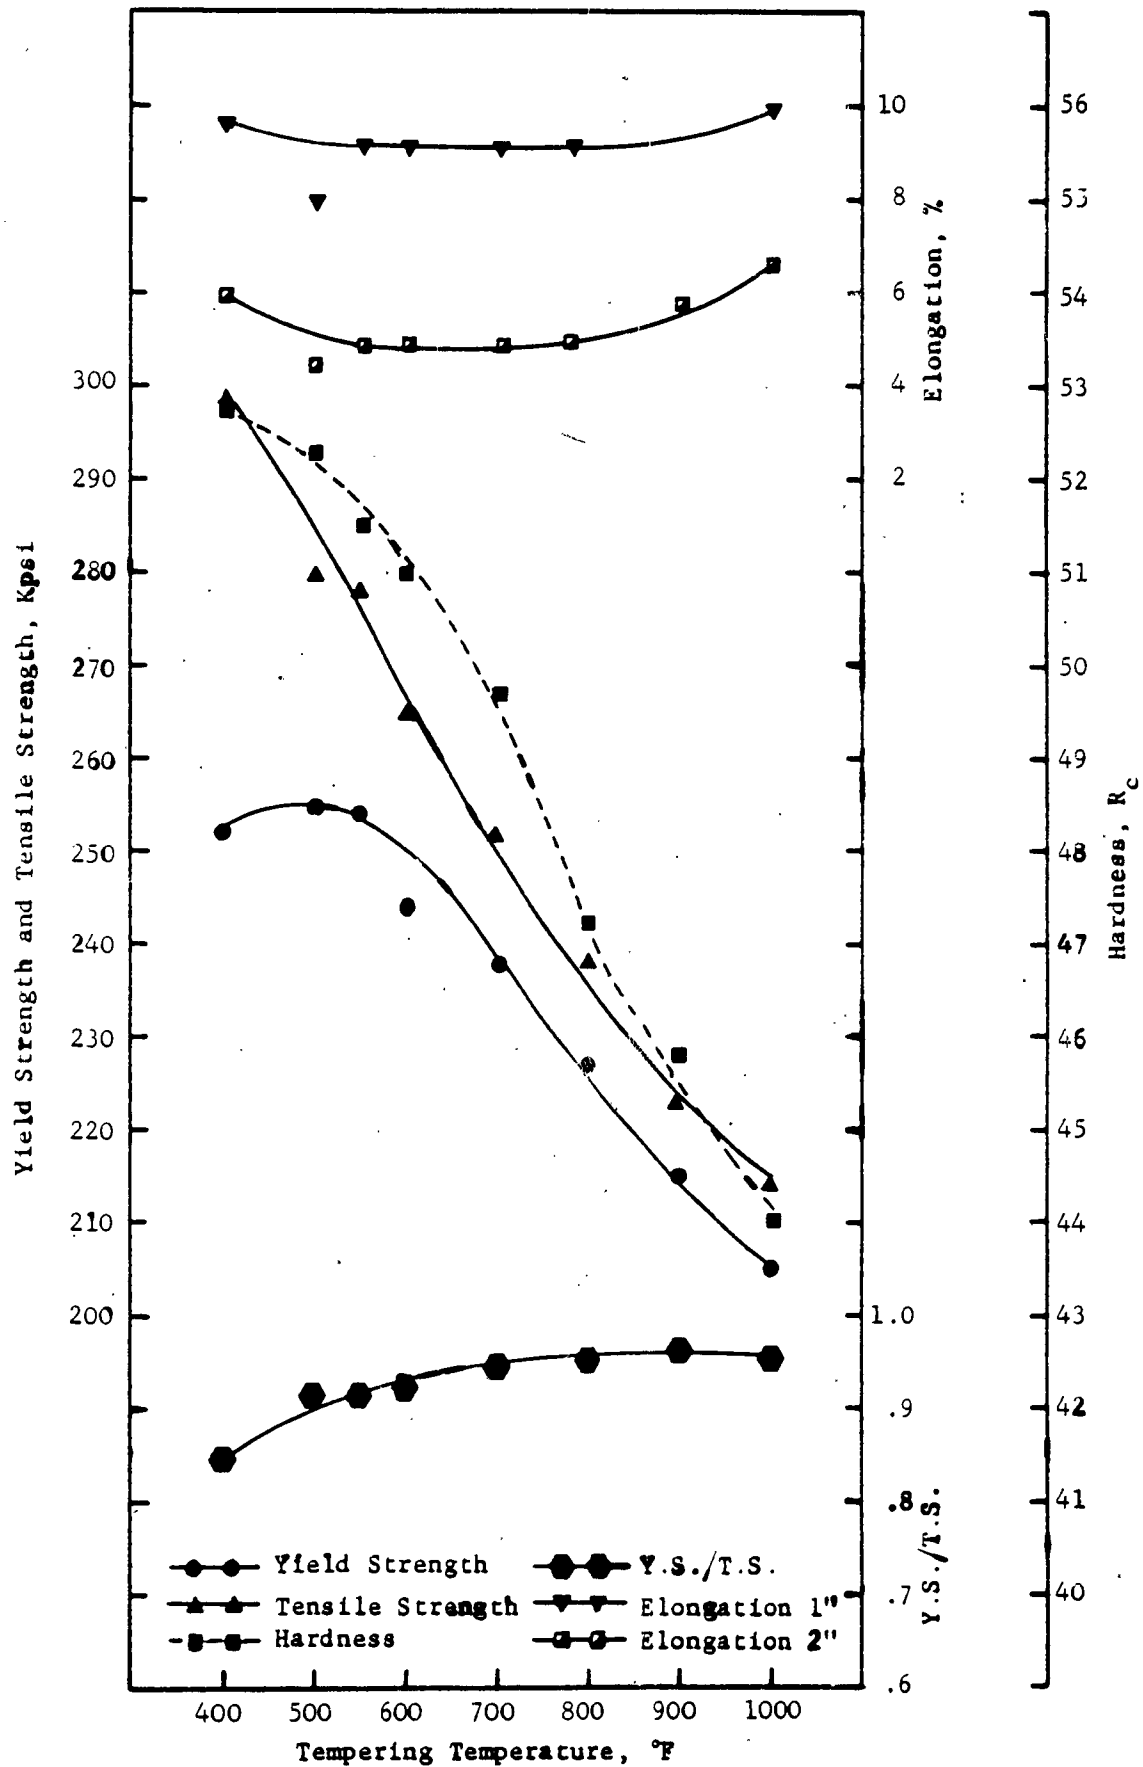
Fig. 5 Heat Treating Survey; D6Ac; Primary Direction

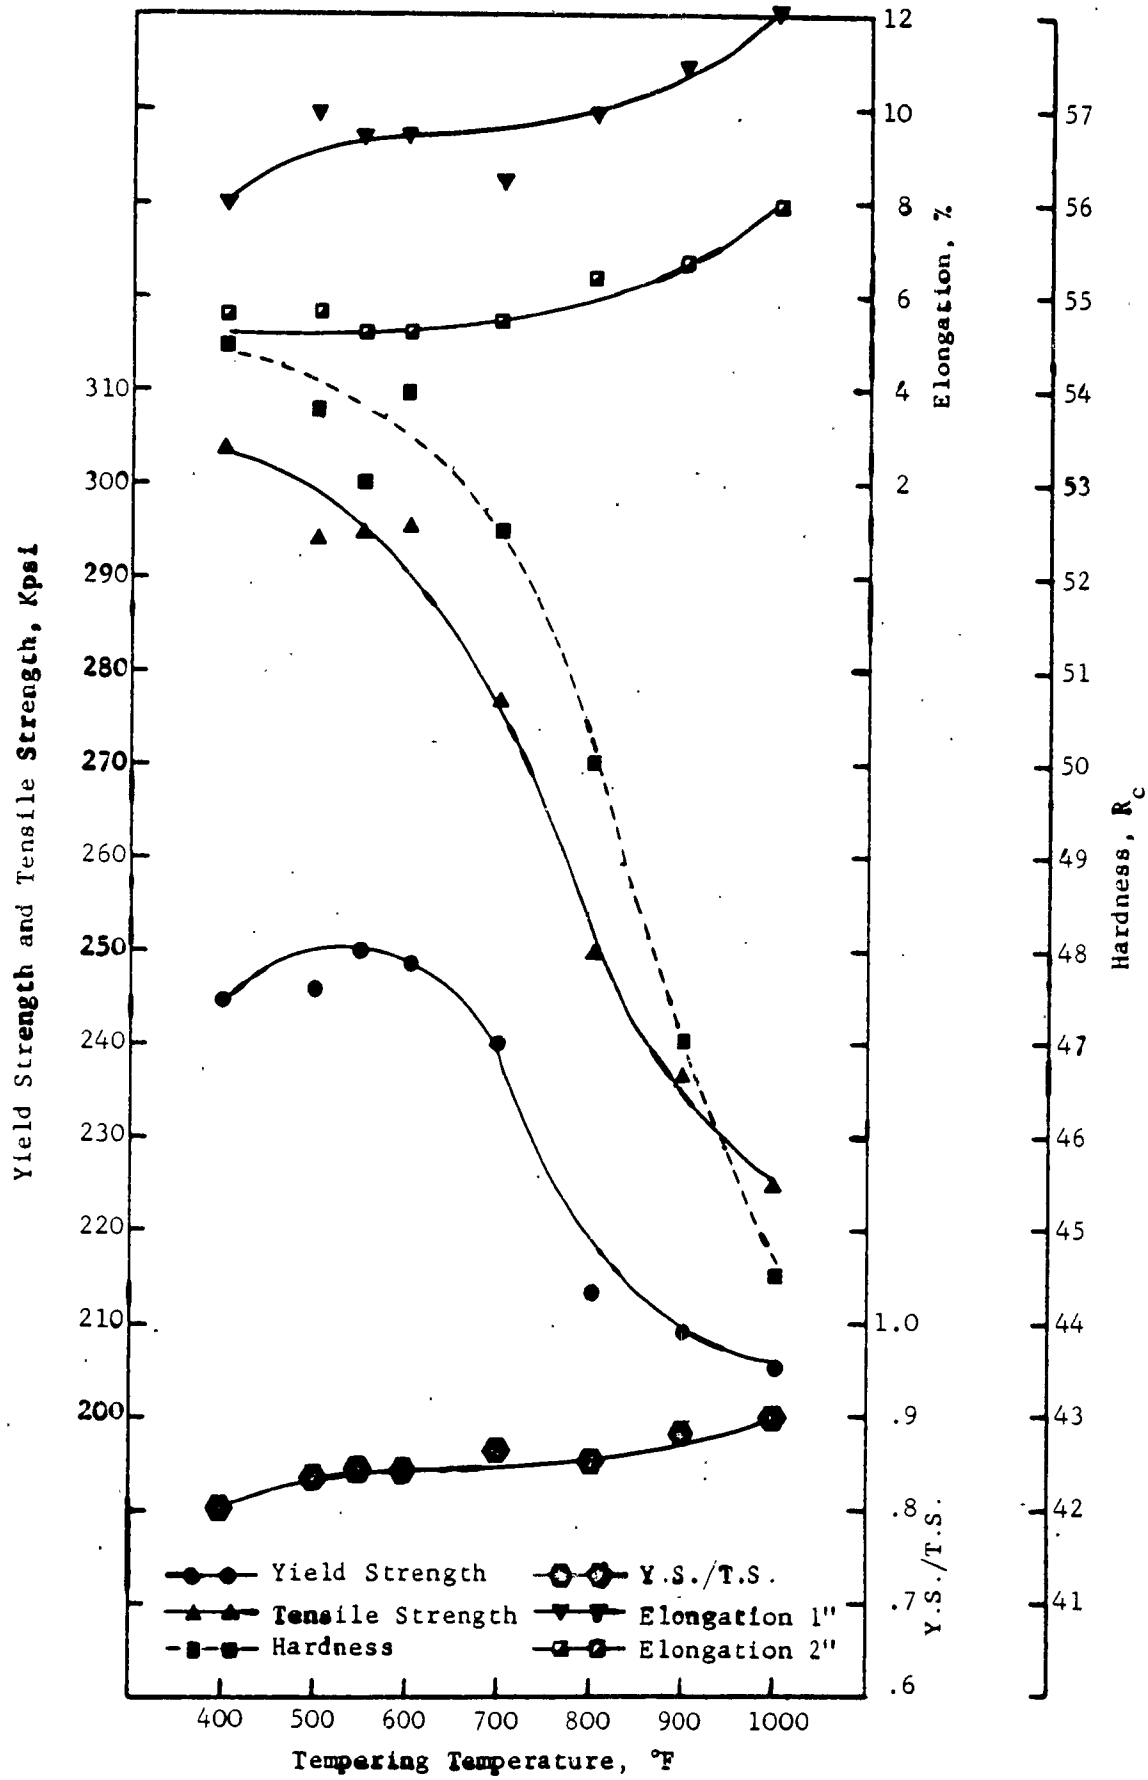
Fig. 6 Heat Treating Survey; 300M; Primary Direction

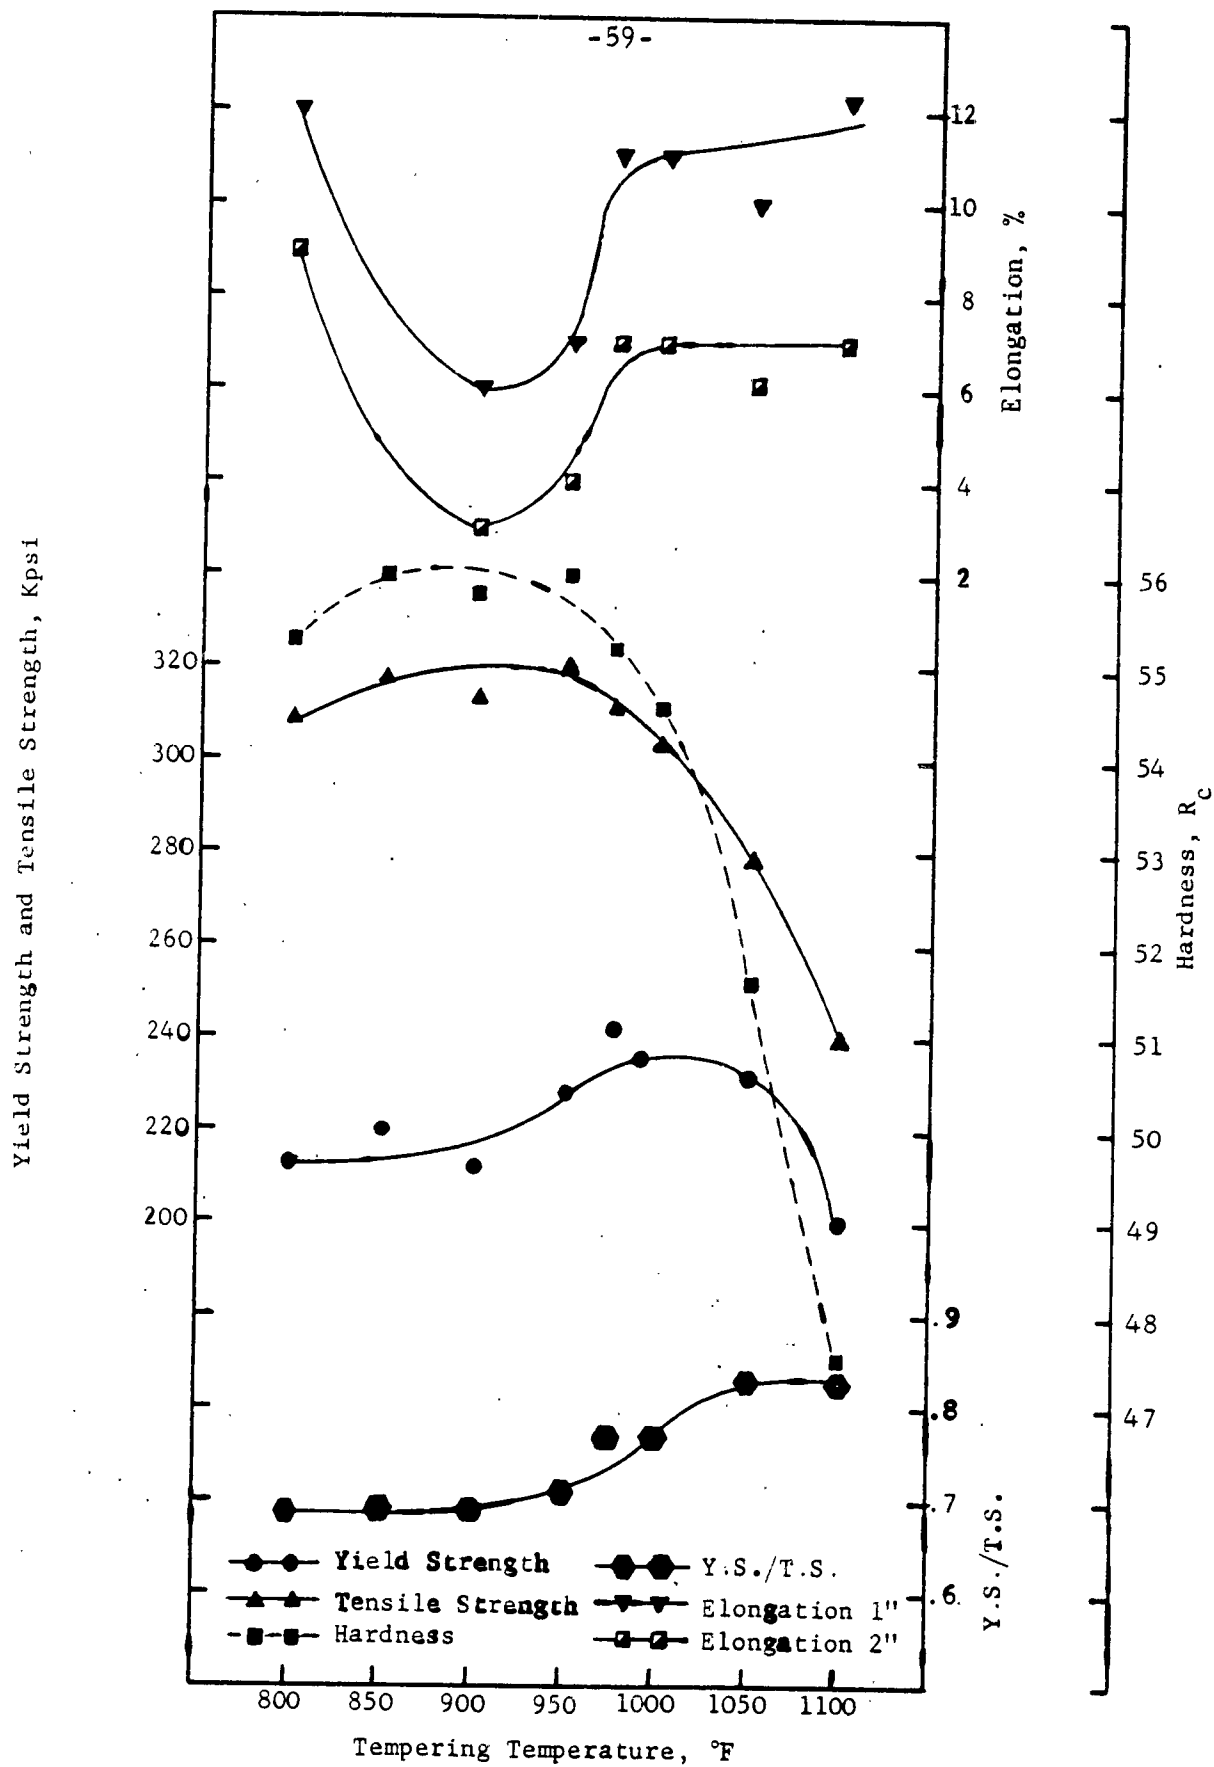
Fig. 7 Vascojet Heat Treatment Survey

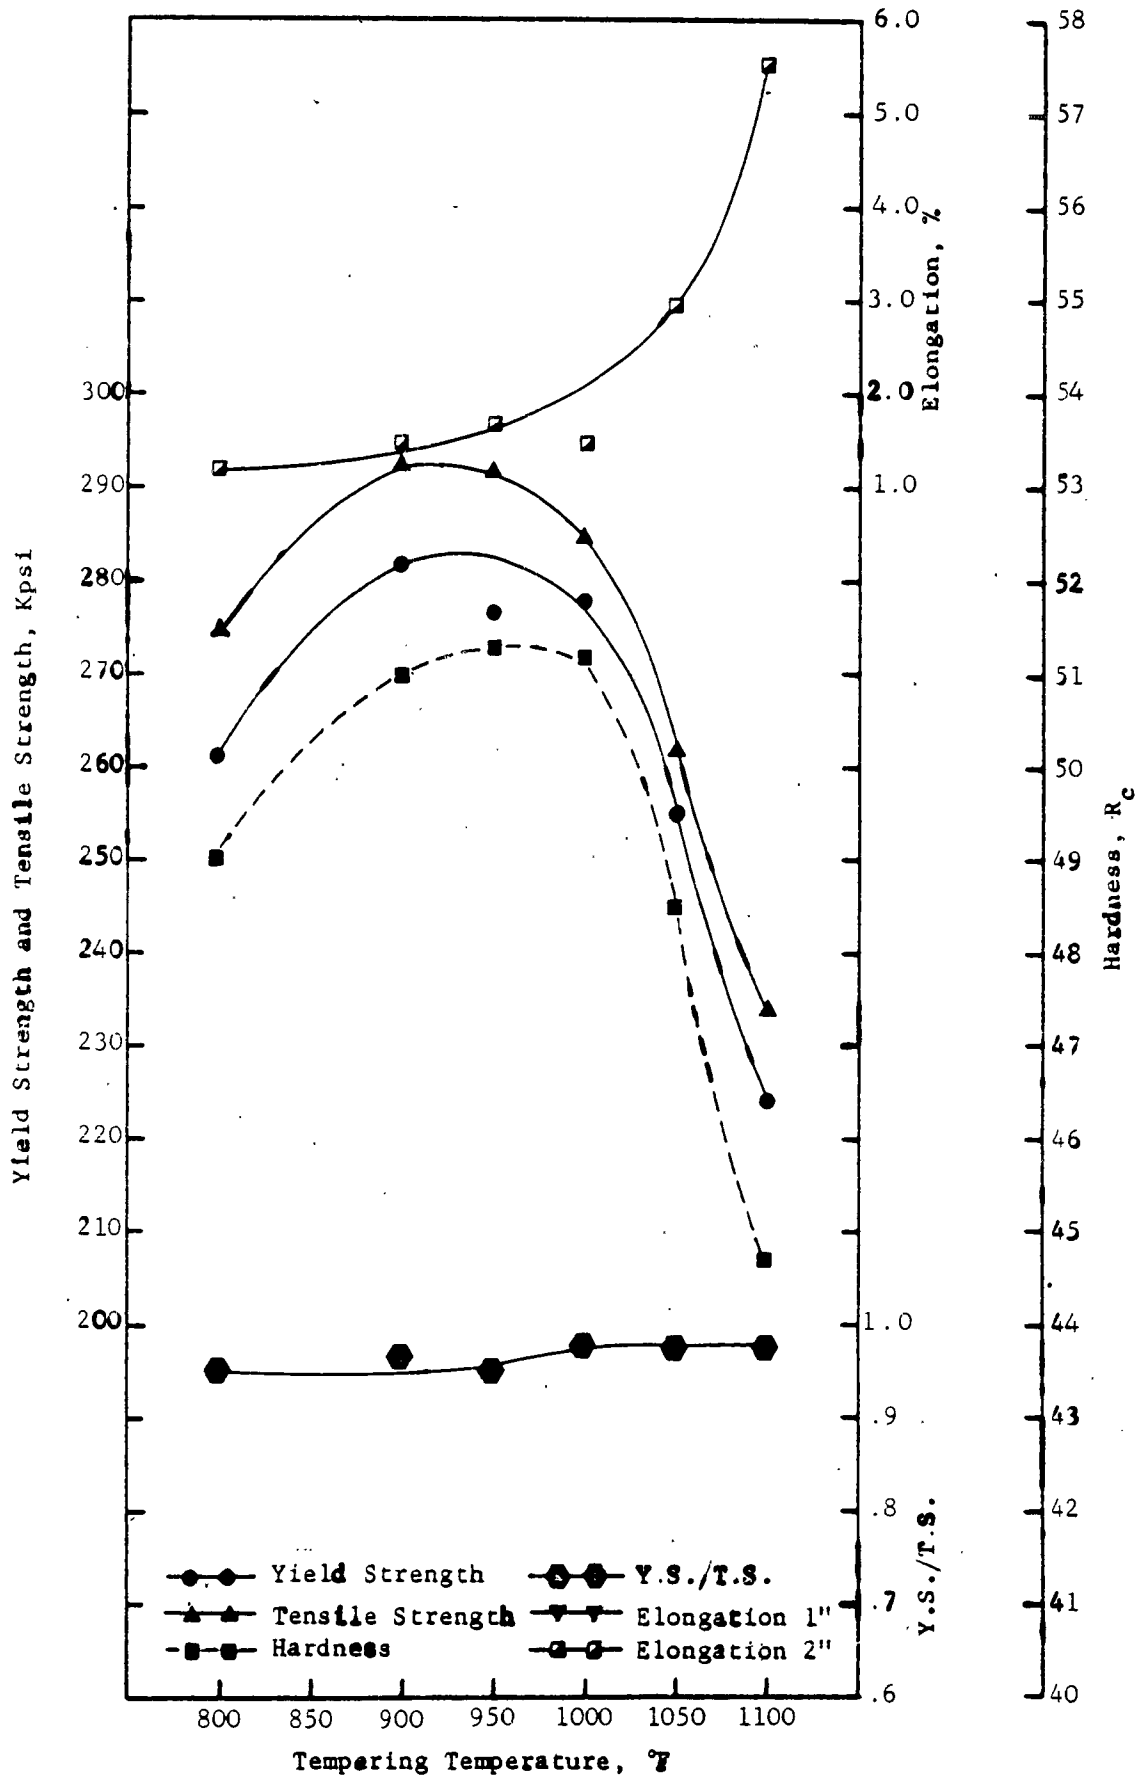
Fig. 8A Heat Treating Survey; PH15-7 Mo; Primary Direction

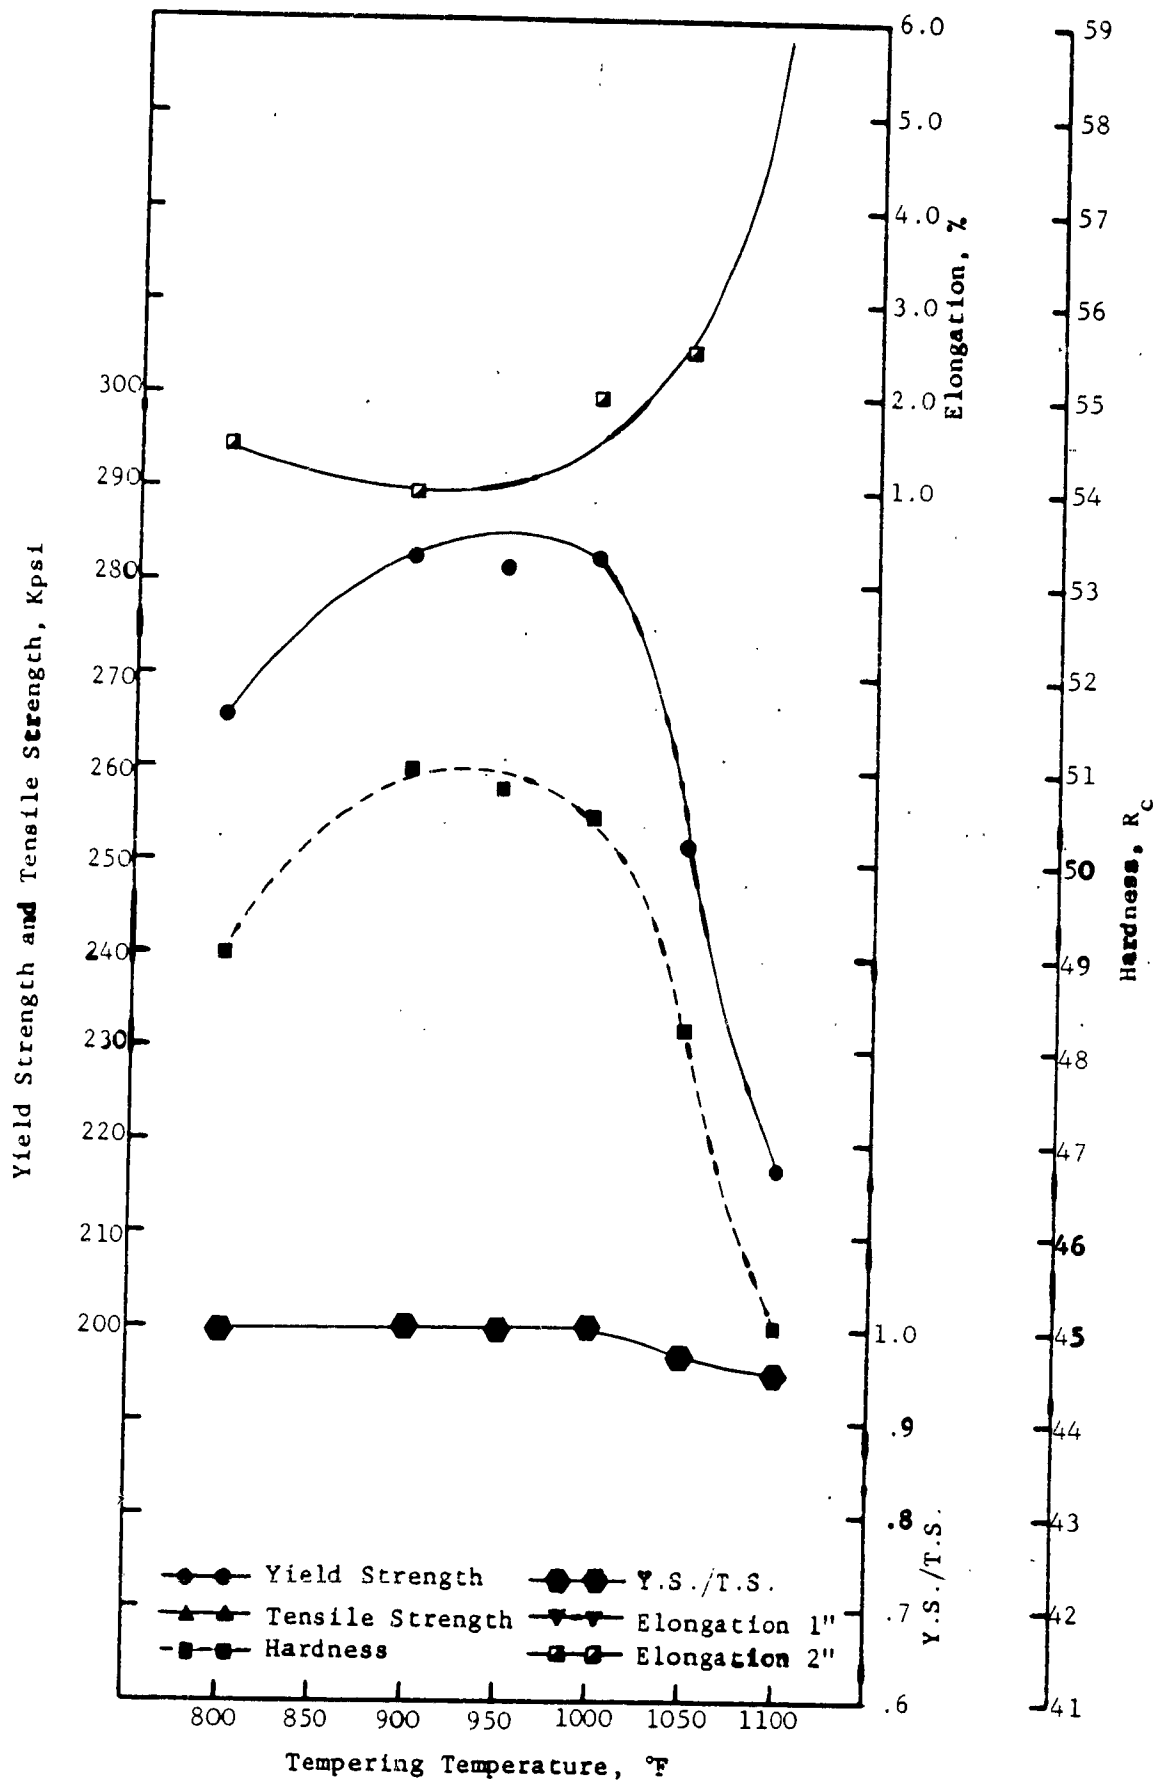
Fig. 8B Heat Treating Survey; PH15-7 Mo; Secondary Direction  
 Note: Tensile Curve Not Shown; Closely Duplicates Y.S. Curve

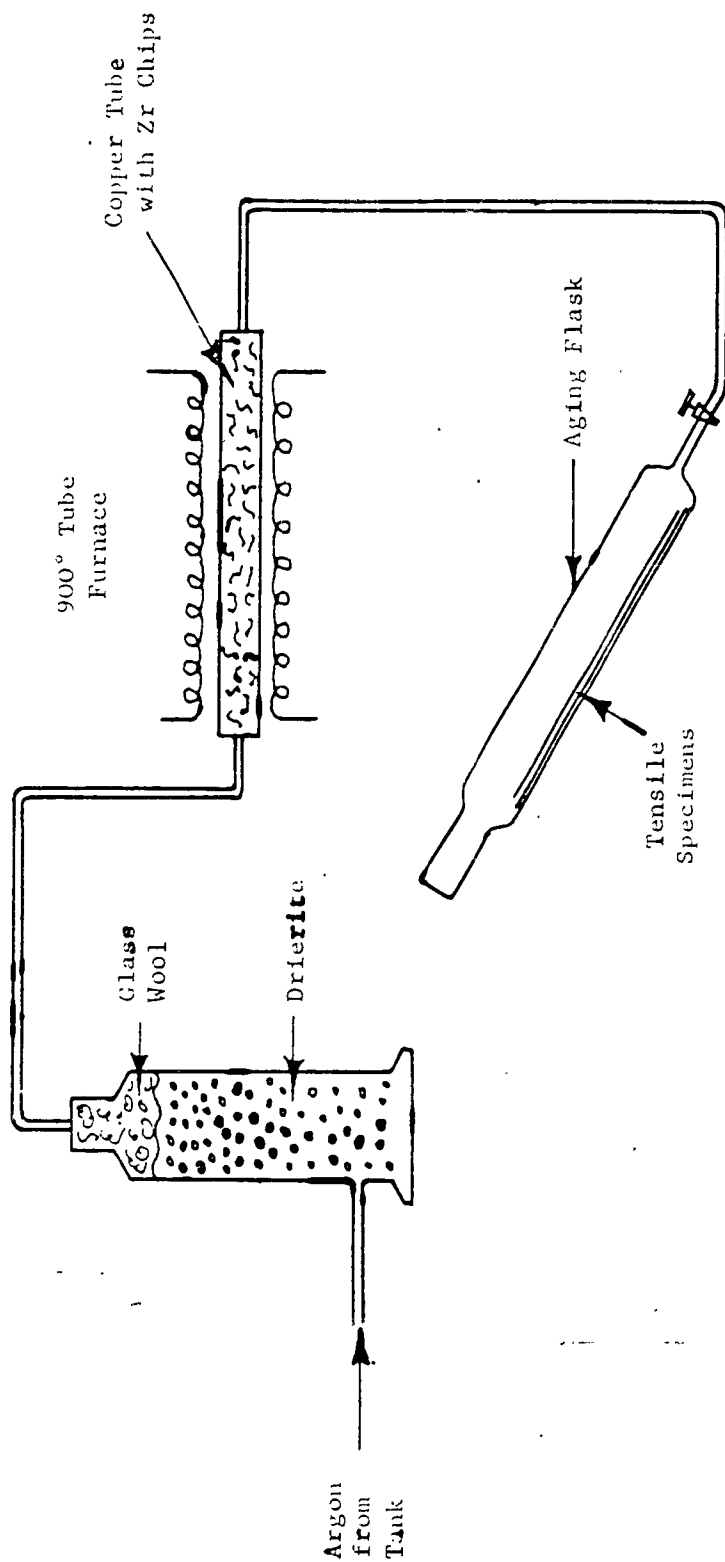
FIG. 9 SCHEMATIC DIAGRAM OF SYSTEM FOR ARGON CHARGING OF AGING FLASKS

f. Titanium Alloy; B120VCA - The high strength titanium vacuum-melted alloy sheet material was received in the solution-treated condition ready for aging. Heat treatment of this alloy required total absence of fingerprints on the sheet surface and an inert atmosphere

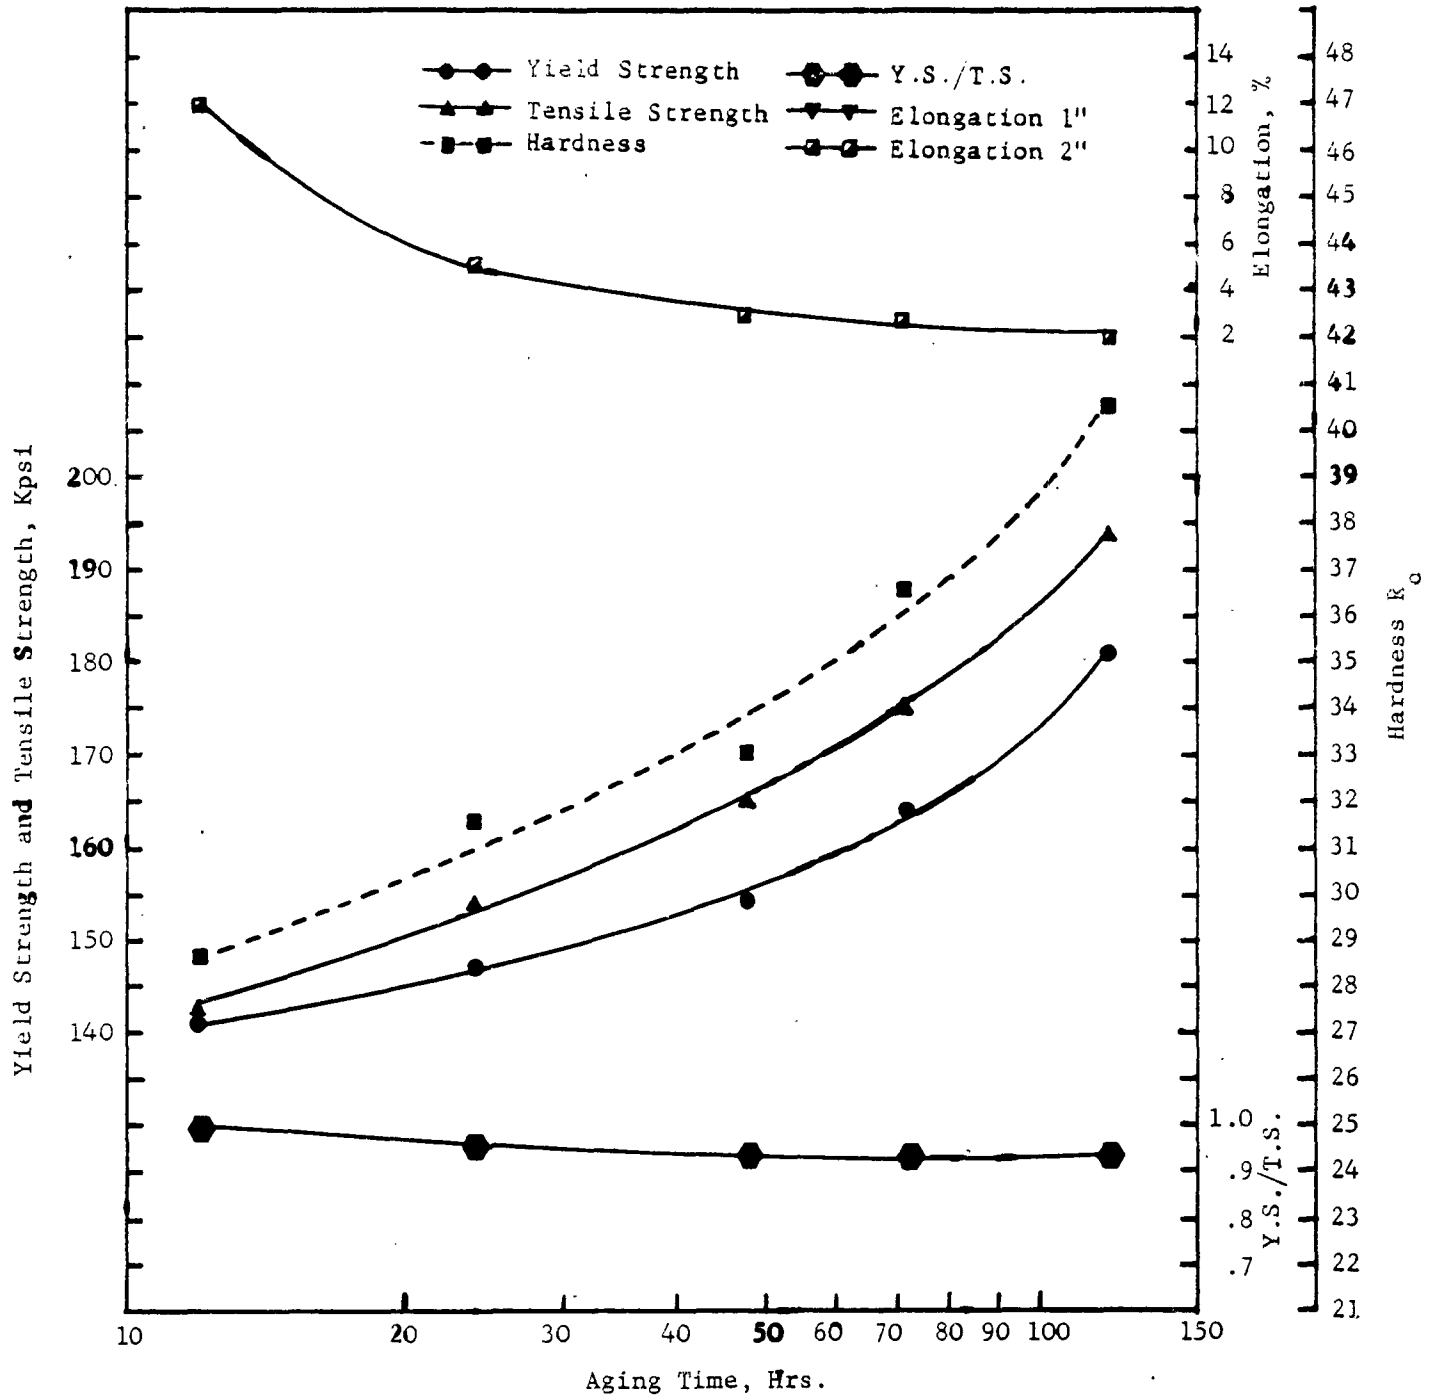
Fig. 10 Heat Treating Survey; B120VCA; Primary Direction

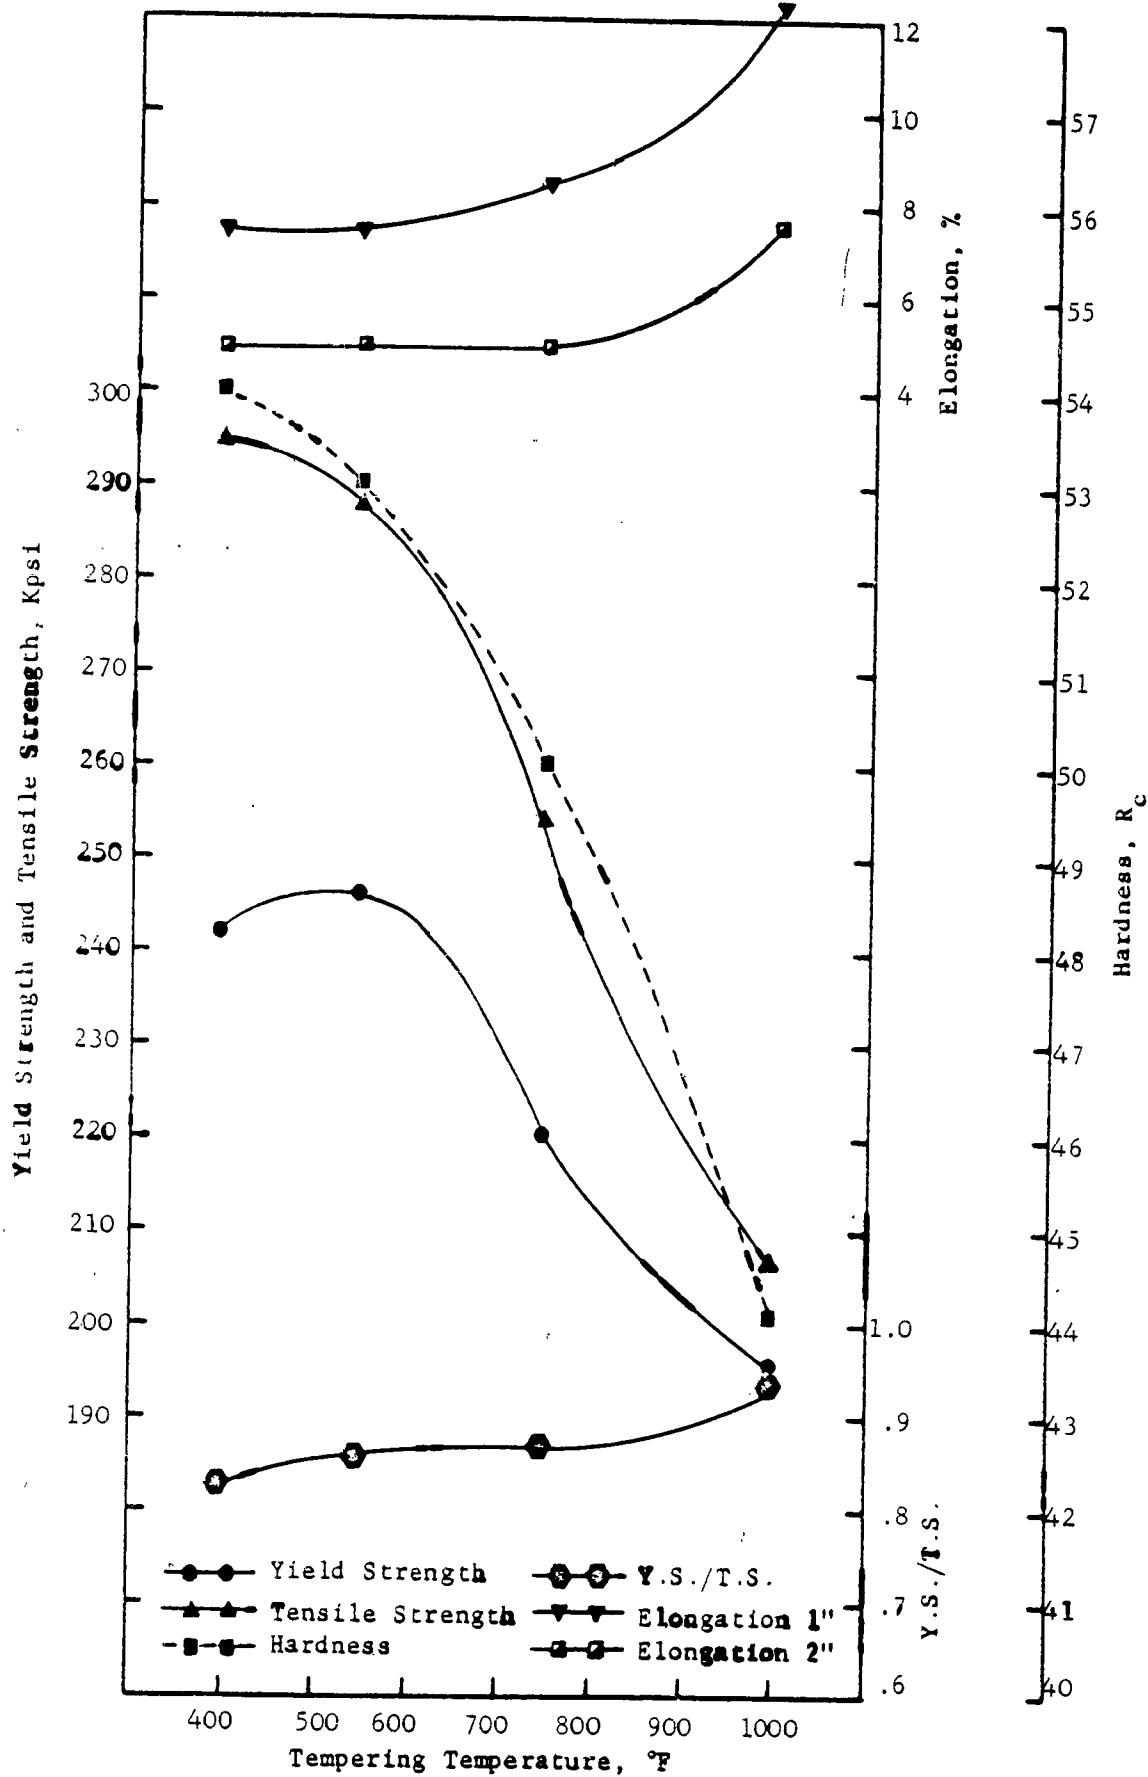
Fig. 11 Heat Treating Survey, 4137 Co; Primary Direction
