# MELLON INSTITUTE

## Annual Scientific Progress Report

## STRESS CORROSION OF HIGH STRENGTH STEELS AND ALLOYS: ARTIFICIAL ENVIRONMENT

Research Project No. 389-1

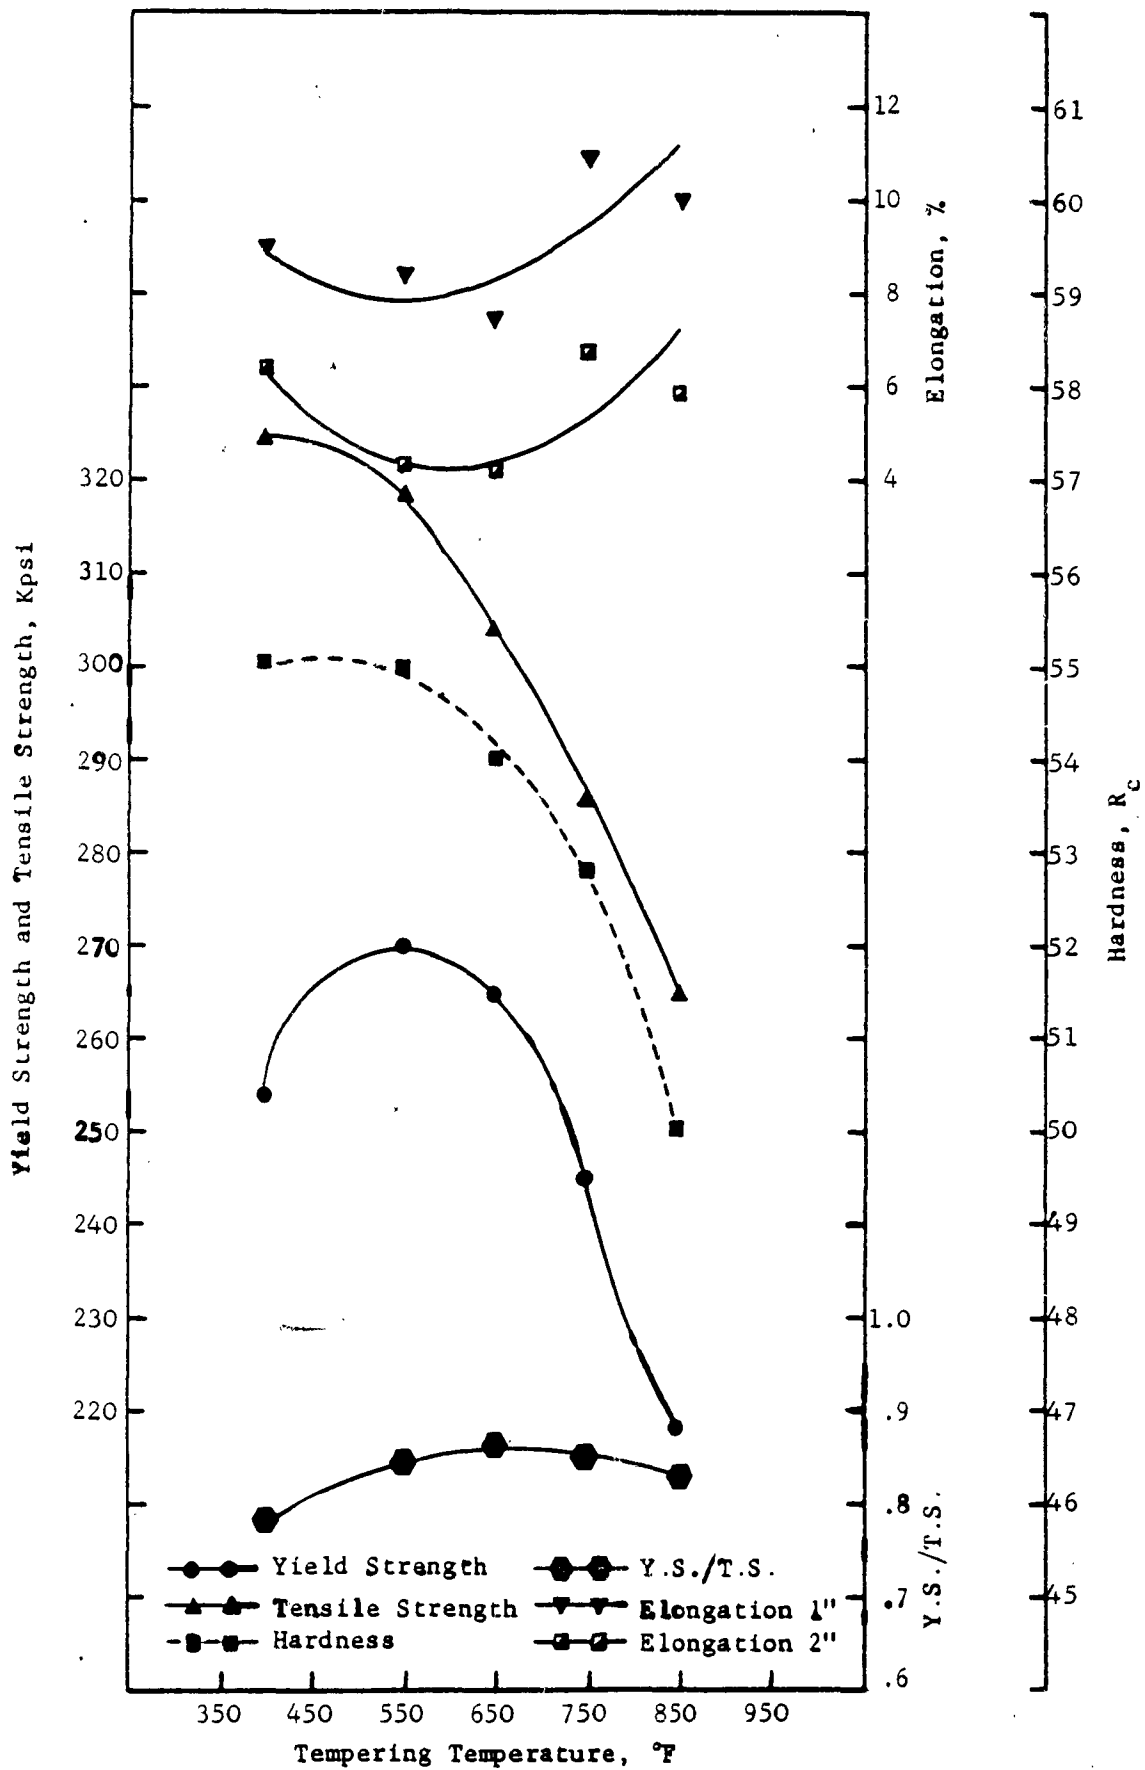
Fig. 12 Heat Treating Survey; R270; Primary Direction
