UNITED STATES ARMY TRANSPORTATION BOARD  
Fort Eustis, Virginia

FINAL REPORT

PROJECT LEAD DOG 60

A TRAVERSE OF NORTH GREENLAND AND AN  
AERIAL AND SURFACE EXPLORATION OF  
PEARY LAND AND CROWN PRINCE CHRISTIAN  
LAND CONDUCTED BY THE US ARMY TRANS-  
PORTATION CORPS MAY-JULY 1960

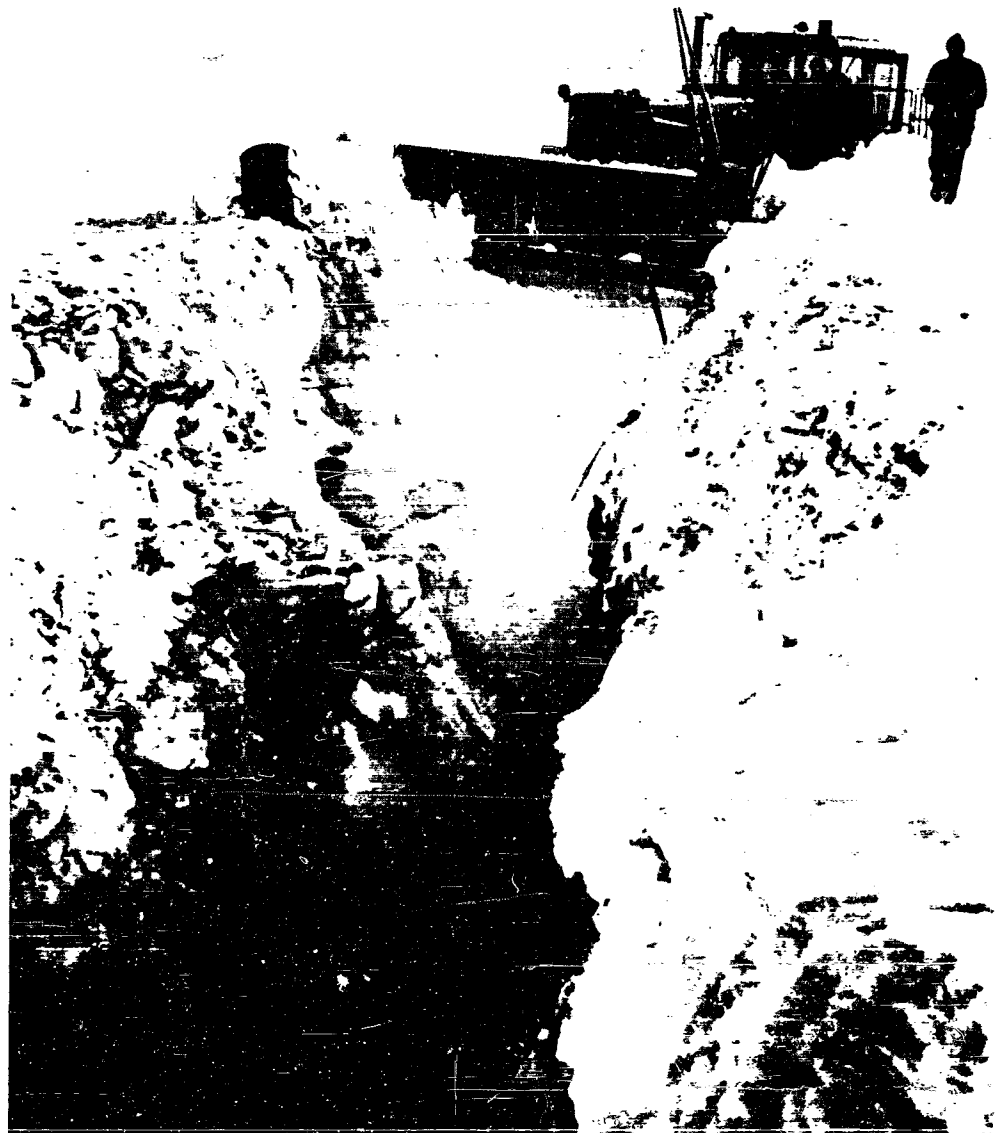
Figure 20. D8 tractor fills open crevasse at Mile 12.

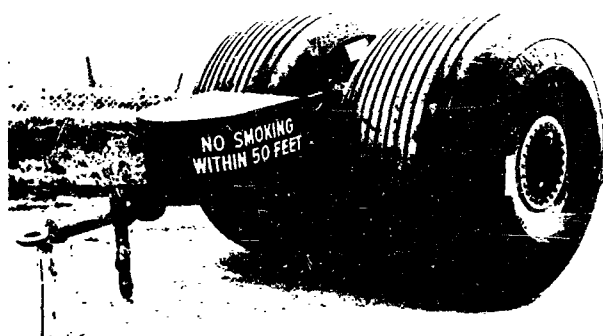
TRANSPORTER, LIQUID, ROLLING WHEEL TYPE,  
1000 GALLON, T-3

Note: All dimensions shown are in inches.

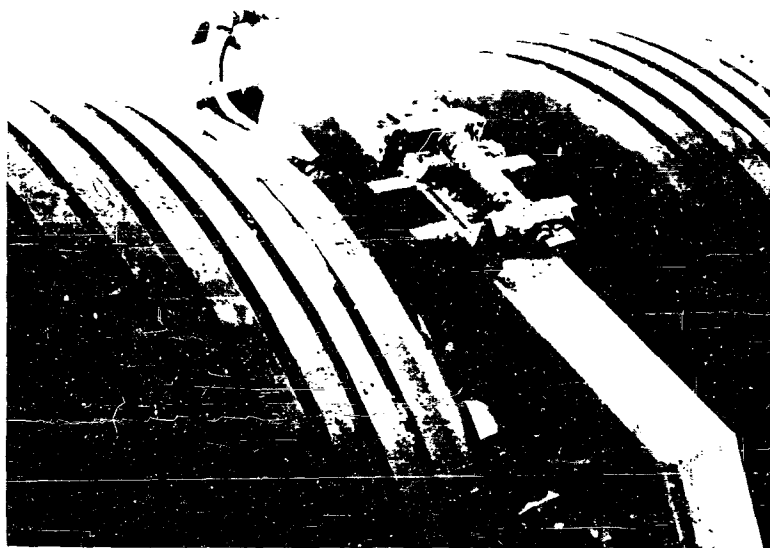
Figure 32. Failure to Rolli-Trailer goose neck occurred at Mile 231 on the return trip.

The goose neck on the Rolli-Trailer failed at Mile 231 and the trailer bed and its RLTs were loaded on a sled.
