# REPORT OF ENVIRONMENTAL OPERATION

TCB-61-045-EO

WILLOW FREEZE

UNITED STATES ARMY TRANSPORTATION BOARD

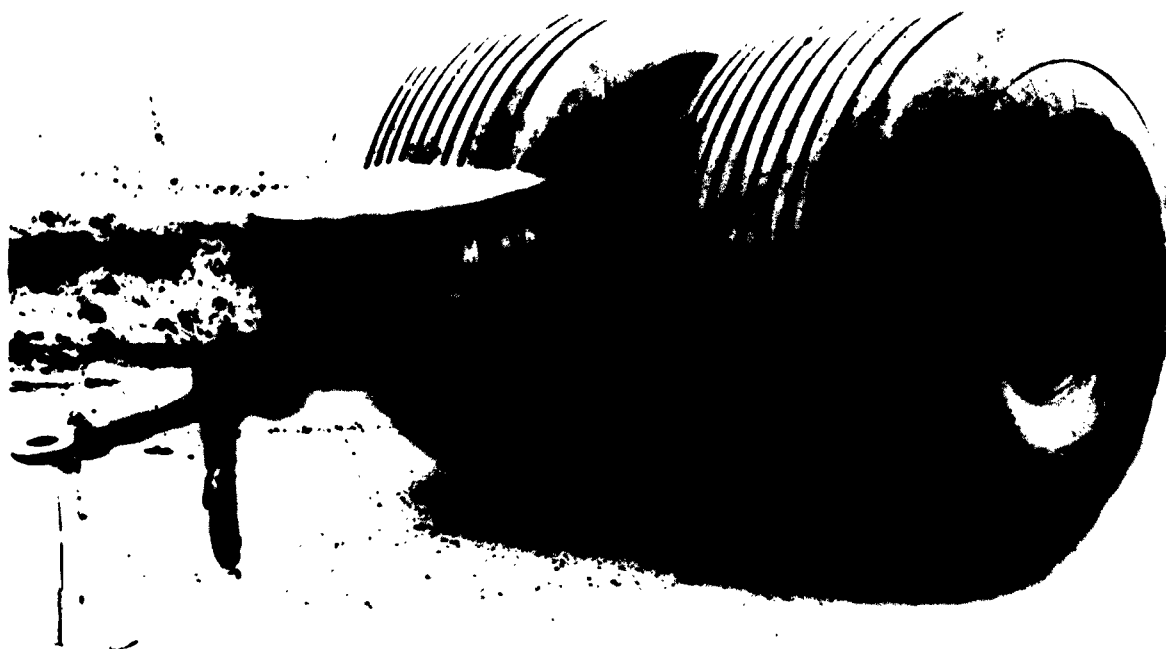
**Figure 5. Rolling Liquid Transporter, M1.**

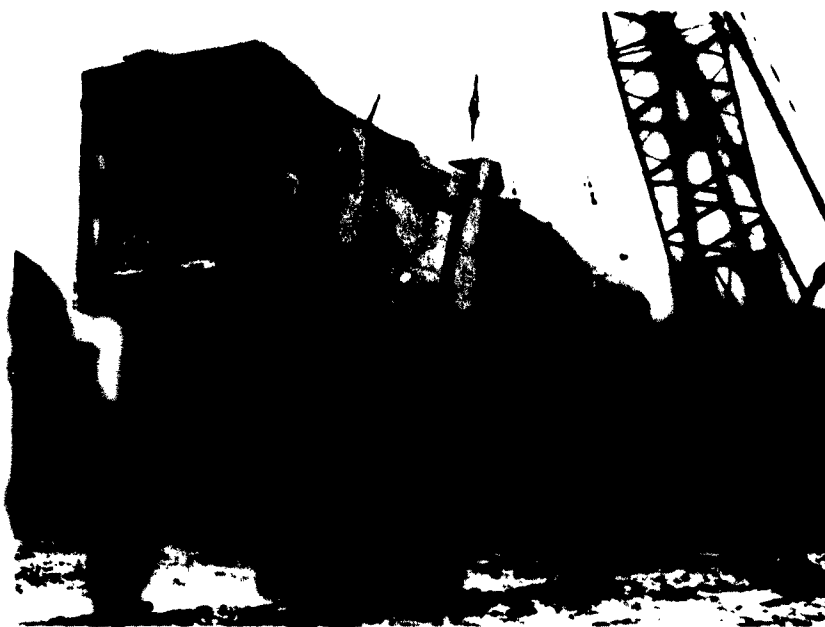
**Figure 10. Placing power car on cribbing, using 50-ton crane .**

Despite the difficult working conditions, the train was unloaded and assembled in 221 man-hours. Previously working under ideal conditions this same operation had required 200 man-hours. This 221 man-hours included 19 hours of forklift operation and 12 hours of crane operation.

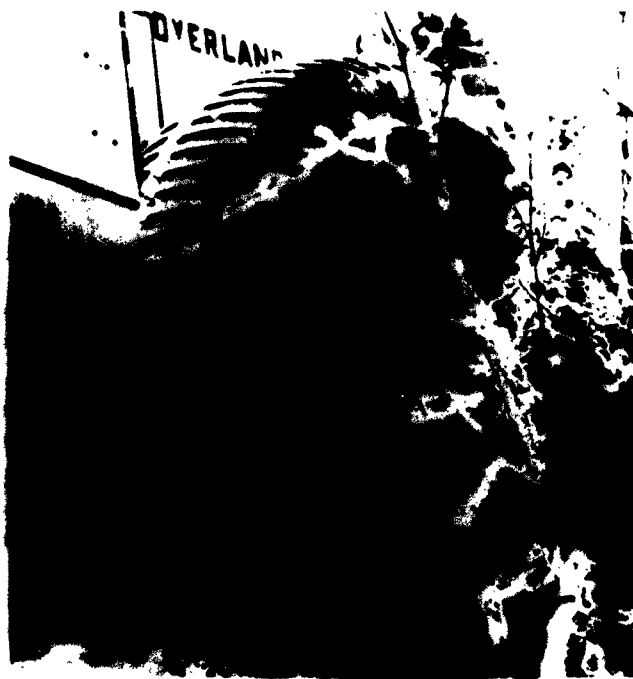
**Figure 14. Power car pushing over scrub trees.**

(b) Bumper. The bumper is not designed so as to adequately protect the front wheels from being damaged by underbrush. The bumper should extend beyond the front wheels to prevent trees that are pushed over from falling against the front section of the power car or between the wheels and the side of the power car. The bumper should also extend downward far enough to break off small brush and stumps evenly with the ground to help prevent tire punctures.

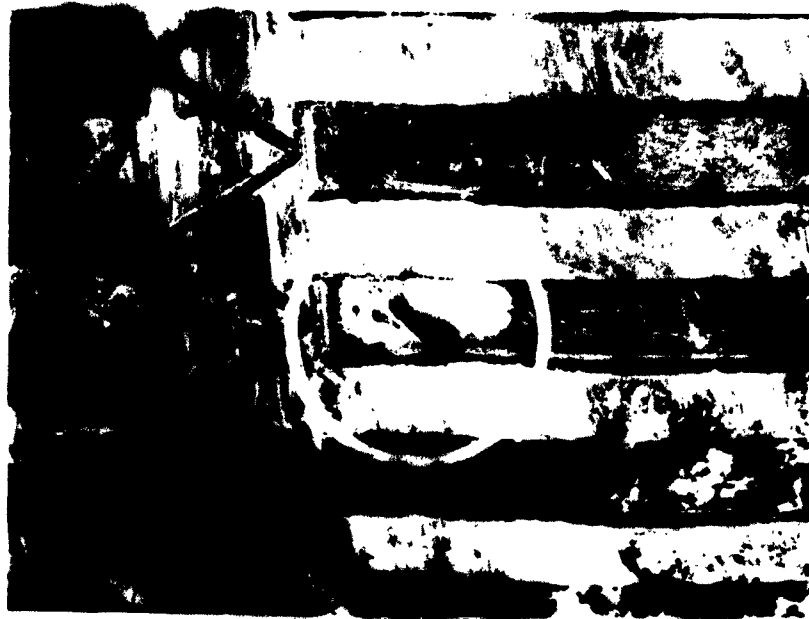
(1) Punctured tires. The train moved along the tractor trace for approximately 3 miles before the two tires on the right side of the power car were punctured simultaneously. The right front tire was punctured by a stump of undetermined size; the right rear tire was punctured by a sharp piece of frozen birch, about 2 inches in diameter, which completely penetrated the tire. The right front tire was severely damaged by the puncture, an 8-inch break developed all the way through the tire; this puncture made it necessary to change the right front wheel assembly. (A wheel assembly consists of a rim and tire.) Although the frozen birch stump completely penetrated the right rear tire, the hole in the tire was small and could have been repaired temporarily if a tire repair kit had been available. Lack of a tire repair kit necessitated changing the rear wheel assembly too.

**Figure 17. Tire damaged by tree stump.**

Tools, spare wheel assemblies, and other equipment required to make the repair were transported to the train from the GSB by another test vehicle (Wagner 4-Track Transporter). Since there is no lifting device on the front of the train to facilitate changing the front wheel assembly (2,322 pounds) in the field, a field expedient was devised. A second trip was made to the GSB by the Wagner 4-Track Transporter to get a 6,000-pound forklift to lift the front of the power car. This field expedient is explained below.

(2) Changing wheel assemblies. Changing the rear wheel assembly was not difficult and was accomplished in approximately 3 hours. A 20-ton railroad jack was used to lift the rear wheel assembly. The jib crane installed on the rear section of the power car was used to remove the wheel assembly with the punctured tire and also to mount a spare wheel assembly.

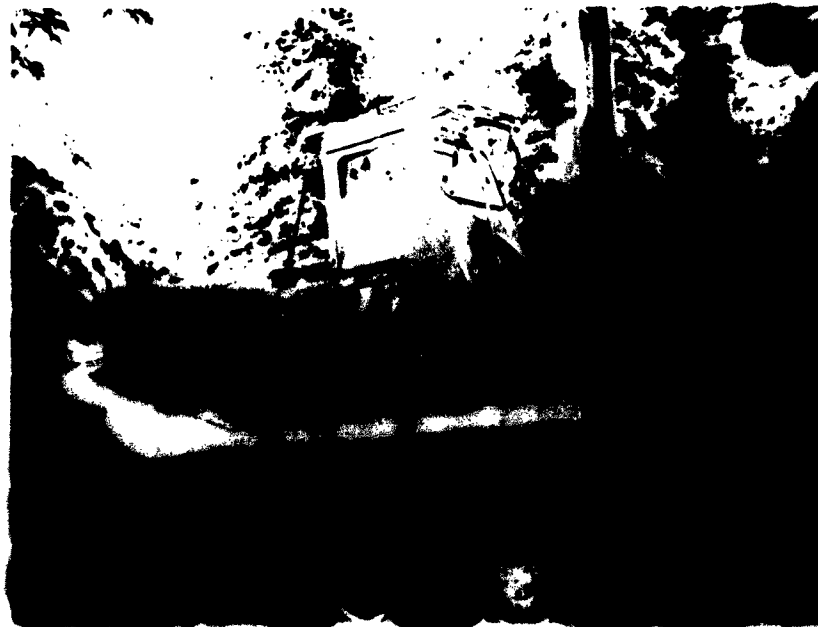
Changing the right front wheel assembly proved to be quite difficult. Facing aft, the 6,000-pound forklift was secured to the trailer bed of the Wagner 4-Track Transporter with chains, and cables were attached to the forks (fig. 19). The right front axle of the power car was

Figure 19. Forklift secured on Wagner Transporter.

raised by using a 20-ton railroad jack. The Wagner 4-Track Transporter was positioned so as to place the forks immediately above the wheel assembly. The wheel assembly was secured to the forks with a sling. With the lift capability of the forklift and a backward and forward movement of the Wagner 4-Track Transporter, the wheel was removed from the hub. The spare wheel assembly was put on the hub by following basically the same procedure as just described. It took 8 hours to make this repair. The temperature averaged -20° F.

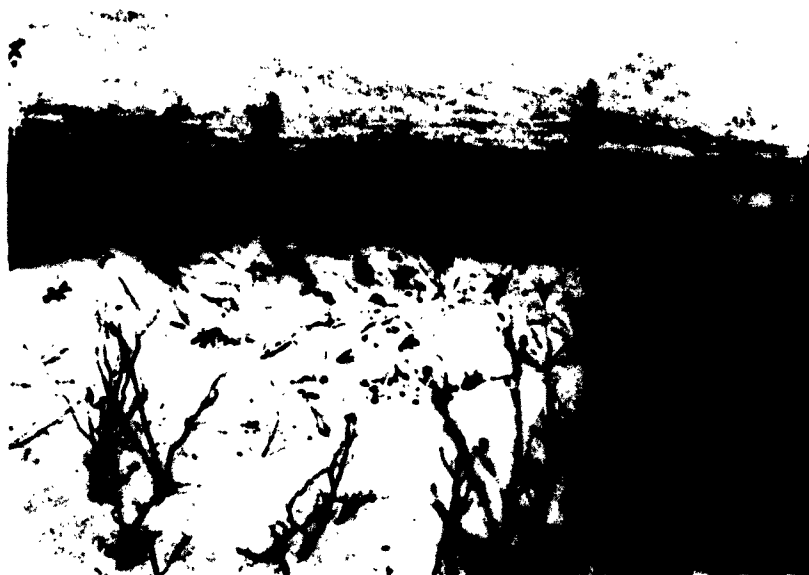
Figure 22. Semiprepared trail in northern part of maneuver area.

(1) Initial movement of the train. On 13 February the train was checked out mechanically; then loaded with 30 tons of POL and 10 tons of rations. The following day, it proceeded along the Richardson Highway to Mile 160. Upon arriving at this point, it was necessary to wait for the engineers to prepare the cross-country trail into the maneuver area. The next morning, the train resumed its movement along the semiprepared trail which was in very good condition and posed no problems (fig. 22). The train averaged from 3 to 5 miles per hour without difficulty. Care was taken to be sure the trail was clear and there was no danger of the tires being punctured.

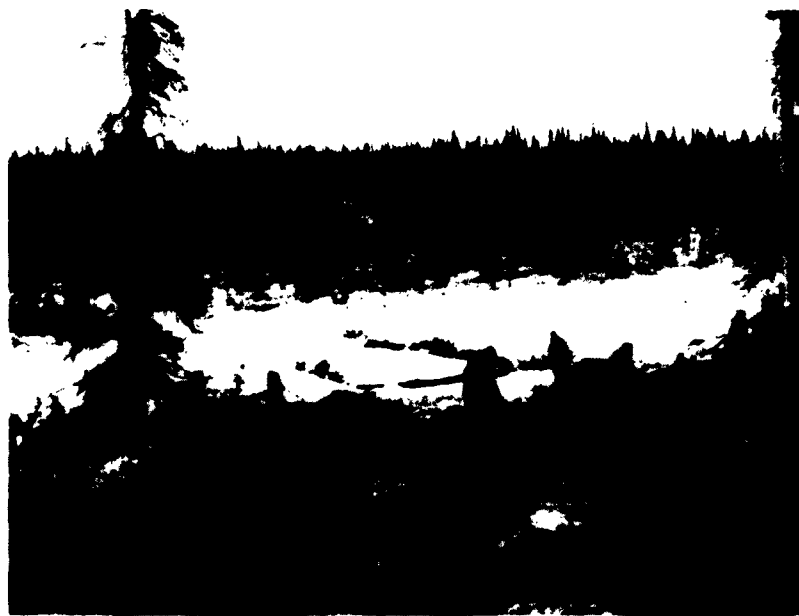
Figure 23. Building ice bridge over Gulkana River.

(2) River crossing. The train continued to move along this semiprepared trail for approximately 5.5 miles before it reached the Gulkana River where an ice bridge had to be constructed (fig. 23). At the crossing site, the river was 200 feet wide and 4 feet deep. The trail across the frozen river was laid out at a 90° angle. The 23-inch depth of the ice on the river was not considered strong enough to support the train. A 16-inch ice bridge was added; this total depth of 39 inches provided sufficient bearing capacity for the train. Using this ice bridge (fig. 24), the train successfully crossed the Gulkana River on the morning of 16 February and continued its movement along the semiprepared trail for another 4 miles. Because one bulldozer broke down and another became immobilized in the muskeg, the engineers were unable to prepare the trail any farther.

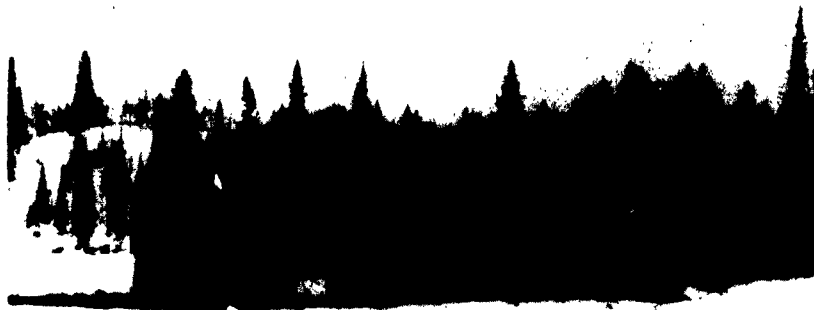
Figure 24. Overland Train crossing the Gulkana River, using the ice bridge.

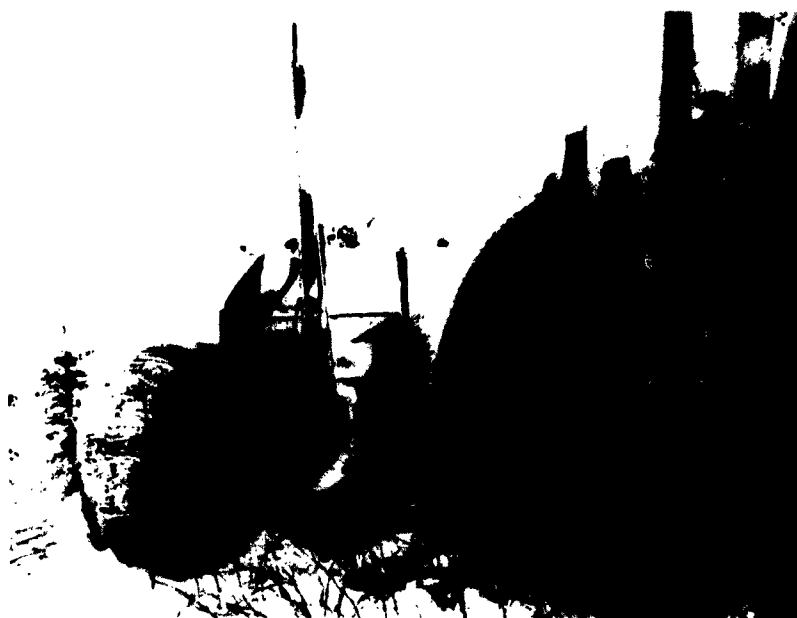
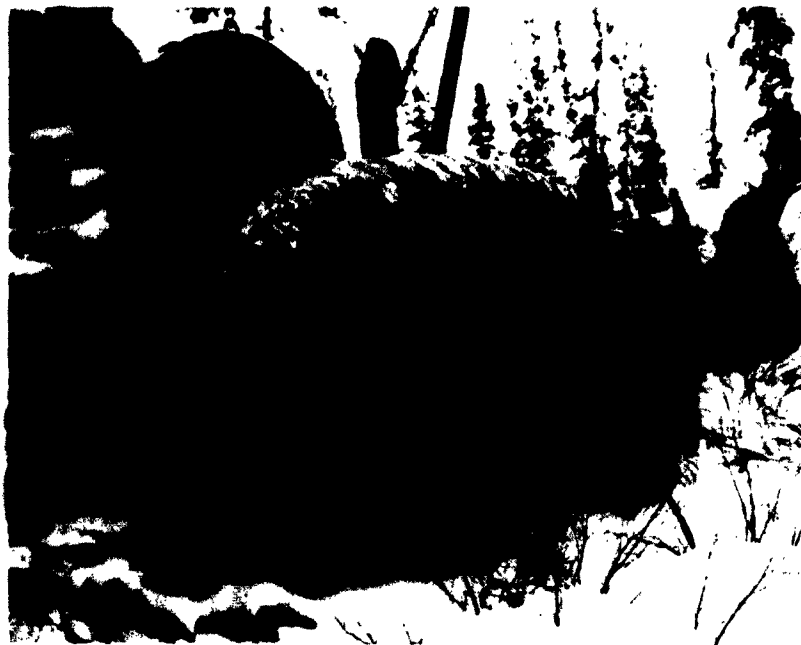
(2) Tire puncture (figs. 27 and 28). After traveling another mile through a relatively thick growth of scrub pine, it was noted that the first powered cargo trailer was tracking out of line. Investigation showed that the tire on the left rear wheel of the power car has been punctured. A spare wheel assembly had to be brought by truck from the GSB to Mile 160 on the Richardson Highway. At Mile 160, the assembly was transferred

Figure 27. Rear view of a punctured tire of power car.

**Figure 28. Side view of punctured tire.**

from the truck to a Nodwell Carrier RN 110 which hauled it to the train. While this was being done, it was discovered that a 5-ton wrecker (M62) was in the area. The wrecker was pulled to the train site by a D-8 tractor to provide the lift capability needed to change the wheel assembly. While the wheel assembly and wrecker were being brought to the train site, the punctured tire was being prepared for removal. It took only 3 hours to change this wheel assembly: no difficulties developed.

(a) Fabrication. The 10-ply tires installed on the train were not fabricated to withstand operations over such terrain as that encountered in the maneuver area. Three tires on the power car were punctured by frozen stumps during the exercise. The side walls of other tires were damaged by being run or jammed against frozen trees or stumps (fig. 31). It is probable that tires of even heavier construction would have been damaged in this operation. Heavier-ply, metal-reinforced tires would probably be less susceptible to puncture.

essential that a spare wheel assembly be carried on the train. Since transporting a wheel assembly in a powered cargo trailer would result in the loss of valuable cargo space, the train should be equipped with a spare wheel assembly rack. The rack should be designed so as not to increase the overall height or width of the train.

(c) Tire repair kit. On-vehicle materiel should include a tire repair kit. Small punctures could be temporarily repaired in the field without removing the wheel assembly or separating the tire from the rim.
