# PROGRESS REPORT

Determination of Engine Condition

Spectrographic Analysis of Engine

Jack F Witten Bureau of Naval Weapons

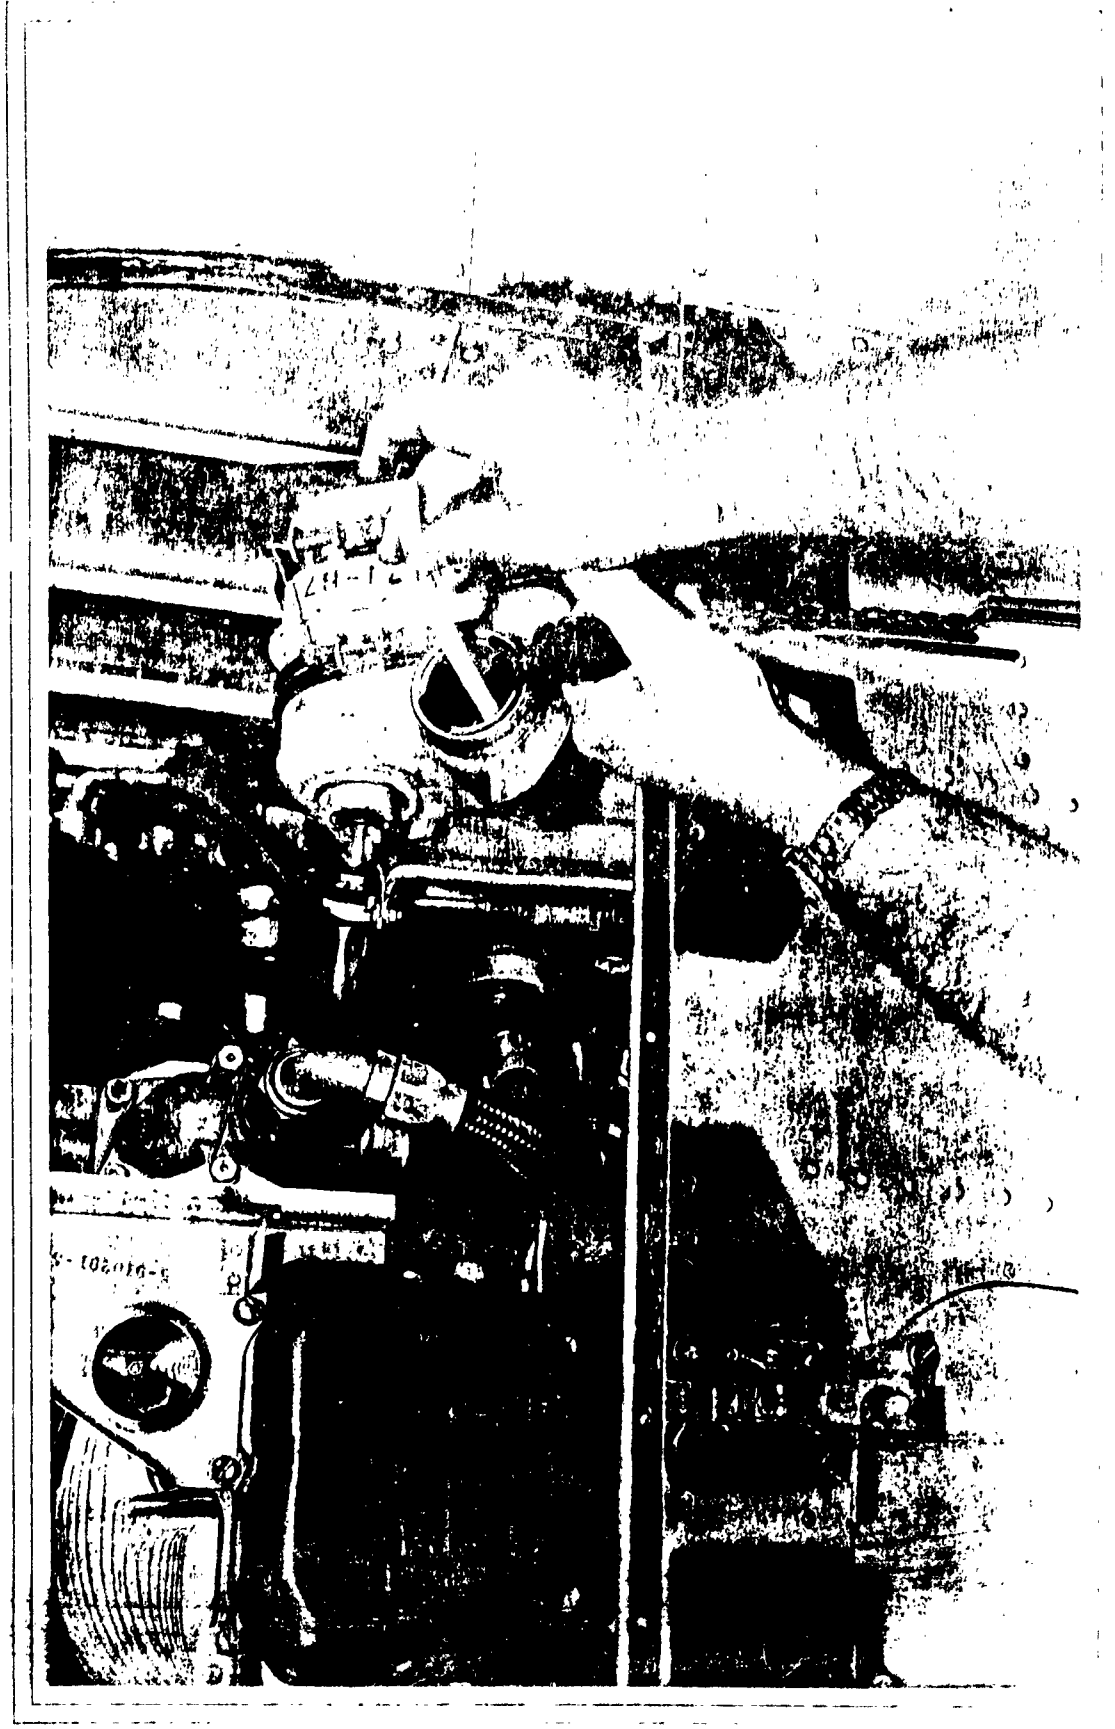
# SAMPLE BEING TAKEN FROM AIRCRAFT OIL TANK

To take a sample, the tube is inserted in the oil tank filler neck, a finger is placed over the end of the tube and a sample is withdrawn and placed in the bottle. The engine operating hours and serial number are entered on the data sheet. The data sheet and sample are air mailed to Pensacola.
