DGRP-TR-61-2

ESTABLISHING PROVEN DESIGN CRITERIA  
FOR CRYOGENIC BOOST TANKS

QUARTERLY PROGRESS REPORT  
PERIOD ENDING 31 JULY 1961

BEEHCRAFT RESEARCH AND DEVELOPMENT, INC.  
BOULDER, COLORADO

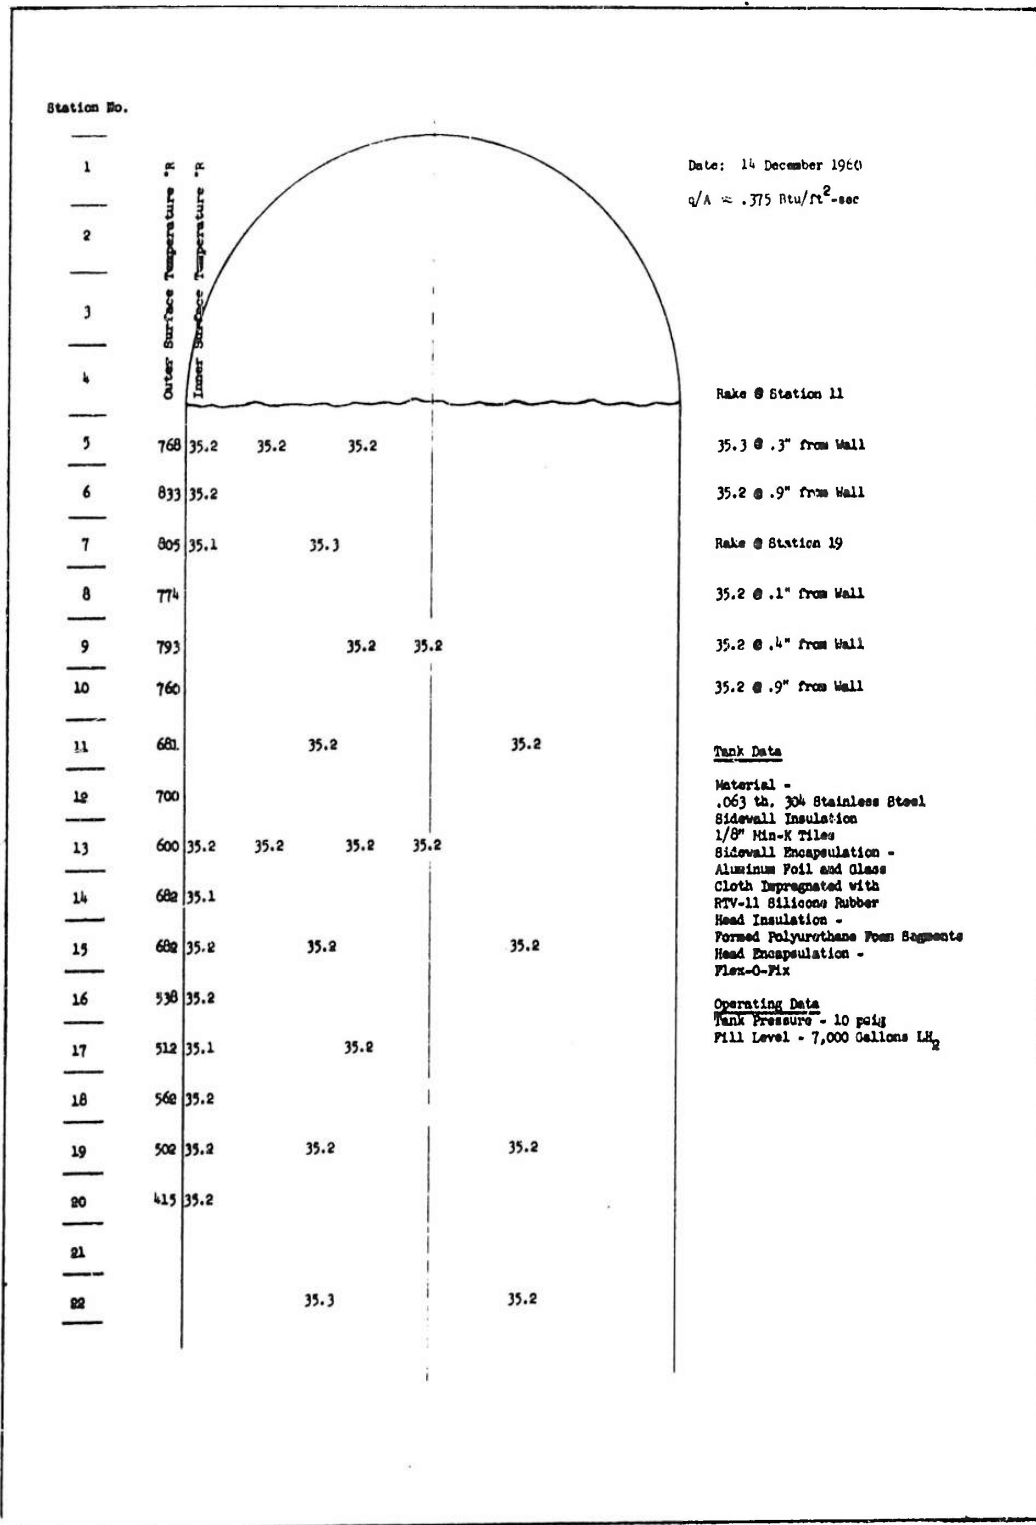
FIGURE 11  
TEMPERATURE DISTRIBUTION  
STAINLESS STEEL TANK THERMAL TEST

A pertinent tank description is that of a 7,000 gallon capacity, liquid hydrogen fill, 1/8" Min-K insulated, stainless steel, pressure stiffened tank. The pressurization was provided by hydrogen gas boil-off maintained at 10 psig.
