TCREC TECHNICAL REPORT 61-127

**FABRICATION AND FIELD EVALUATION OF A**  
**HIGH-CAPACITY, HIGH-EFFICIENCY CHARGE AIR FILTER SYSTEM**  
**FOR ARMY AIRCRAFT**

**FRAM CORPORATION**  
Providence, Rhode Island

(Phase II, Evaluation of H-23C Engine Air and Lube Oil Filter  
System by Radioactive Tracer Techniques)

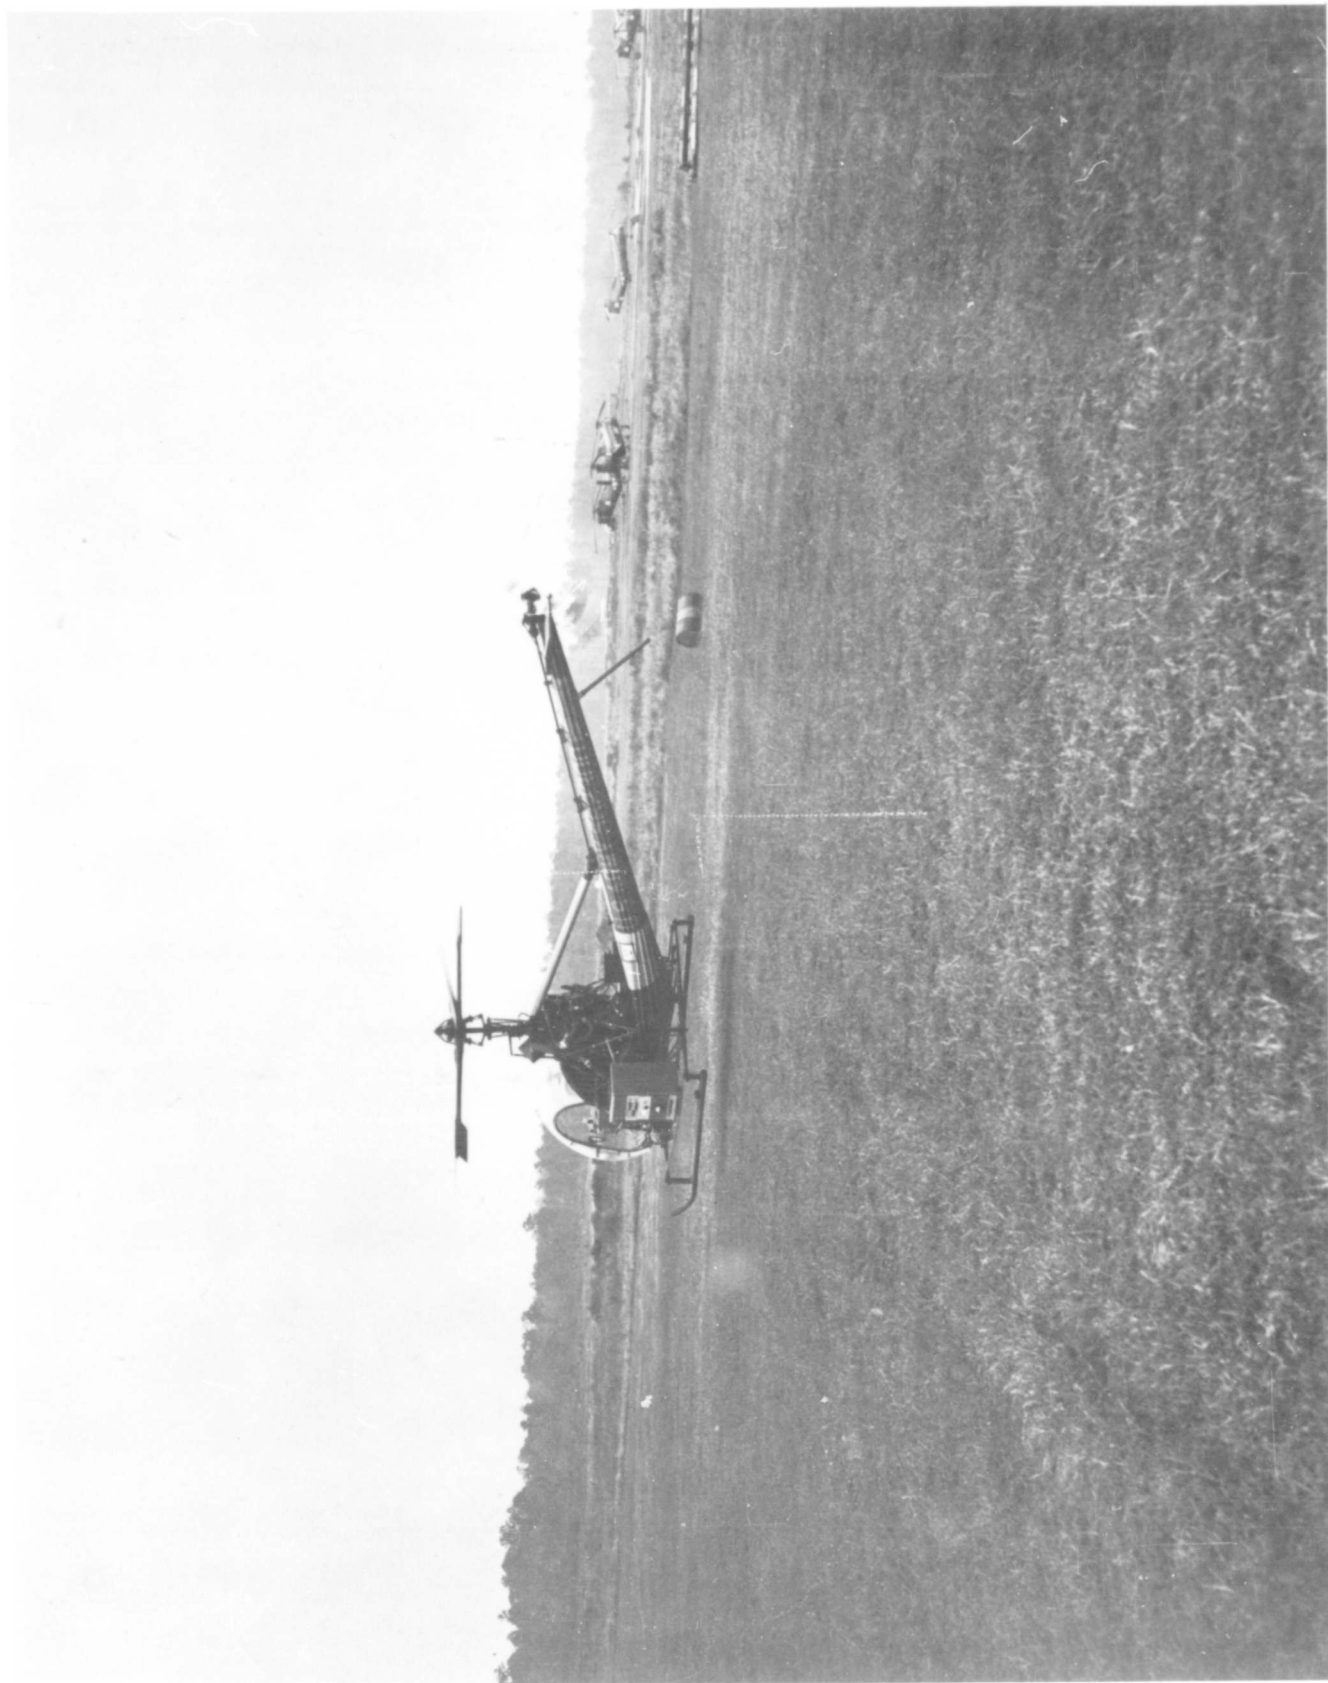
Figure 5. Radioactive Tracer Flight Test H-23C Helicopter
