Air force surveys in geophysics  
No. 127

Investigations of ice-free sites for aircraft landings  
in East Greenland, 1959

Joseph H. Hartshorn  
George E. Stoertz  
Allan N. Kover  
Stanley N. Davis

September 1961

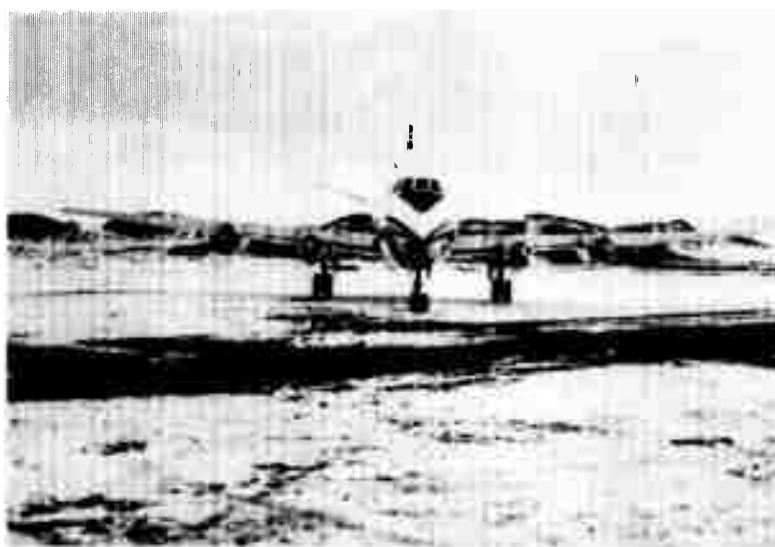
Photograph 1. Aircraft operations in East Greenland and North Greenland are exemplified by this view of a commercial prop-jet Viscount on a snow-covered, unsurfaced airstrip at Mesters Vig. Increasing use of the northern airways by commercial and military aircraft and the abrupt and severe changes in weather common in this area have created a need for emergency landing areas to supplement existing airfields. Date: 9 September 1959.

Both American and Danish authorities have noted the need for additional emergency landing fields in northern and eastern Greenland to supplement existing airfields at Nord, Mesters Vig, and elsewhere (Photograph 1). Groundhog III (1959), in addition to advancing general objectives set by previous Groundhog operations, had been asked by the

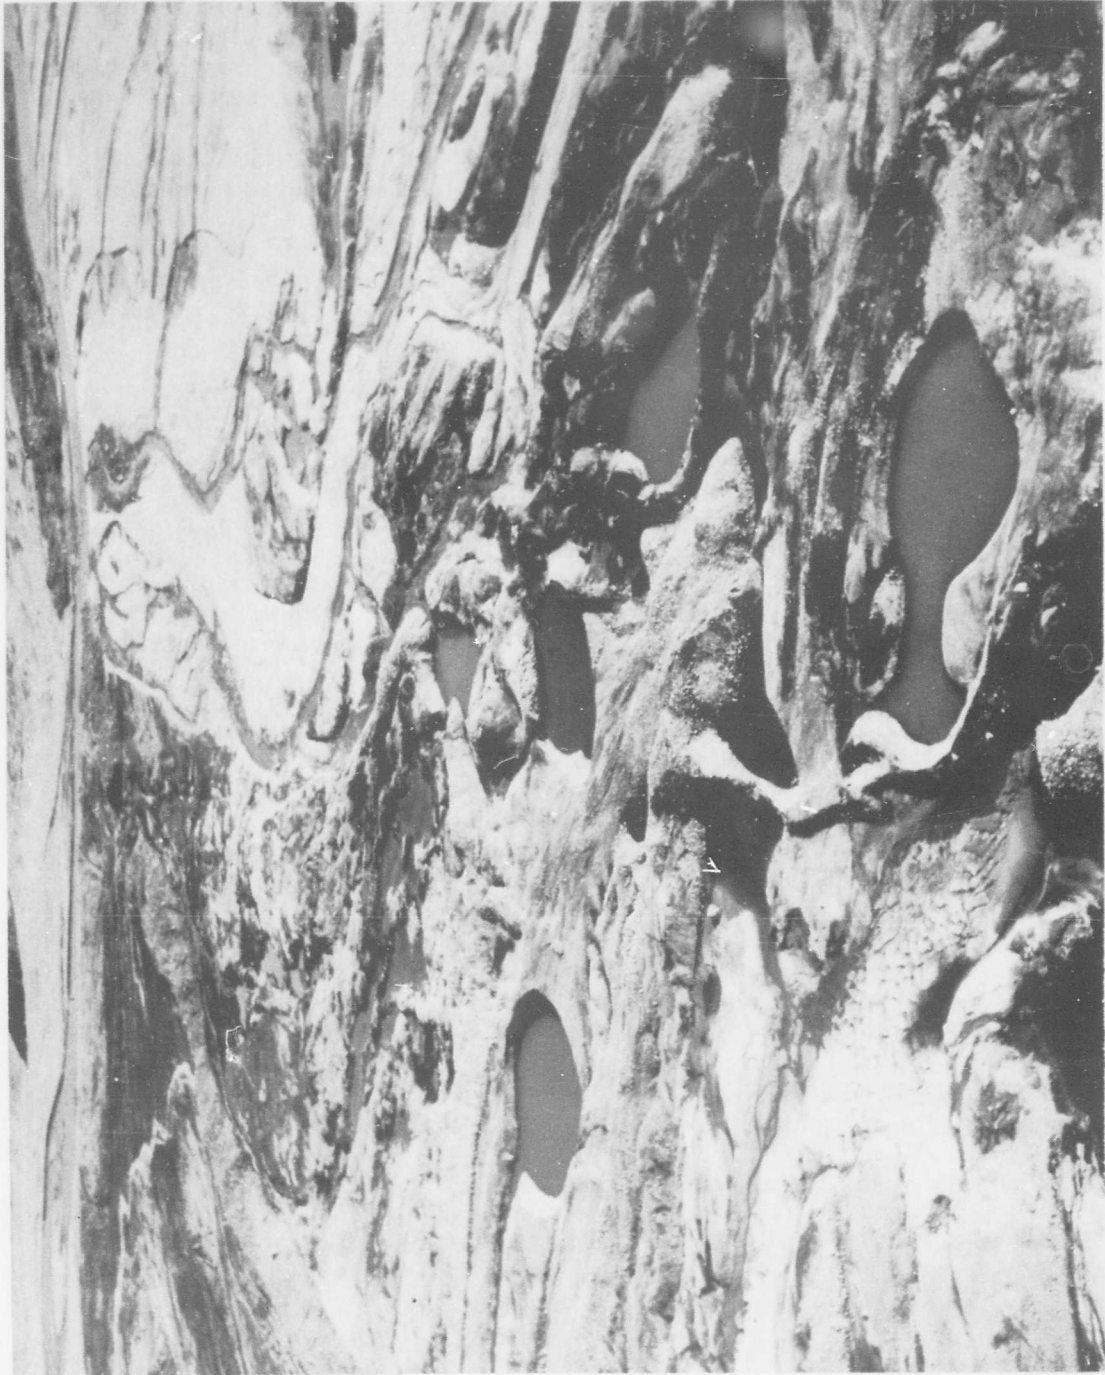
Photograph 2. View near Charcot Glacier. Slumped and pitted older outwash in foreground, deposited on and around blocks of stagnant ice; younger outwash in right background. End moraine runs diagonally across picture in left background, Charcot Glacier off to right. Elevation approximately 600 feet. Date: 20 August 1959.

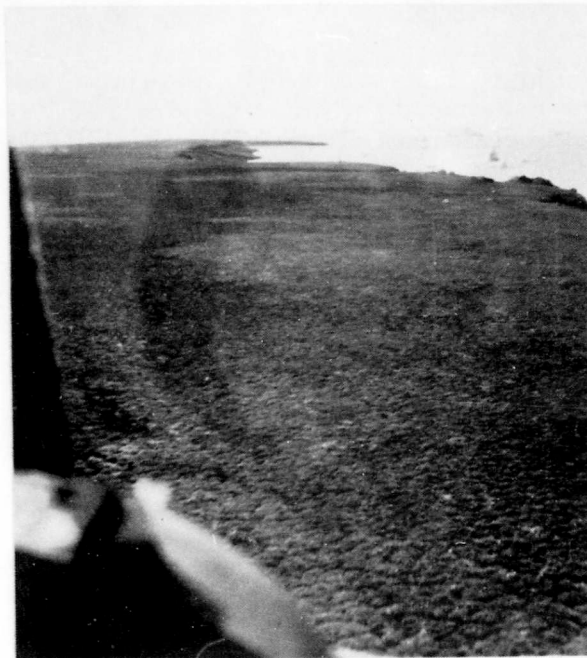
Slope and microrelief. The surface is fairly flat, with one or two gentle rolls less than 5 feet deep within a horizontal distance of 200 to 300 feet. The surface is covered by soil hummocks 2 to 3 feet in diameter and about 6 inches high, separated by narrow depressions in which bare ground is exposed (Photograph 4). These hummocks would make any landing hazardous unless the tops of the hummocks were covered by at least 6 inches of snow, in which case ski-landings would be feasible. There is a possibility that strong winds considerably reduce snow cover on the site area in winter.

Photograph 4. Aerial view southward of the Nordøst Fjord Site (#7) from an elevation of about 100 feet. Soil hummocks hazardous to landings unless covered by at least 6 inches of snow. Large icebergs in Nordøst Fjord (right) and Hall Bredning (left) are visible in background. Date: 19 August 1959.

Recommendations. It is recommended that the site not be used for aircraft landings in summer, but that it be used for emergency landings in winter if better sites are inaccessible.

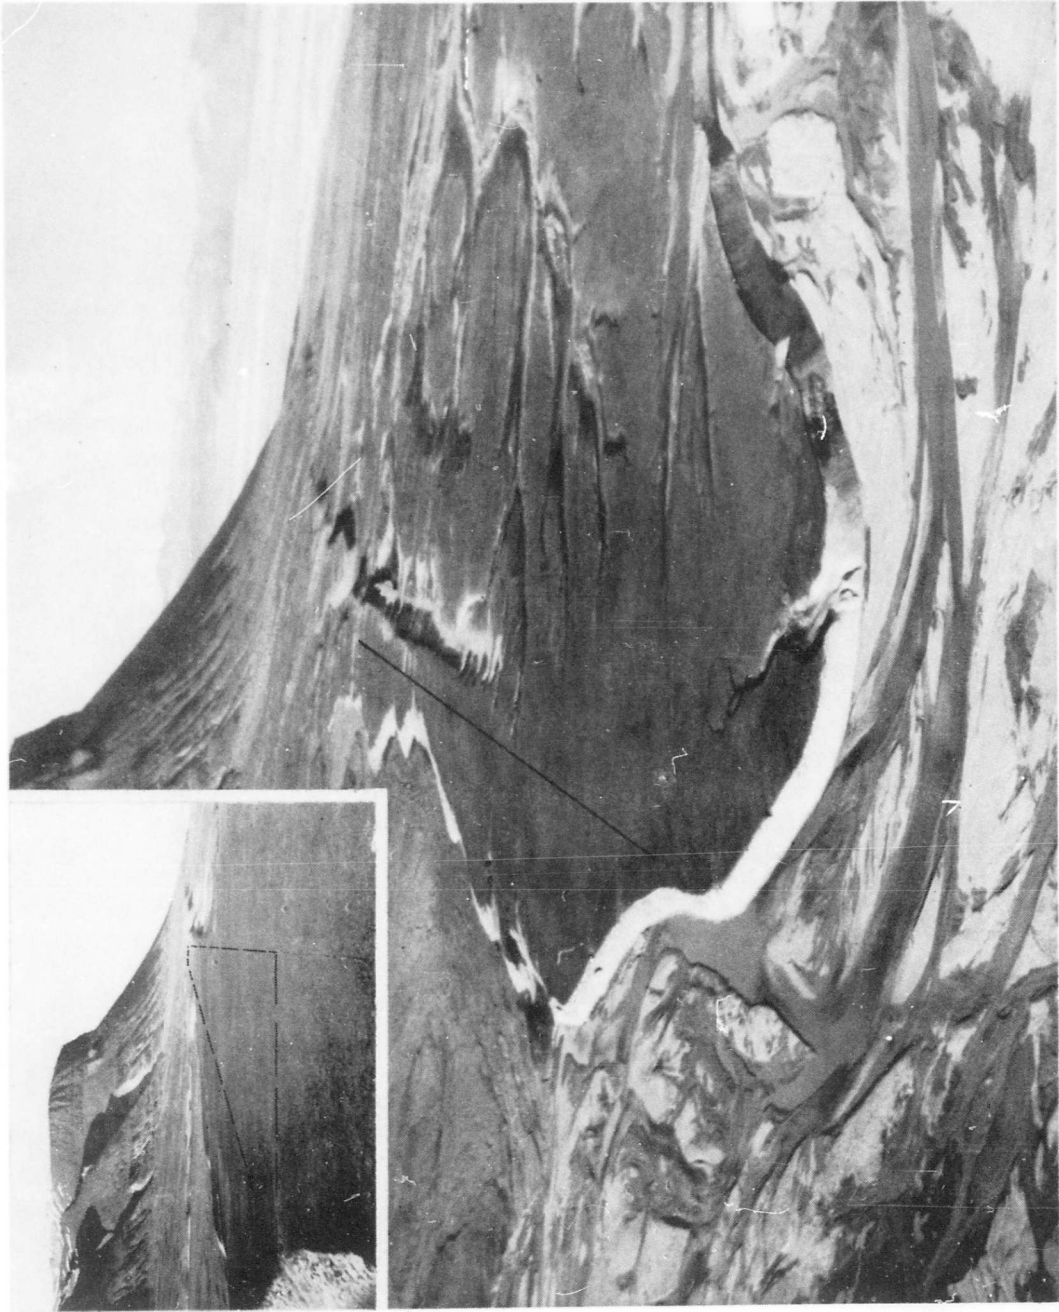
Conclusions. The site appears to be a suitable year-round landing area for aircraft with ground runs up to 3500 feet long. However air approaches are only fair to poor (fair from northeast, poor from southwest) and crosswinds may be prevalent. The site is the best emergency landing area for large aircraft known in East Greenland south of Mesters Vig (lat. 72° 14' N). Its location midway between the airfield at Mesters Vig and the short airstrips near Scoresbysund makes it well-situated as an emergency landing site for aircraft flying along the east coast of Greenland.

Photograph 5. Aerial views of the Carlsberg Fjord Site (#10), looking northward along a ridge of dissected valley fill, perhaps outwash gravel, located in valley on west side of Carlsberg Fjord. Centerline and outline of a potential 4000-foot runway are shown, oriented approximately N30° E. Date: 27 August 1959.

Recommendations. It is recommended that investigations be completed on the ground at the Carlsberg Fjord Site, including exact location and marking of runway and better evaluation of topography and soil conditions.

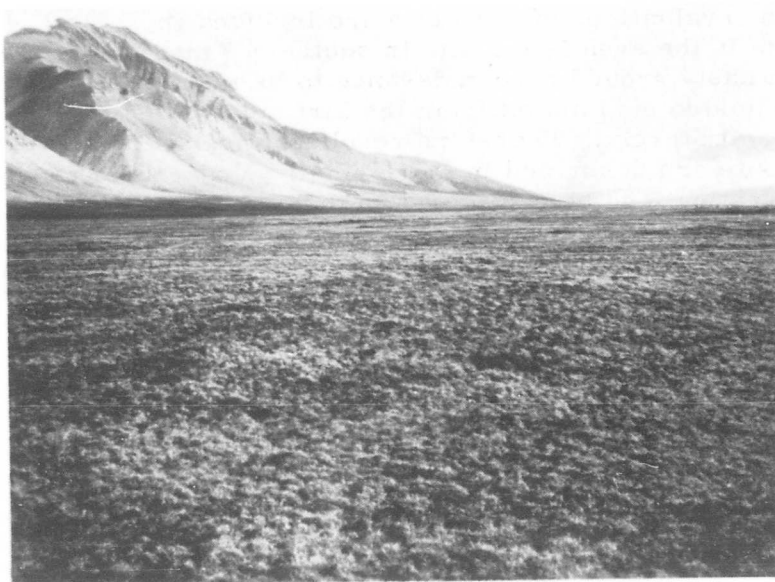
Slope and microrelief. The surface is fairly smooth, as shown by Photograph 6. A few very shallow swales cross the landing area and a few boulders less than 2 feet in diameter may have to be removed, depending on the exact location of the runway. Longitudinal slope is very low; transverse slope is estimated to be between 2 and 4 percent.

Photograph 6. Possible emergency landing area in southern Ymer Ø (Site #21). View east along the gently sloping coastal plain at the juncture of Kong Oscar Fjord and Sofia Sund. A few shallow swales cross the area and a few boulders are visible. Date: 30 August 1959.

Soil characteristics. Hasty penetrometer tests indicate that the strength of the upper 4 or 5 inches of soil is low, probably consisting largely of vegetation and silty sand. A thin mantle of wind-deposited silt or fine sand may be present. Within 6 to 8 inches below the surface the soil becomes coarser and the strength increases rapidly. During melt season, the surface is probably moist and softer. Bearing strength in late summer is estimated to be adequate to support emergency landings by cargo planes such as a C-130.

Conclusions. The site appears to be a suitable landing area in winter or summer, but may become too moist and soft during, and shortly after, the melt season.

Recommendations. It is recommended that investigations be completed on the ground at the Ymer Ø Site, including exact location and marking of runway, and better evaluation of topography and soil conditions.

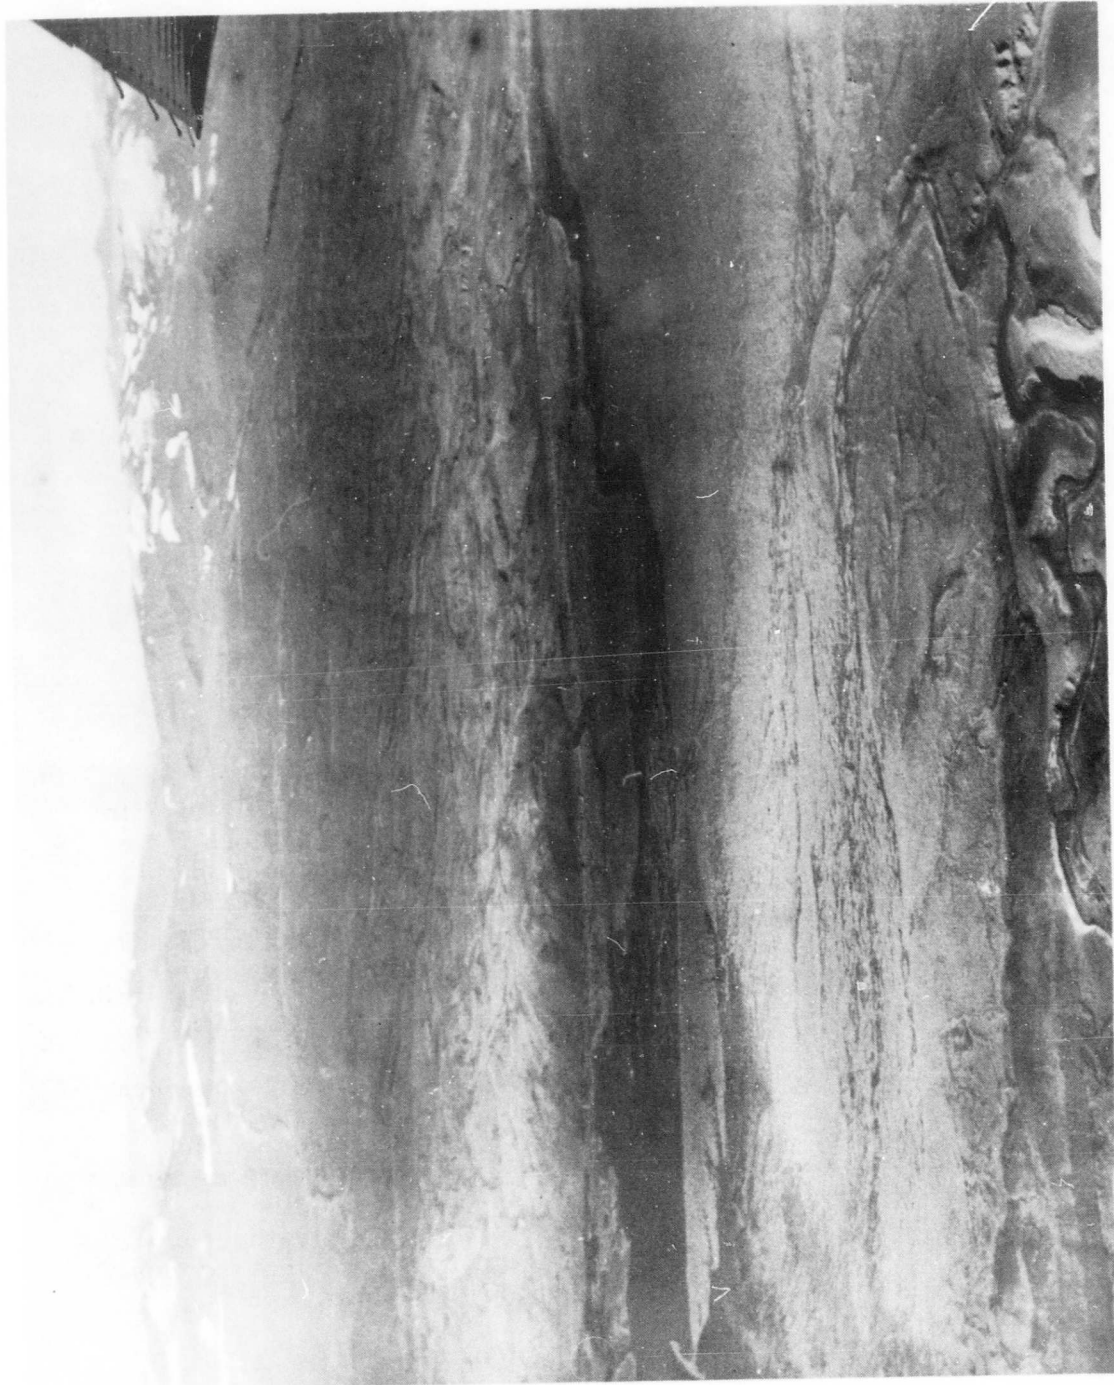
Broad extensive lowlands occupy the southeastern part of Hold With Hope and the area between MacKenzie Bugt and the heads of Loch Fyne and Moskusoksefjord. The lowland of southeastern Hold With Hope is known as Østersletten. Much of the lowland topography of this area is hummocky, characterized by scattered low hills and poorly drained boggy depressions. These areas are principally underlain by glacial moraine, consisting of an unconsolidated, unsorted mixture of silt, sand, and gravel, containing scattered cobbles and boulders. Areas of relatively flat-surfaced outwash and alluvium are also present. The highlands in this area, including those of Hold With Hope and eastern Gauss Halvø, are composed largely of basalt (of Tertiary age). The lower slopes of the basalt mountains are characterized by parallel bedrock terraces defended by successive flows of basalt. Terraces of this type are found along the west side of Hold With Hope, bordering the broad lowland at the head of Loch Fyne. One of the outstanding features of that lowland is an exceptionally flat, emerged bottom-land that extends for a distance of several miles south of Loch Fyne (Photograph 7).

Photograph 7. View eastward across the broad lowland at the head of Loch Fyne. In the foreground is an emerged bottom-land that extends for a distance of several miles south of Loch Fyne, which can be seen on the left margin of the photograph. Elevation approximately 3000 feet. Date: 30 August 1959.

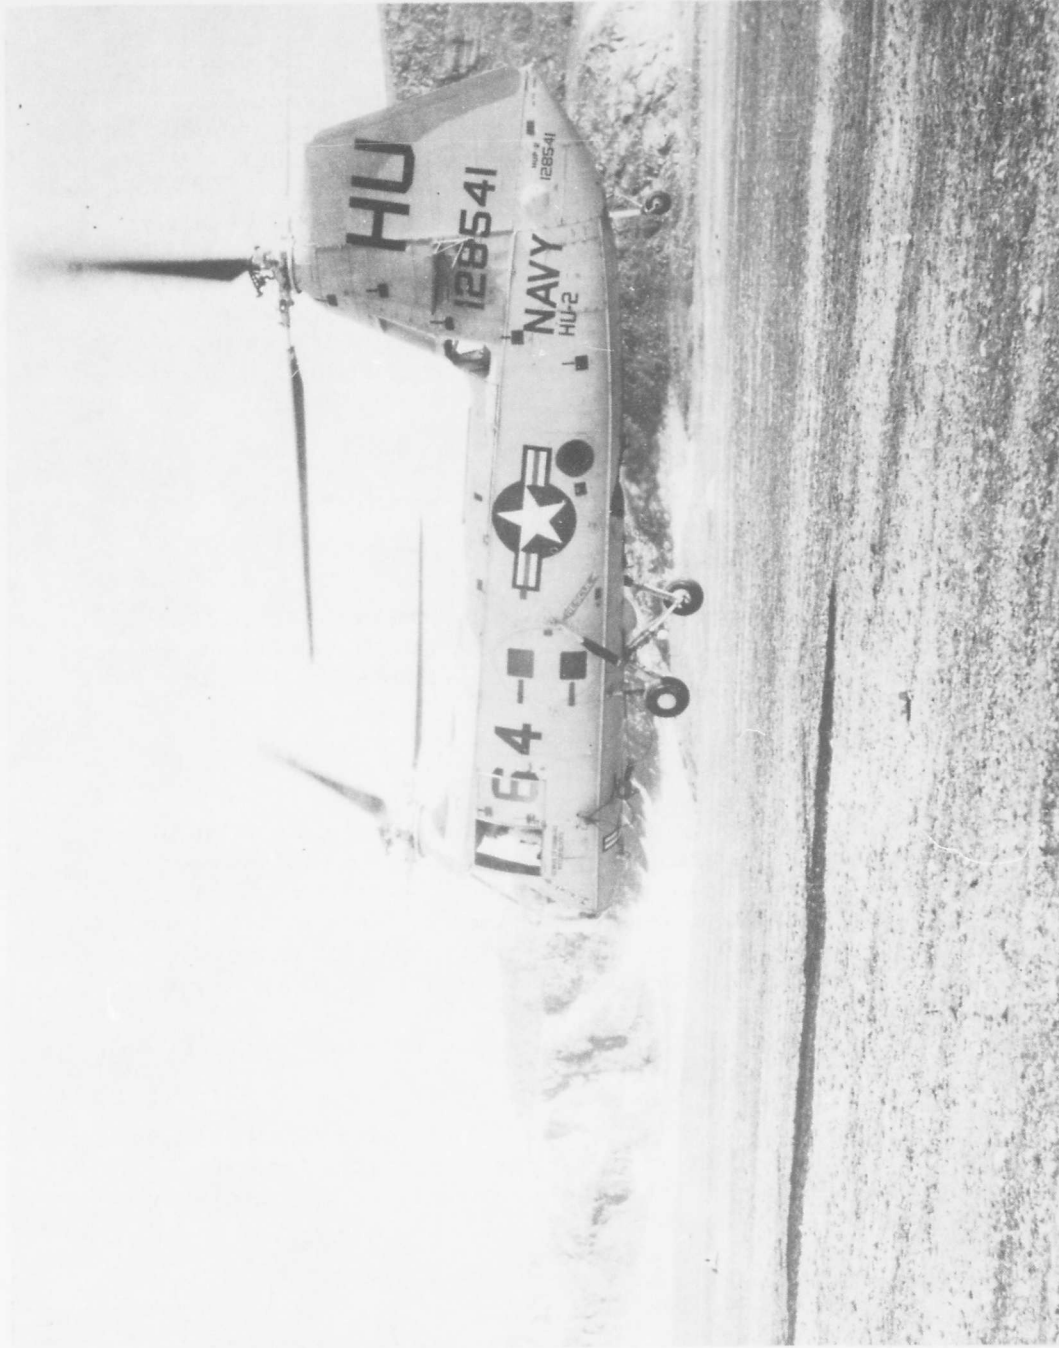
Photograph 8. HUP-2 helicopter at Hvalrosbugt Site. HUP-2 used for helicopter operations taking off from unprepared landing strip on outwash plain at Hvalrosbugt, one mile north of the village of Scoresbysund. Date: 18 August 1959.

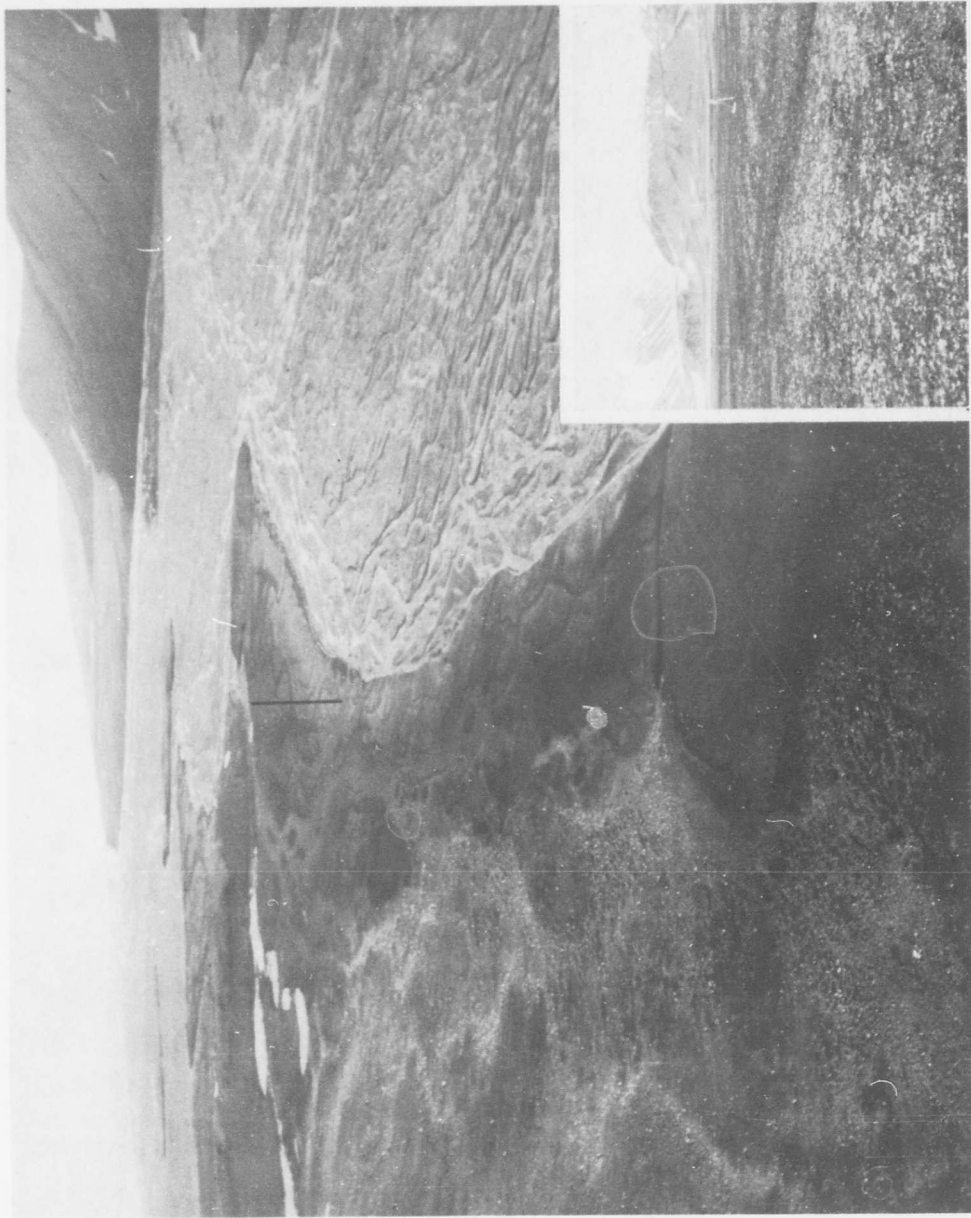
Photograph 9. Ground and aerial views of the Jaettedal airstrip (Site #2L). Aerial view is southwest toward Rosenvinge Bugt, showing location of centerline. Ground view is along the centerline from near the south end. The range poles mark the centerline; the flags mark the edges. The site is smooth and free of microrelief features with the exception of shallow swales, such as the one shown in the foreground, about 6 inches lower than the predominant level of the landing strip. However these are nearly parallel to the runway and would not impede landings and takeoffs. View northeast. Date: 21 August 1959.

The Jaettedal Site is recommended for use in support of Scoresbysund and Kap Tobin if Danish authorities desire to: (1) increase some safety factors such as runway length; (2) use aircraft with longer ground runs than those presently in use at Scoresbysund; (3) increase significantly the number of landings and takeoffs in the area; or (4) have an alternative NE-SW strip available for use during repairs or improvement of the present site at Hvalrosbugt.

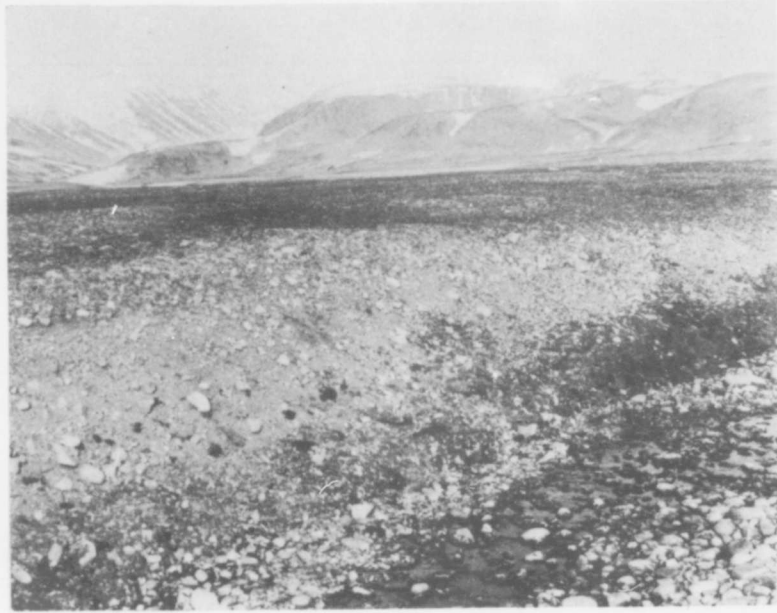
Photograph 10. Terrace of outwash gravel and sand on which the Jaettedal airstrip is situated, about 6 feet above the flood plain of the Jaette. Abundant sand and gravel can be obtained from the flood plain or from the edge of the terrace. A test landing by a Dornier (DO-27) demonstrated that the natural surface will safely support that aircraft and will probably support landings by an Otter (DHC-3) or a Caribou (DHC-4). View northeast. Date: 21 August 1959.

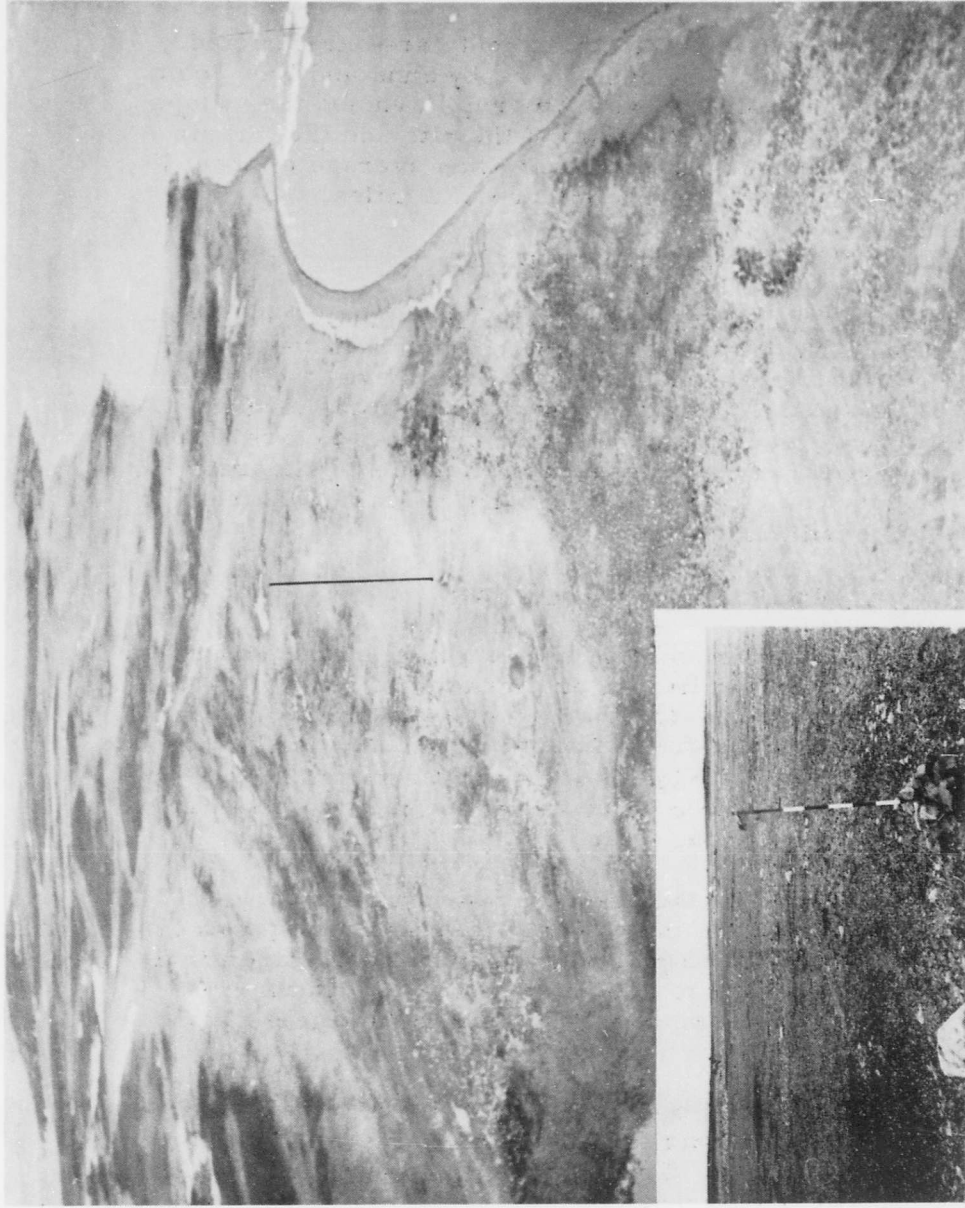
The bedrock, thinly mantled by surficial debris, is of two main types: (1) a biotite-quartz-feldspar schist, with some amphibolitic schist; and (2) a granite gneiss. Both rocks tend to split into angular slabs under the impact of weathering.

Photograph 11. Ground and aerial views of the Kap Tobin Site (#11). Aerial view is southward toward Kap Tobin (center background), showing location of centerline. Ground view is along the centerline from the north end. The range pole marks the centerline of the strip. If it is essential to have a short landing strip near Kap Tobin, this is considered to be the best available site for constructing a 710-foot x 100-foot strip with a minimum of effort. The site is at present unsuitable for aircraft landings because of scattered large cobbles and boulders. View south. Date: 17 August 1959.

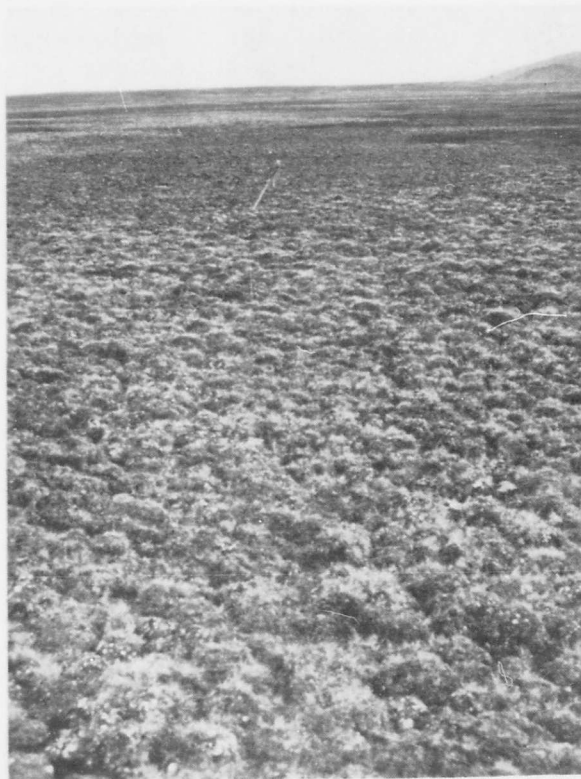
In some areas, possibly where the mantle of wind-deposited silty sand is thinnest, the hummocks would be small enough to permit safe landings and takeoffs by a C-130, provided that the length of the area was sufficient and other safety factors adequate. In such areas the typical dimensions of hummocks are thought to be 6 to 12 inches in diameter and 2 to 6 inches high (Photograph 12). Such an area is found along the 11,500-foot strip, extending from 4000 feet to about 6500 feet from the northwest end of the strip. In winter, 6 inches of snow cover on the tops of hummocks is considered sufficient to permit safe ski-landings by light planes. Even when the ground is free of snow it is reported that skis, retracted a few inches above the tire tread, may assist in landing some planes with small tires (such as the Dornier, DO-27) on hummocked areas.

Photograph 12. Typical surface near center of 11,500-foot runway site near Storelv, showing typical size of hummocks that occur from 4000 to about 6500 feet from the northwest end of the strip. Typical dimensions of the hummocks shown are 6 to 12 inches in diameter and 2 to 6 inches high. Hummocks of this size would probably permit safe landings and takeoffs by planes of the C-130 type. View is S15° E, along the center-line, near its midpoint. Date: 1 September 1959.

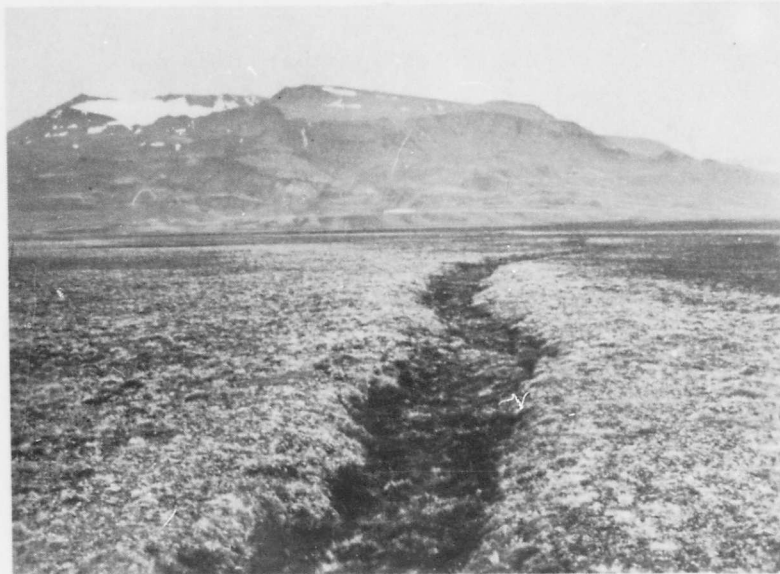
Photograph 13.  
Frost crack that crosses center of surveyed runway site at Storely.

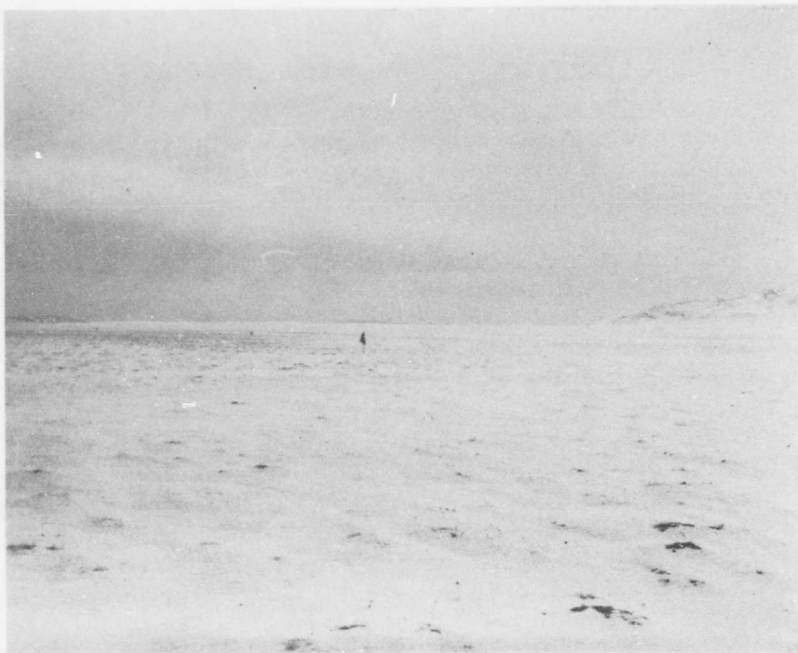
Photograph 14.  
View along the surveyed runway at Storely after snowfall. View is from the northwest corner, looking southeast. The flag in the foreground marks the corner of the strip, which is 200 feet wide. The centerline extends into the background and to the right, marked by flags spaced 500 feet apart, at least two of which are visible near the corner-marker. Date: 5 September 1959.

path. For this reason the northwest approach to the site must be considered inadequate for a landing strip longer than about 6000 feet or for a landing strip that starts within 3000 feet of the northwest end of the 11,500-foot strip.

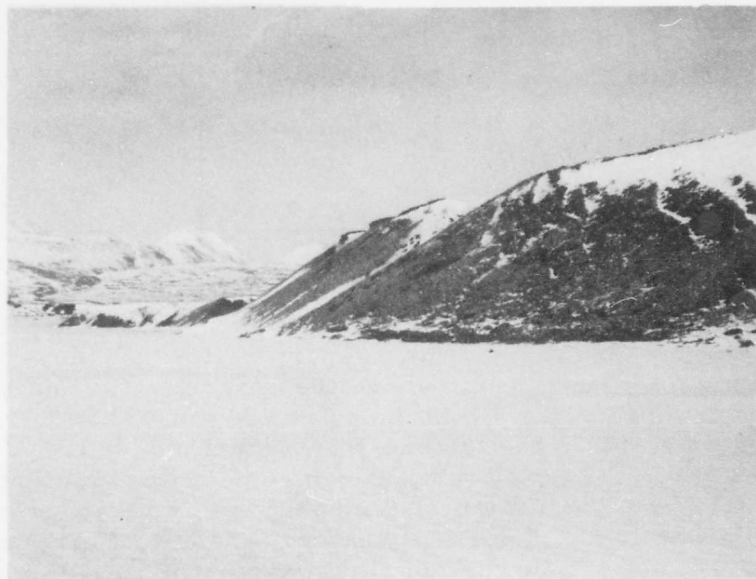
Photograph 15. Abundant sand and gravel for construction can be obtained from the edges of outwash terraces within one mile of all possible airfield sites in the Storelv area. Steep, bare, south-facing slopes such as this one have a deep permafrost table, permitting easy excavation during summer. View: WNW from point 2 3/4 miles southwest of campsite. Date: 6 September 1959.

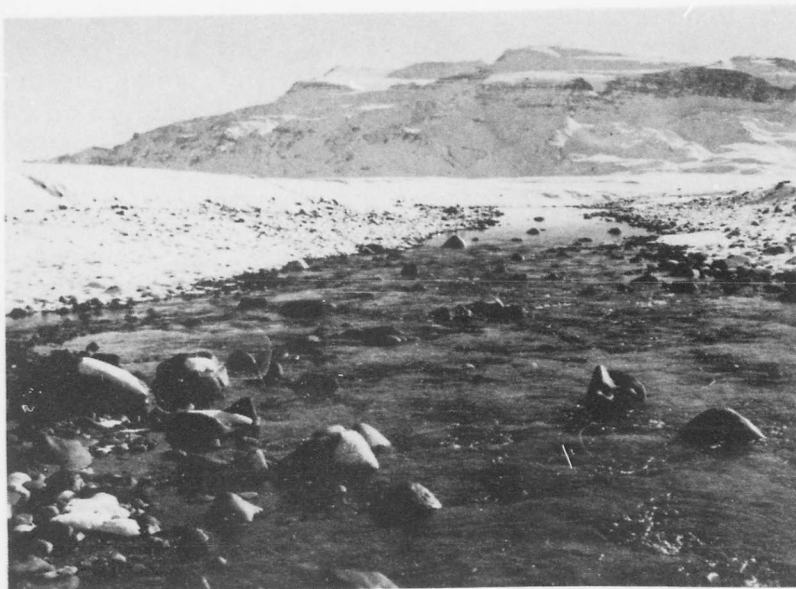
Storelv is located less than 500 feet from either the northwest end of the proposed landing strip, from the campsite and cache, or from either of the two short landing strips. The river is a good source of drinking water in summer (Photograph 16), but in winter would probably

Photograph 16. Storelv at period of low discharge (early September). View south in the narrows 1 1/2 miles southwest of the campsite and 1 mile downstream from Sampling Site 34. The river and its tributaries are good sources of drinking water in summer, but in winter would probably be completely frozen. Date: 3 September 1959.
