ANPP CORROSION PROGRAM

Final Summary Report

MND-E-2727

February 1962

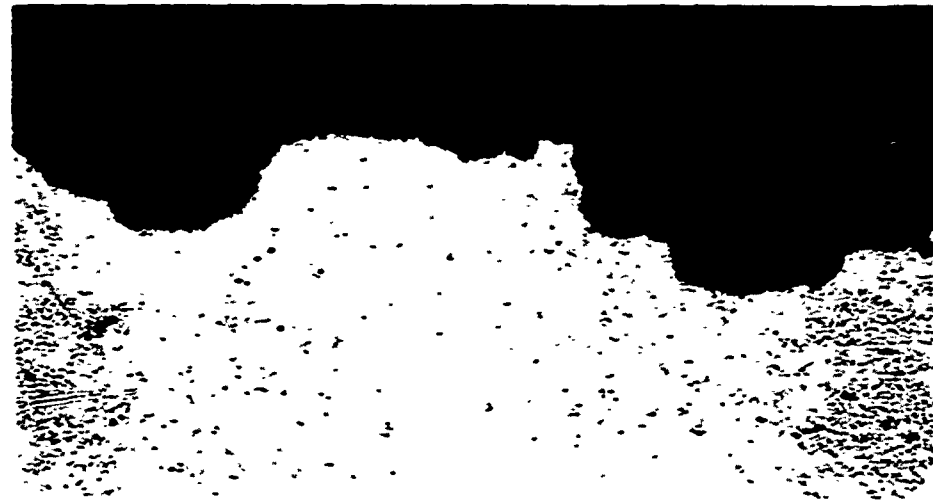
**Fig. 24. Section Taken from Secondary Side Tube Exposed to Steam Phase-- Worst Case of Pitting Seen in MIN 4 or MIN 5**

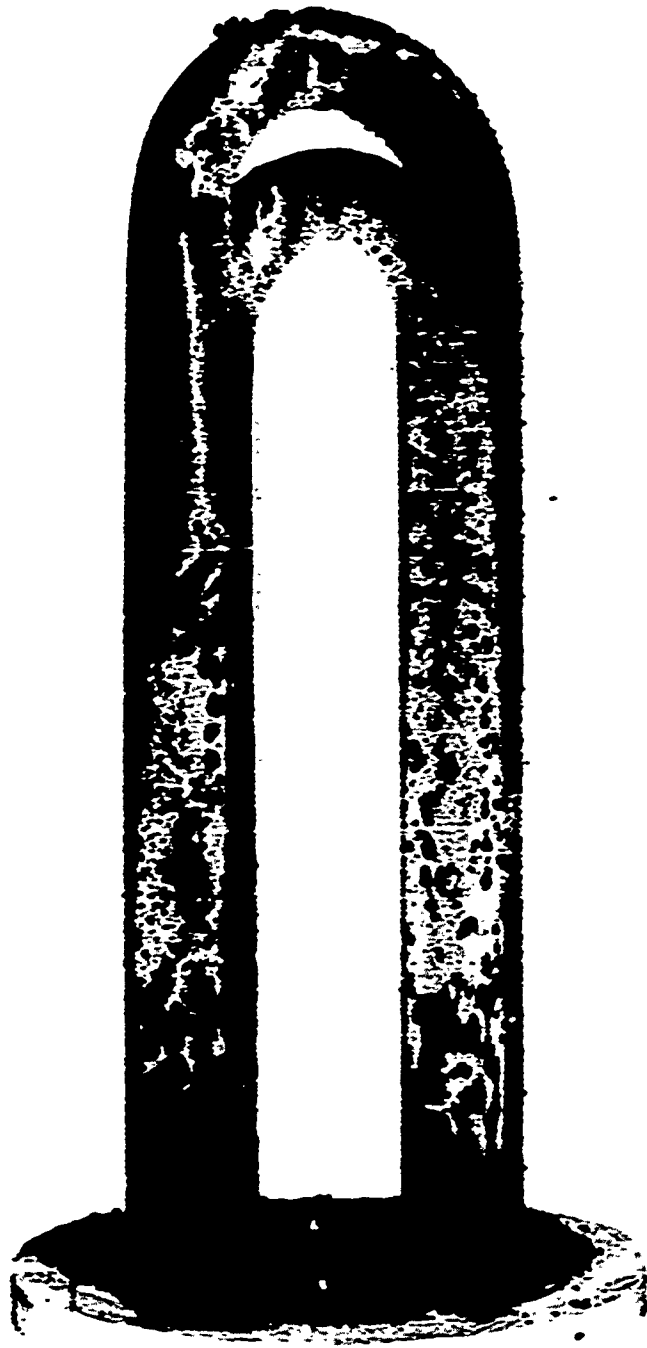
Fig. 25. MIN 7 with Secondary Shell Removed

Figure 25 shows the tubes with the corrosion products as removed from the shell. Examination of the secondary tube and tube sheet surfaces revealed no evidence of cracks, as expected.

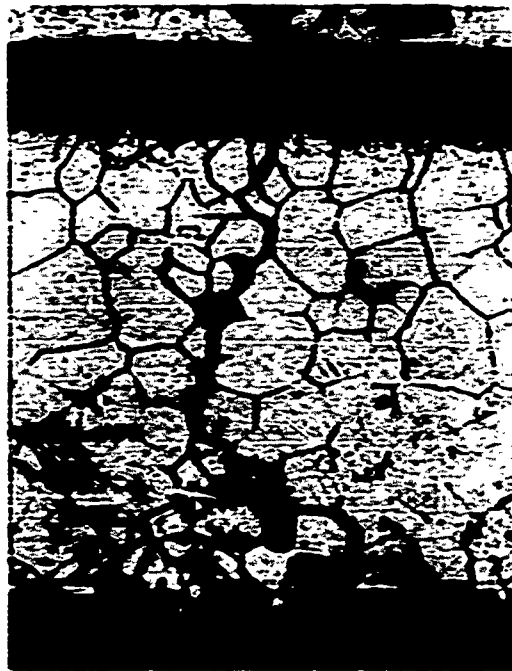
**Fig. 26. Intergranular Cracking in Type 304 SS  
Clad of Bimetal Tube Containing Numerous  
Irregularities (MIN 7) Magn 250x**

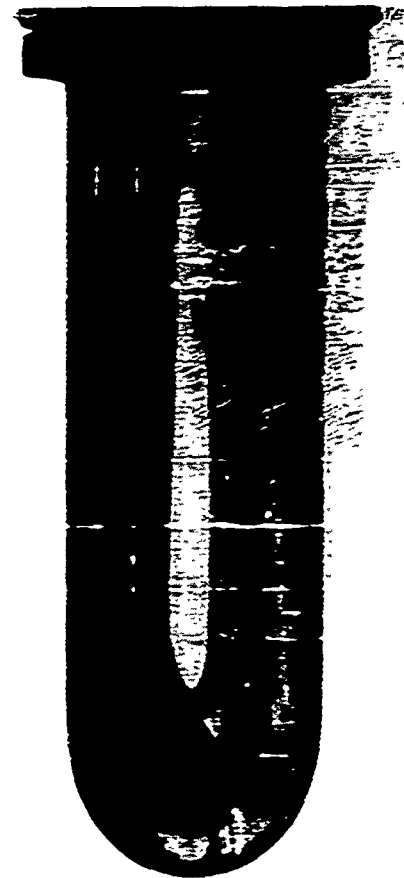
Fig. 28. Overall View of MIN 9, Note Pale Yellow-Green Film on Submerged Portion of Tubes

The visual appearance of MIN 9 contrasted sharply with the appearance of MIN 8. Figure 28 shows the unit with the secondary shell removed. The pale yellow-green film on the submerged portion of the tubes was less than 0.1 mil in thickness. X-ray diffraction identified two dominant structures in the film from the submerged tubes--a distorted NiO-H<sub>2</sub>O structure with traces of Fe<sub>2</sub>O<sub>3</sub>. The portions of the tubes exposed to vapor had very little corrosion film except at the point where water, condensed by the cooling coil, dripped onto the tubes. Some areas of the tubes showed bright metal. A metallographic cross section of the submerged tube, after cleaning, showed some isolated areas of slight pitting in the range of 1 to 2 mils in depth. Environmental solids were again found in the crevices of the unrolled tube.

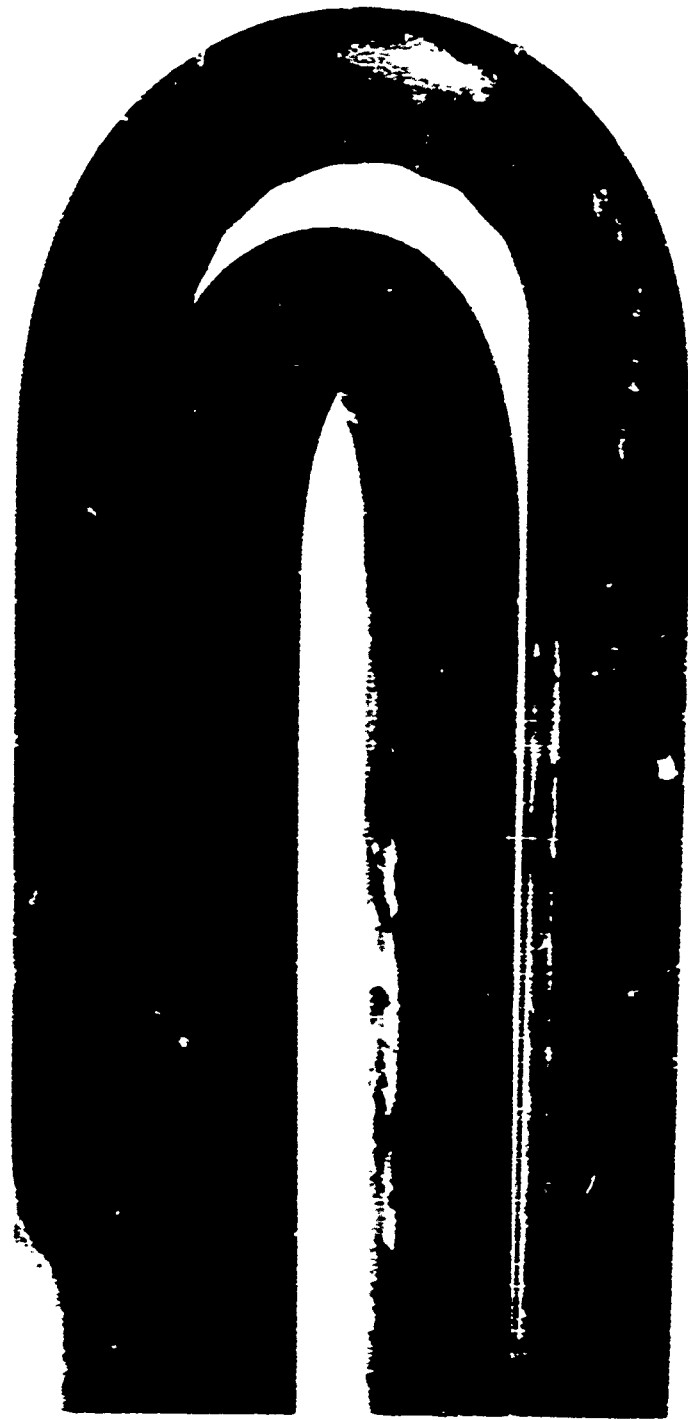
MIN 18 was tested for 1385 hours. Figure 36 shows a closeup of the tubes before they were cleaned. The secondary surfaces were free of any measurable quantity of a corrosion film. There was a dark gray discoloration on the tube surfaces in both vapor and liquid phases. The thin deposit on the tubes was mostly  $Fe_3O_4$  in both the vapor and liquid phases. There was a very small deposit of corrosion products at the interface. The submerged portions of the tubes were slightly darker than the portions exposed to the vapor phase. In MIN 18, all the tube-to-tube sheet joints were expanded, and there was no penetration of the joints by the secondary environment. The tubing was pitted and the extent of attack was about equal to the attack on the Monel tubes in MIN 13. There was little difference in the extent of attack between the vapor and liquid phases. The pits ranged up to 5 mils in depth.

Fig. 36. MIN 18--Appearance After 1385 Hours of Testing
